**FOR INFORMATION**

UPPER FLOOR PLAN 1:50

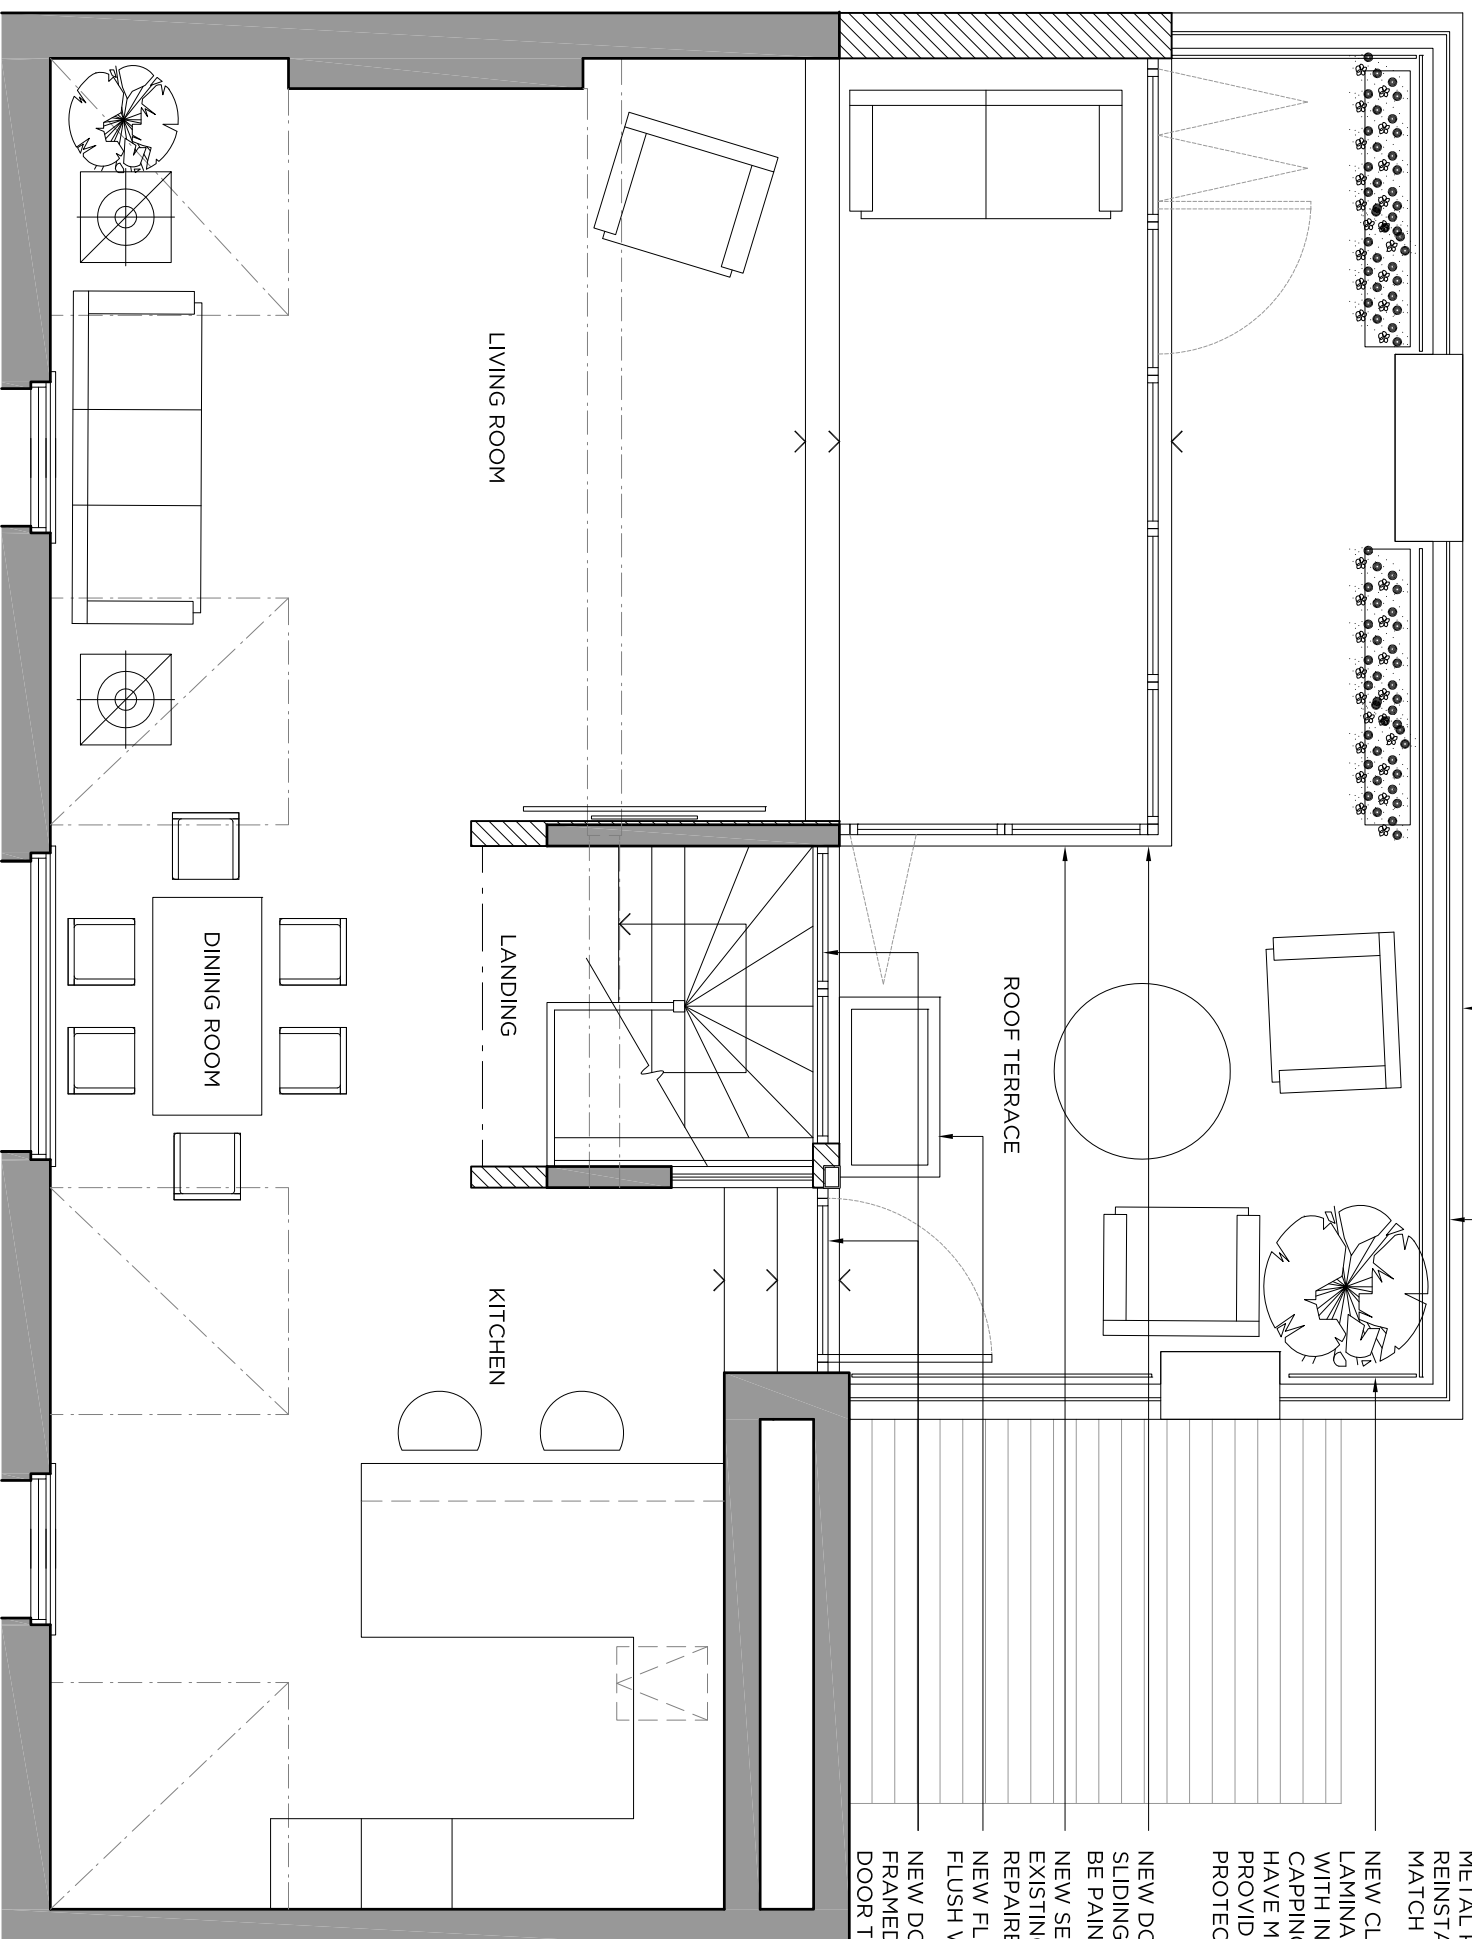
- EXISTING (POSSIBLY ORIGINAL) METAL RAILING TO BE REPAIRED AND REINSTATED AS NECESSARY TO MATCH EXISTING
- NEW CLEAR TOUGHENED AND LAMINATED GLASS BALUSTRADE WITH INVISIBLE FIXING AND NO CAPPING HANDRAIL (DESIGNED TO HAVE MINIMAL IMPACT WHILE PROVIDING SUITABLE HEIGHT PROTECTION FROM FALLING)
- NEW DOUBLE GLAZED FOLDING SLIDING TIMBER FRAMED DOORS TO BE PAINTED WHITE
- NEW SECTION OF WALL TO MATCH EXISTING. EXISTING WALL TO BE REPAIRED AND RE-POINTED
- NEW FLAT STYLE ROOFLIGHT TO SIT FLUSH WITH TERRACE FINISH
- NEW DOUBLE GLAZED TIMBER FRAMED FIXED LIGHTS AND GLAZED DOOR TO BE PAINTED WHITE
