CLIENT: SOAS University of London

PROJECT TITLE: SOAS INTO SENATE HOUSE MALET STREET LONDON, WC1E 7HU

DRAWING TITLE: CEILING DETAILS SHEET 1

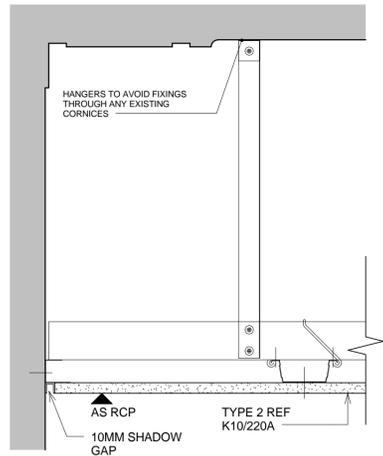
4 TYPE 2 PARALLEL PERIMETER DETAIL
1:5

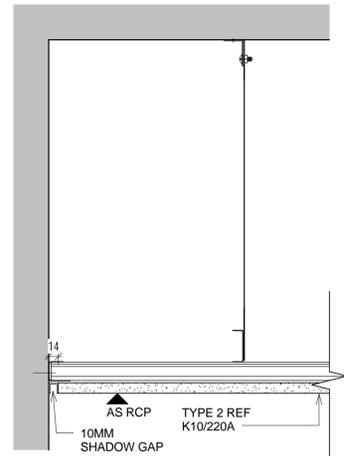
5 TYPE 2 PERPENDICULAR PERIMETER DETAIL
1:5

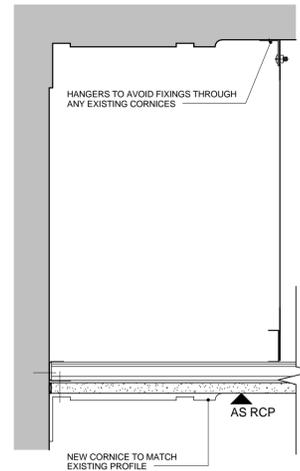
6 TYPE 2 PERIMETER DETAIL WITH CORNICE
1:5

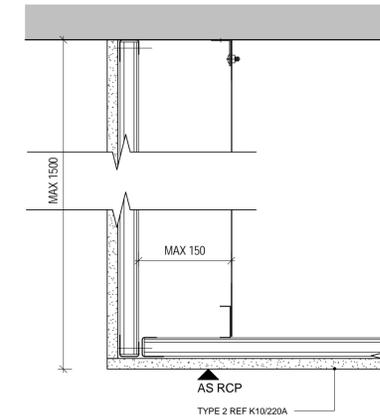
7 TYPE 2 DETAIL BULKHEAD
1:5

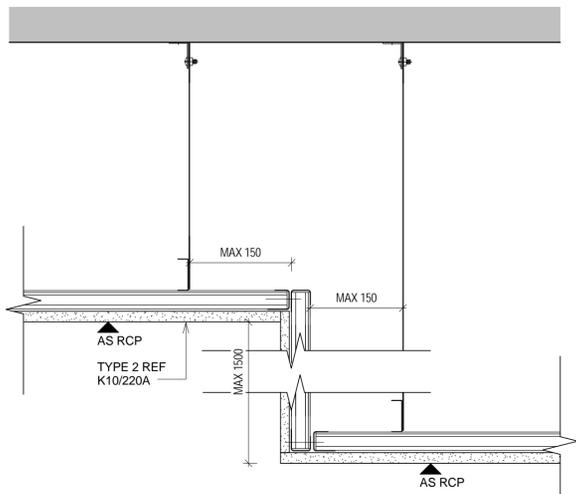
8 TYPE 2 DETAIL CHANGE OF LEVEL
1:5

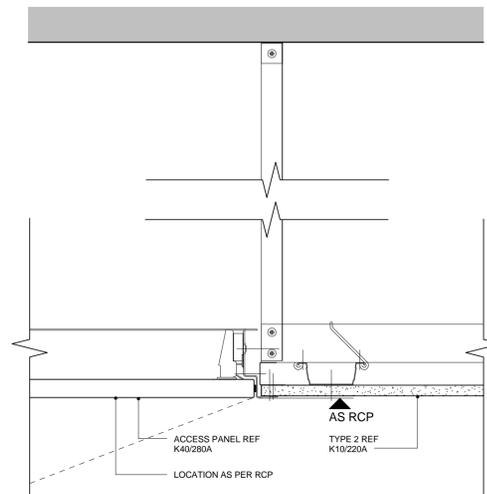
9 TYPE 2 ACCESS PANEL DETAIL
1:5

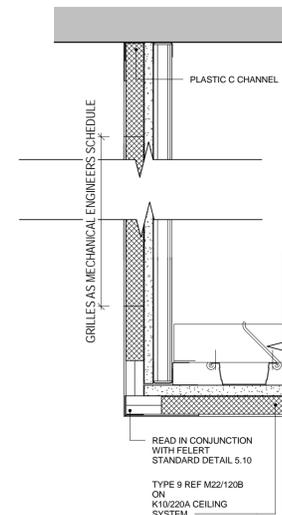
10 TYPE 9 BULKHEAD ACCESS PANEL DETAIL
1:5
