# BASEMENT IMPACT ASSESSMENT

3 DOWNSHIRE HILL

LONDON NW3

This Basement Impact Assessment, BIA, has been prepared for the proposed single storey basement under No 3 Downshire Hill LondonNW3 6XE.

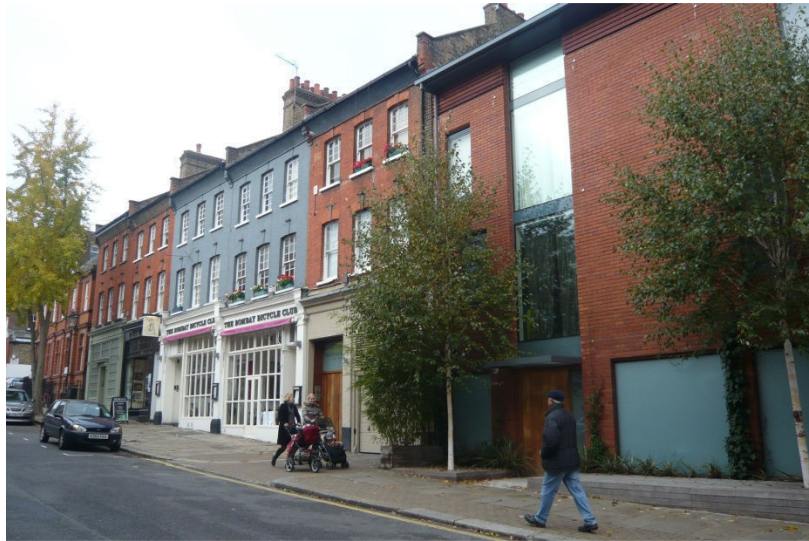
**Front elevation of No 3**

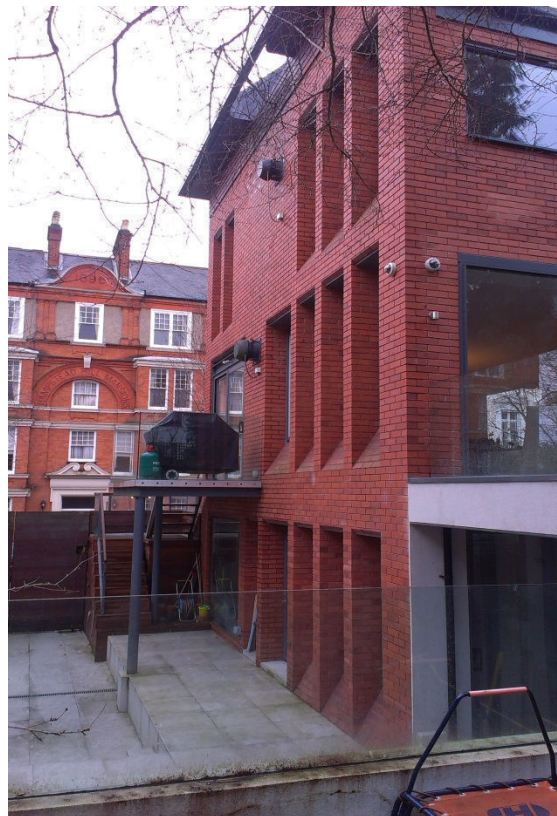
**Flank wall of No 3 with existing hard impermeable paving**

Screen	Response	Amplification
<b>Subterranean (groundwater) flow</b>		
GW1. Is the site founded on an aquifer	No	CGHH Fig 4 show the site is founded on London Clay. CGHH Fig 8, Aquifer Designation Map, shows that London Clay is unproductive strata
GW1A Will the basement extend beneath the water table	No	The basement will not be below the watertable
GW1B Will the basement encounter water issues	Possibly	There may be local areas of perched water but these will be dealt with on site.
GW2. Is the site within 100m of a watercourse or a spring	No	CGHH Fig 12, Watercourses, a pond on the heath approximately 500mm from the property  There are no springs in the area
GW3. Is the site within Hampstead Ponds catchment	No	CGHH Fig 14, shows the property is beyond any catchment areas
GW4. Will proportions of impermeable areas change	No	The basement is being extended but under and area of existing impermeable paving

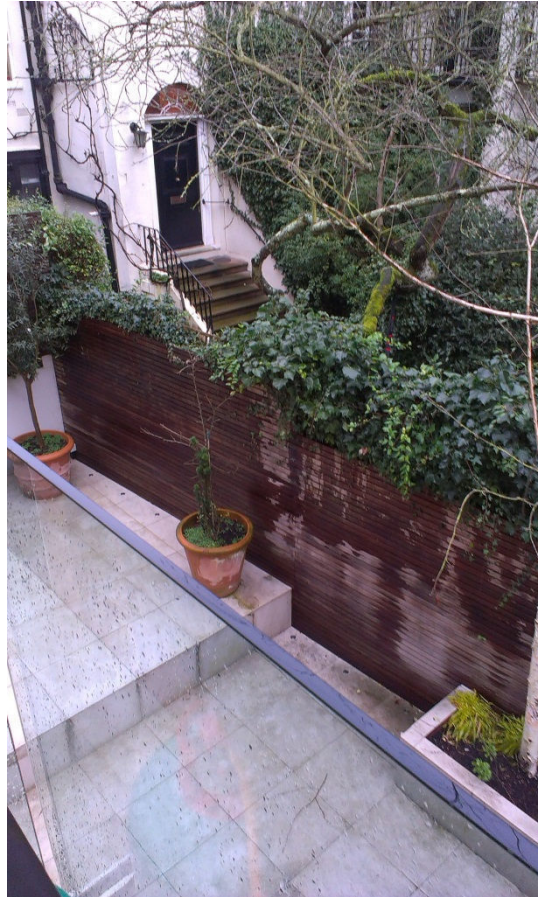
**View showing rear garden and distance to No 4**

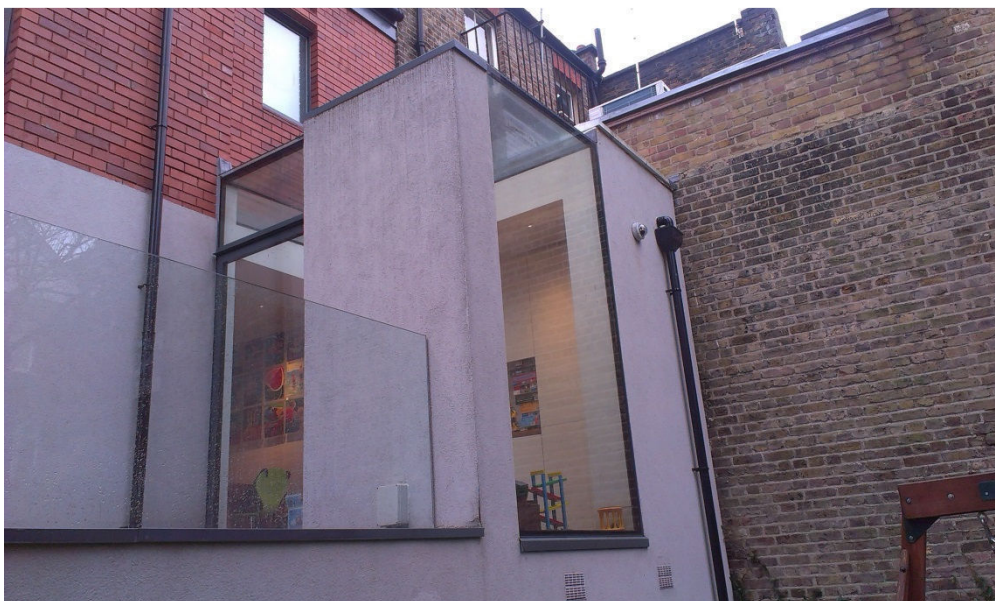
**View showing rear wall and junction with party wall of No 2**

These total movements can be used to predict the likely strains to which adjacent buildings will be subjected. The critical building is No. 2 Downshire Hill which is located between the 2.5m and 7.5m contours. The differential movement across 2 Downshire Hill is 11 – 5.5 = 5.5mm vertically and 13.25 – 6.5 = 6.75mm horizontally. Taking the building as being 5m wide this generates a deflection ratio of 0.11% and a horizontal stain of 0.135%.

This would place the potential crack as being Category 2, Slight, with cracks easily filled but redecoration probably being required.

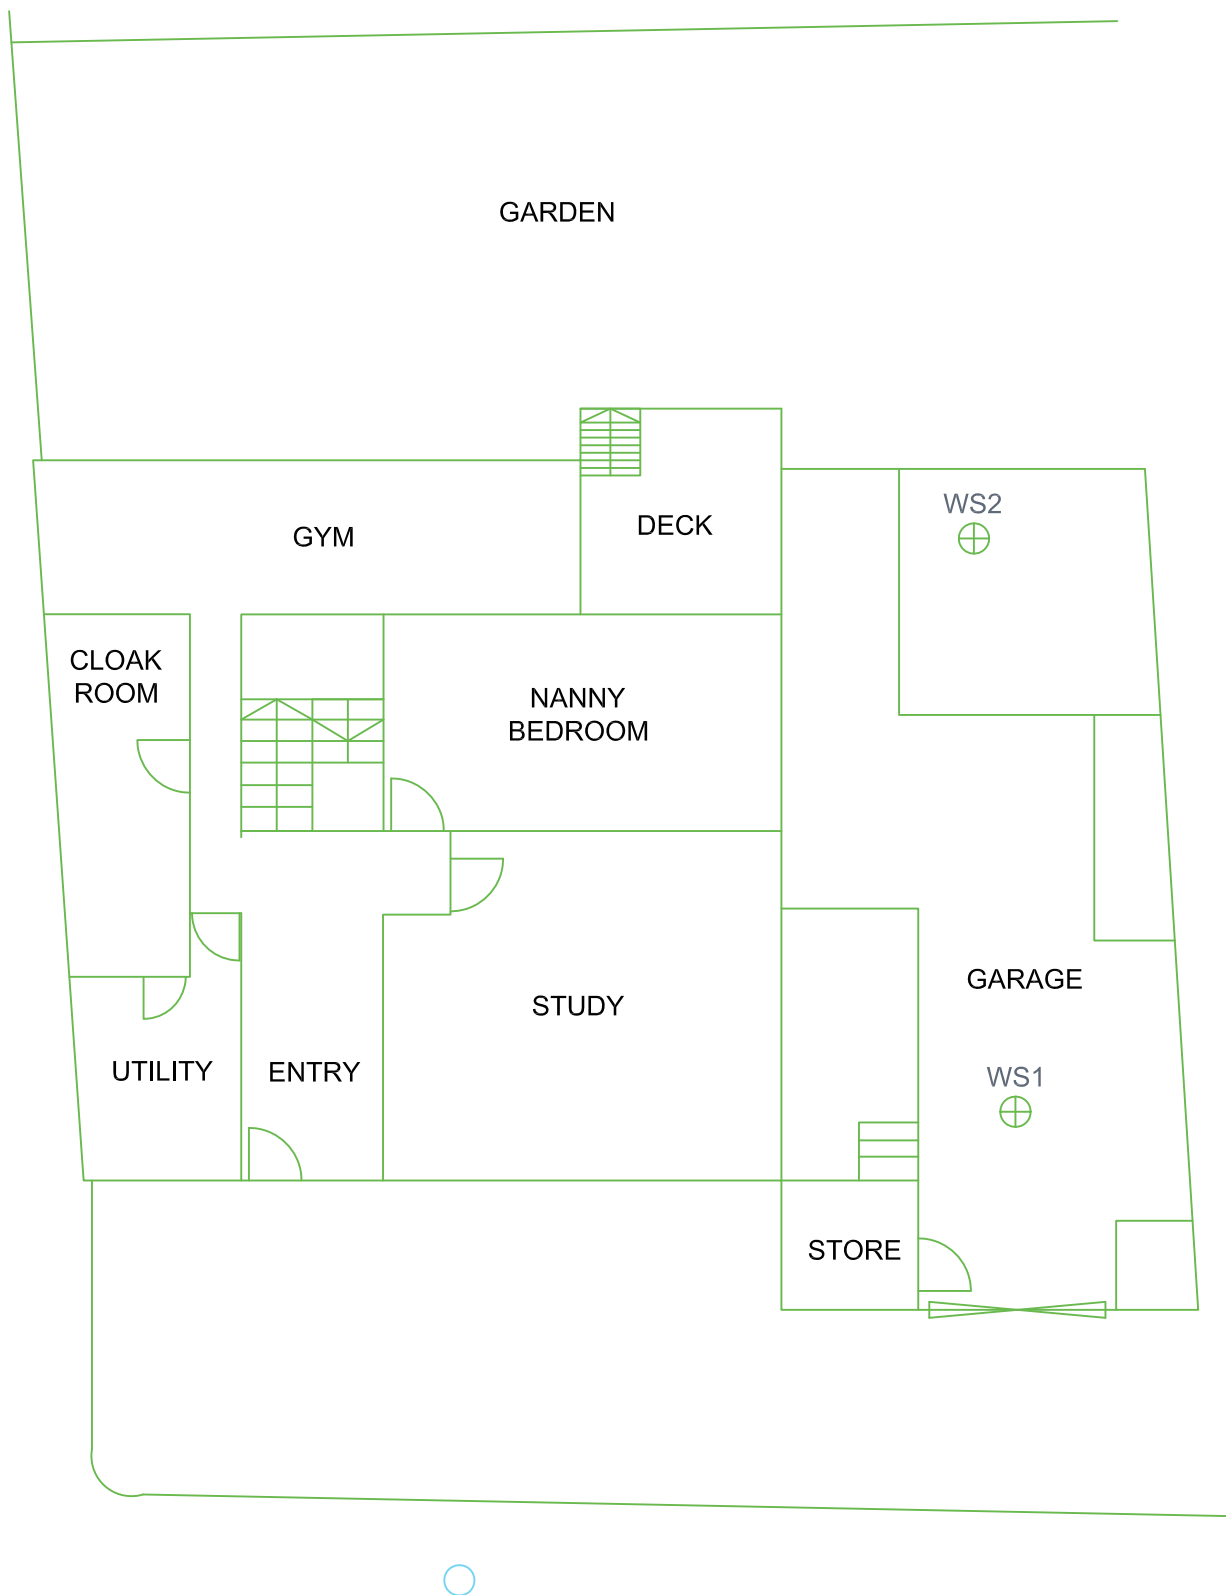
Scale :	N.T.S.
Drawn By :	P.L.E.
Job No:	52180
Fig:	A1.1

- 3.2 Two boreholes, designated WS1 and WS2, were undertaken by drive-in window sampler technique at the positions shown on the site plan, Appendix 1, Figure A1.1. The depths of boreholes, descriptions of strata encountered and comments on groundwater conditions are given in the borehole records, Appendix 2, Figures A2.1 and A2.2.

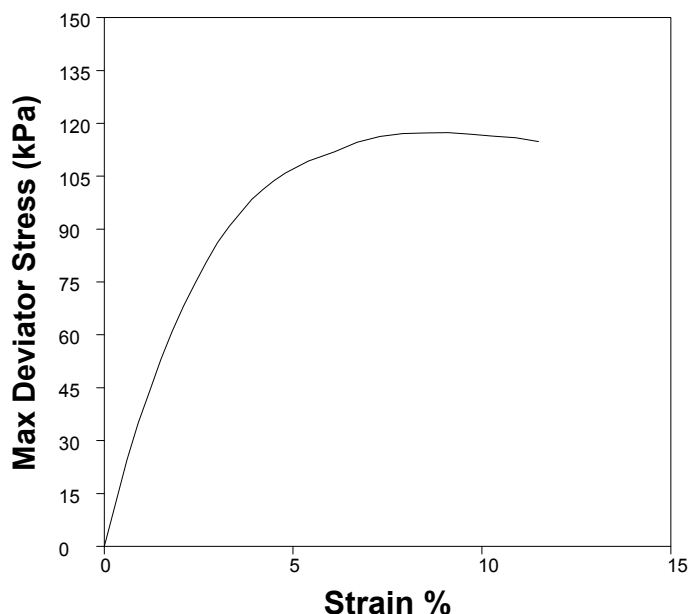
<b>Length of Sample (mm)</b>	221
		<b>Depth from top of sample (mm)</b>	25
		<b>Condition of Sample:</b>	Undisturbed
		<b>Orientation:</b>	Vertical
<b>Test Type</b>		Single Stage	
<b>Length of Specimen (mm)</b>		165.1	
<b>Diameter of Specimen (mm)</b>		81.3	
<b>Moisture Content (%)</b>		30	
<b>Bulk Density (Mg/m³)</b>		1.87	
<b>Dry Density (Mg/m³)</b>		1.44	
<b>Membrane Thickness (mm)</b>		0.44	
<b>Membrane Type</b>		Latex	
<b>Rate of Strain (%/min)</b>		1.95	
<b>Test Results</b>	<b>Measured Cell Pressure (kPa)</b>	35	
	<b>Strain at Failure (%)</b>	9.1	
	<b>Membrane Correction (kPa)</b>	1.1	
	<b>Corrected Deviator Stress (kPa)</b>	116	
	<b>Shear Stress (kPa)</b>	<b>58</b>	
	<b>Mode of Failure (B/P/C)</b>	<b>Compound</b>

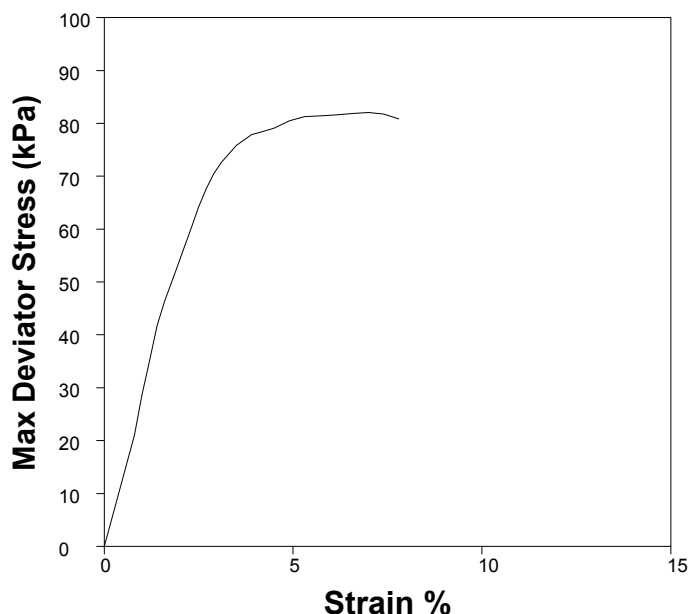
<b>Length of Sample (mm)</b>	265
		<b>Depth from top of sample (mm)</b>	0
	<b>Condition of Sample:</b>		Undisturbed
	<b>Orientation:</b>		Vertical
<b>Test Type</b>		Single Stage	
<b>Length of Specimen (mm)</b>		121.6	
<b>Diameter of Specimen (mm)</b>		60.1	
<b>Moisture Content (%)</b>		35	
<b>Bulk Density (Mg/m³)</b>		1.91	
<b>Dry Density (Mg/m³)</b>		1.42	
<b>Membrane Thickness (mm)</b>		0.37	
<b>Membrane Type</b>		Latex	
<b>Rate of Strain (%/min)</b>		1.98	
<b>Test Results</b>	<b>Measured Cell Pressure (kPa)</b>	95	
	<b>Strain at Failure (%)</b>	7	
	<b>Membrane Correction (kPa)</b>	1.0	
	<b>Corrected Deviator Stress (kPa)</b>	81	
	<b>Shear Stress (kPa)</b>	41	
	<b>Mode of Failure (B/P/C)</b>	Compound

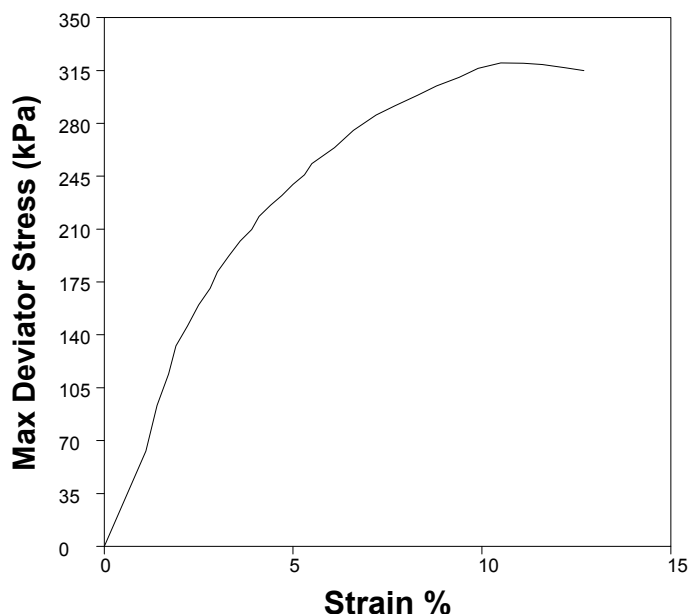
<b>Length of Sample (mm)</b>	140
		<b>Depth from top of sample (mm)</b>	0
	<b>Condition of Sample:</b>		Undisturbed
	<b>Orientation:</b>		Vertical
<b>Test Type</b>		Single Stage	
<b>Length of Specimen (mm)</b>		90.5	
<b>Diameter of Specimen (mm)</b>		45.3	
<b>Moisture Content (%)</b>		32	
<b>Bulk Density (Mg/m³)</b>		2.19	
<b>Dry Density (Mg/m³)</b>		1.66	
<b>Membrane Thickness (mm)</b>		0.41	
<b>Membrane Type</b>		Latex	
<b>Rate of Strain (%/min)</b>		1.99	
<b>Test Results</b>	<b>Measured Cell Pressure (kPa)</b>	135	
	<b>Strain at Failure (%)</b>	10.5	
	<b>Membrane Correction (kPa)</b>	2.1	
	<b>Corrected Deviator Stress (kPa)</b>	318	
	<b>Shear Stress (kPa)</b>	<b>159</b>	
	<b>Mode of Failure (B/P/C)</b>	<b>Compound</b>

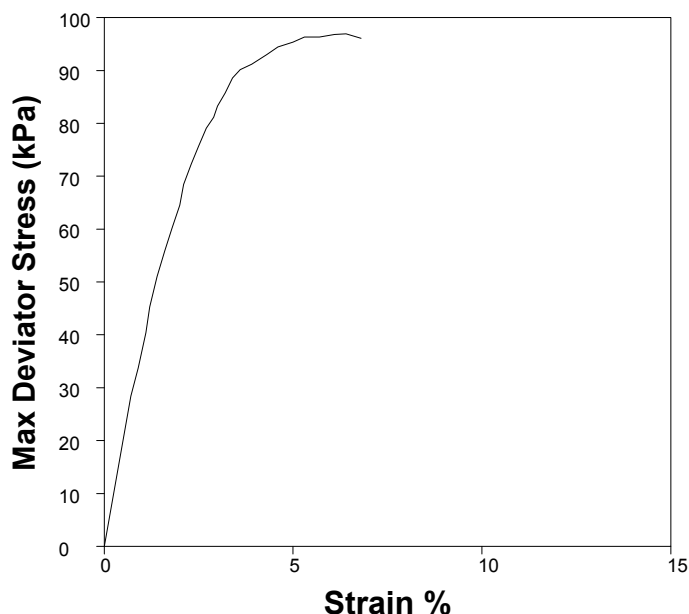
<b>Length of Sample (mm)</b>	225
		<b>Depth from top of sample (mm)</b>	10
		<b>Condition of Sample:</b>	Undisturbed
		<b>Orientation:</b>	Vertical
<b>Test Type</b>		Single Stage	
<b>Length of Specimen (mm)</b>		140.3	
<b>Diameter of Specimen (mm)</b>		69.4	
<b>Moisture Content (%)</b>		32	
<b>Bulk Density (Mg/m³)</b>		1.92	
<b>Dry Density (Mg/m³)</b>		1.45	
<b>Membrane Thickness (mm)</b>		0.4	
<b>Membrane Type</b>		Latex	
<b>Rate of Strain (%/min)</b>		2.00	
<b>Test Results</b>	<b>Measured Cell Pressure (kPa)</b>	55	
	<b>Strain at Failure (%)</b>	6.4	
	<b>Membrane Correction (kPa)</b>	0.9	
	<b>Corrected Deviator Stress (kPa)</b>	96	
	<b>Shear Stress (kPa)</b>	48	
	<b>Mode of Failure (B/P/C)</b>	Compound

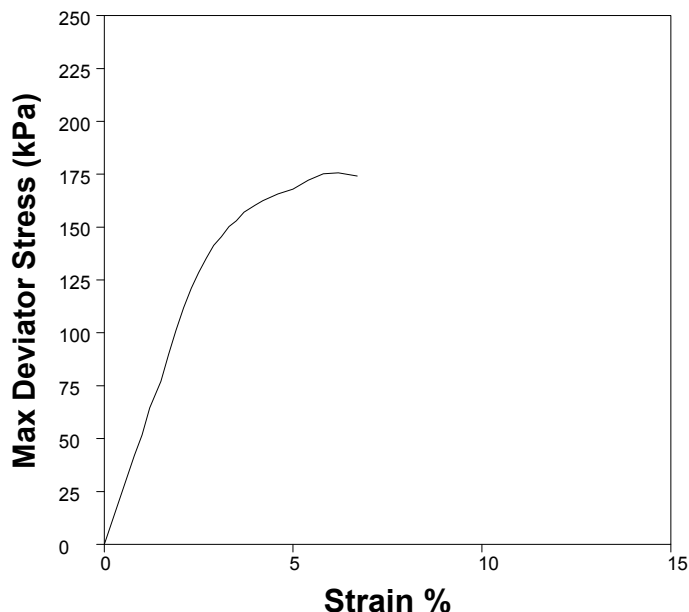
<b>Length of Sample (mm)</b>	181
		<b>Depth from top of sample (mm)</b>	0
	<b>Condition of Sample:</b>		Undisturbed
	<b>Orientation:</b>		Vertical
<b>Test Type</b>		Single Stage	
<b>Length of Specimen (mm)</b>		120.1	
<b>Diameter of Specimen (mm)</b>		57.9	
<b>Moisture Content (%)</b>		32	
<b>Bulk Density (Mg/m³)</b>		1.96	
<b>Dry Density (Mg/m³)</b>		1.48	
<b>Membrane Thickness (mm)</b>		0.48	
<b>Membrane Type</b>		Latex	
<b>Rate of Strain (%/min)</b>		2.00	
<b>Test Results</b>	<b>Measured Cell Pressure (kPa)</b>	96	
	<b>Strain at Failure (%)</b>	6.2	
	<b>Membrane Correction (kPa)</b>	1.2	
	<b>Corrected Deviator Stress (kPa)</b>	175	
	<b>Shear Stress (kPa)</b>	87	
	<b>Mode of Failure (B/P/C)</b>	Compound

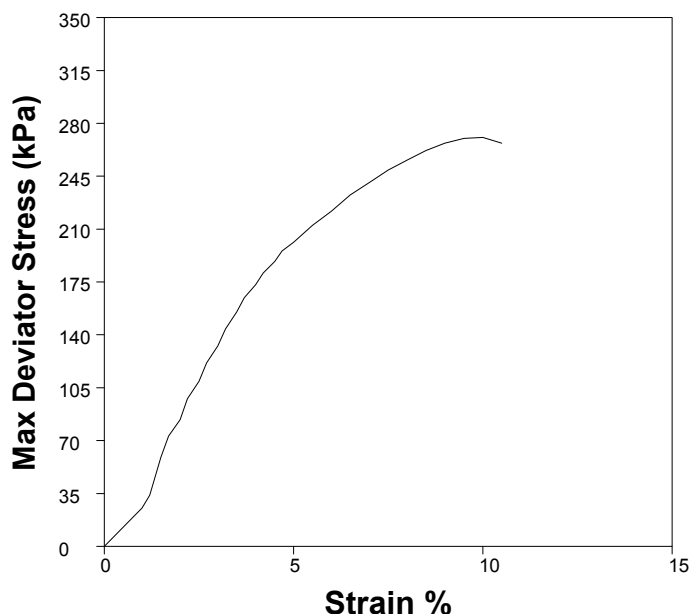
<b>Length of Sample (mm)</b>	200
		<b>Depth from top of sample (mm)</b>	40
		<b>Condition of Sample:</b>	Undisturbed
		<b>Orientation:</b>	Vertical
<b>Test Type</b>		Single Stage	
<b>Length of Specimen (mm)</b>		100.4	
<b>Diameter of Specimen (mm)</b>		50.6	
<b>Moisture Content (%)</b>		32	
<b>Bulk Density (Mg/m³)</b>		1.84	
<b>Dry Density (Mg/m³)</b>		1.40	
<b>Membrane Thickness (mm)</b>		0.41	
<b>Membrane Type</b>		Latex	
<b>Rate of Strain (%/min)</b>		1.99	
<b>Test Results</b>	<b>Measured Cell Pressure (kPa)</b>	135	
	<b>Strain at Failure (%)</b>	10	
	<b>Membrane Correction (kPa)</b>	1.8	
	<b>Corrected Deviator Stress (kPa)</b>	269	
	<b>Shear Stress (kPa)</b>	134	
	<b>Mode of Failure (B/P/C)</b>	Compound

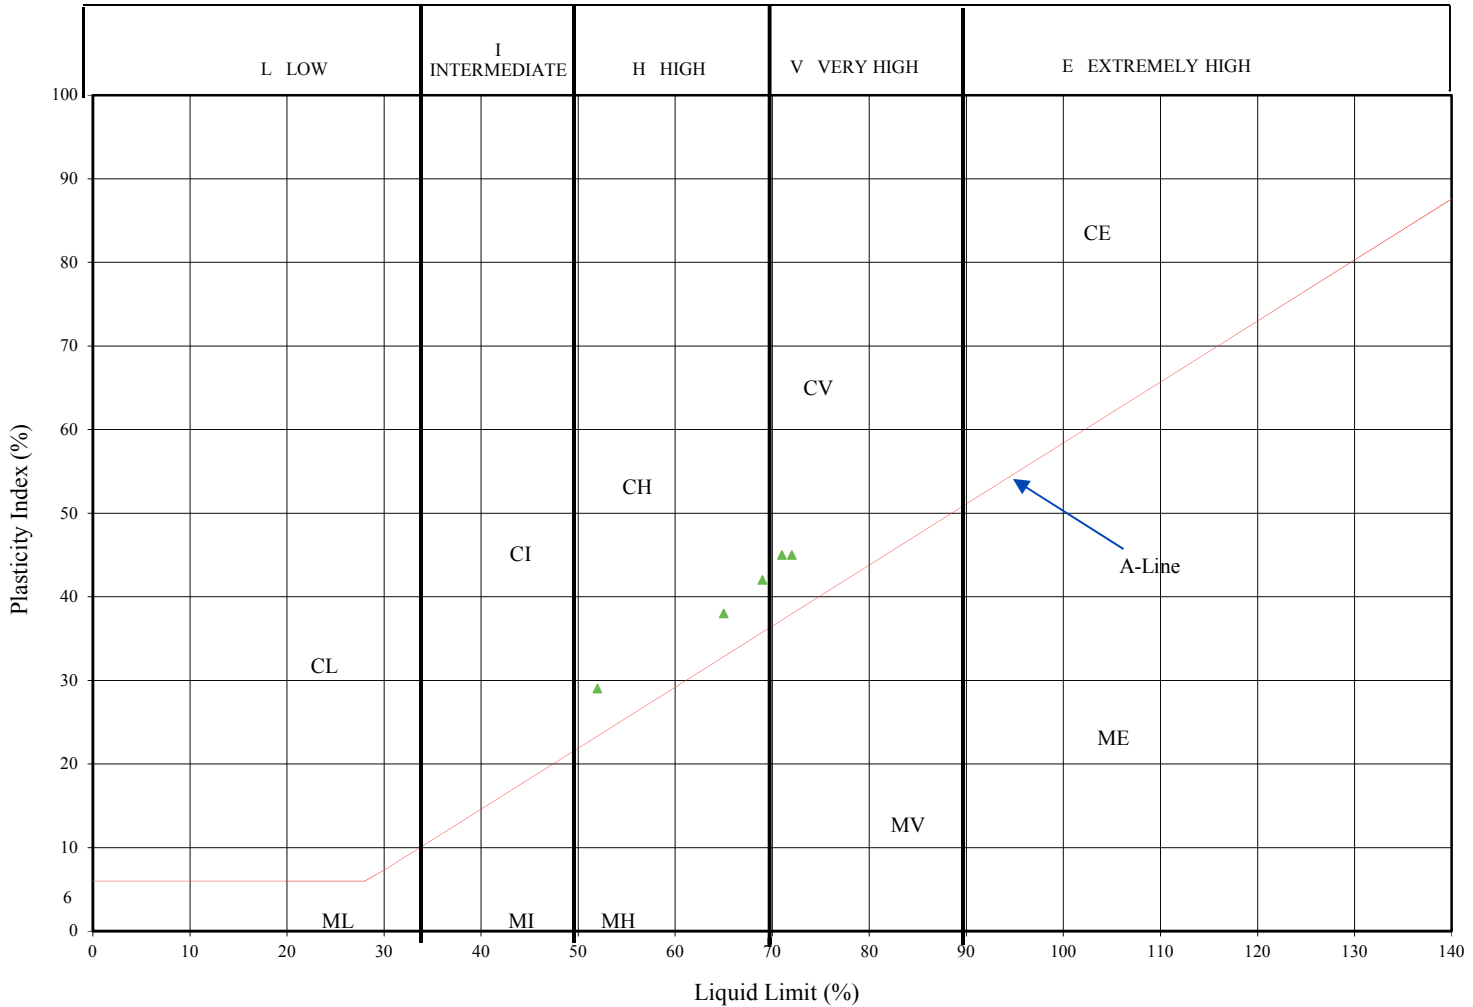
SILTS generally plot below A Line  
 CLAYS generally plot above A Line

6.4.1 Laboratory testing for the London Clay Formation recorded natural moisture contents of between 25% and 35%, with an average of 31%, liquid limits of between 52% and 72%, with an average of 66%, plastic limits of between 23% and 27%, with an average of 26% and plasticity indices of between 29% and 45%, with an average of 40%. The plastic index test results are presented on the plasticity classification chart, Appendix 3, Figure A3.3.

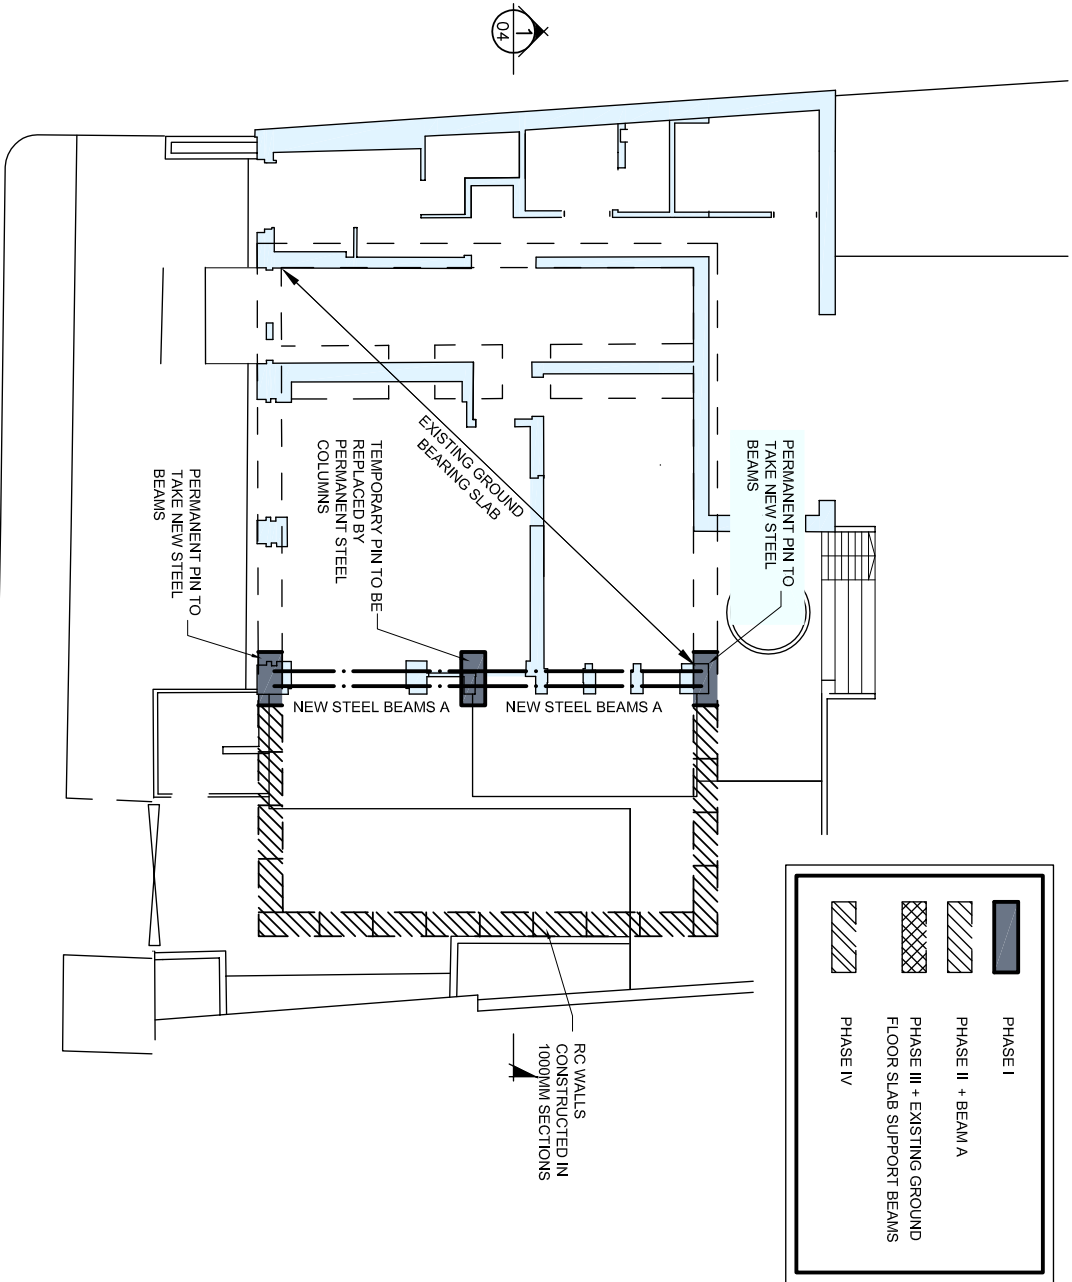
Drawing No: 12741\_SK-01

**GROUND FLOOR PLAN SHOWING BASEMENT OUTLINE UNDER PHASE I & II**

PHASE I
	PHASE II + BEAM A
	PHASE III + EXISTING GROUND FLOOR SLAB SUPPORT BEAMS
	PHASE IV

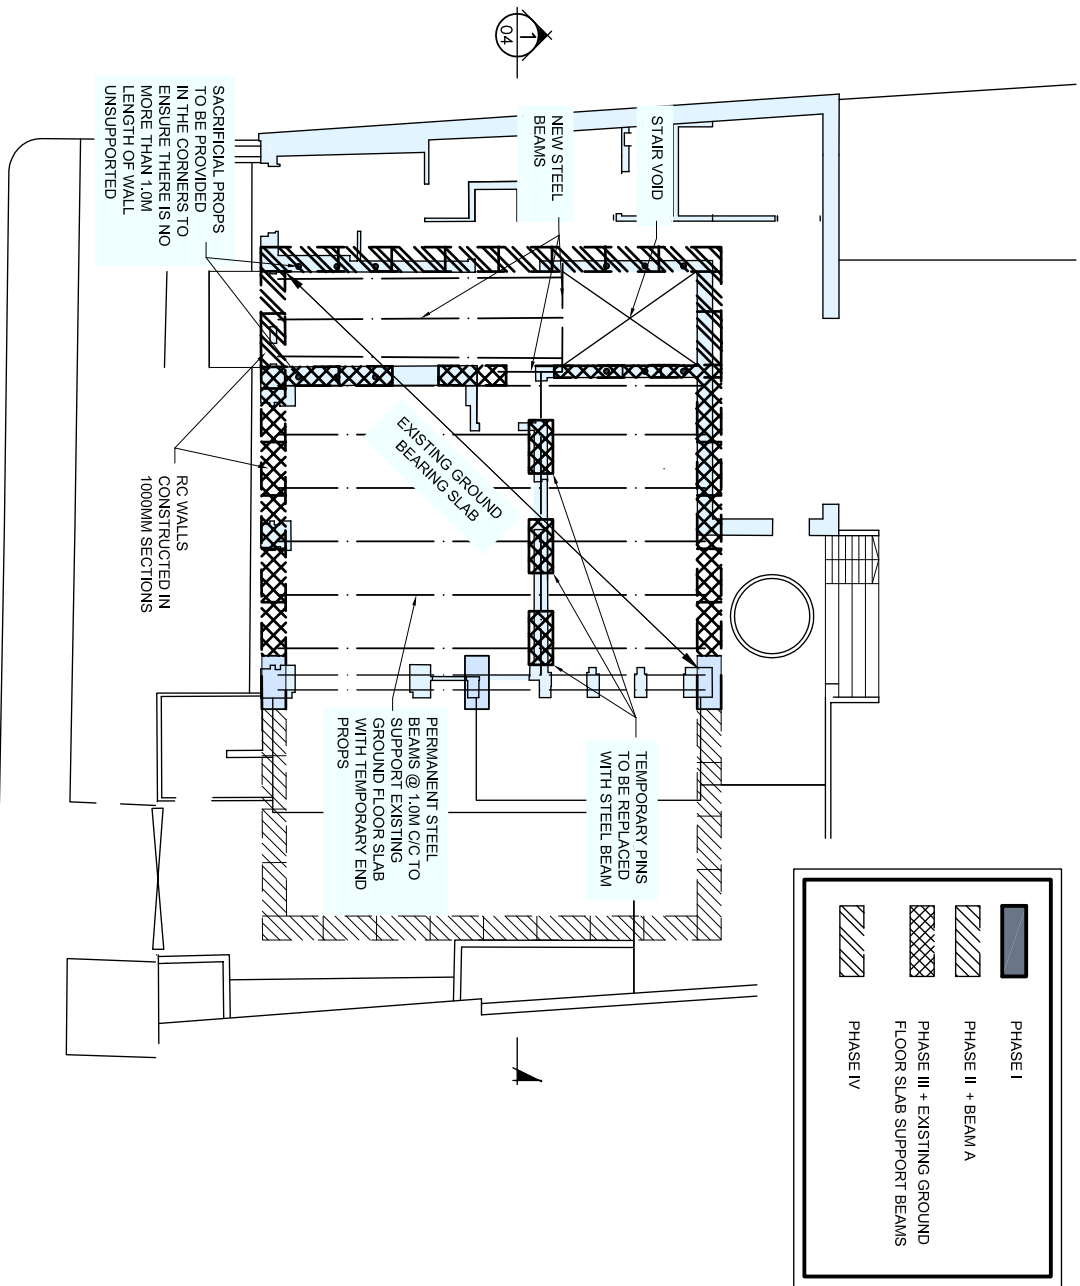
Drawing Status: <b>PRELIMINARY</b>	
Date: MARCH 2014	Drawing No.
Scale: 1:100 @ A3	<b>12741_SK-02</b>
Drawn: AM	Rev. <b>P1</b>
CHKD: MS

**GROUND FLOOR PLAN SHOWING BASEMENT OUTLINE UNDER SHOWS PHASE III & IV**

PHASE I
	PHASE II + BEAM A
	PHASE III + EXISTING GROUND FLOOR SLAB SUPPORT BEAMS
	PHASE IV

Title: **SEQUENCING DRAWING**  
**2 OF 2**

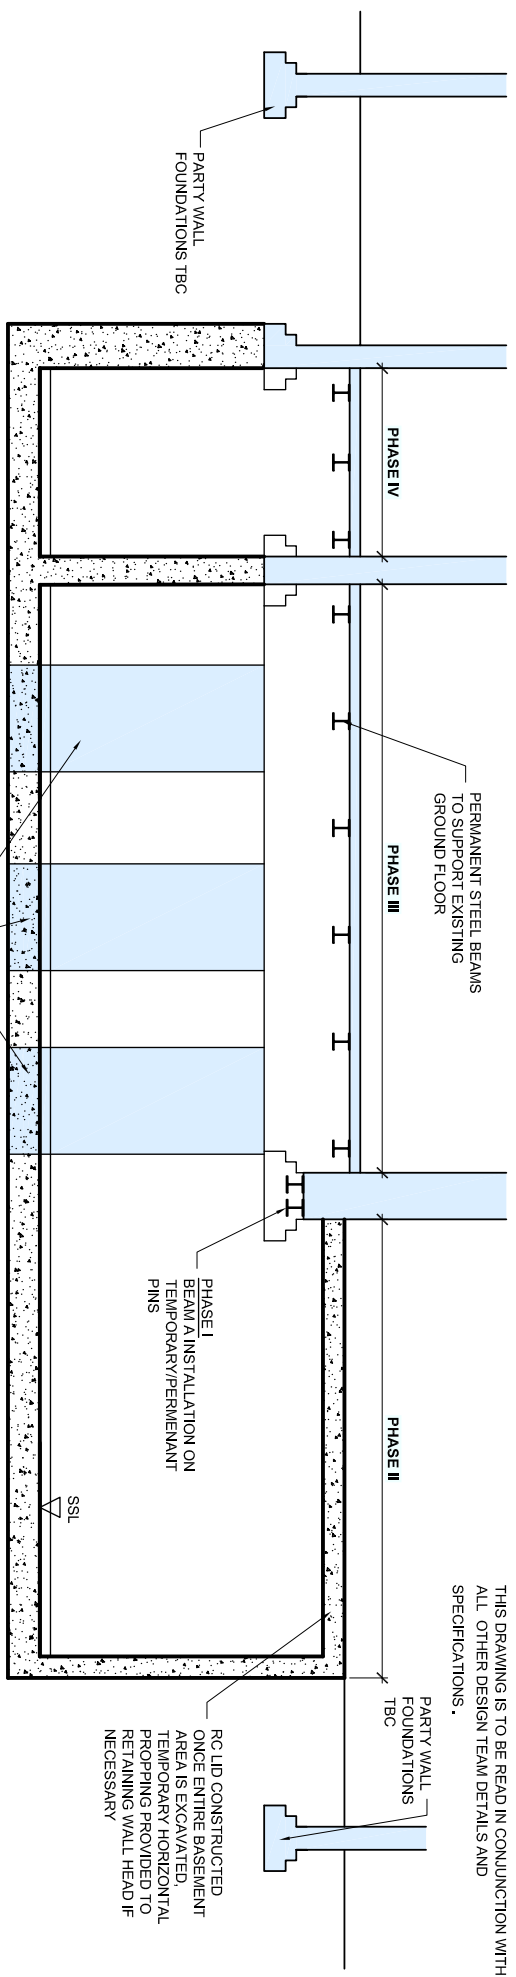
- SUGGESTED SEQUENCE OF WORKS:**
1. INSTALL 3NO. PINS SHOWN AS PHASE I
  2. NEW STEEL BEAM A TO BE INSTALLED TO SUPPORT FLANK WALL
  3. RETAINING WALL/UNDERPIN SECTIONS SHOWN AS PHASE II TO BE CONSTRUCTED
  4. WALLS SHOWN AS PHASE III TO BE UNDERPINNED IN 1M SECTIONS WORKING UNDER THE PROPERTY FROM THE RHS INCLUDING THE INSTALLATION OF TEMPORARY INTERNAL PINS AND STEEL BEAMS TO SUPPORT THE EXISTING GROUND FLOOR SLAB WALLS
  5. SHOWN AS PHASE IV TO BE UNDERPINNED

ALL WORKS TO BE UNDERTAKEN EXTERNALLY

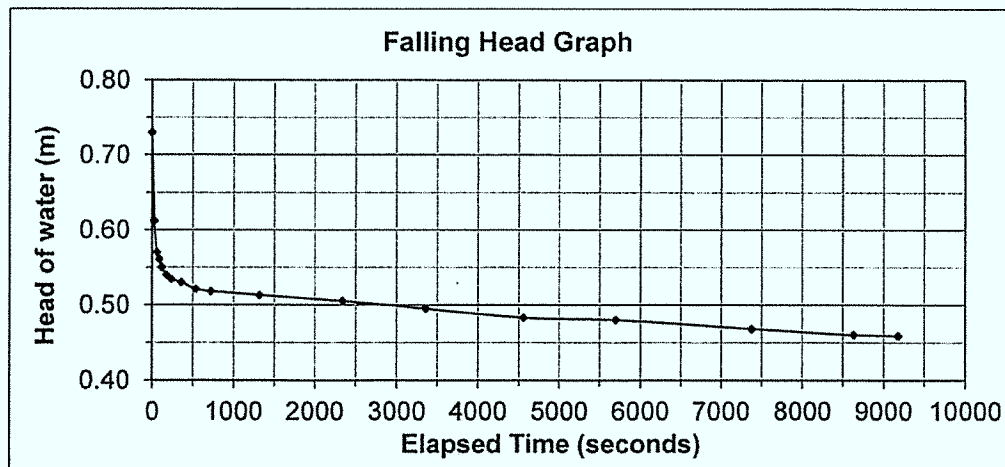
Intake Factor (F) =	1.648445507	Intake Factor model (F)	BS5930 fig 6d
Cross sectional area of response zone (A) =	0.005026548		
	100% to 0% level		75% to 25% level
$t_2(9180)-t_1(0)$	9180	$t_2(360)-t_1(20)$	340
$H_1$	0.73	$H_1$	0.66
$H_2$	0.46	$H_2$	0.53
$k=$	1.53399E-07	$k=$	1.96734E-06

Additional testing was carried out by Ian Farmer Associates comprising a falling head test in each borehole to estimate the rate of infiltration into the established head of water. The results of set out in Appendix 6

The testing carried out by Ian Farmer Associates has established the infiltration rates of the subsoil as  $6.45 \times 10^{-6}$  of the subsoil.

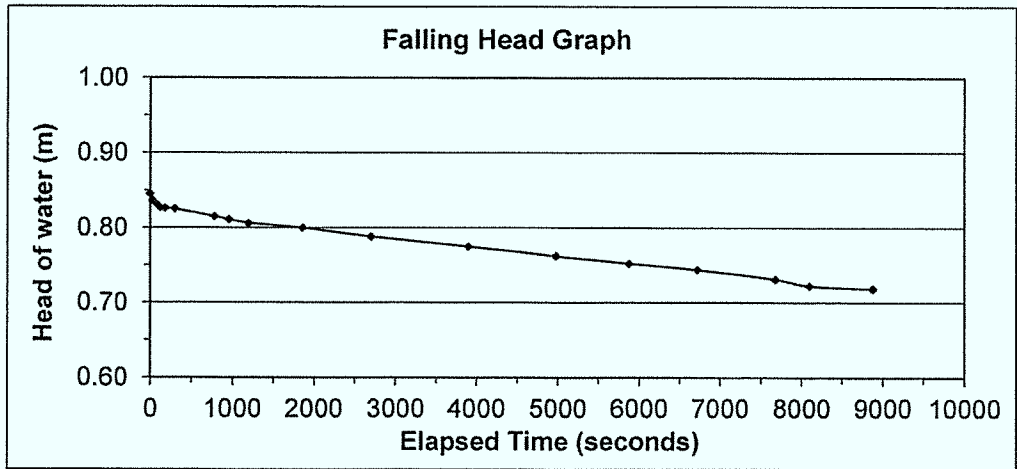
### Falling Head Test Record Sheet

Intake Factor (F) =	1.773804724	Intake Factor model (F) BS5930 fig 6d	
Cross sectional area of response zone (A) =	0.005026548		
	100% to 0% level		75% to 25% level
$t_2(8880)-t_1(0)$	8880	$t_2(5880)-t_1(780)$	5100
H <sub>1</sub>	0.85	H <sub>1</sub>	0.82
H <sub>2</sub>	0.72	H <sub>2</sub>	0.75
k =	5.29688E-08	k =	4.95804E-08
