LOWER GROUND  
FLOOR

1435 - P021

Kitchen//Existing//Elevation 1\_1:20

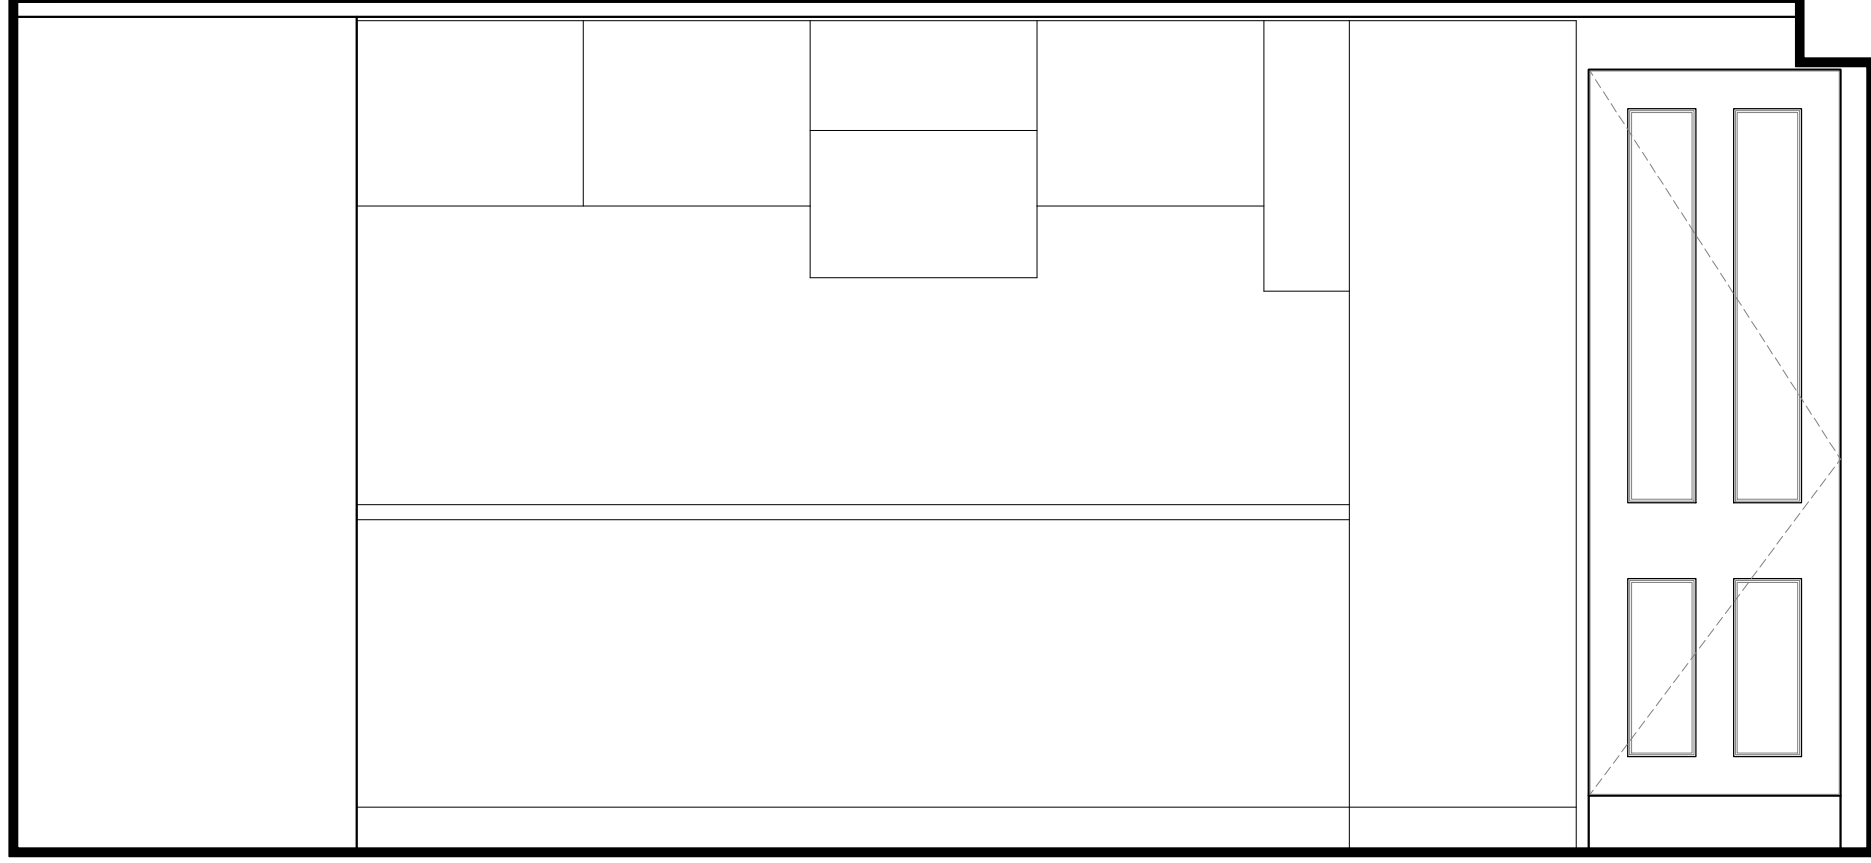
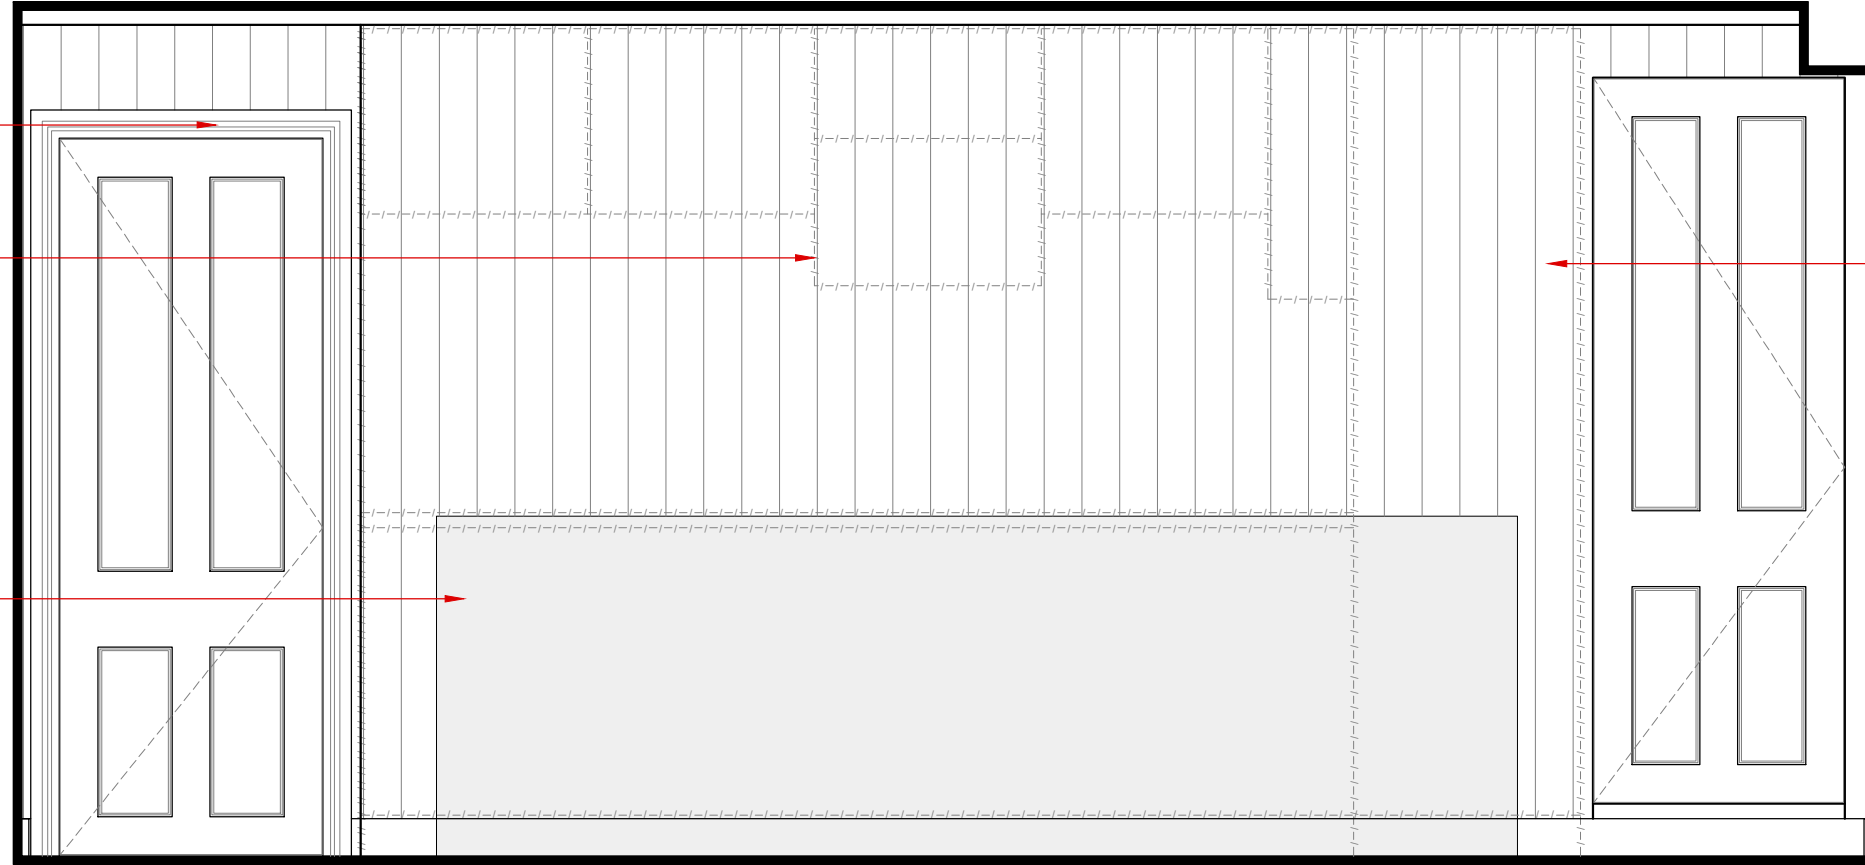
1435 - P022

Proposed 75mm  
ogee architrave.

Existing kitchen  
units removed.

Proposed joinery  
units.

Proposed TG&V  
boarding fixed to  
timber battens  
throughout laundry.

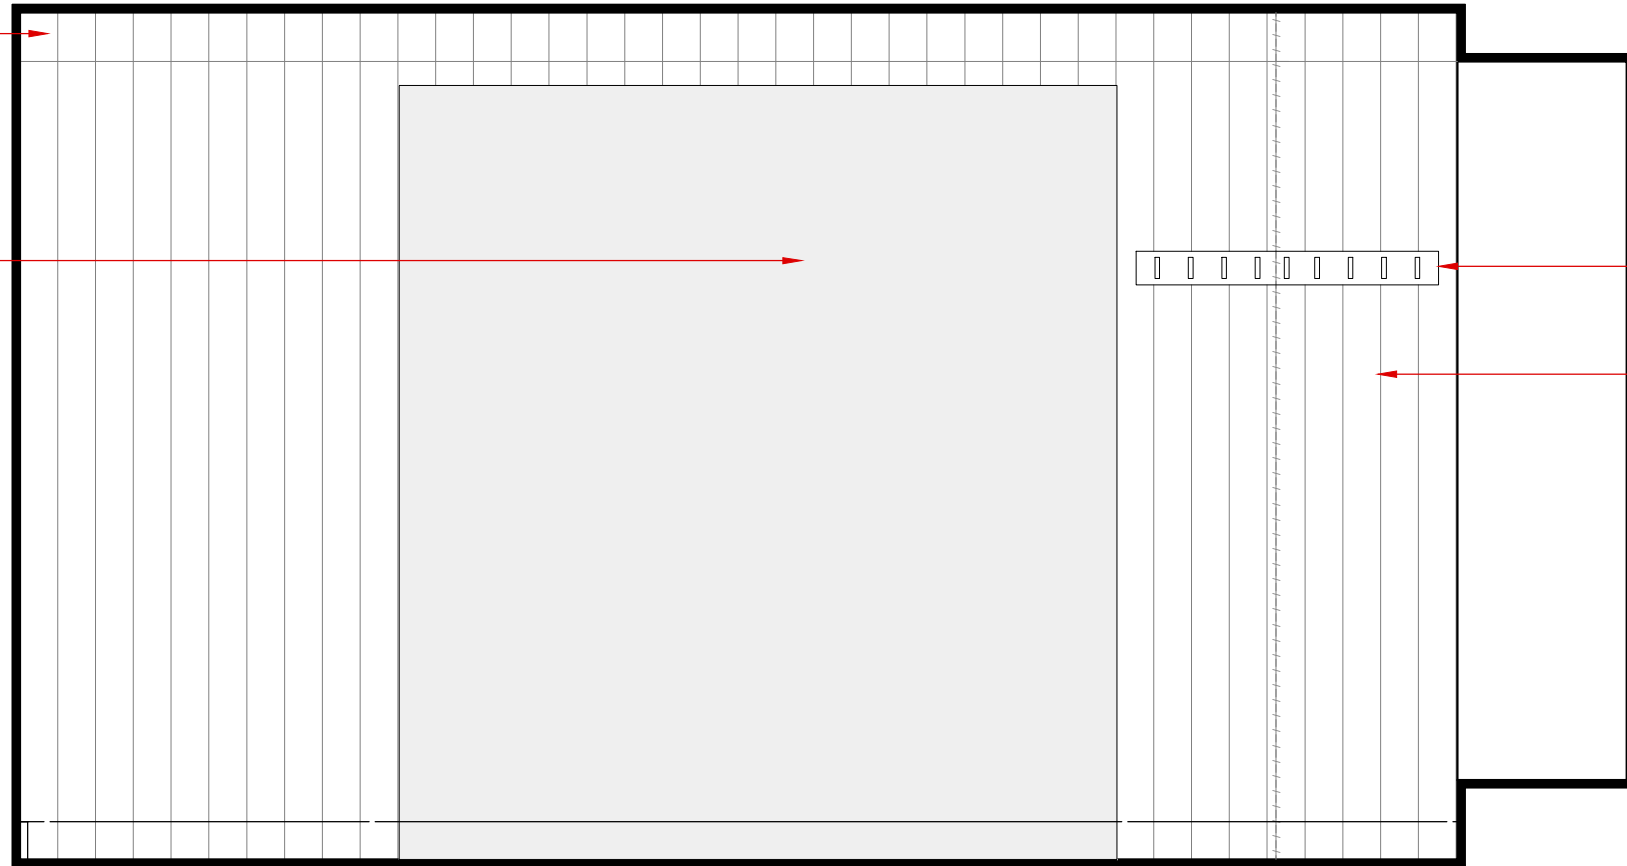
1435 - P023

Existing boxing to be removed.

Proposed storage unit.  
Proposed electrical  
distribution board  
within cupboard.

Coat board and hooks.

Existing kitchen unit  
removed.

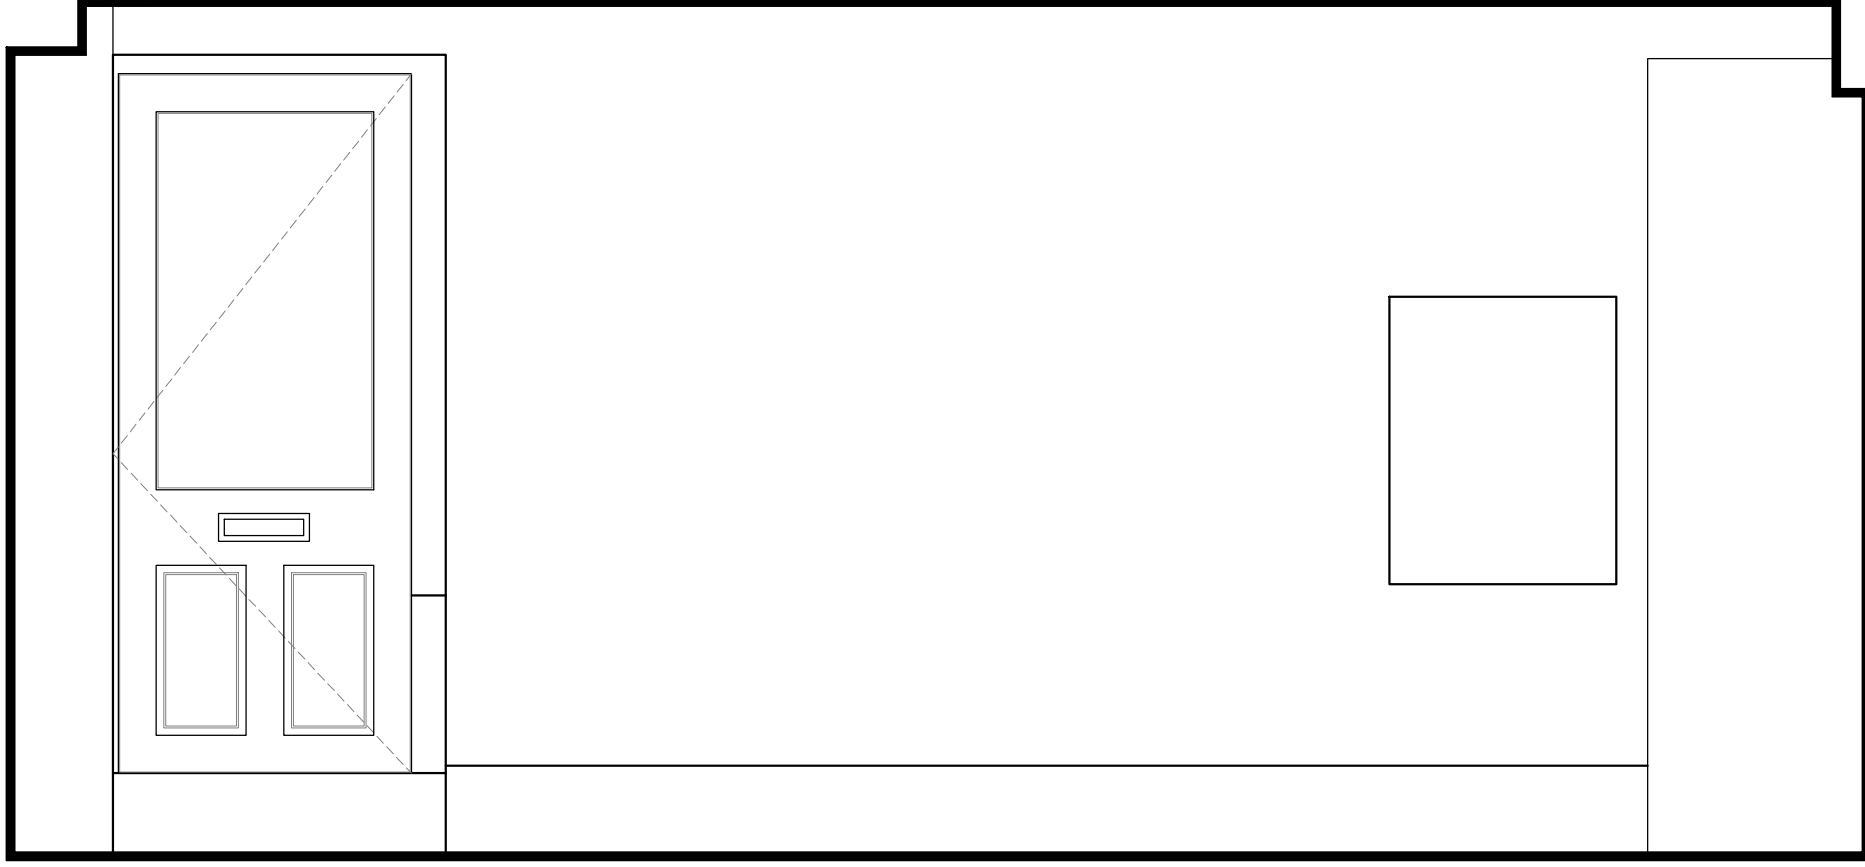
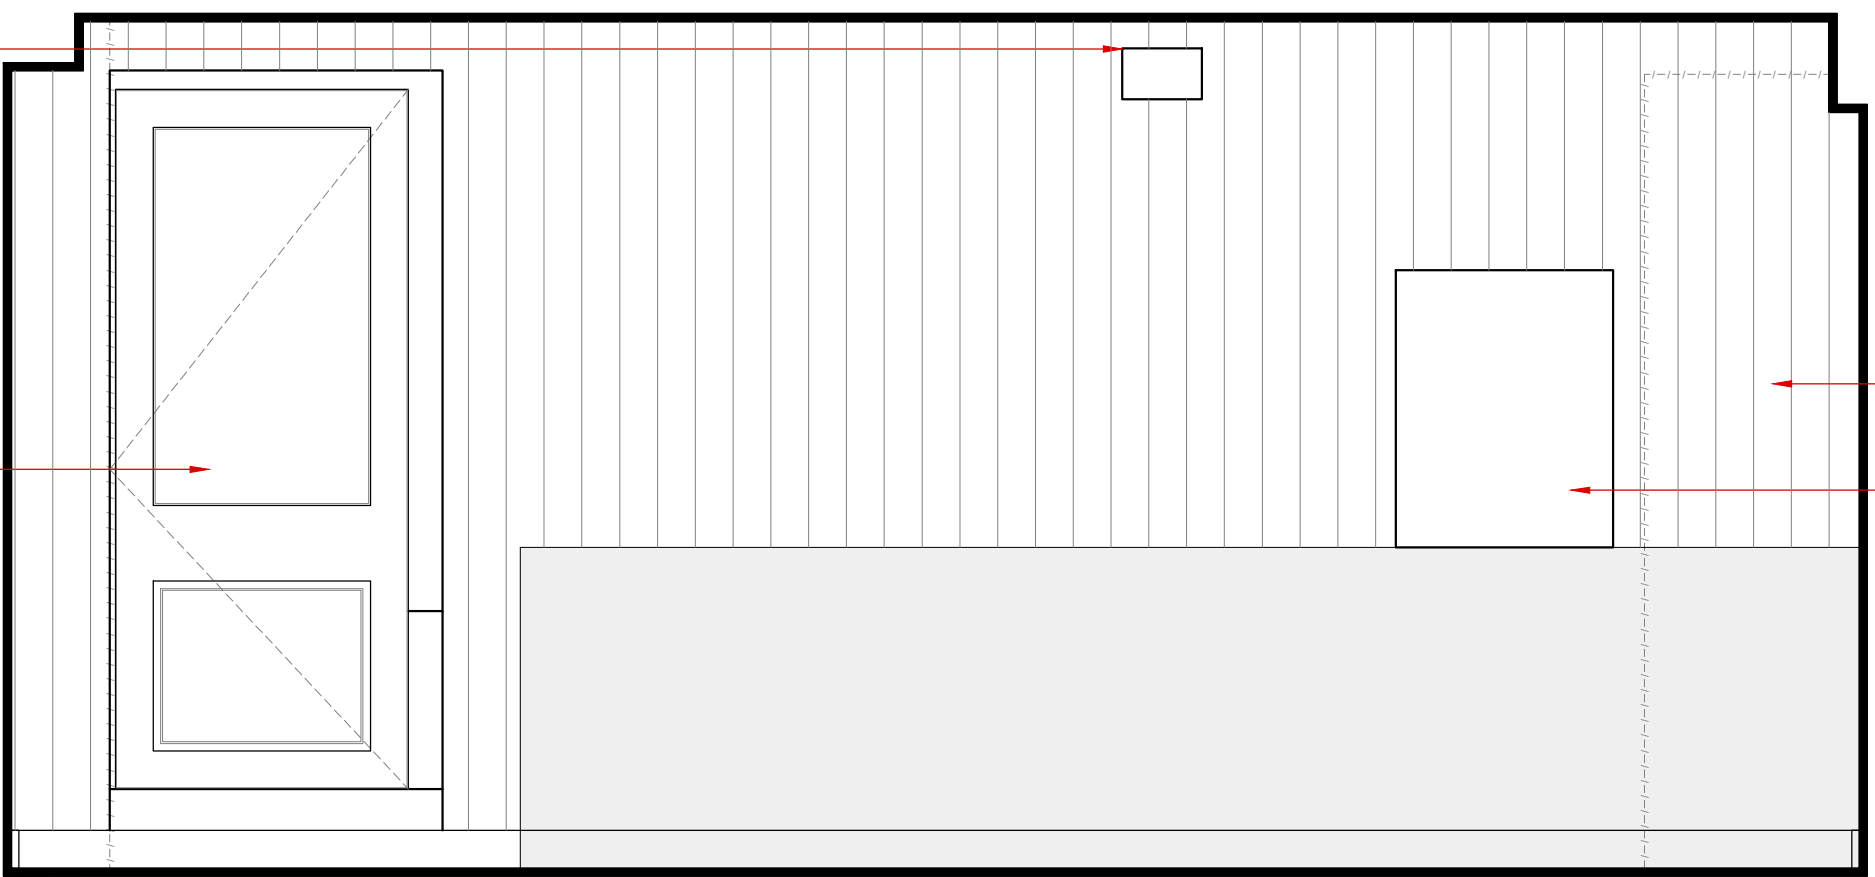
1435 - P024

Proposed extraction.

Existing external door removed and replaced with new 2 panel door.

Existing kitchen unit to be removed..

Existing safe to be retained.

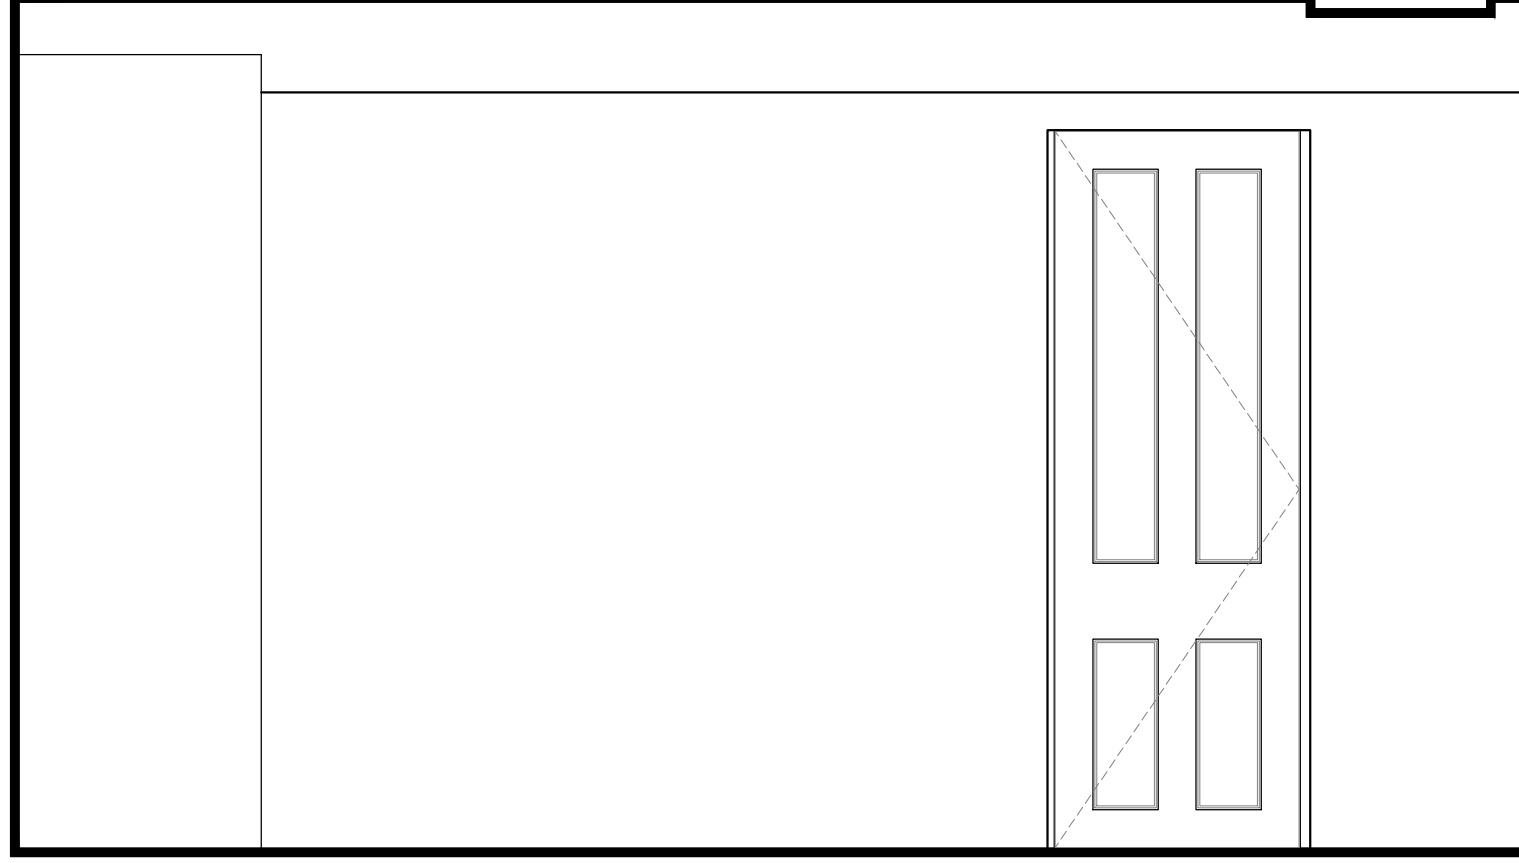
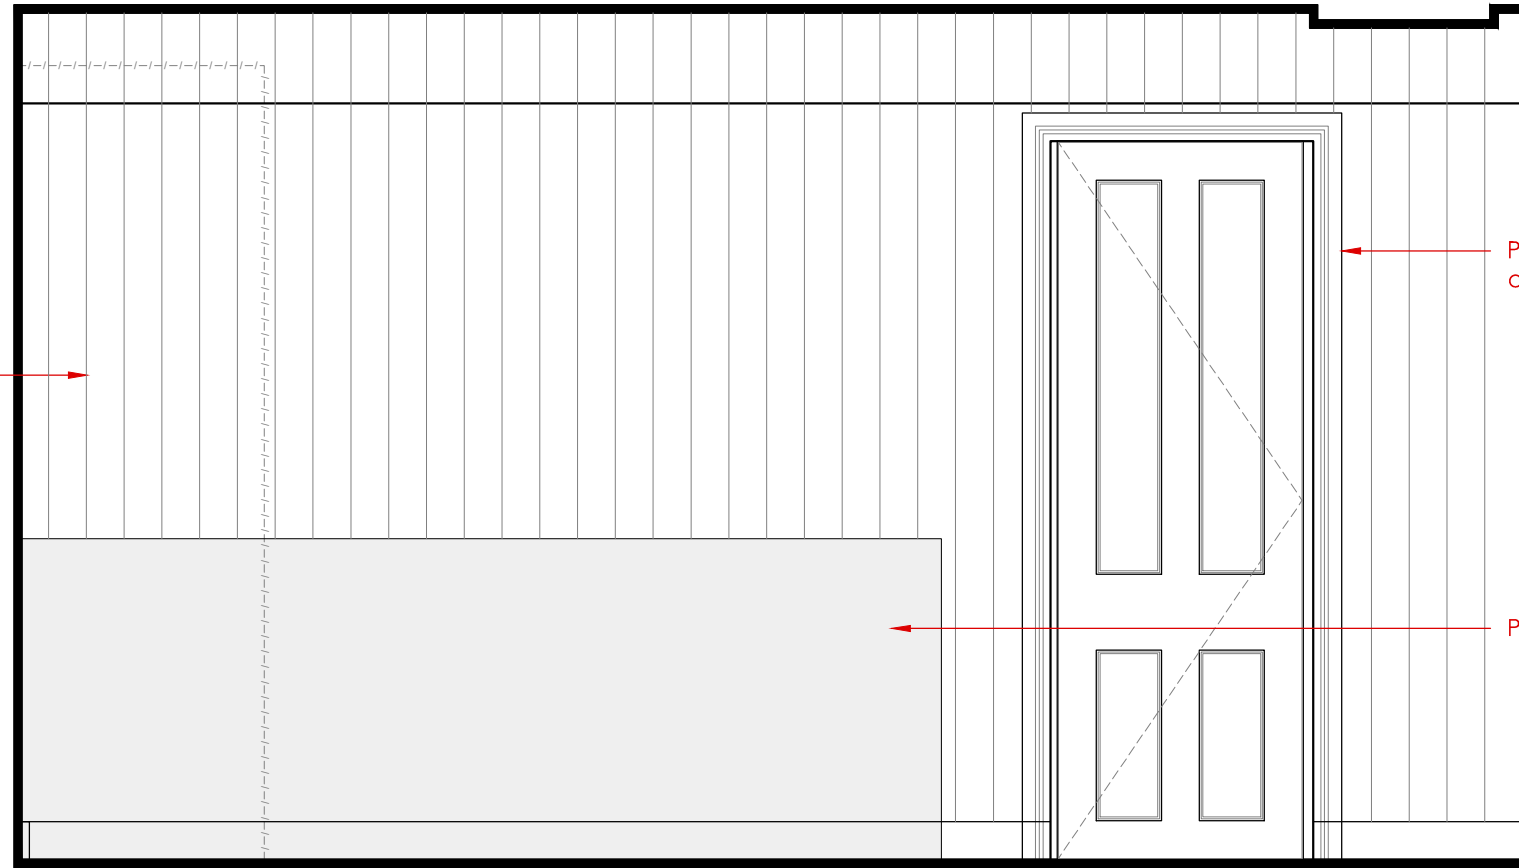
1435 - P224

Existing kitchen unit to  
be removed..

Proposed 75mm  
ogee architrave.

Proposed joinery.

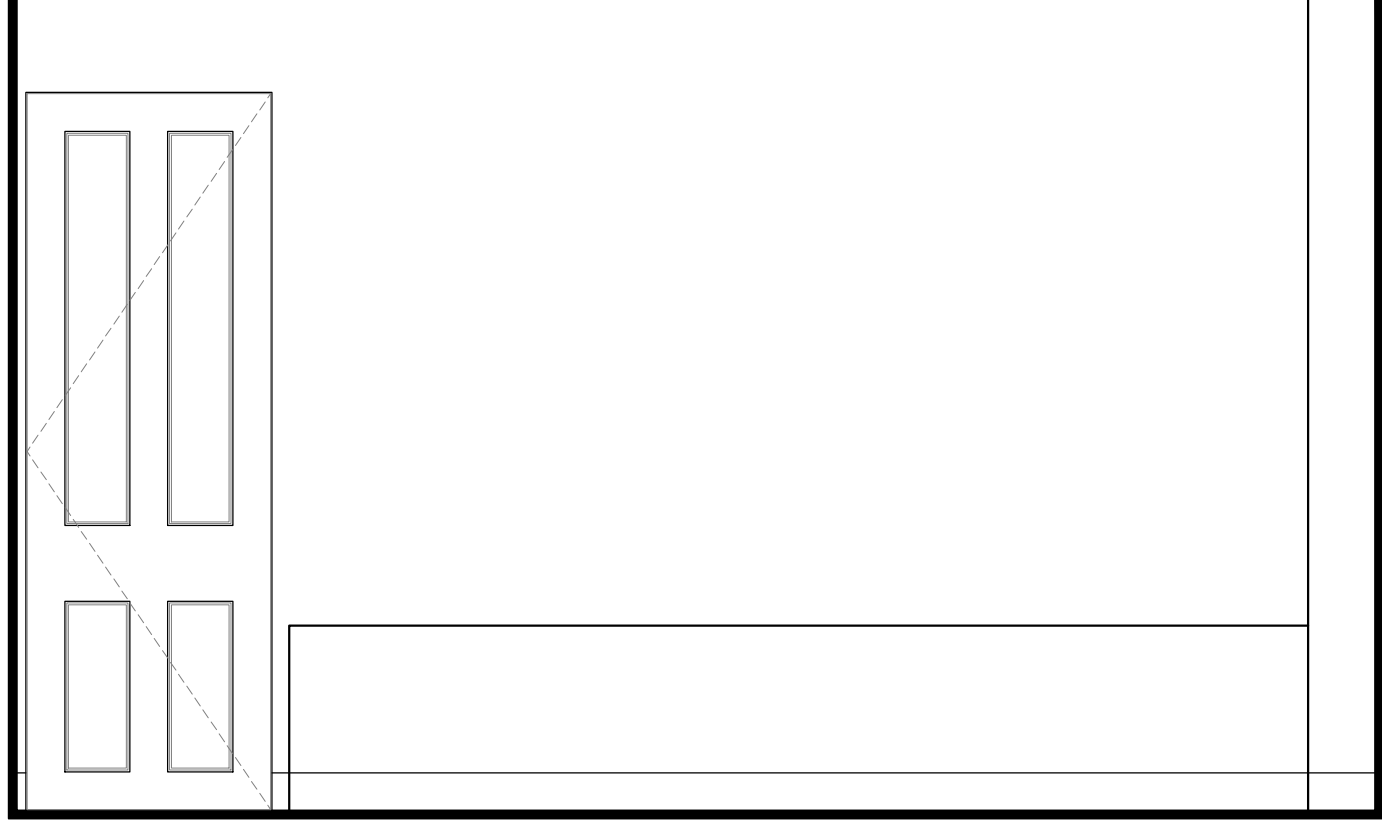
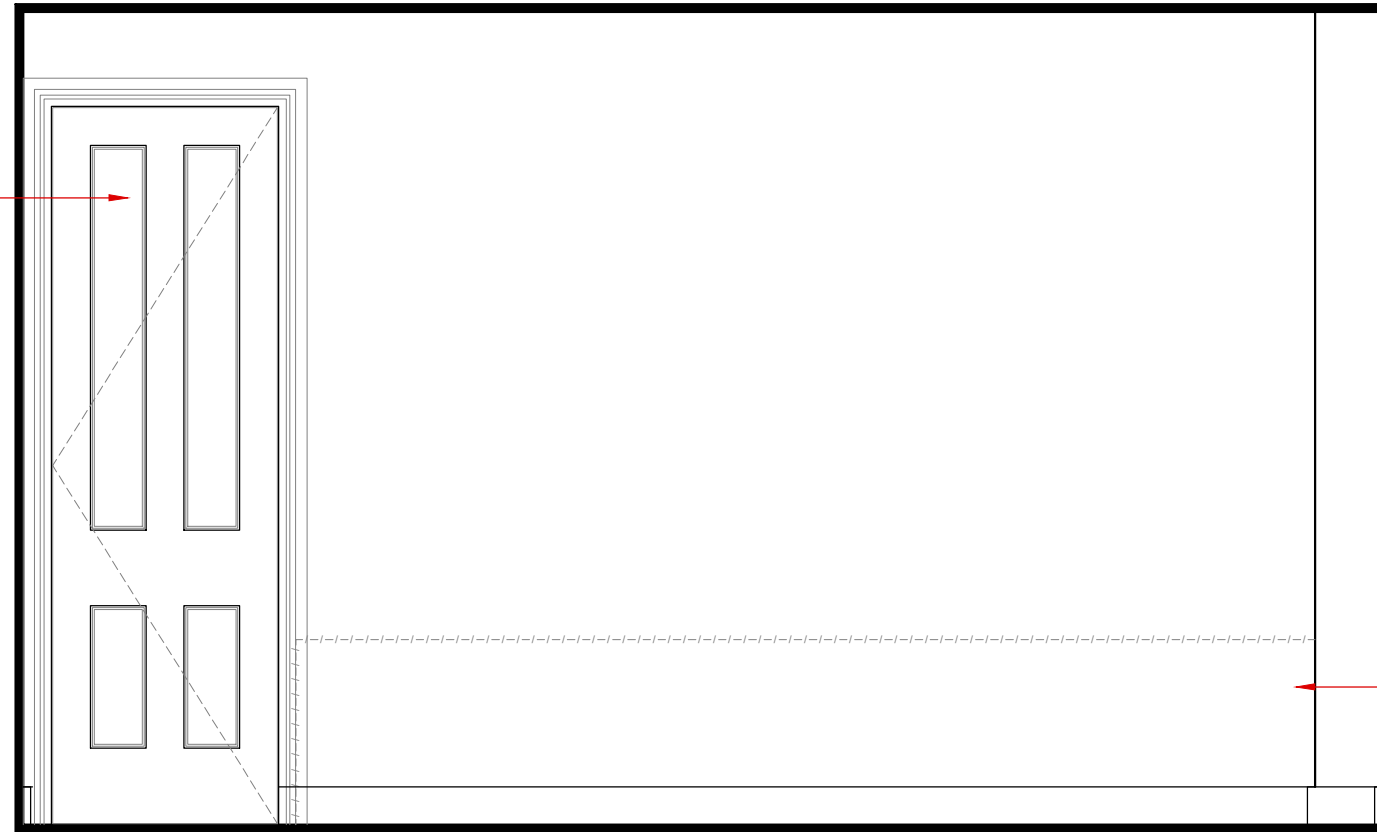
1435 - P028

Existing doorway  
checked to ensure full  
architrave

Existing boxing to level  
wall to be removed.

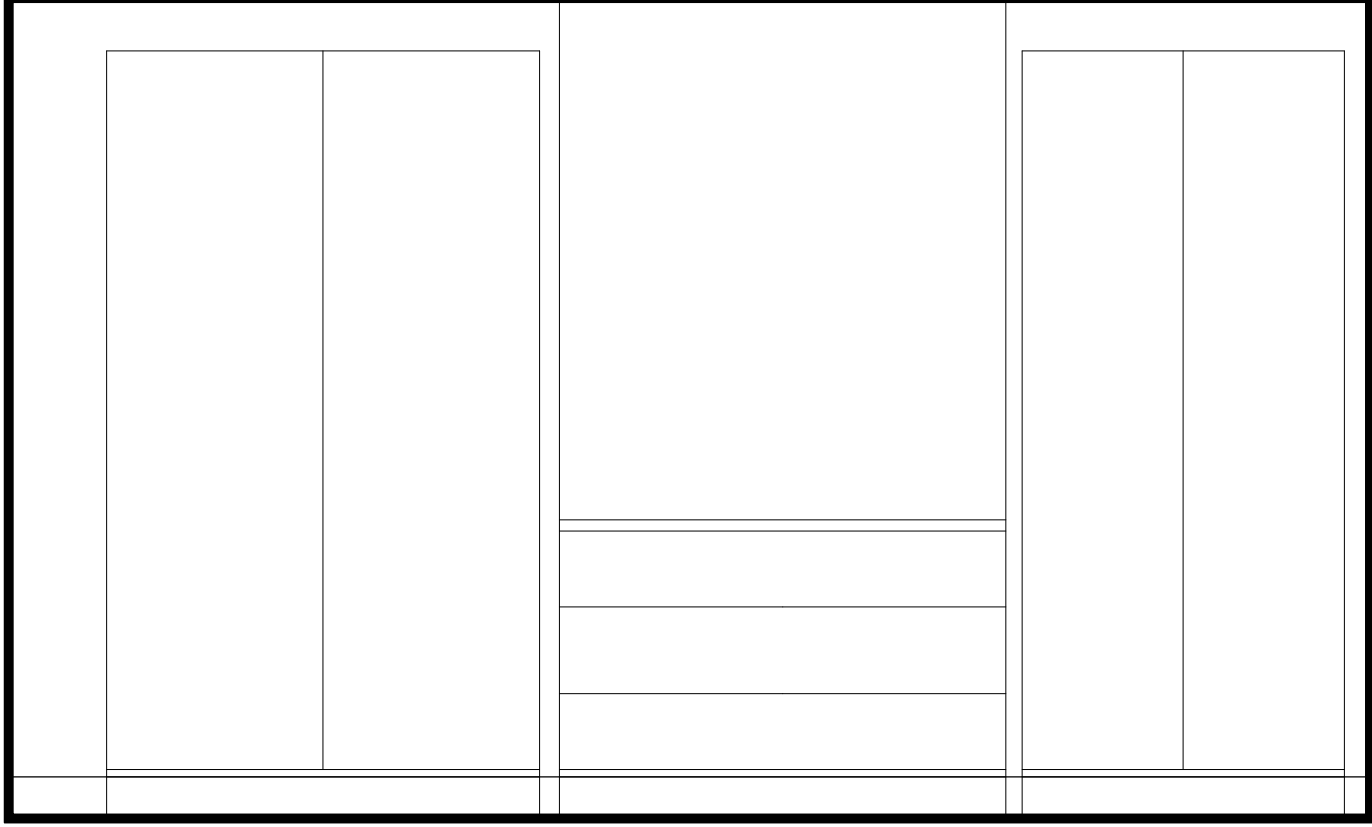
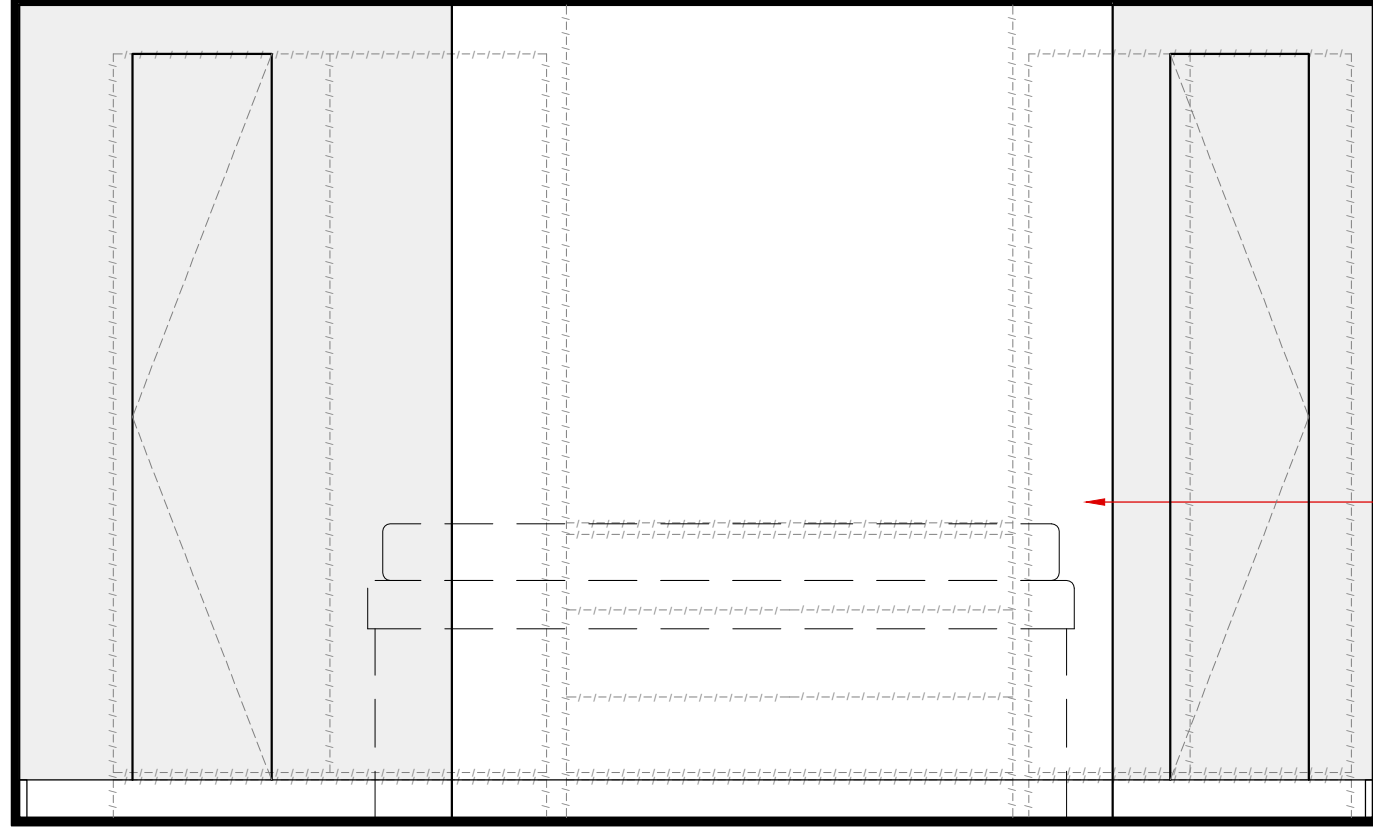
Existing non-original  
joinery removed.  
Fireplace breast to be  
flushed out with access  
doors to form  
cupboards.

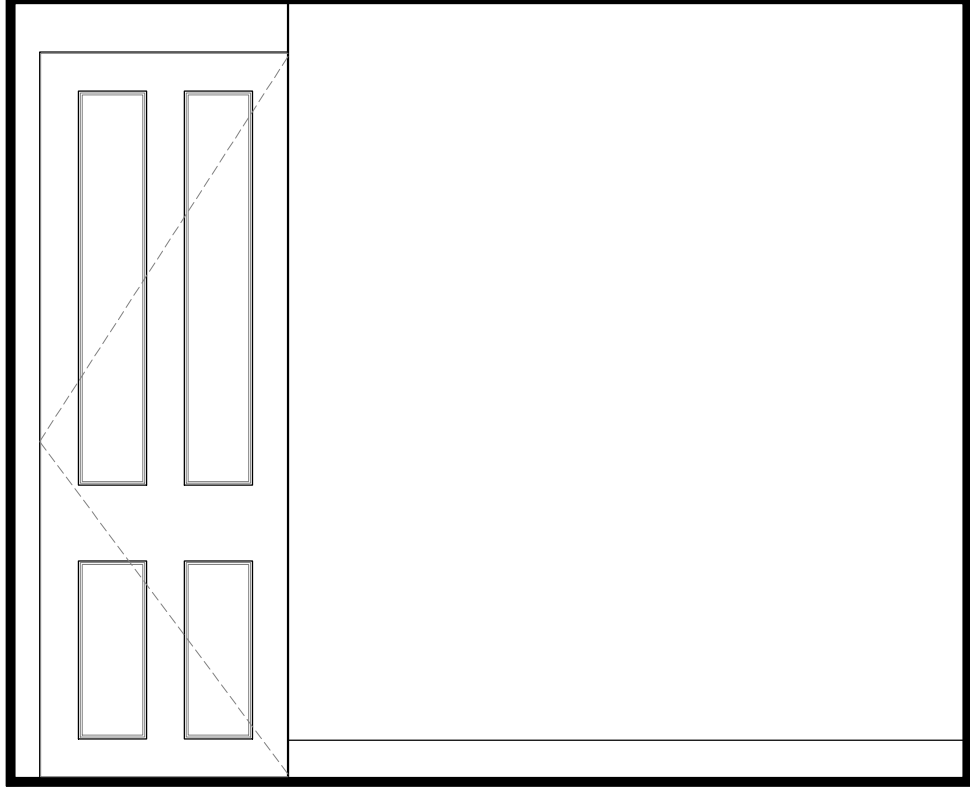
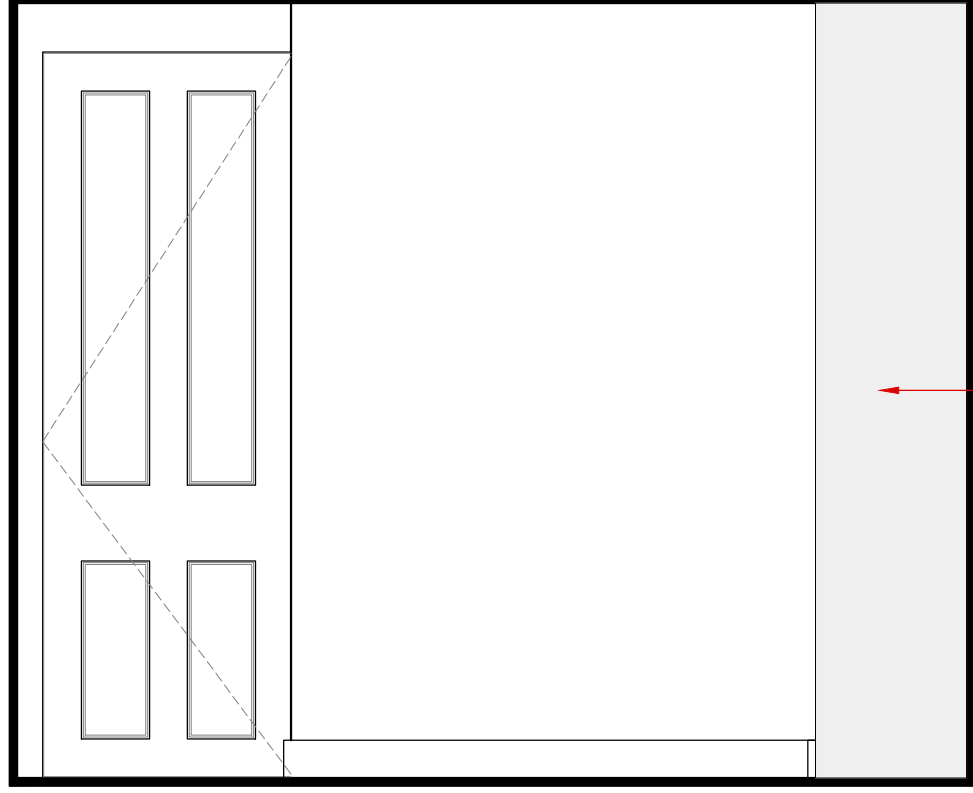
1435 - P034

Proposed bookshelves.

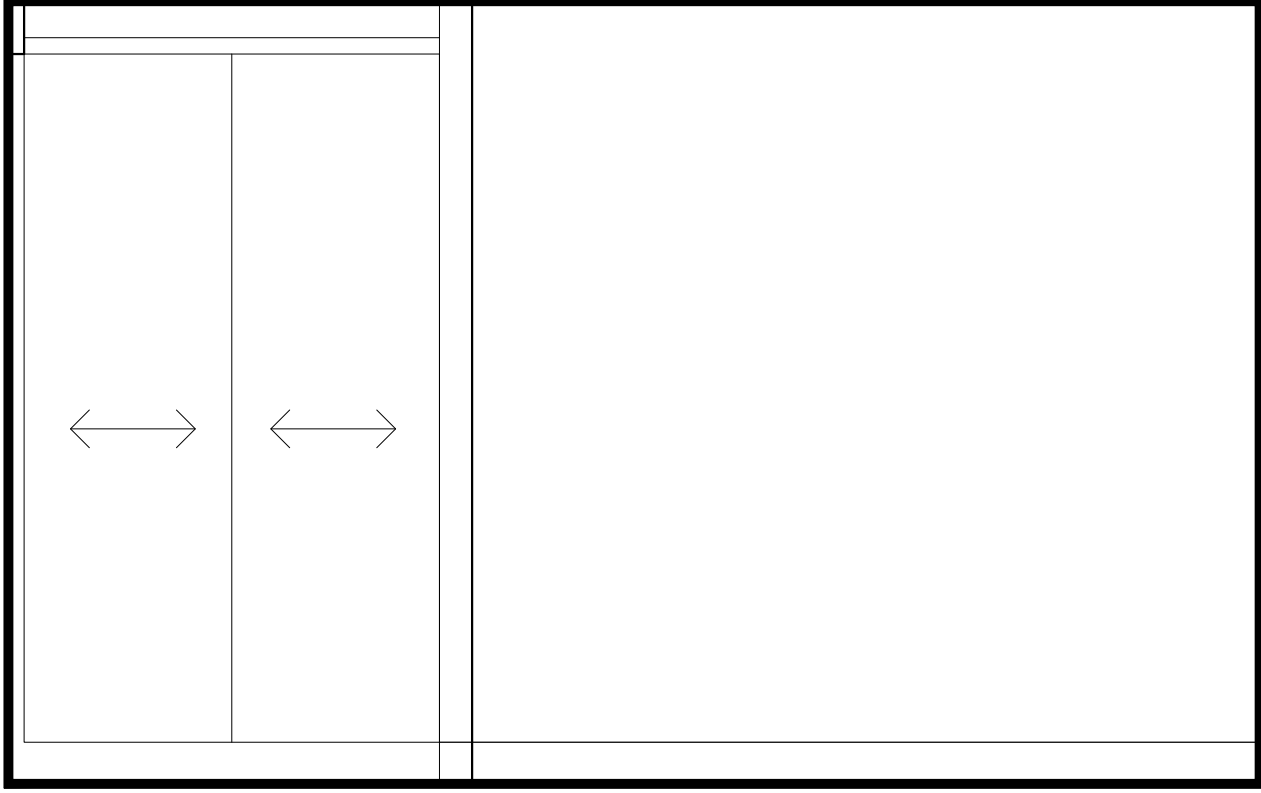
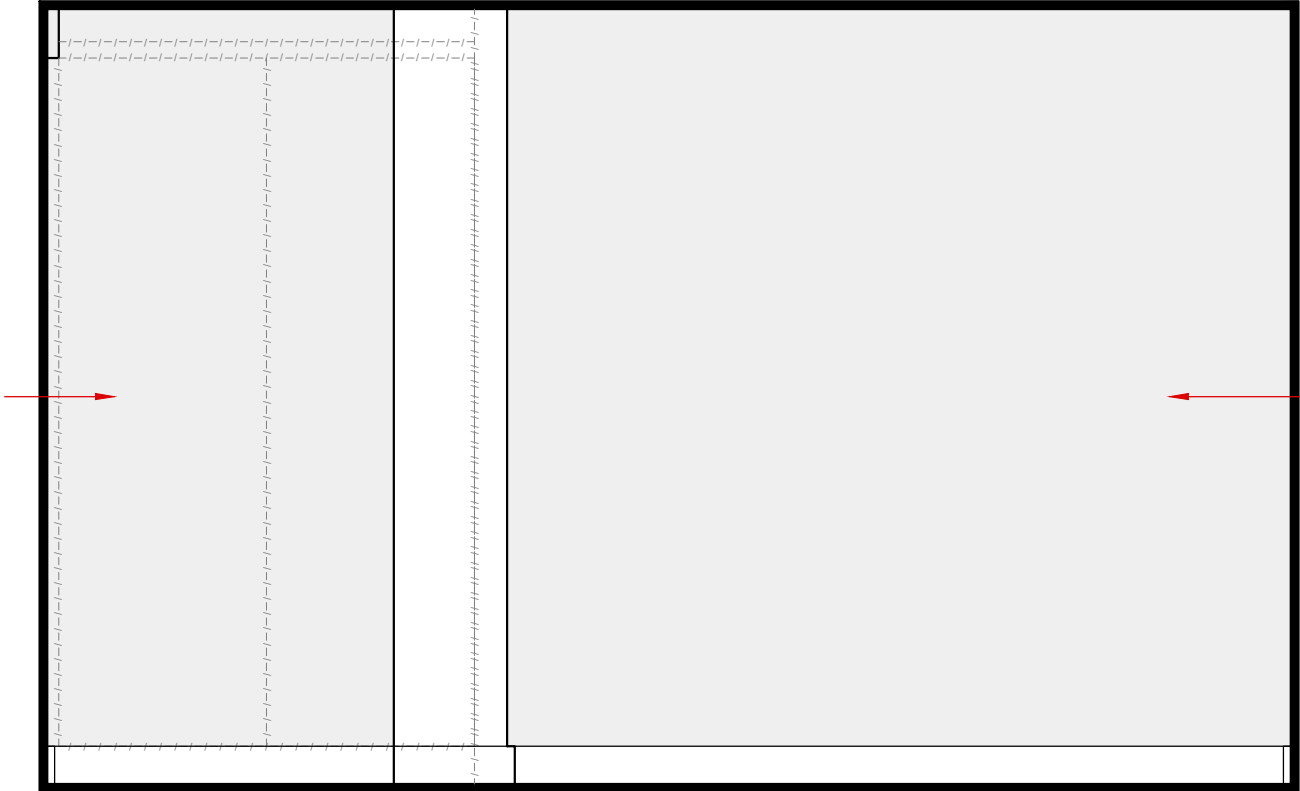
1435 - P035

Proposed bookshelves  
within existing recess.

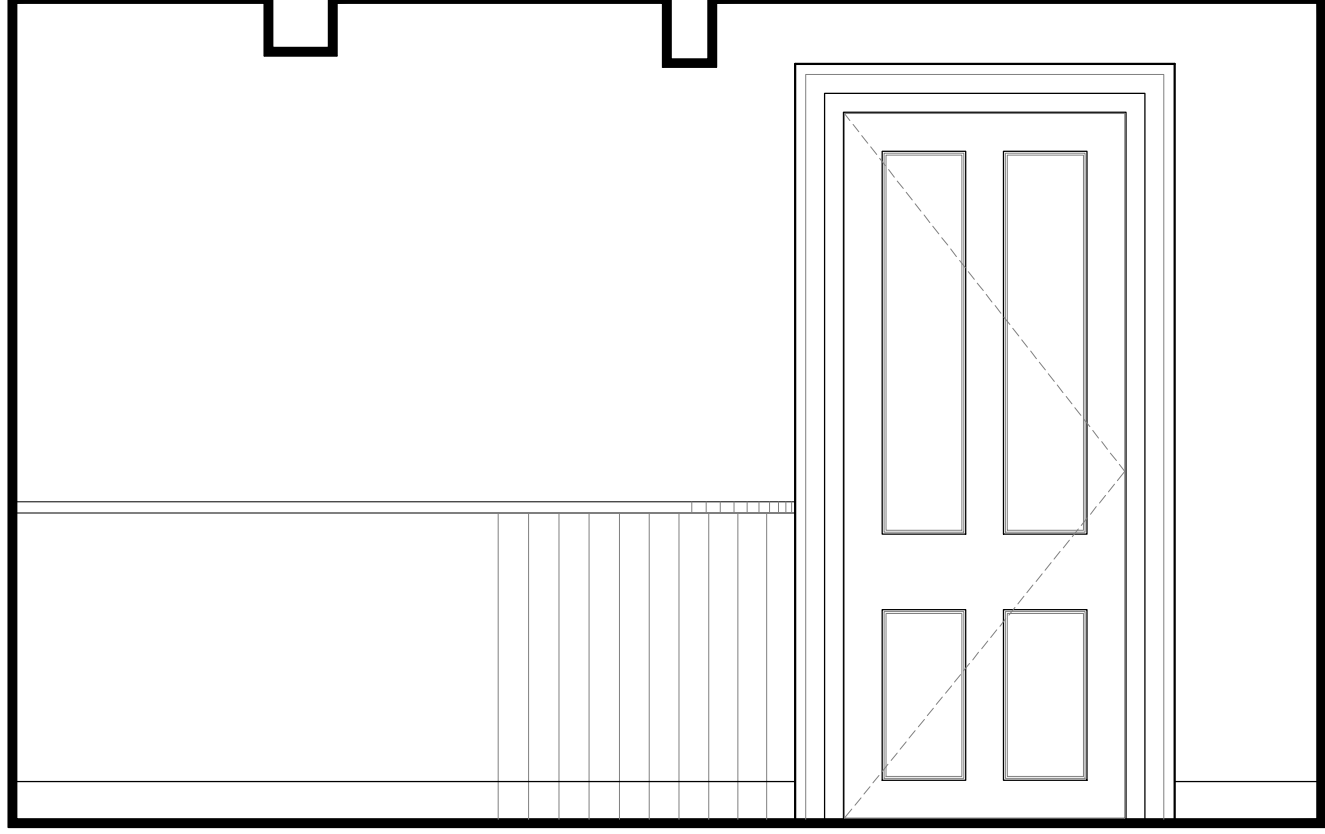
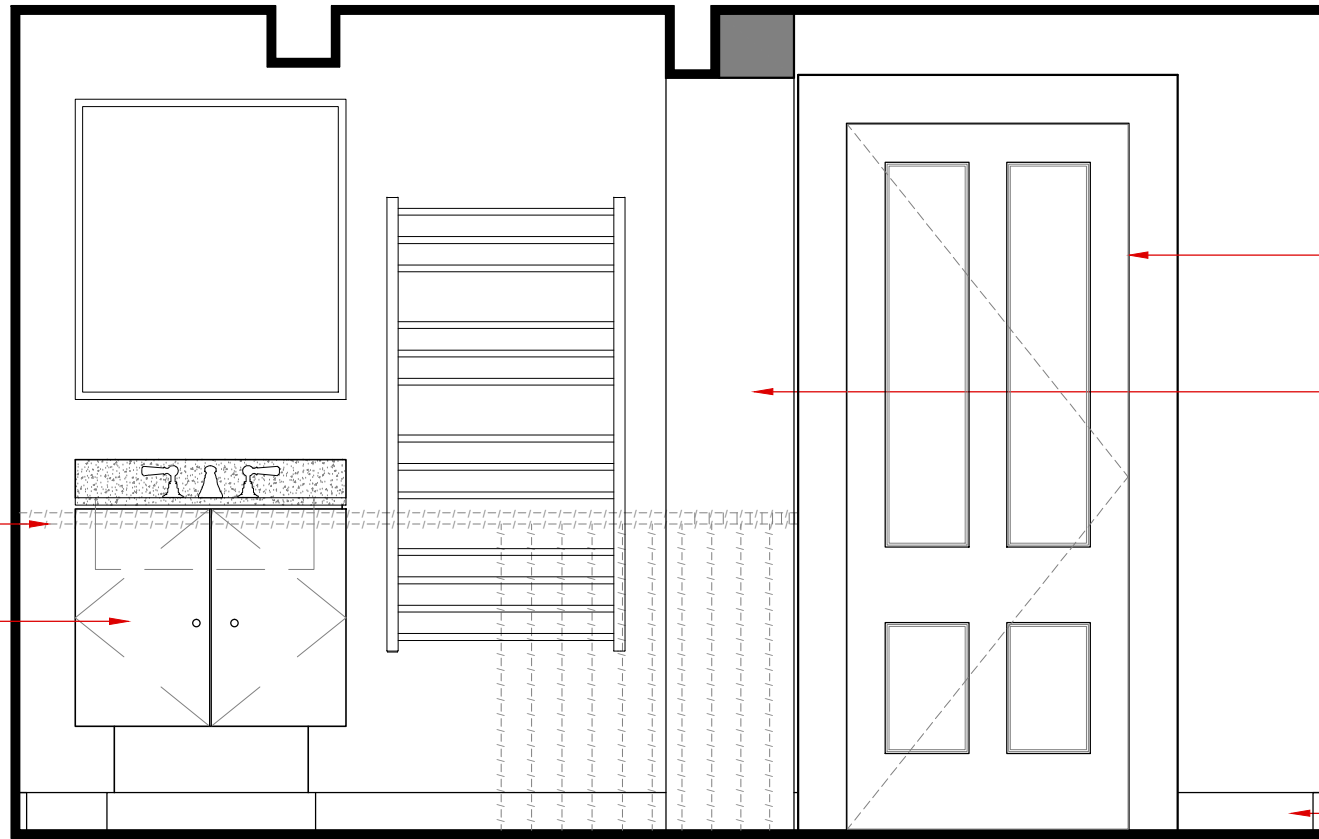
1435 - P038

Existing step in wall to  
be removed.

Proposed bathroom  
joinery.

Existing door removed  
and turned into  
opening.

Proposed timber  
studwall to separate  
Lobby and bathroom.  
Door to match 4 panel  
doors to Lower Ground  
floor.

Proposed skirting to  
match existing.
