LOWER GROUND  
FLOOR

1435 - P021

Kitchen//Existing//Elevation 1\_1:20

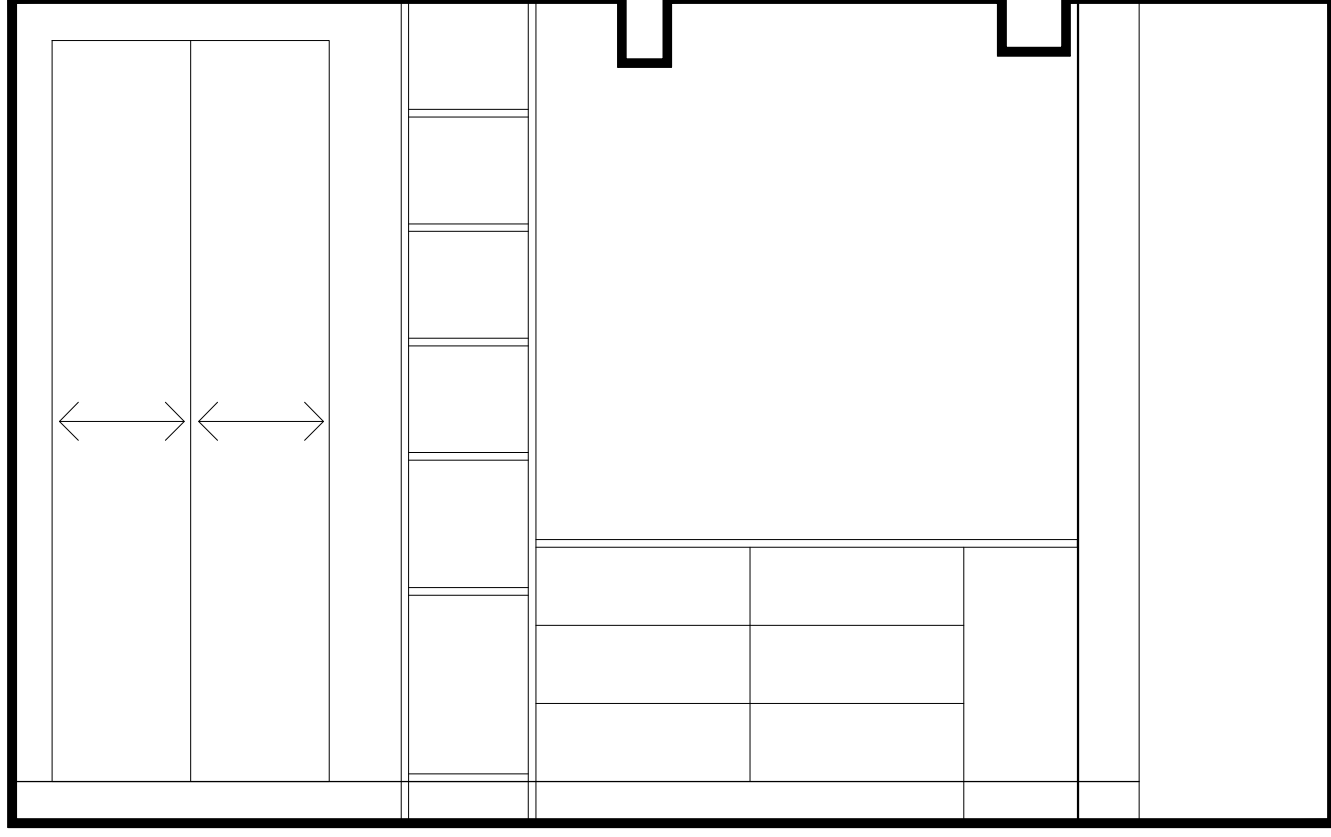
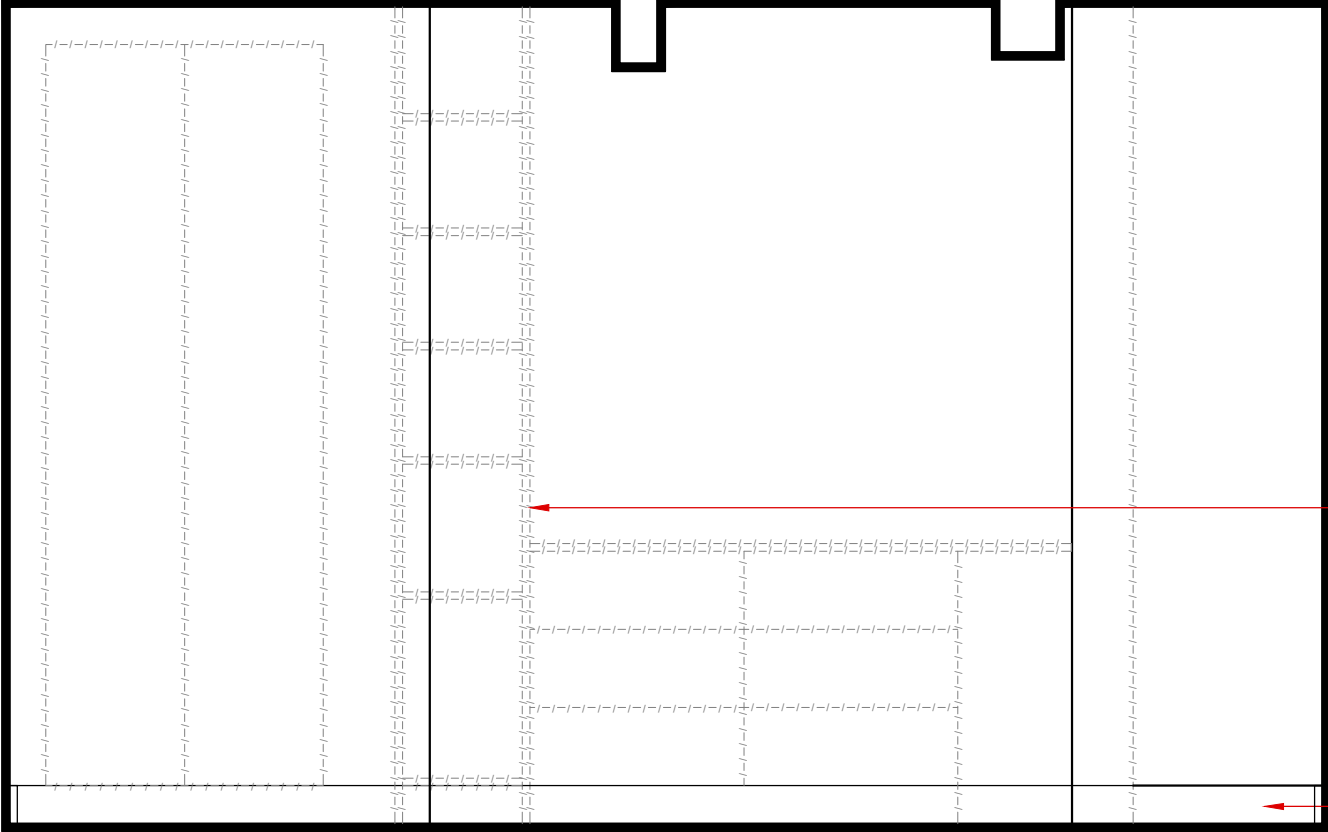
1435 - P040

Existing non-original  
joinery removed.

Proposed skirting to  
match existing.

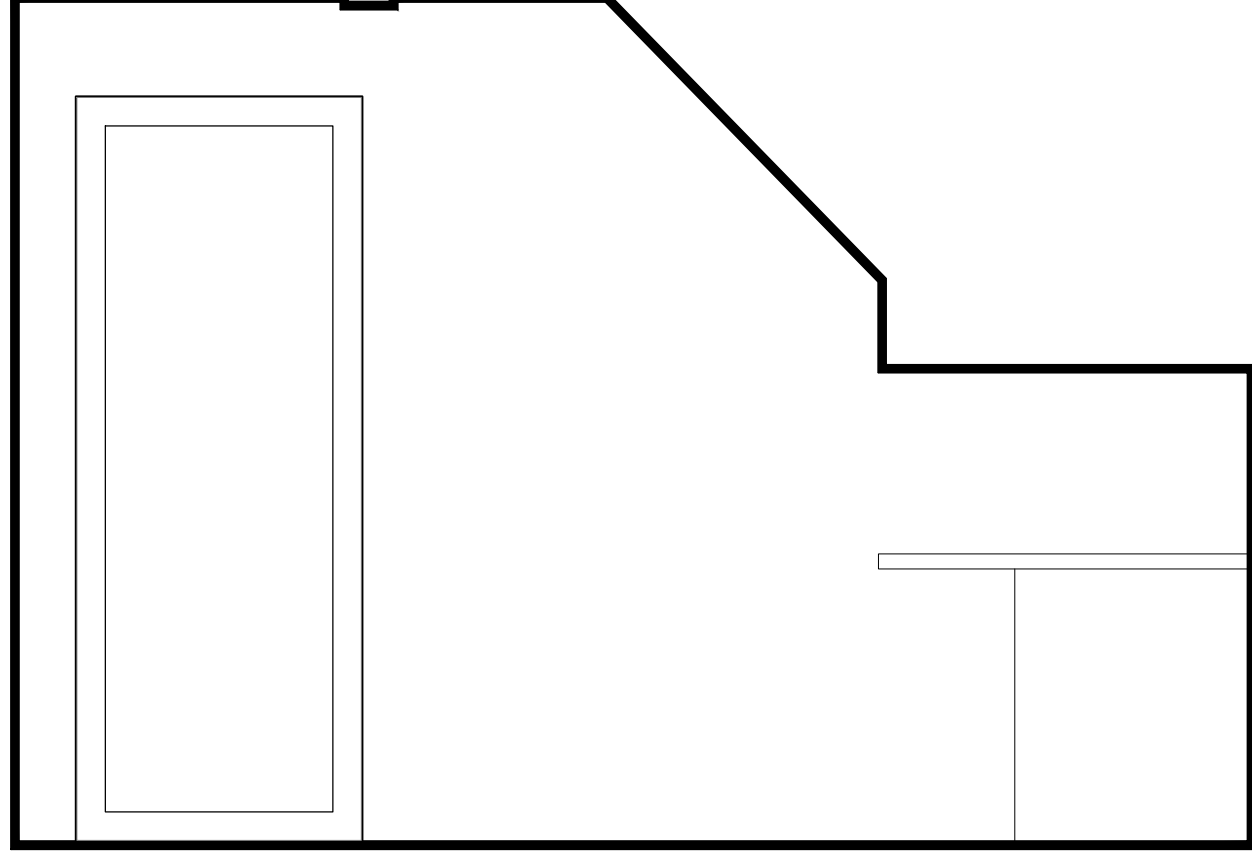
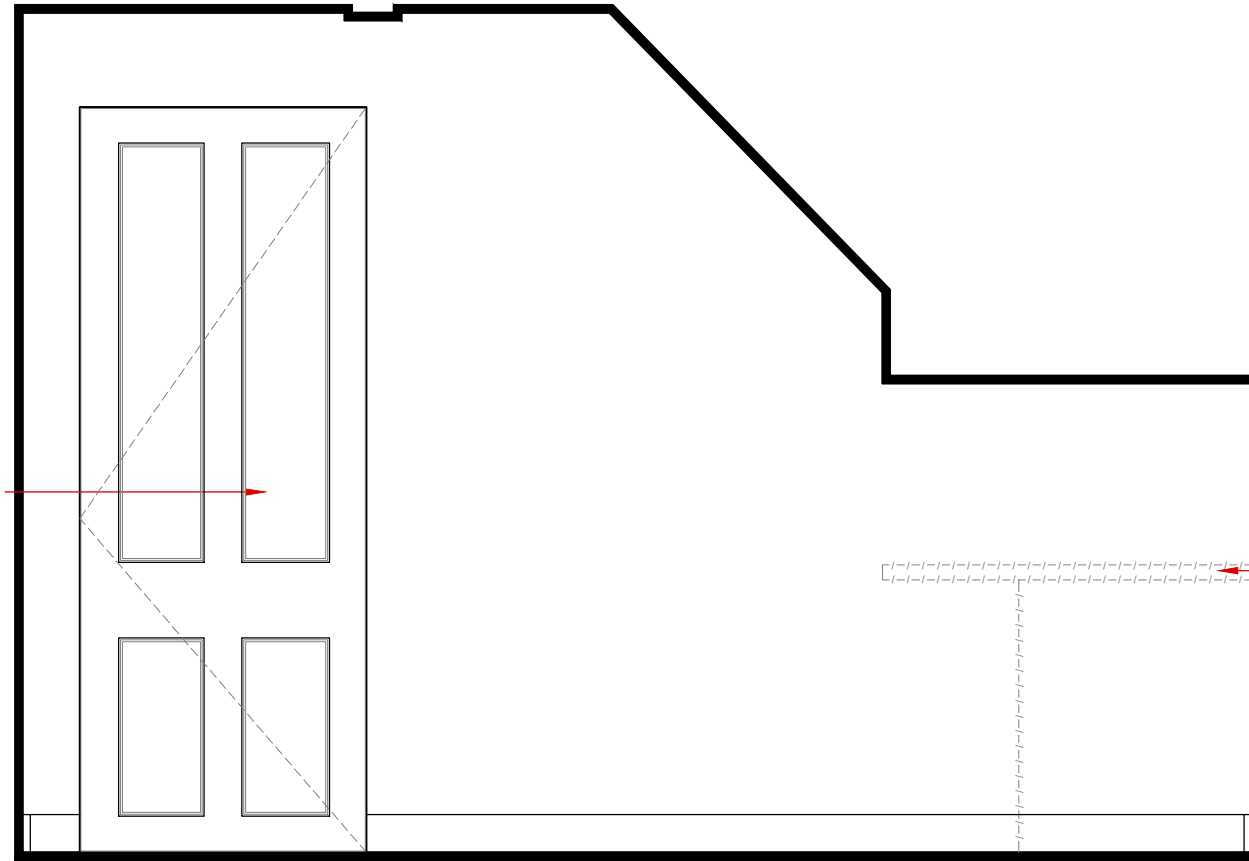
Proposed door to match  
existing on Lower  
Ground Floor.

Existing sanitaryware  
removed.
