Entrance Hall//Existing//Plan\_1:20

Drawing Room//Existing//Elevation 1\_1:20

Study//Existing//Plan\_1:20

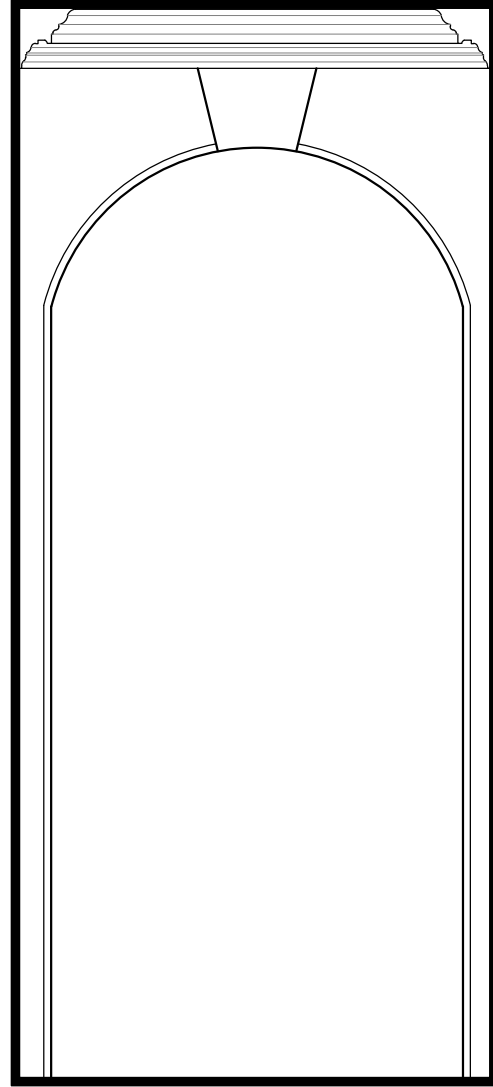
Elevation 1

Proposed glazed 2 panel door.

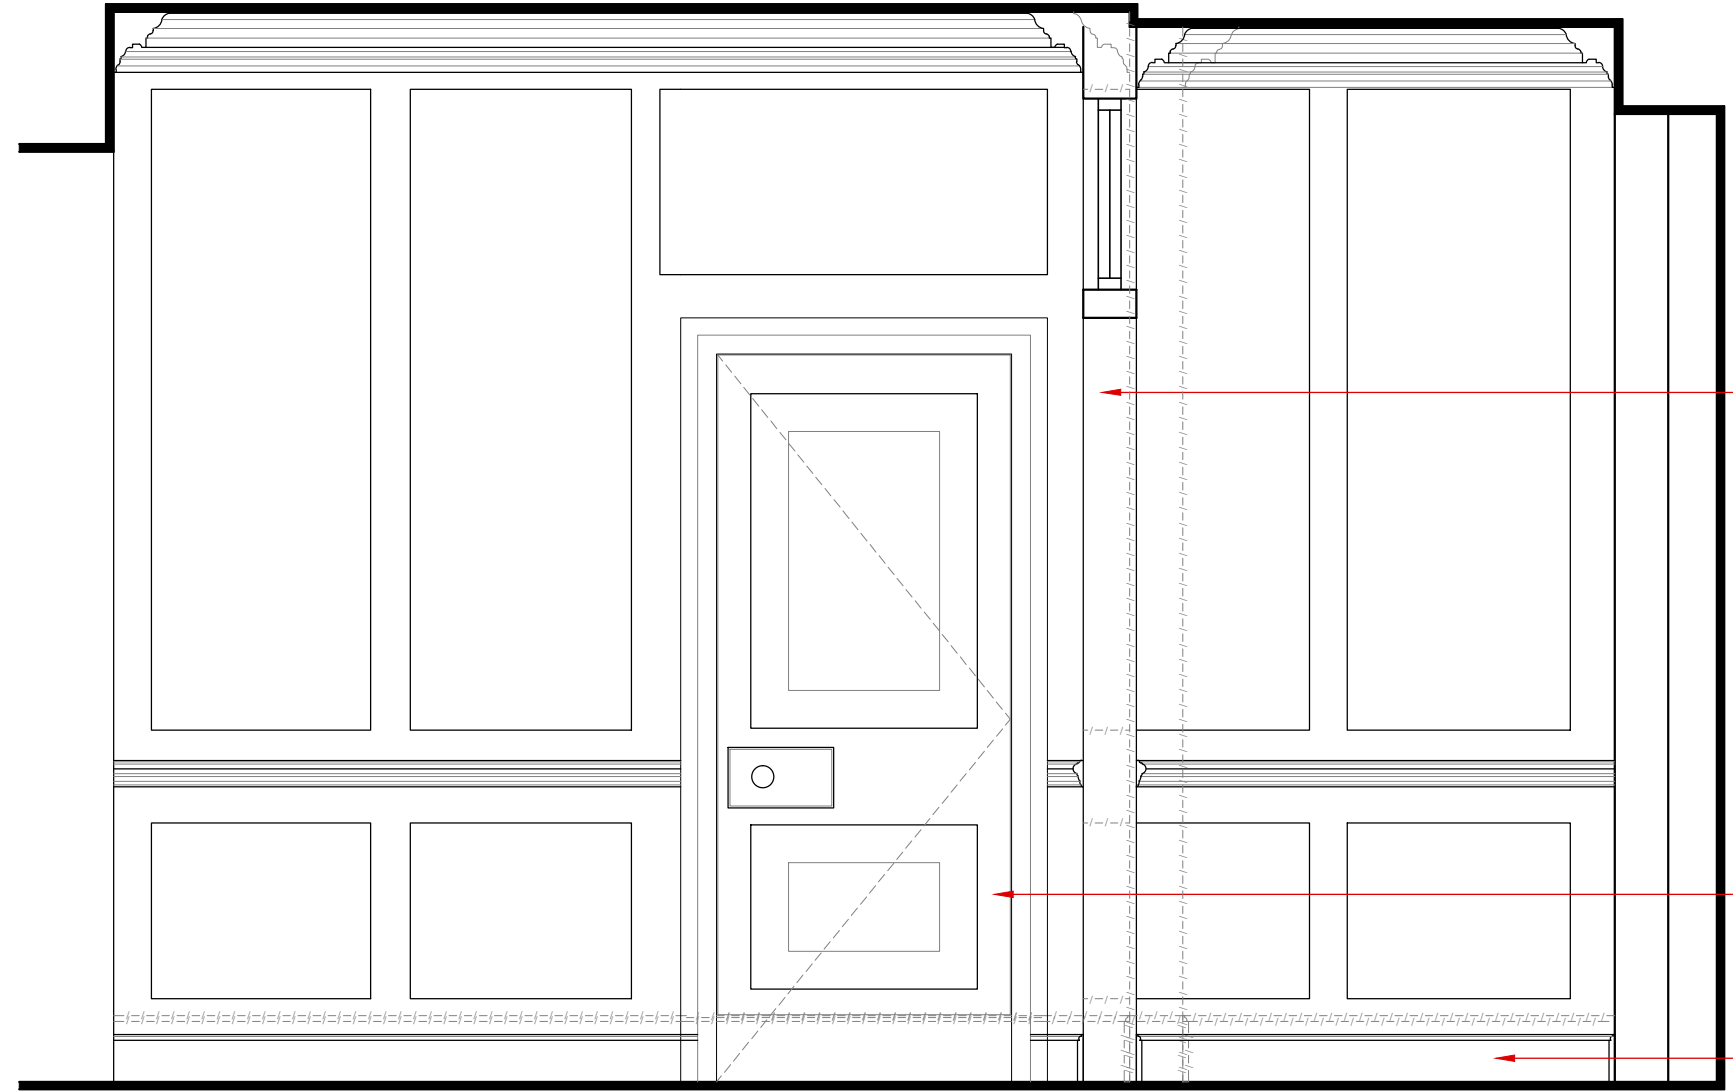
Existing non original door and opening moved to ensure equal panelling. Door to be replaced with 1/2 glazed door. Door swing revised.

Existing door retained.

Existing skirting removed and new skirting proposed to even panelling gaps.

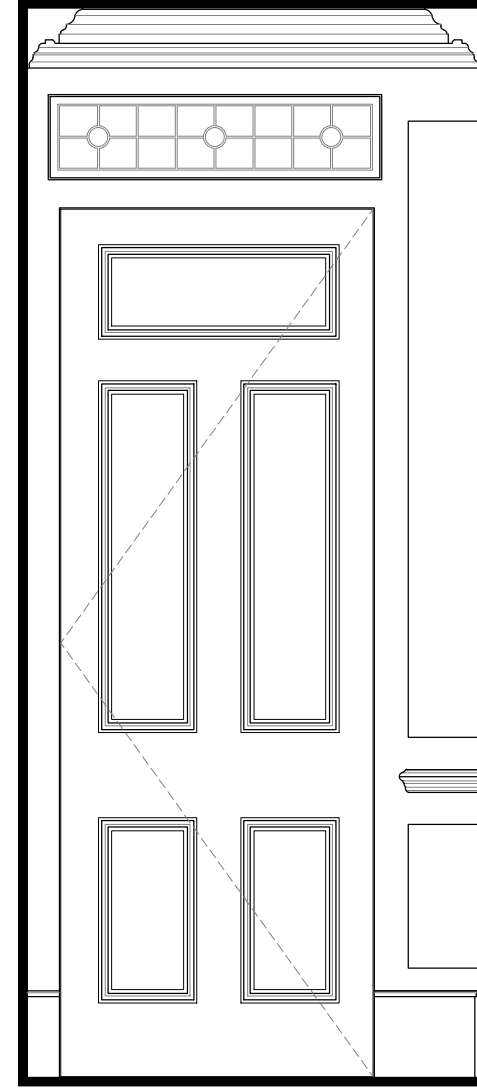
Elevation 3a

Replace non-original rotten front door and replaced with Georgian style. Door swing revised.

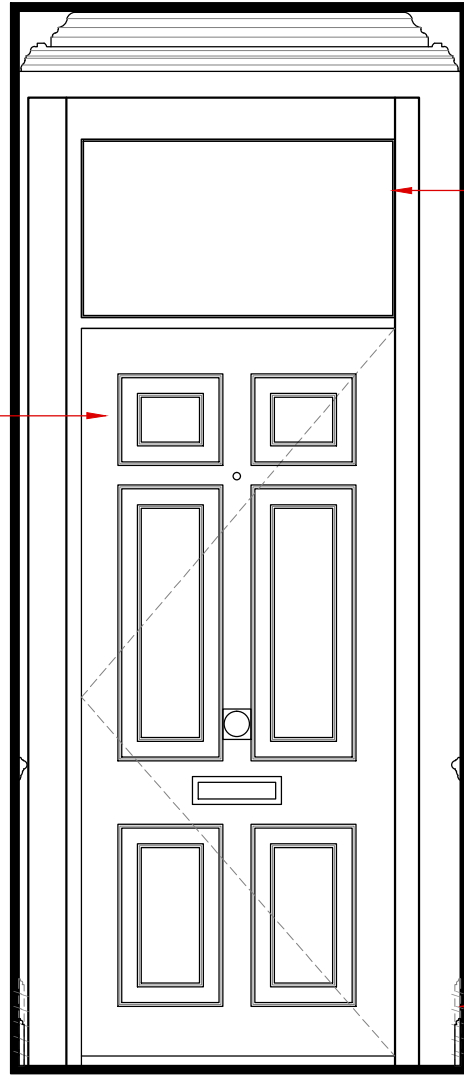
Elevation 3

Existing glass to be replaced with new plain glass.

Existing skirting removed and new skirting proposed to even panelling gaps.

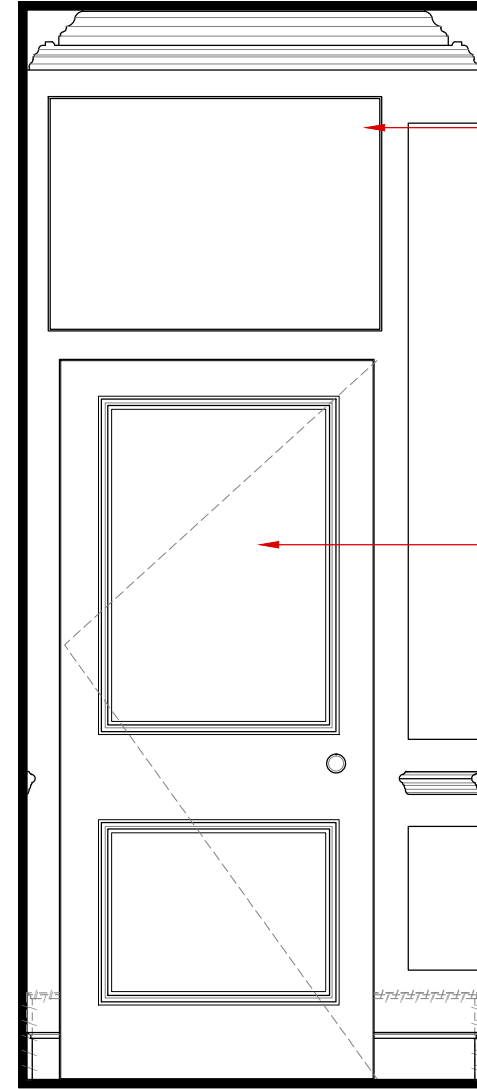
Elevation 3a

Existing glass to be replaced with new plain glass.

Proposed glazed 2 panel door.

Existing skirting removed and new skirting proposed to even panelling gaps.

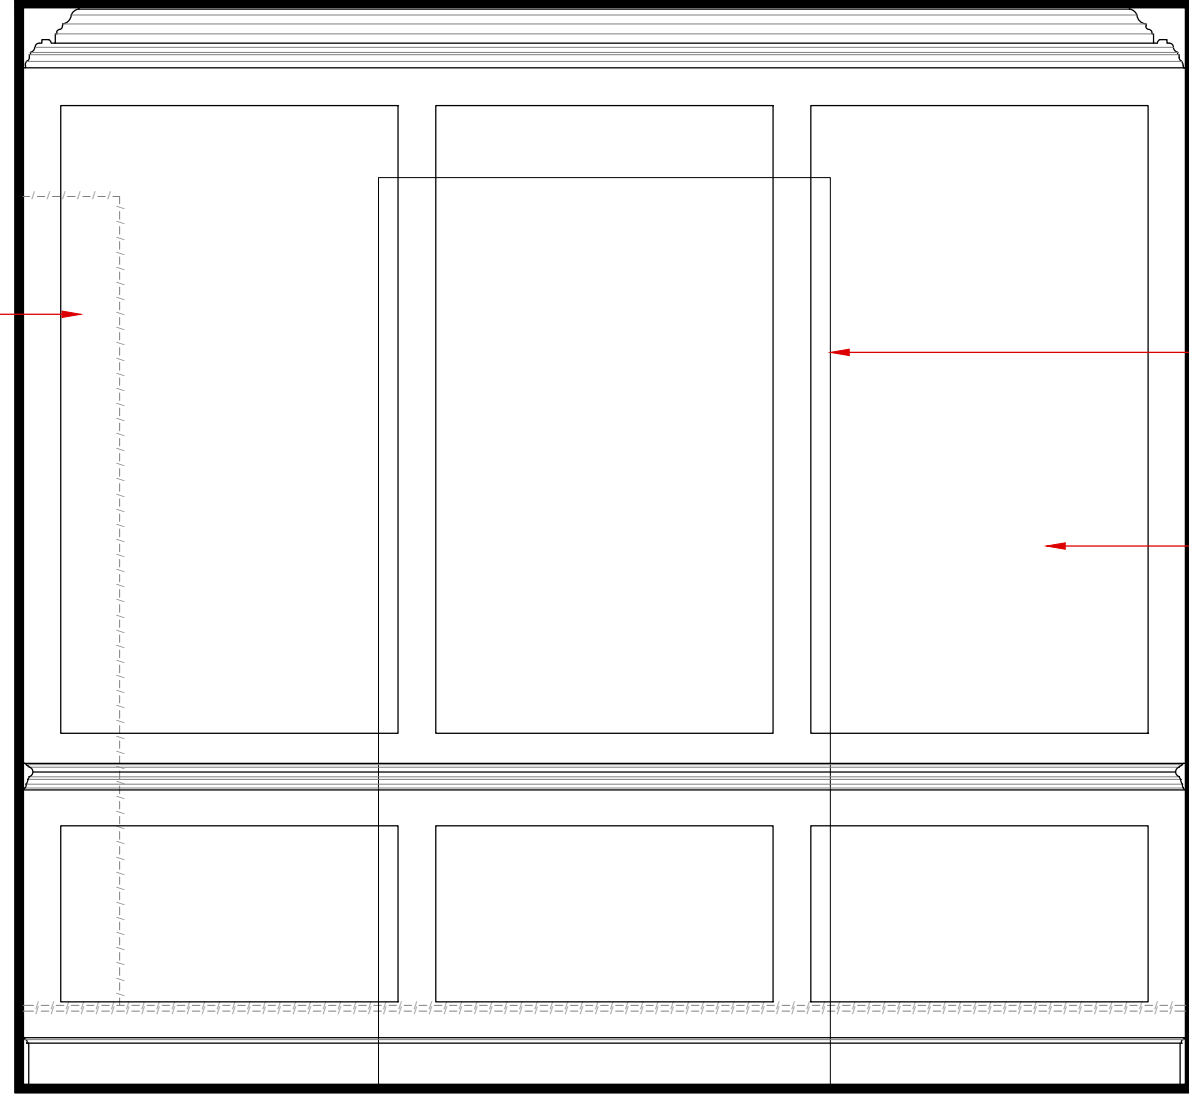
Proposed free standing unit.

Proposed simple panelling to match existing within Drawing Room.

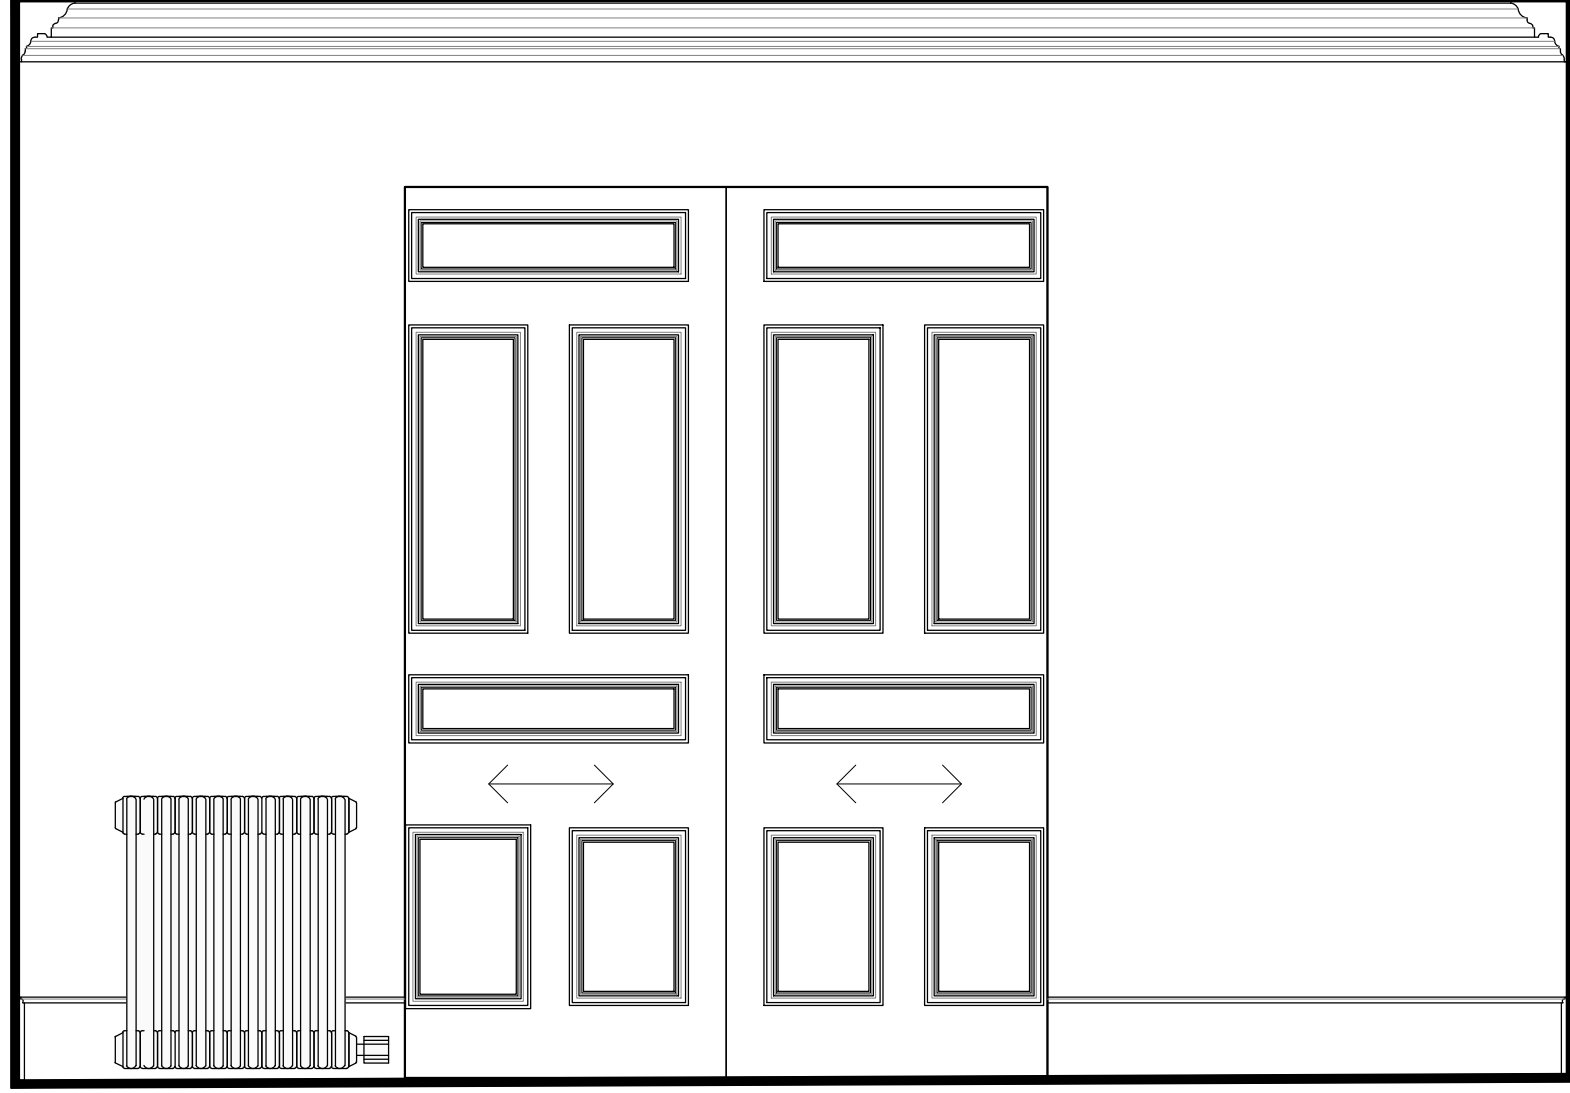
Proposed cornice to  
adjusted wall to match  
existing.

Existing column radiator  
removed.

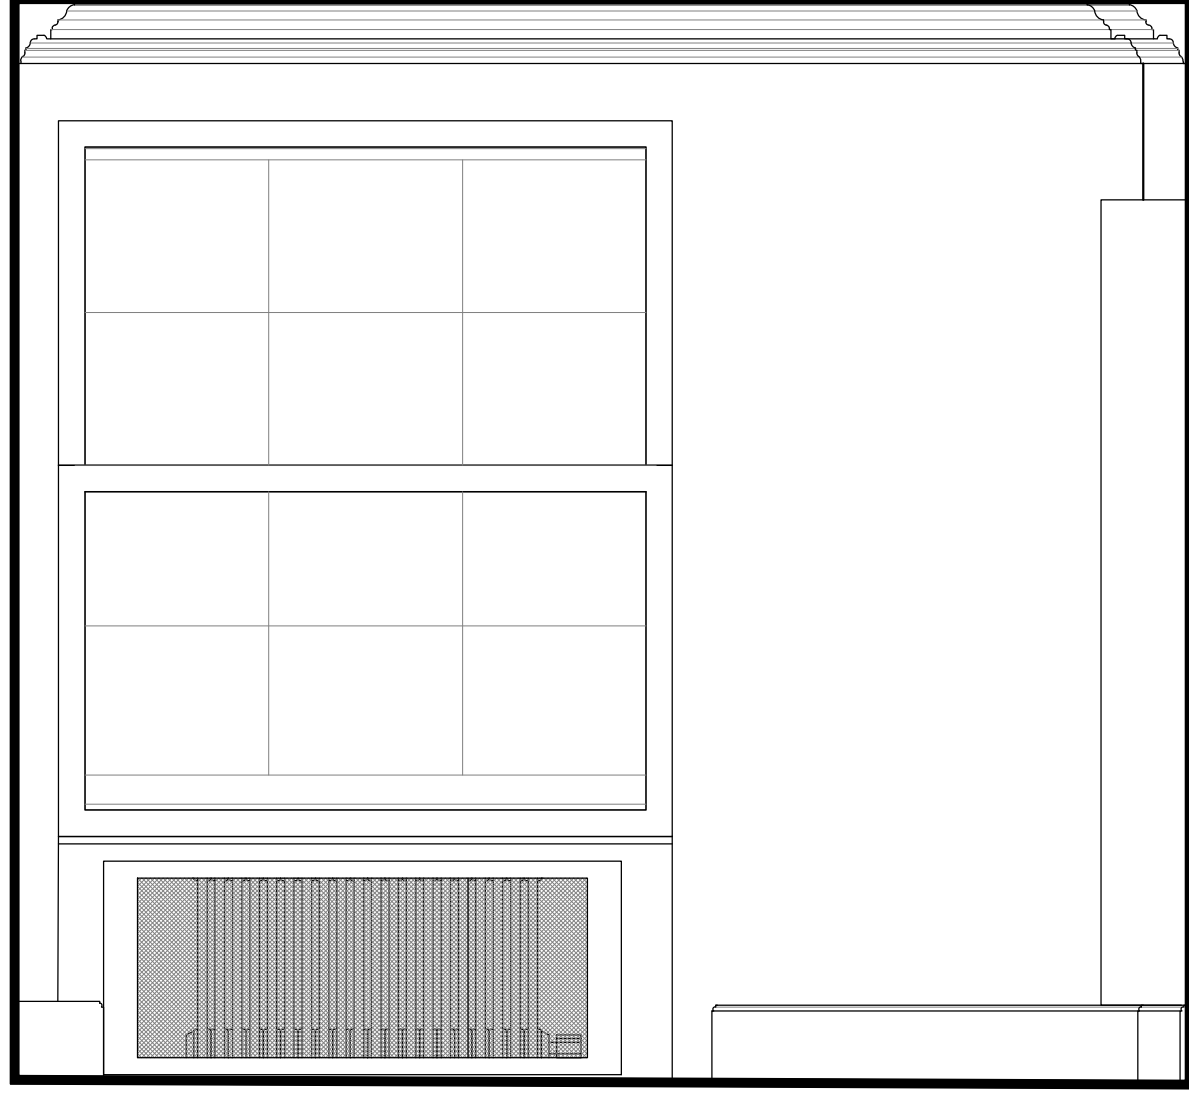
Existing single panel double glazing removed and replaced.

Proposed window architrave.

Proposed sliding shutters to window to have panelling to match walls.

Existing radiator removed, opening reformed and relined.

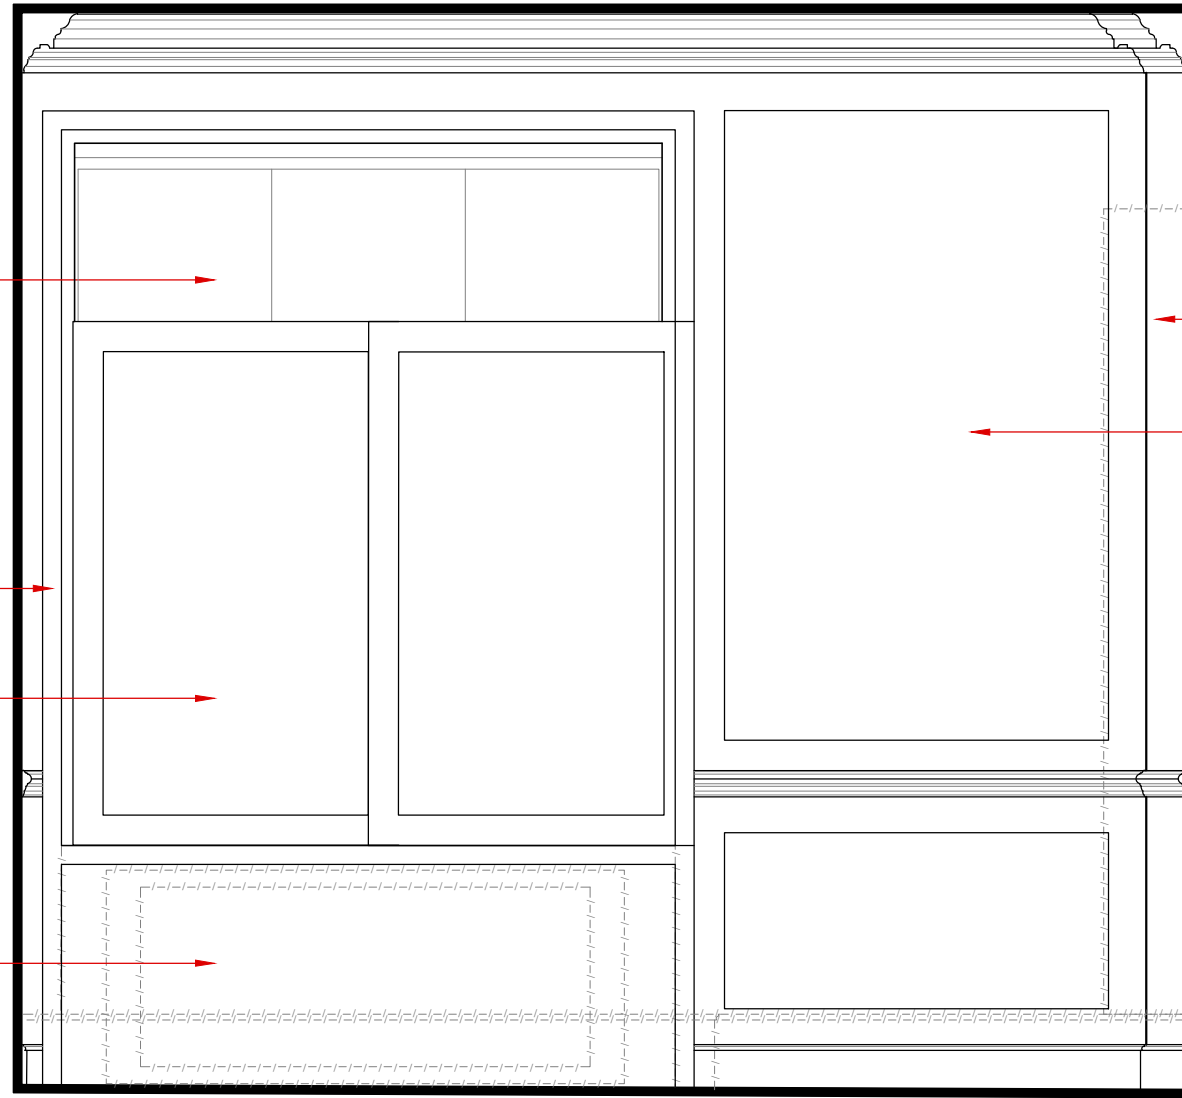
Existing bookshelves removed.

Stud wall form to allow for recessed sliding shutter to window. Panelling proposed to new studwork.

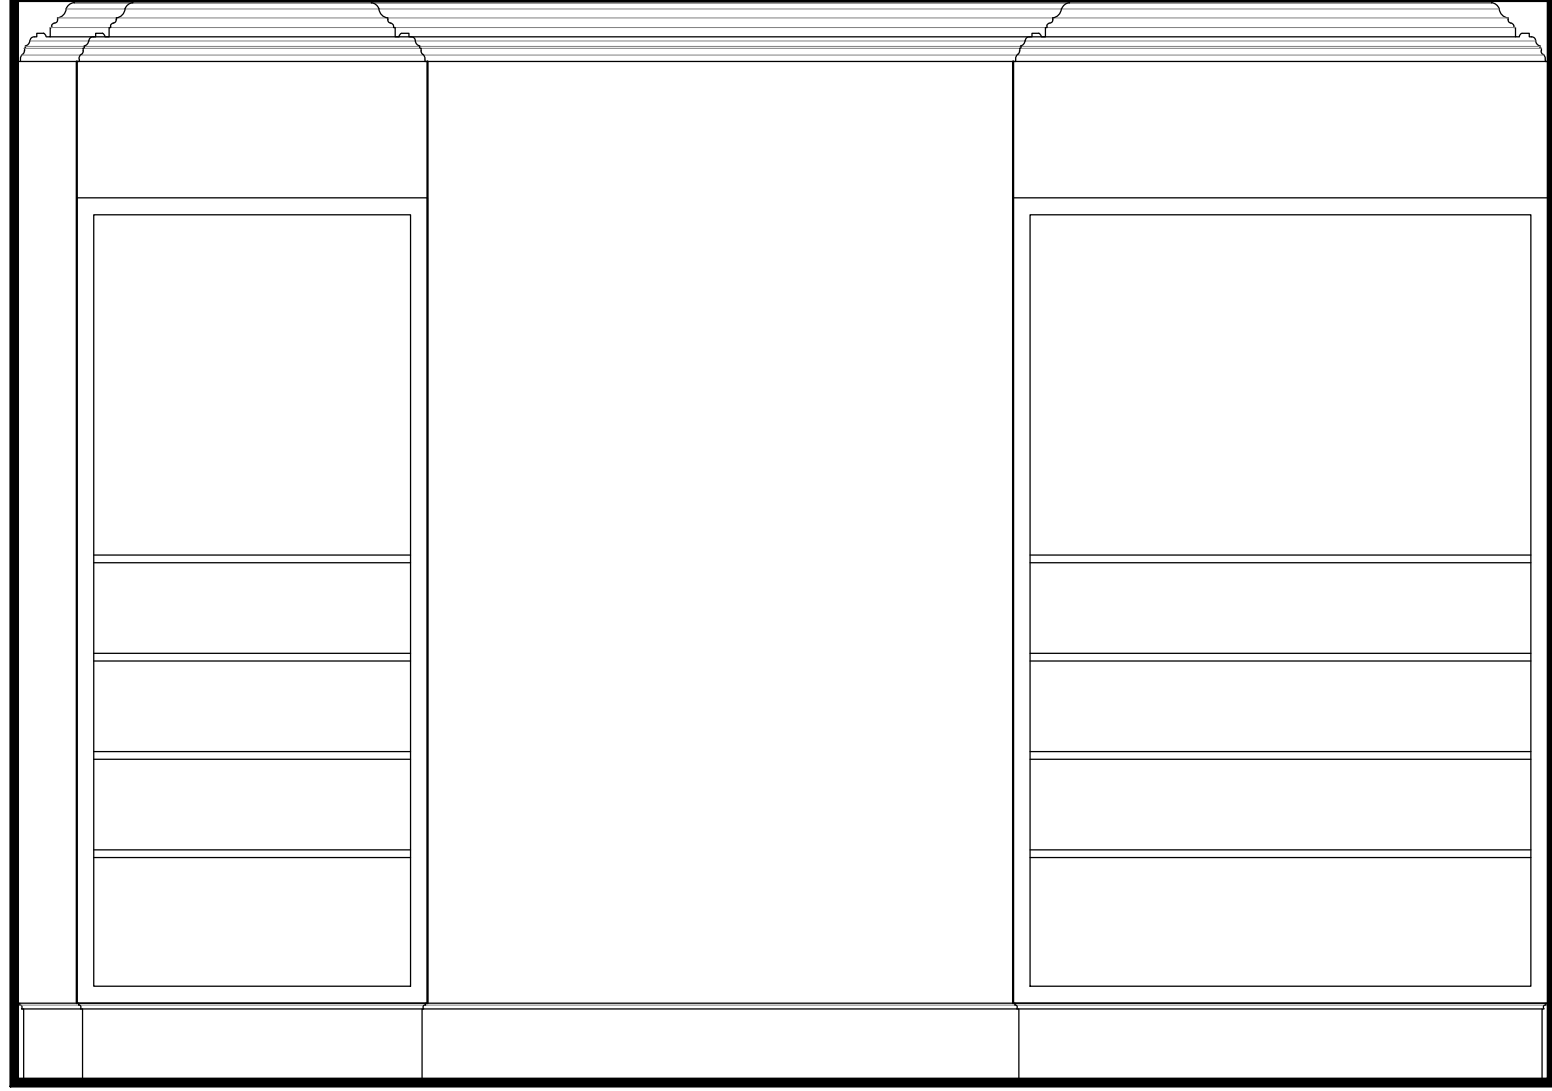
Proposed free standing unit.

Existing bookshelves removed.

Reline flue, and add new surround and heath.

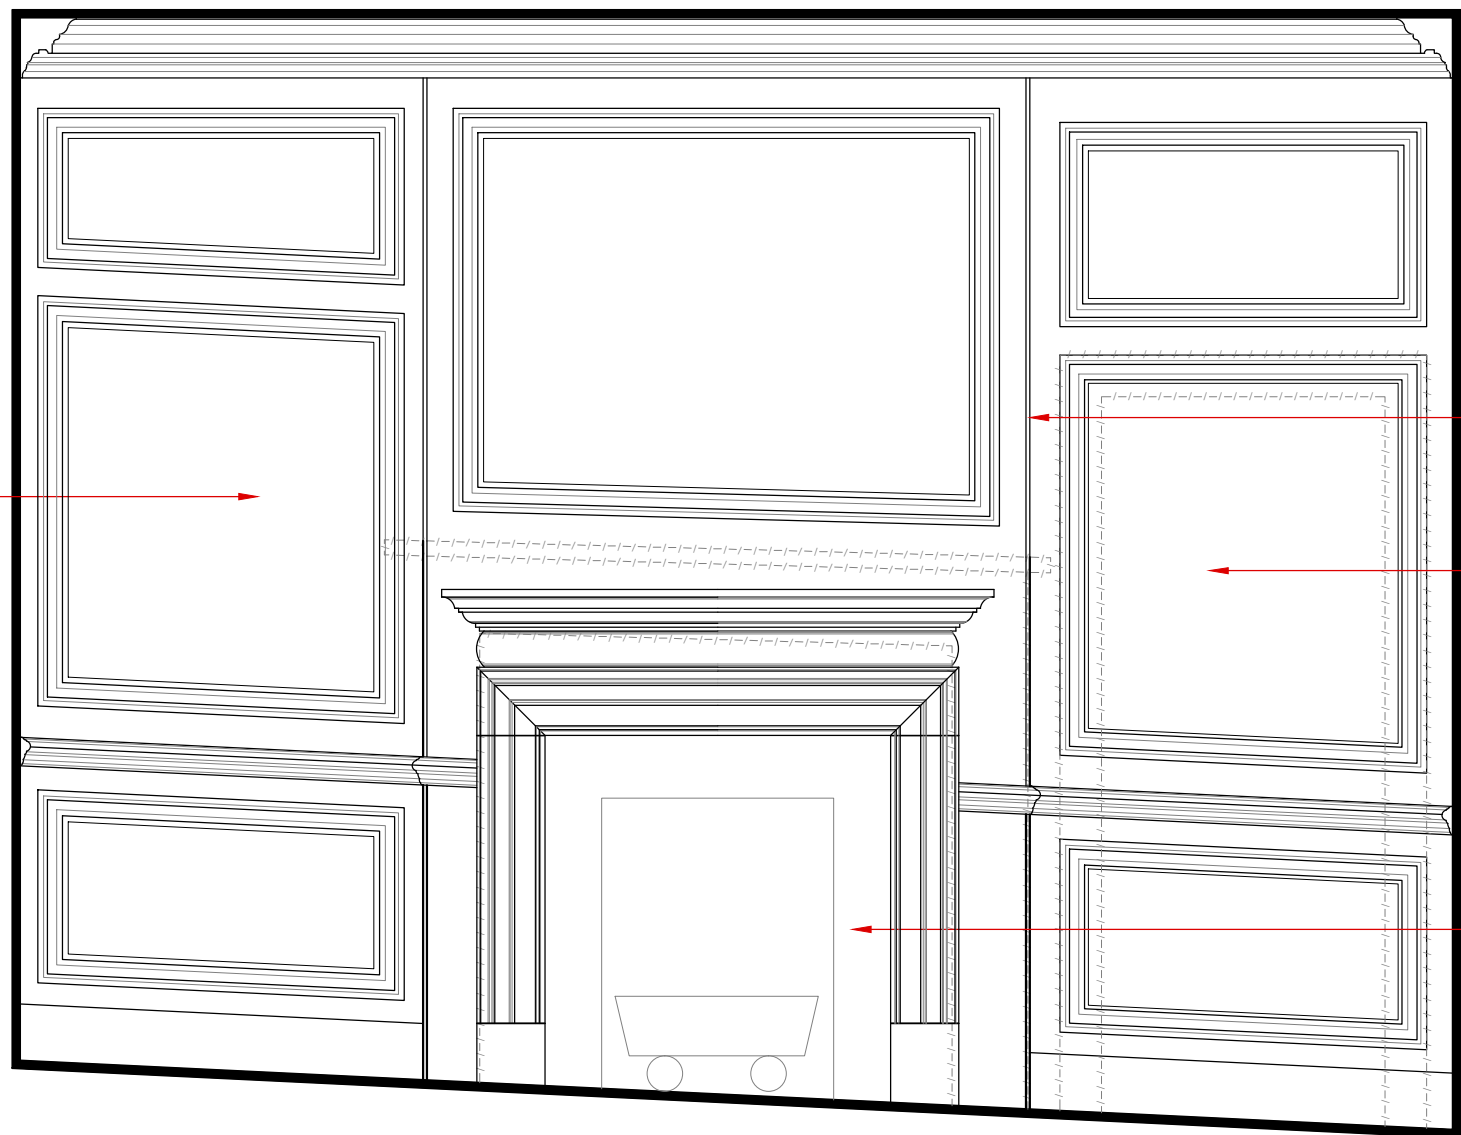
New panelling to match other side of fireplace.

Dowel to corner.

Remove existing non-original fitted book shelf and reinstate panelling to studwall.

Reduce opening of hearth. Render inside. reline flue and new surround and hearth

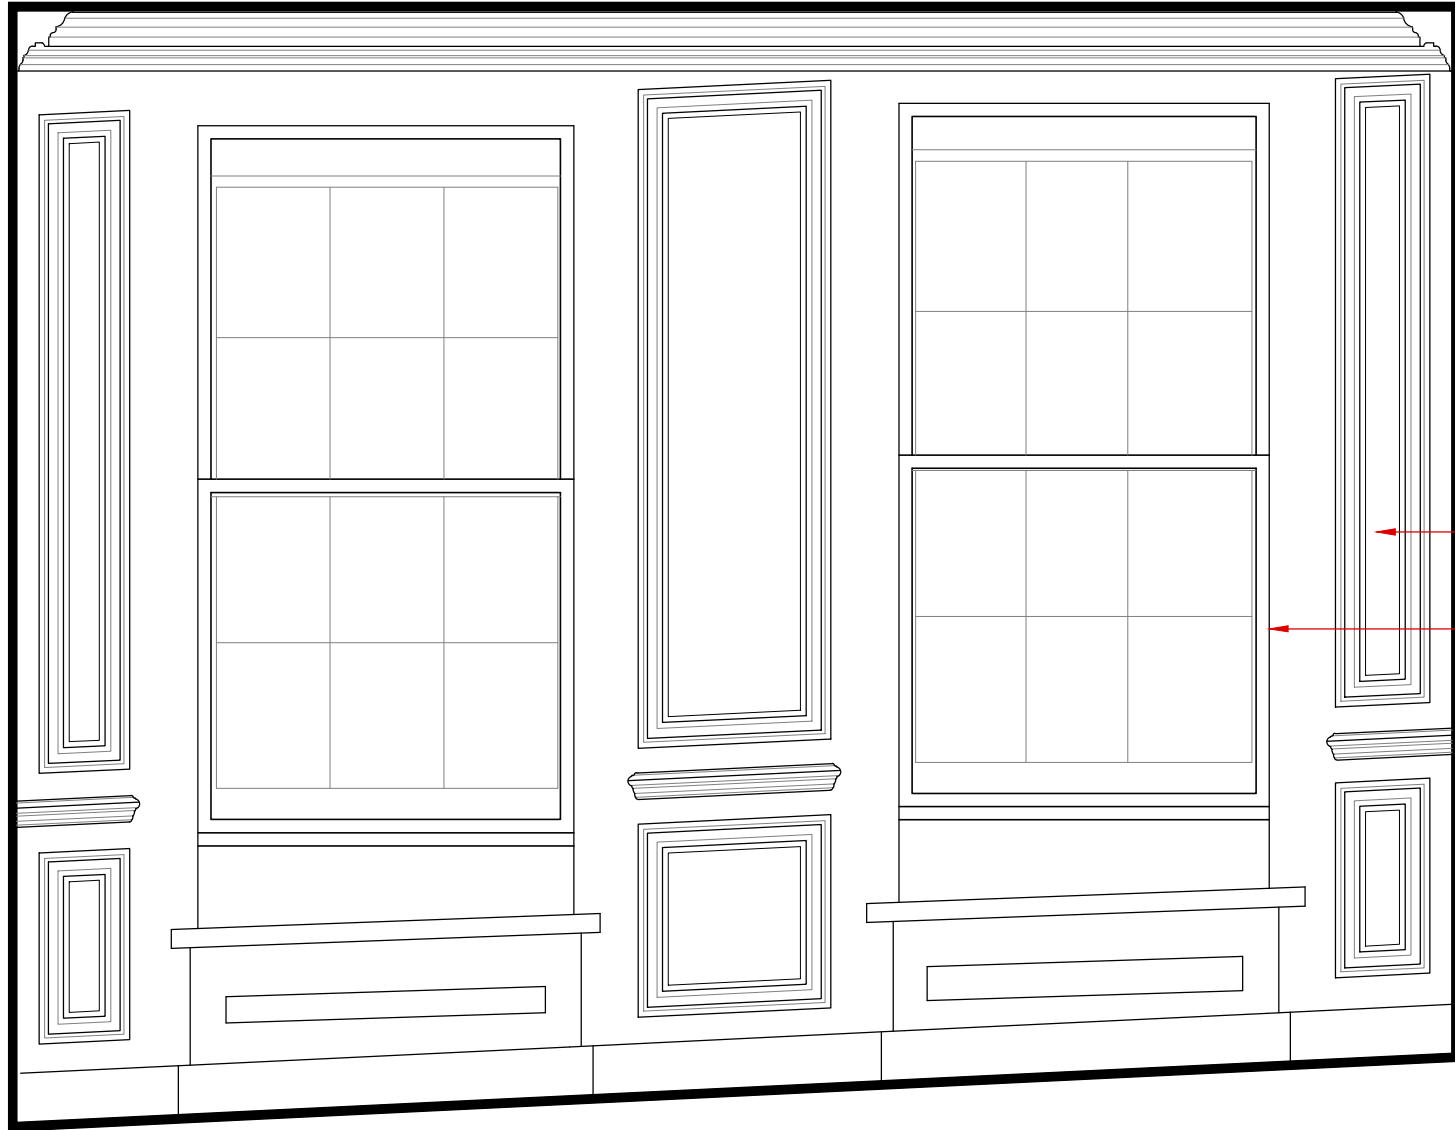
Existing panelling retained.

Existing shutters to windows to be reinstated to work with secondary double glazing.

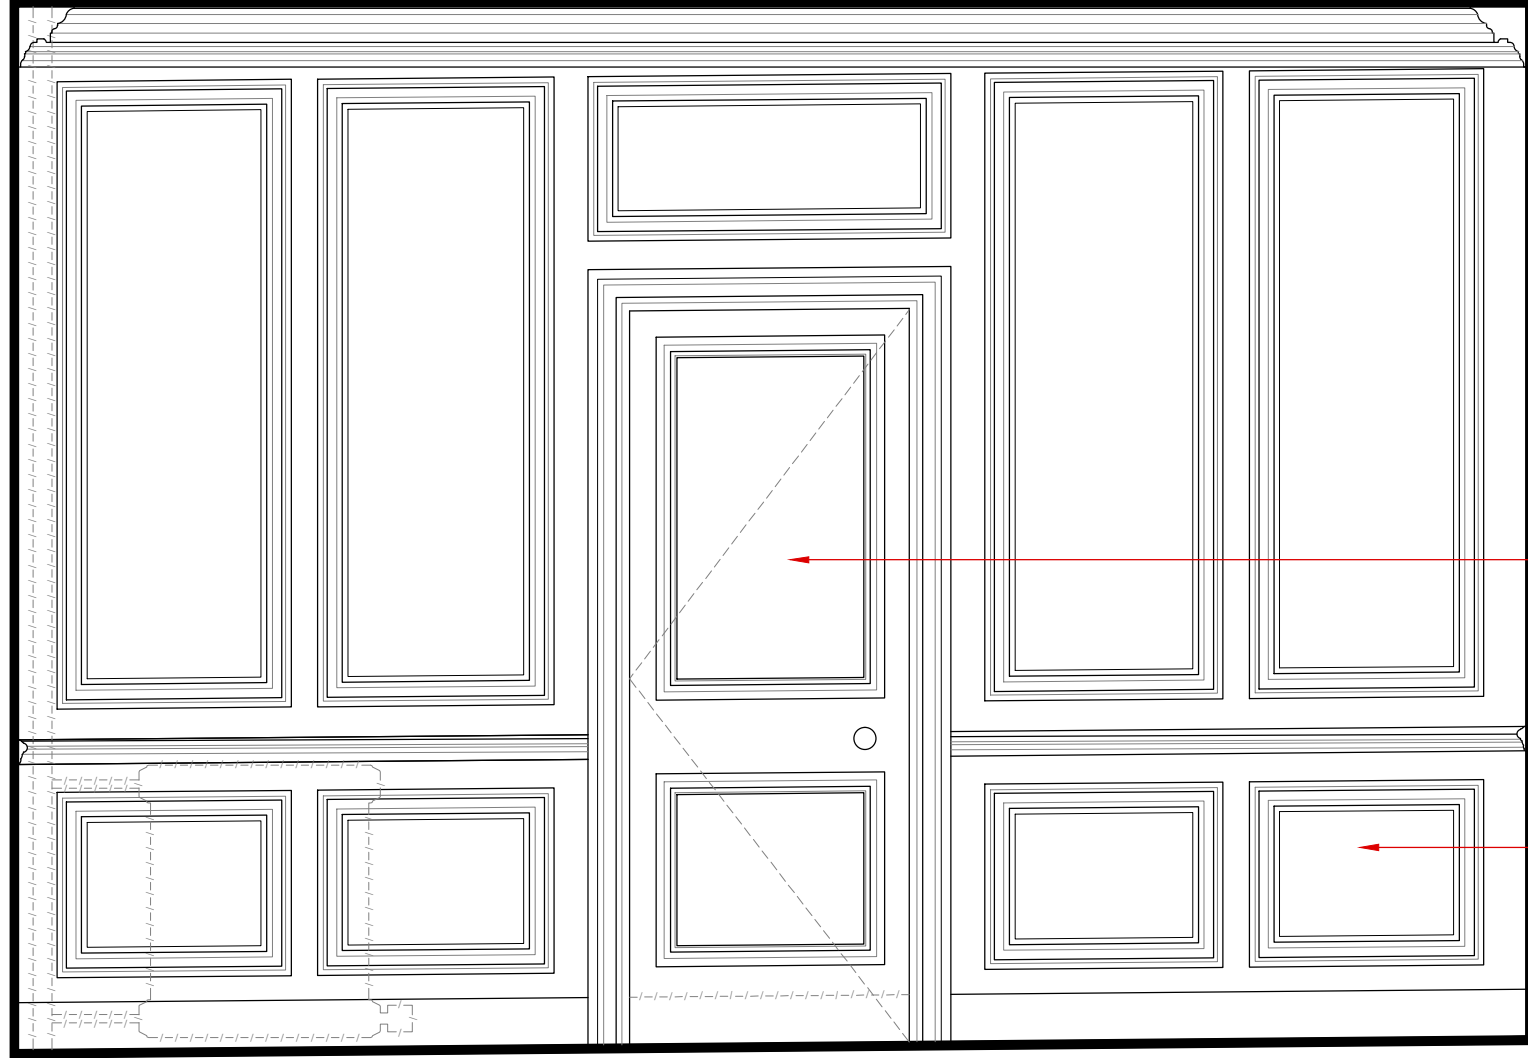
Existing fixed door to be re-hinged to be reused as doorway.

Existing panelling retained.

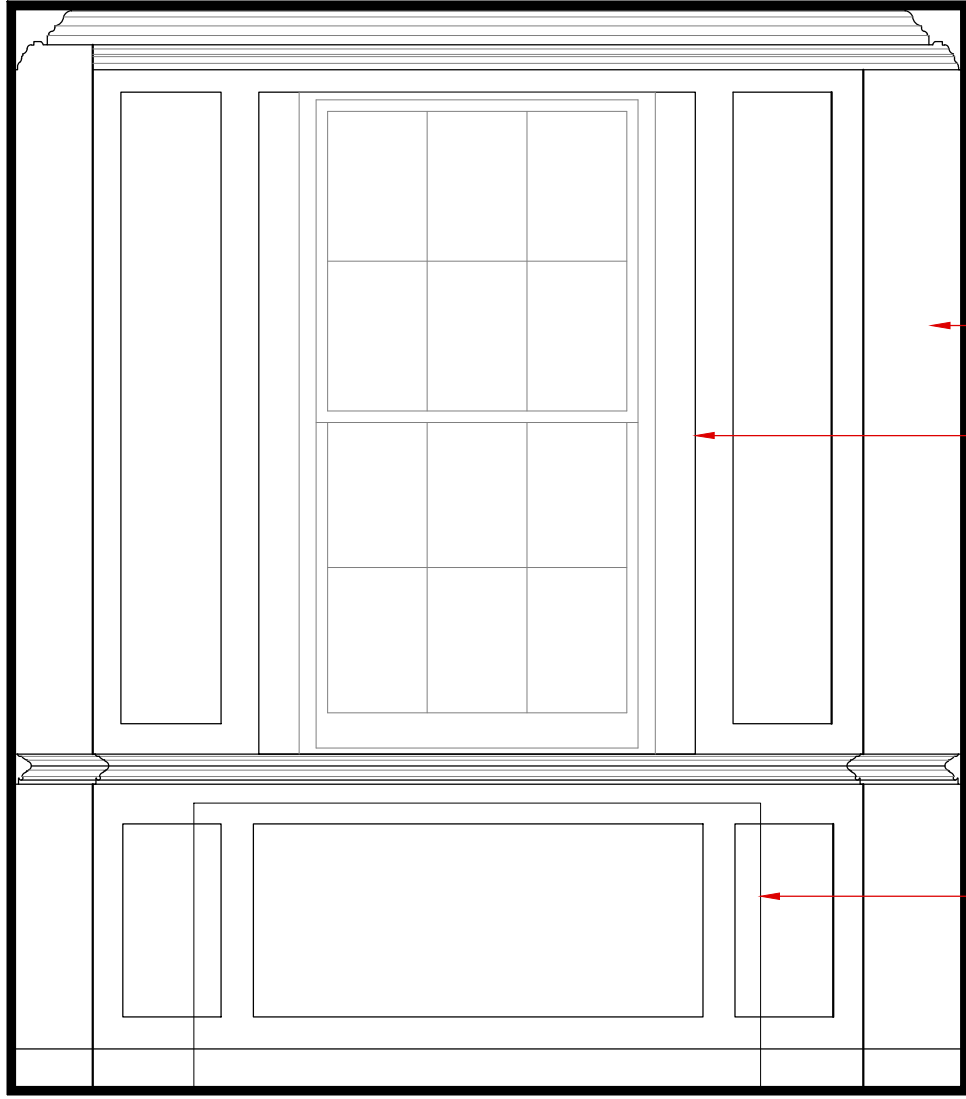
Remove boxing.

Remove secondary double glazing.

Proposed freestanding furniture.

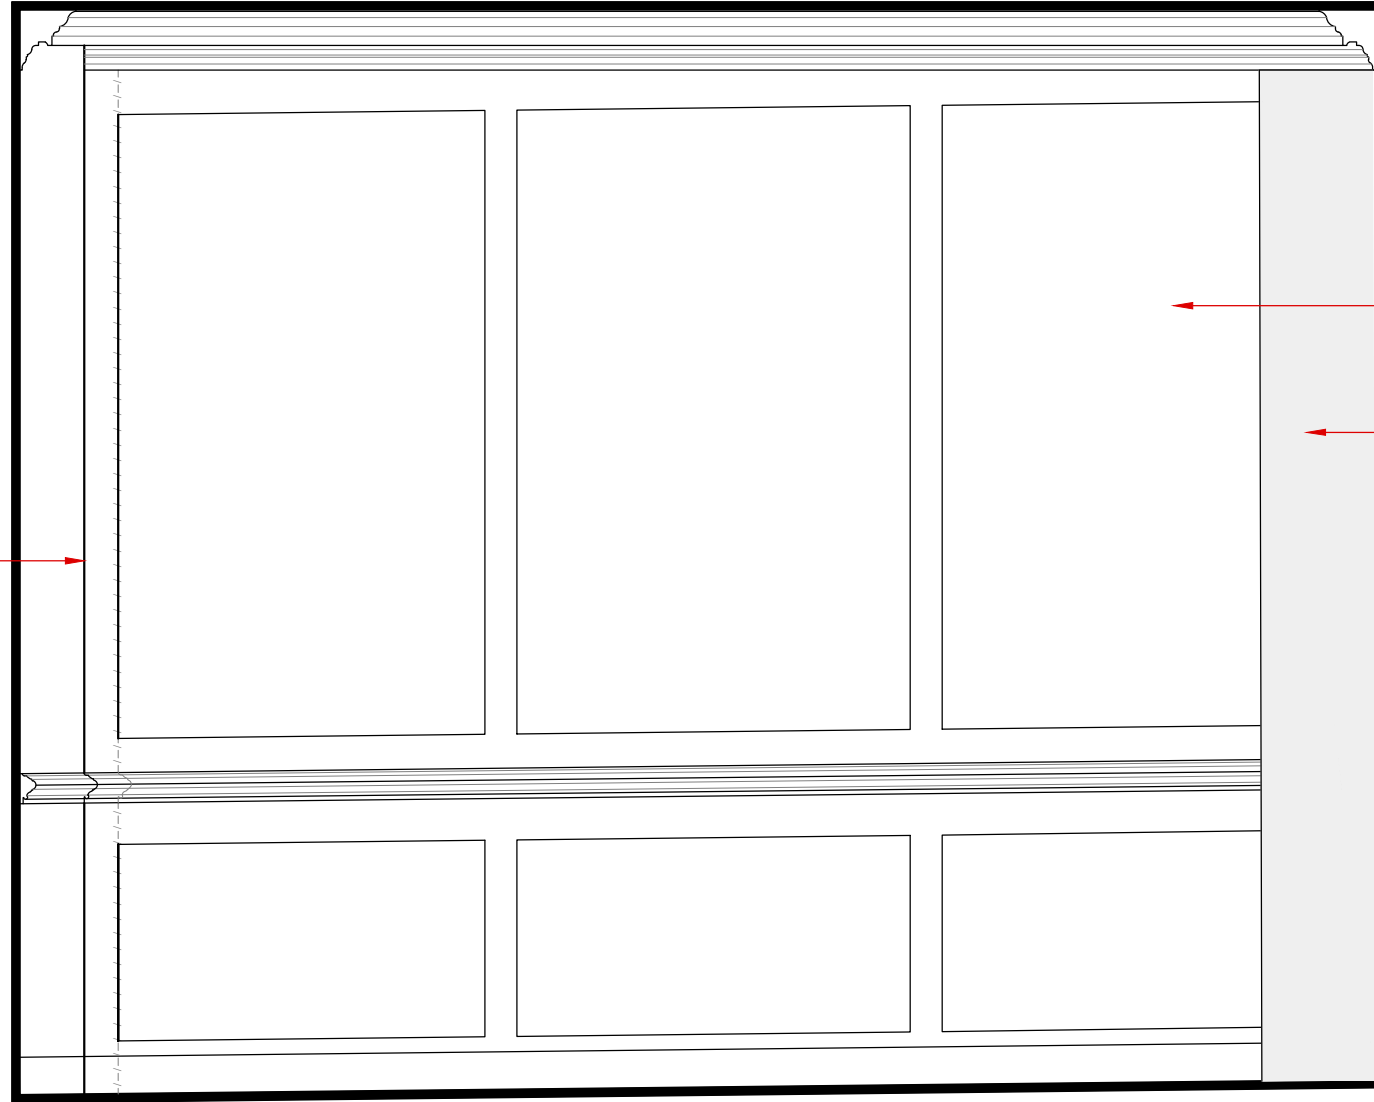
Remove boxing back to wall and remove all existing pipework.

Existing cornice and panelling to retain.

Proposed joinery to be scribed into the walls.

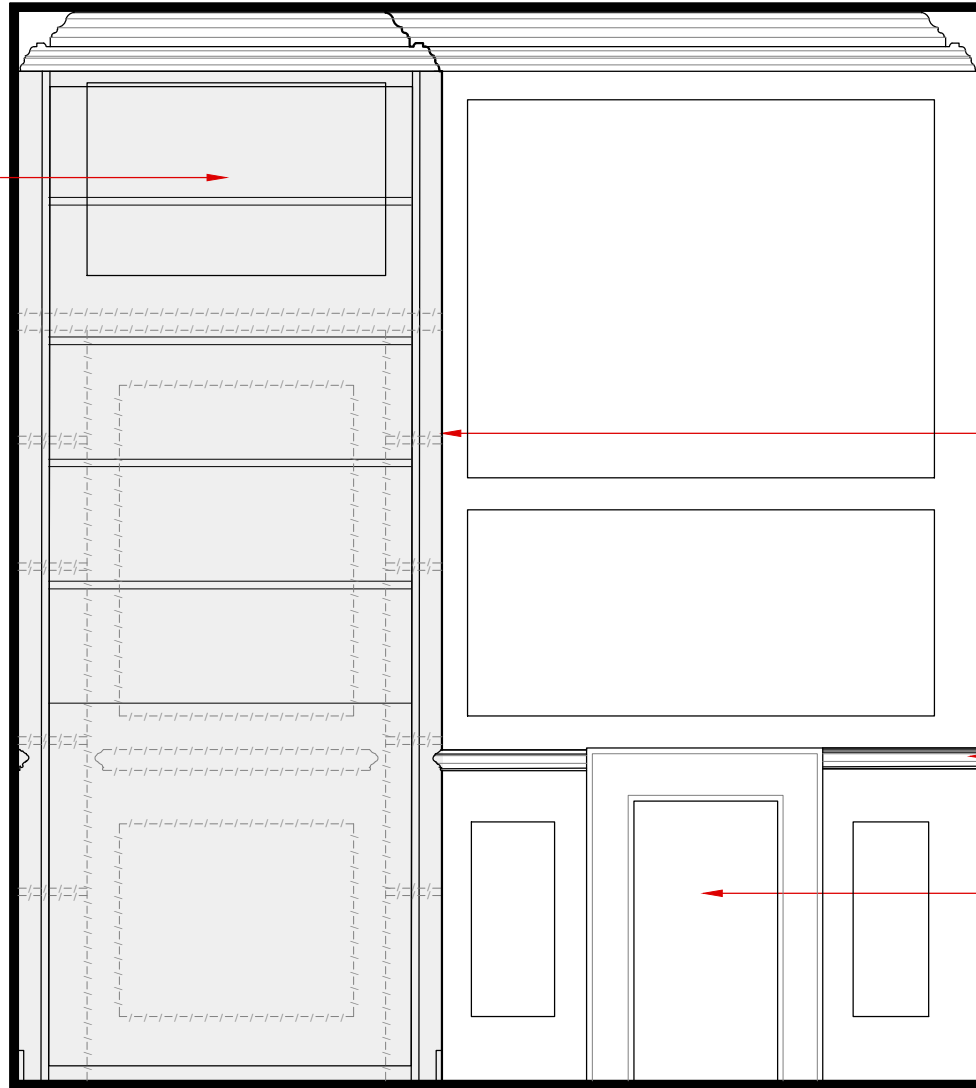
Proposed bookcase with  
panelling behind  
retained.

Top and side scribed  
timber to fill gap  
between proposed  
bookshelf. Panelling to  
remain as existing

Existing miss matched  
dado railing to be  
justified to single style.

Existing marble surround  
retained. Remove timber  
shelves and reline  
existing fireplace.

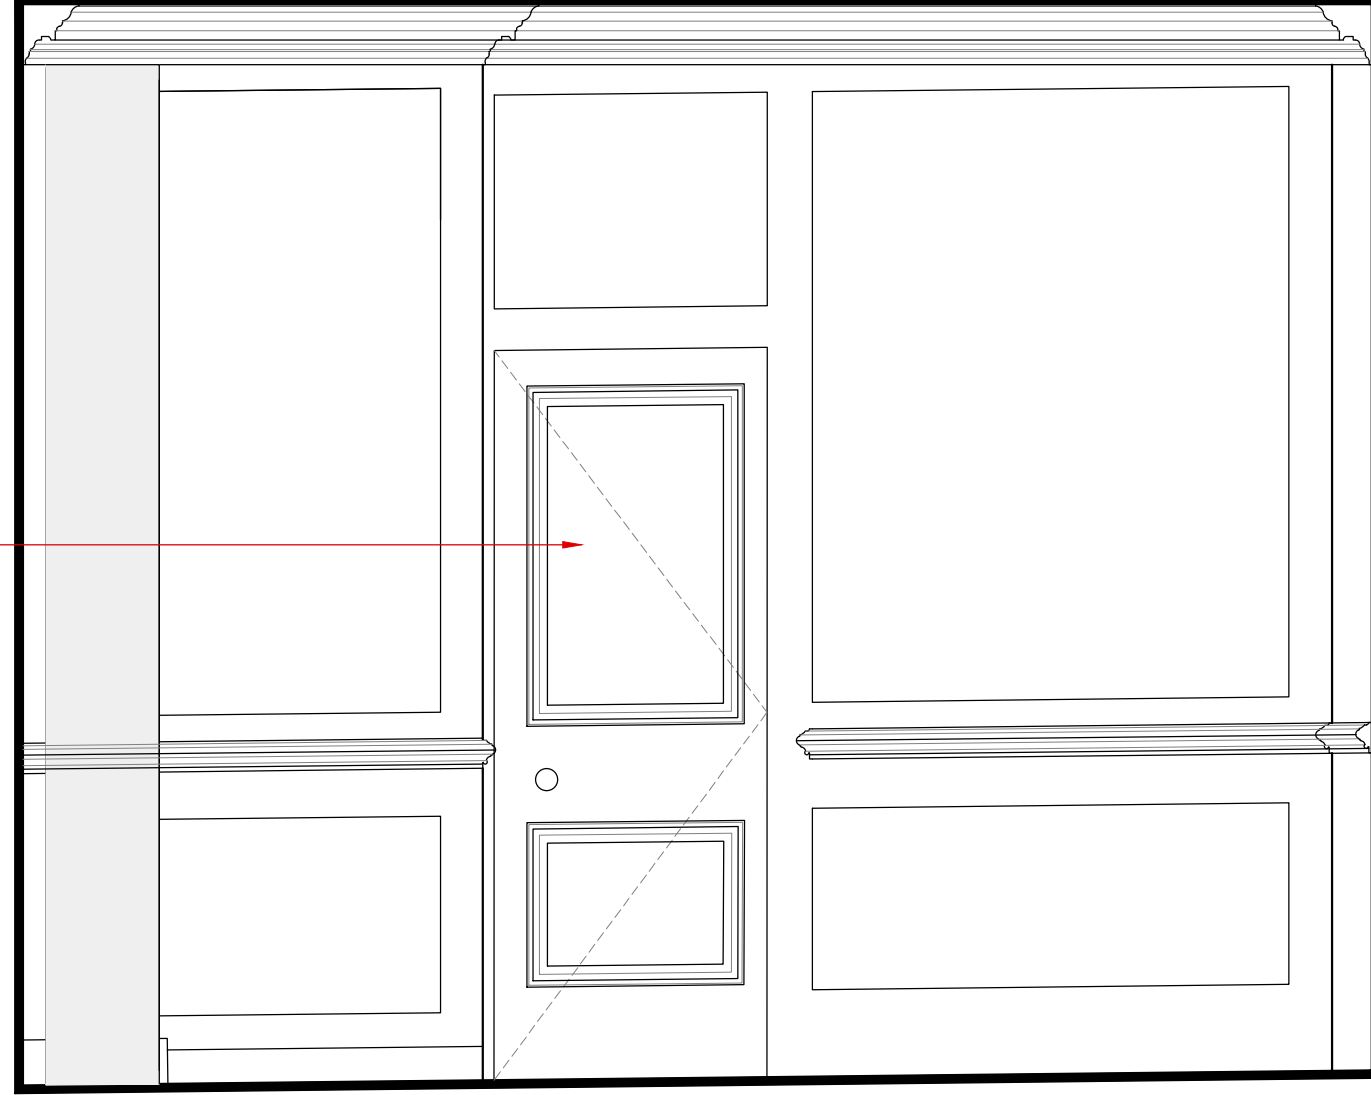
Proposed 2 panel door  
to match D.G.06.

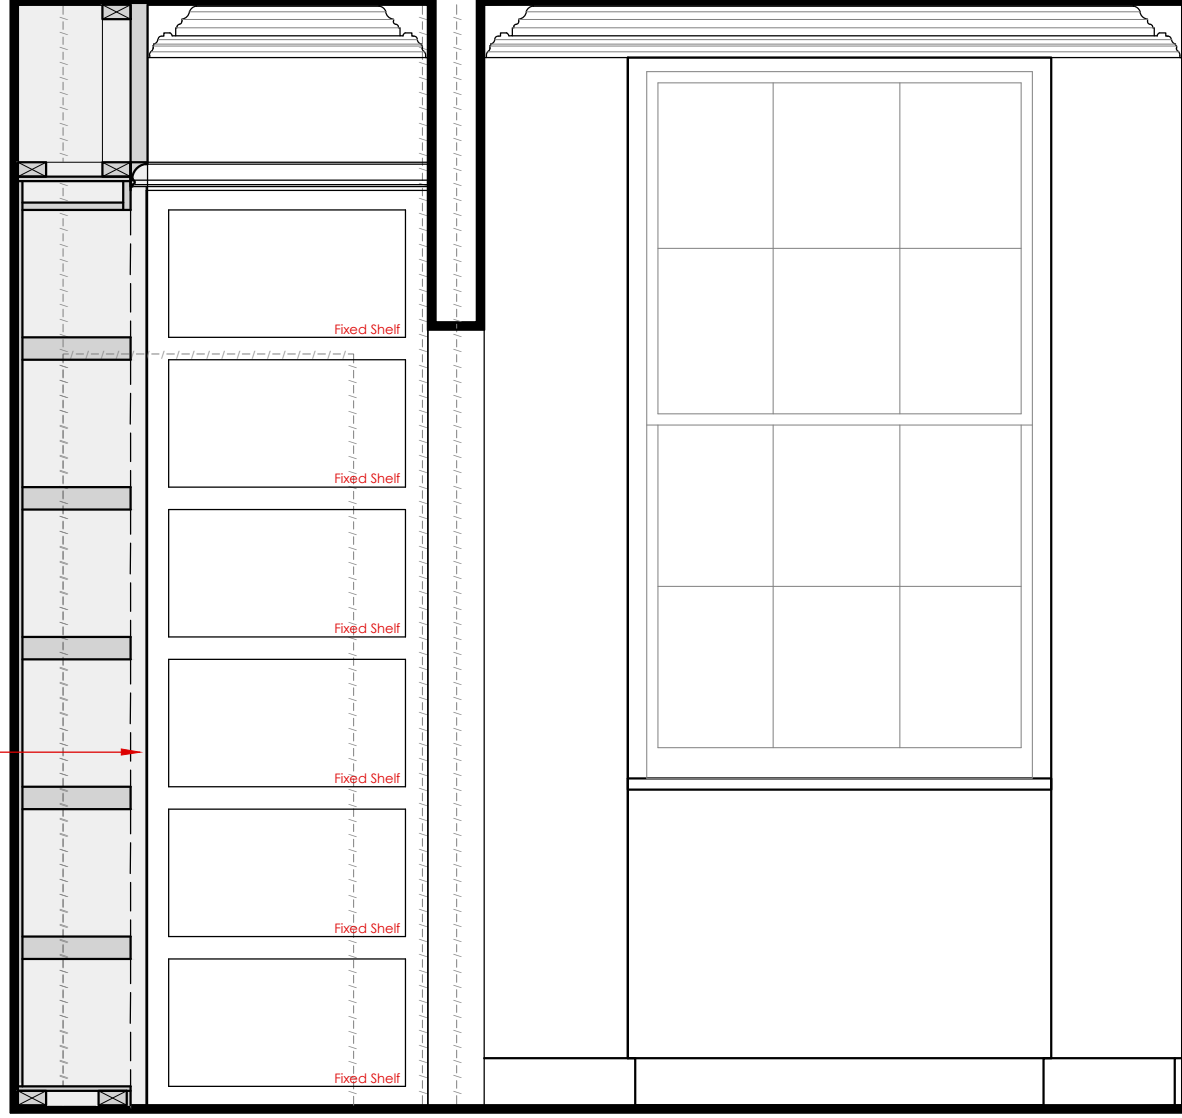
Proposed fixed joinery  
to be within new  
alcove.
