Entrance Hall//Existing//Plan\_1:20

Drawing Room//Existing//Elevation 1\_1:20

Study//Existing//Plan\_1:20

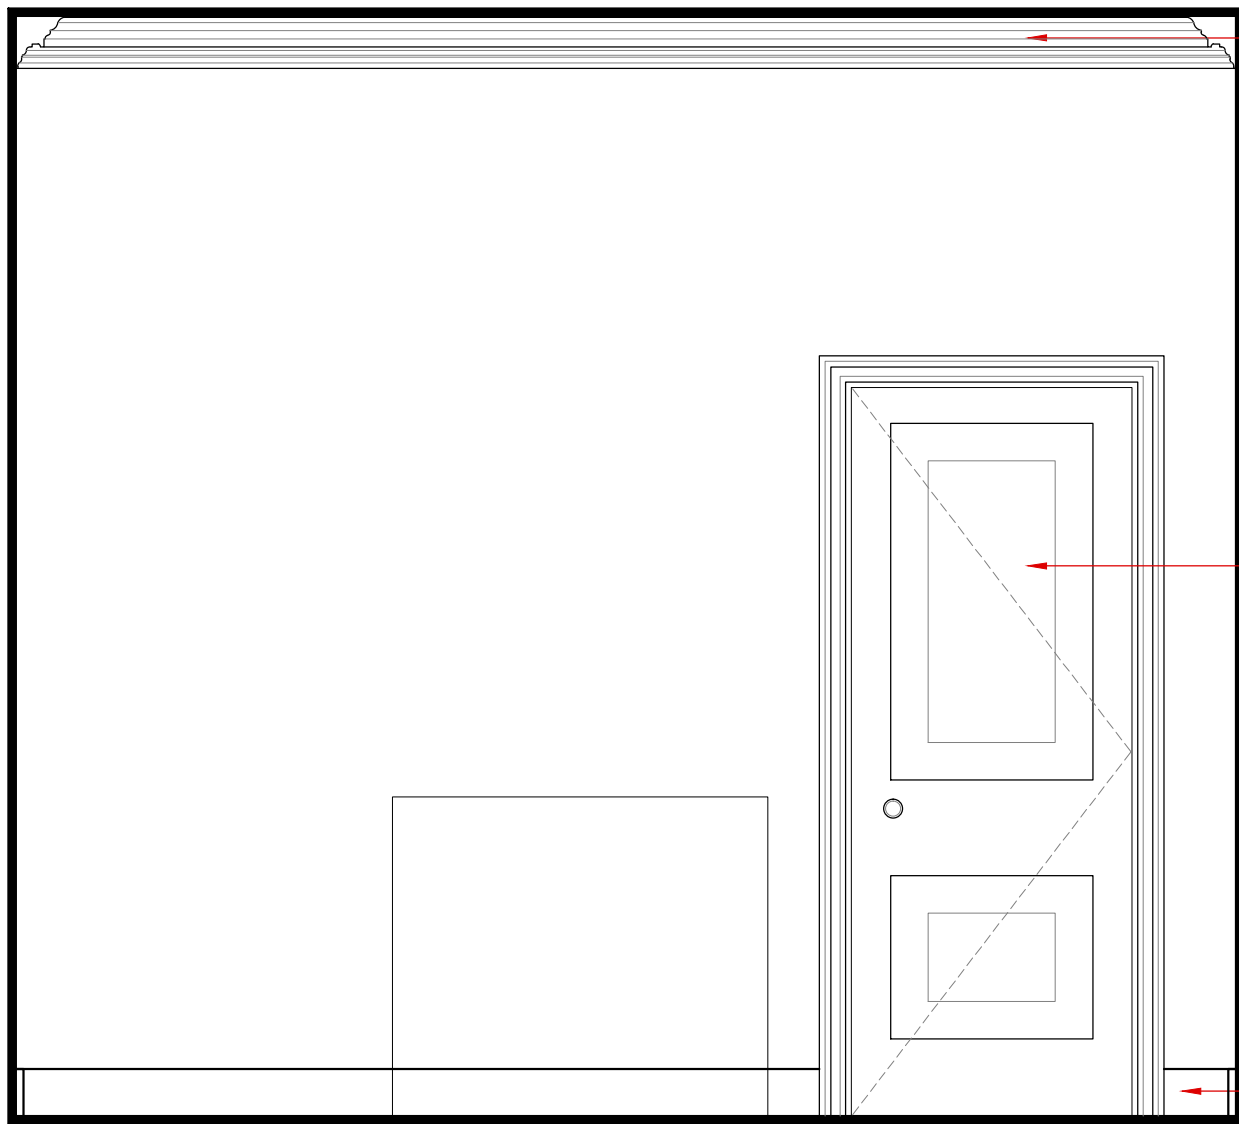
Proposed cornice to match existing with Drawing Room.

Existing door replaced with 2 panel door to match D.G.06.

Proposed skirting to match existing.

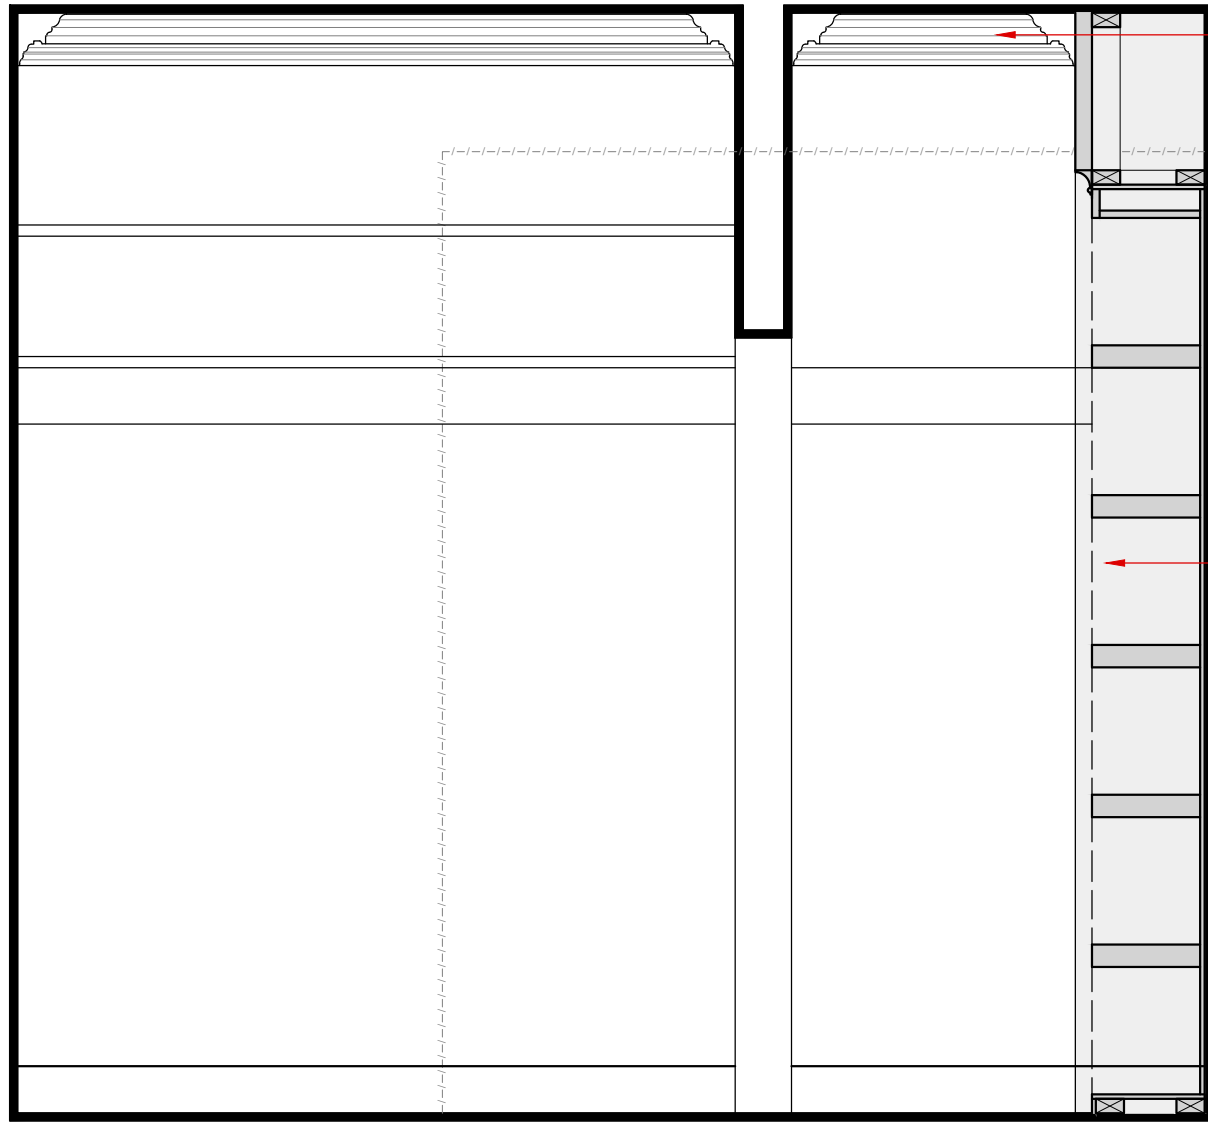
Proposed cornice to run in front of joinery. Cornice to match existing with Drawing Room.

Proposed fixed joinery to be within new alcove.

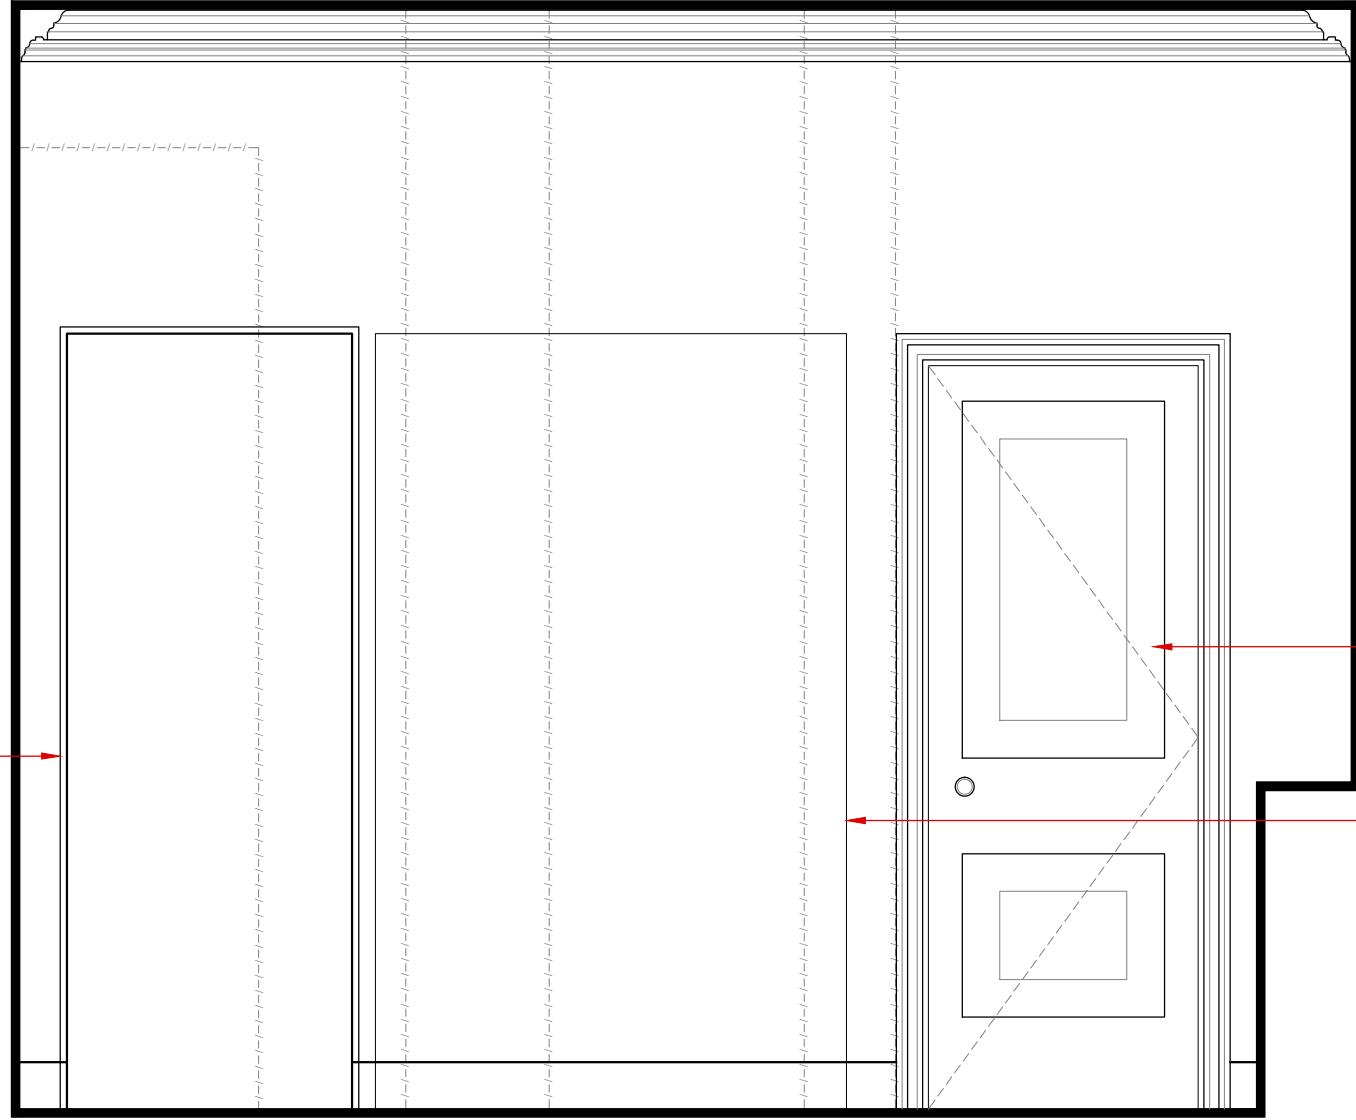
Proposed 18mm dowel trim to edge.

Proposed 2 panel door to match D.G.06.

Proposed freestanding furniture.

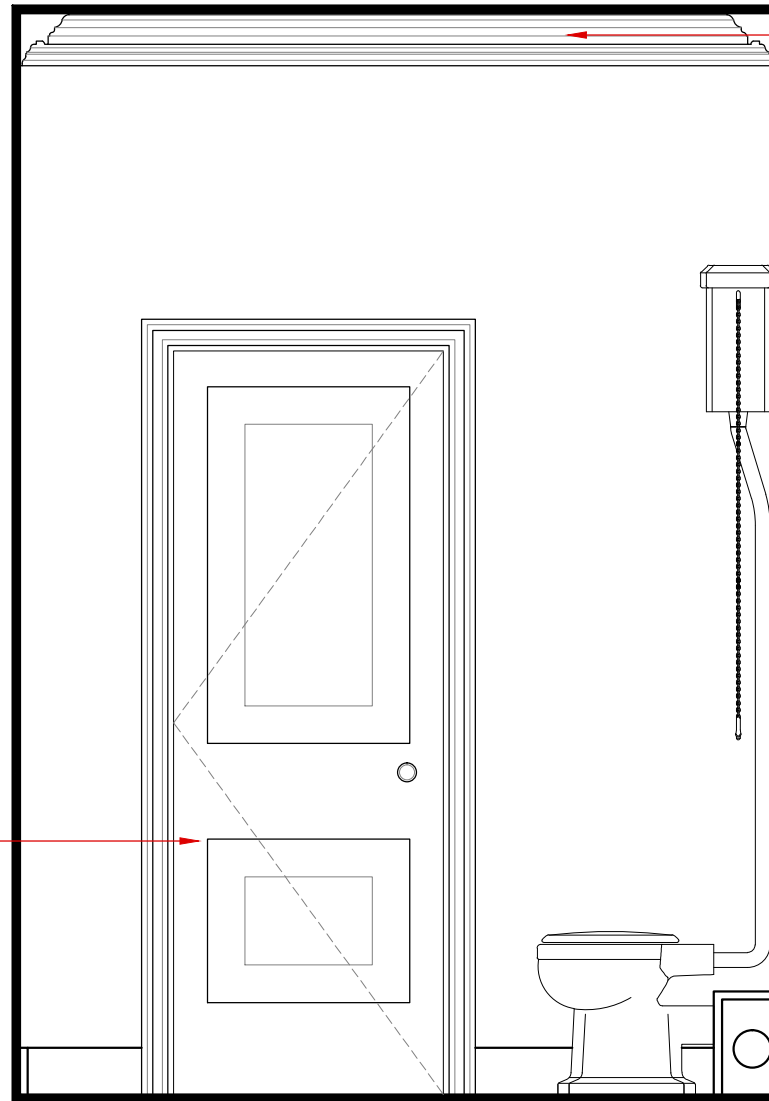
Elevation 2

Proposed cornice to match existing with Drawing Room.

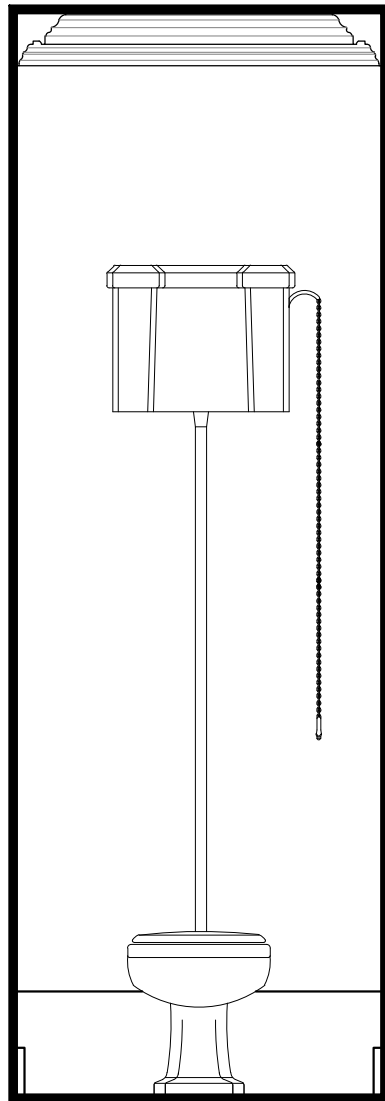
Elevation 3

Proposed pipework within boxing.

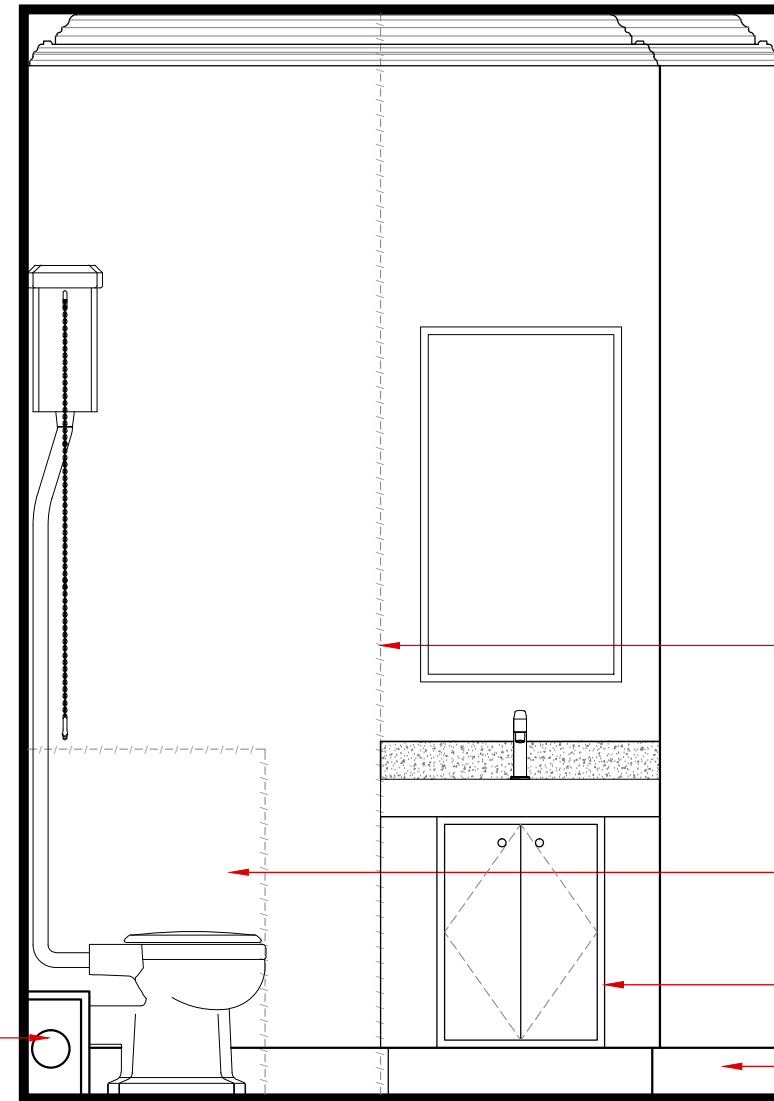
Elevation 4

Existing wall to be levelled off.

Existing unused fireplace recess to be blocked in.

Proposed vanity unit.

Proposed skirting to match existing.
