Site		Drawing Number	
15 Gayton Crescent London NW3 1TT		A-01-10	
Title			
Appeal B: APP/X5210/C/14/2217197 Discharge of Condition 1			
Drawing		Scale	Date
Lower & Upper Ground plans		1:100 @ A3	Feb 2015

Site	Drawing Number	
15 Gayton Crescent London NW3 1TT	A-01-11	
Title		
Appeal B: APP/X5210/C/14/2217197 Discharge of Condition 1		
Drawing	Scale	Date
upper plans	1:100 @ A3	Feb 2015

Site 15 Gayton Crescent London NW3 1TT		Drawing Number A-02-10
Title Appeal B: APP/X5210/C/14/2217197 Discharge of Condition 1		
Drawing Front & East elevations	Scale 1:100 @ A3	Date Feb 2015

Site	15 Gayton Crescent London NW3 1TT		Drawing Number	A-02-11	
Title	Appeal B: APP/X5210/C/14/2217197 Discharge of Condition 1				
Drawing	South & North elevations	Scale	1:100 @ A3	Date	Feb 2015

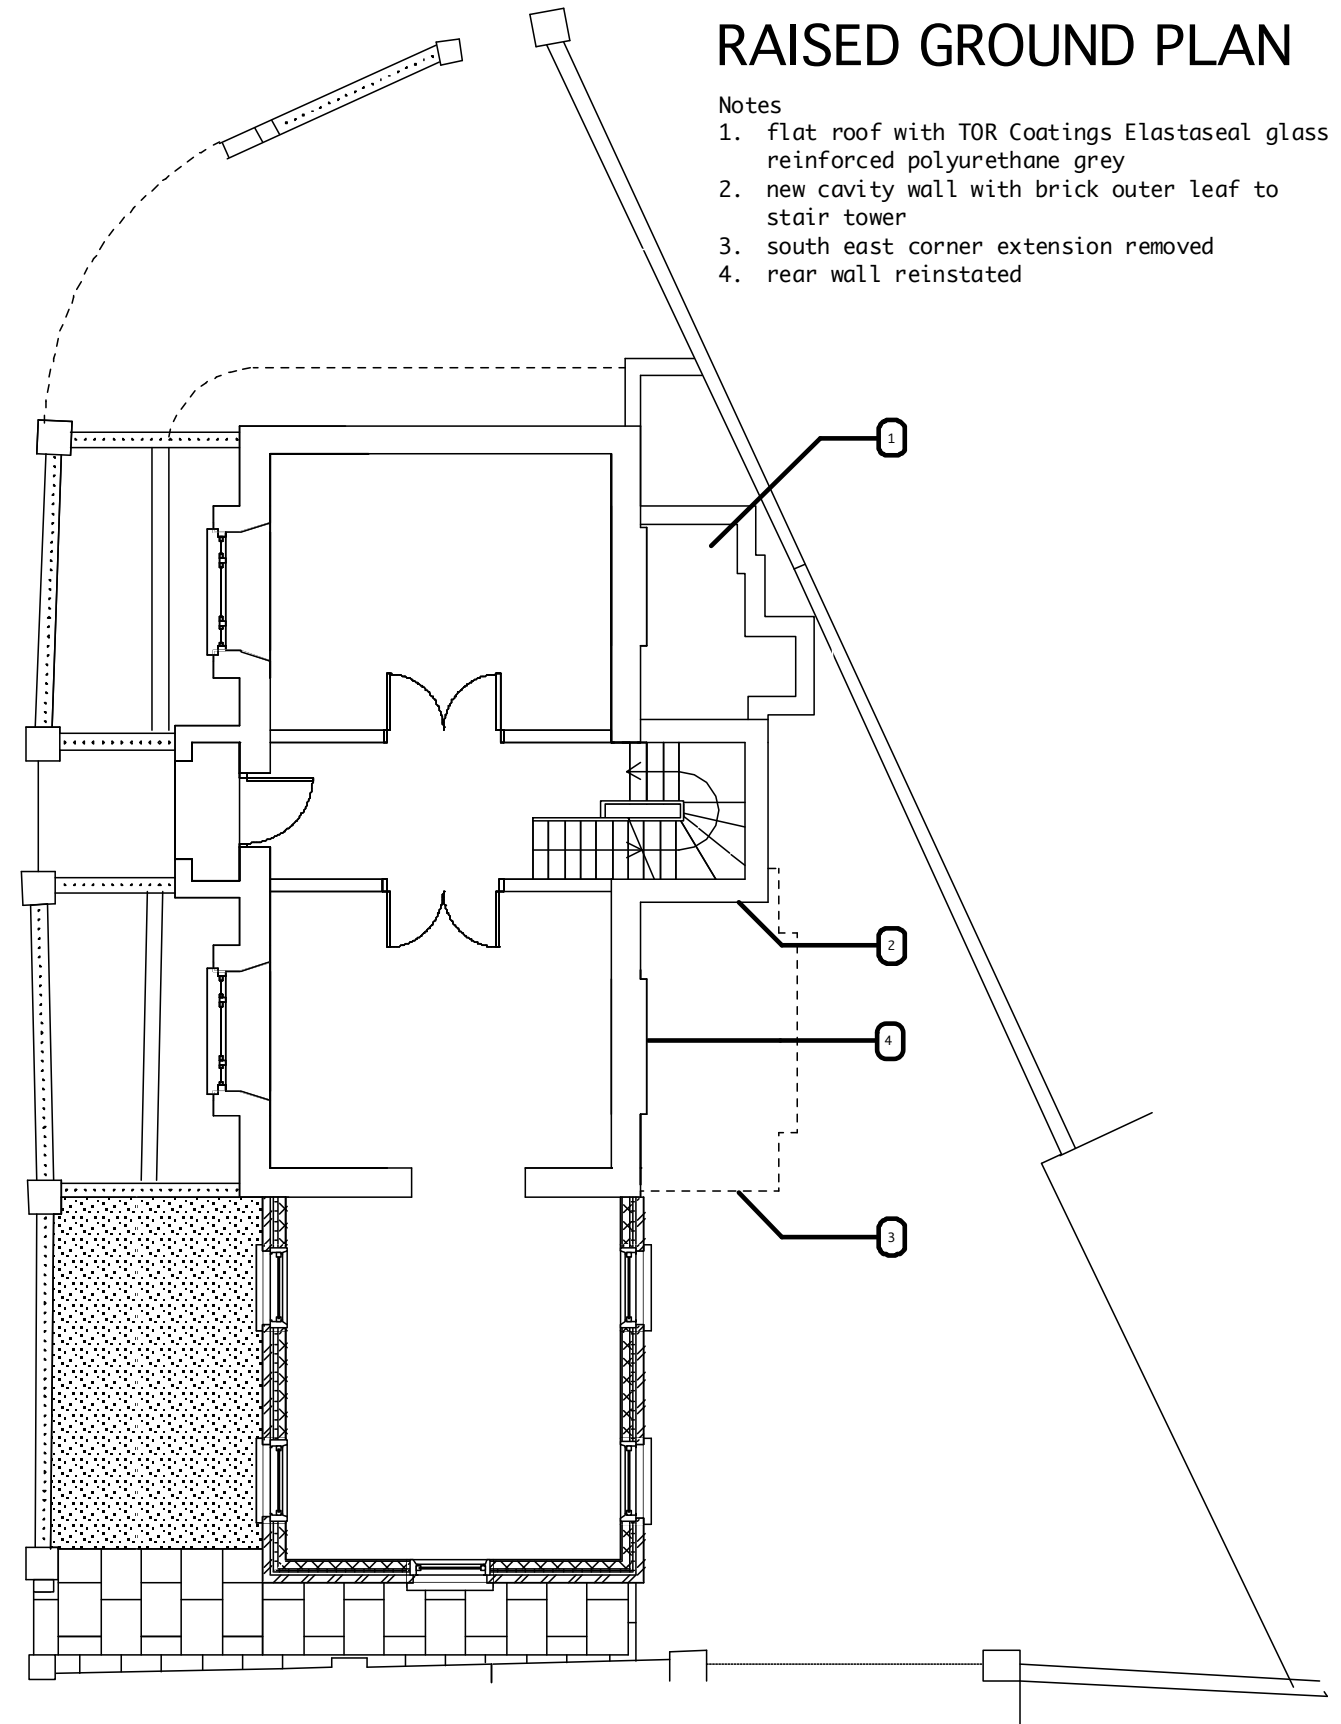
# RAISED GROUND PLAN

- Notes
- 1. flat roof with TOR Coatings Elastaseal glass reinforced polyurethane grey
  - 2. new cavity wall with brick outer leaf to stair tower
  - 3. south east corner extension removed
  - 4. rear wall reinstated

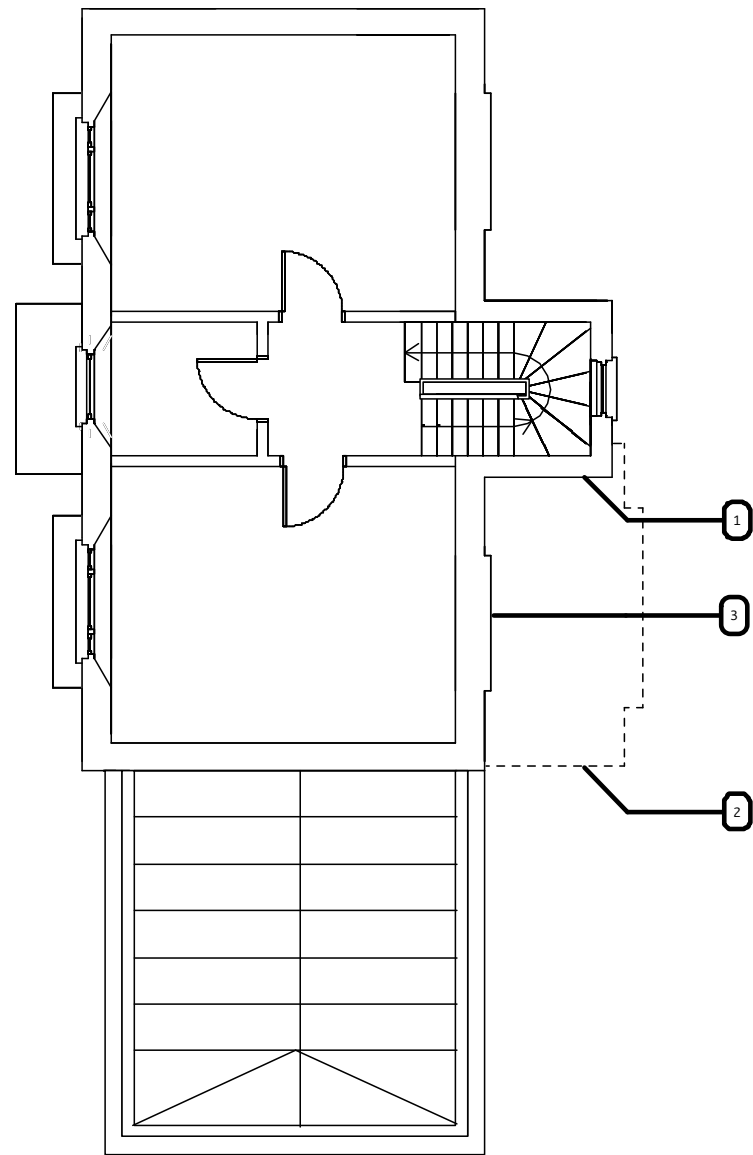
FIRST FLOOR PLAN

- Notes
1. new cavity wall with brick outer leaf to flank of stair tower
  2. south east corner extension removed
  3. rear wall reinstated

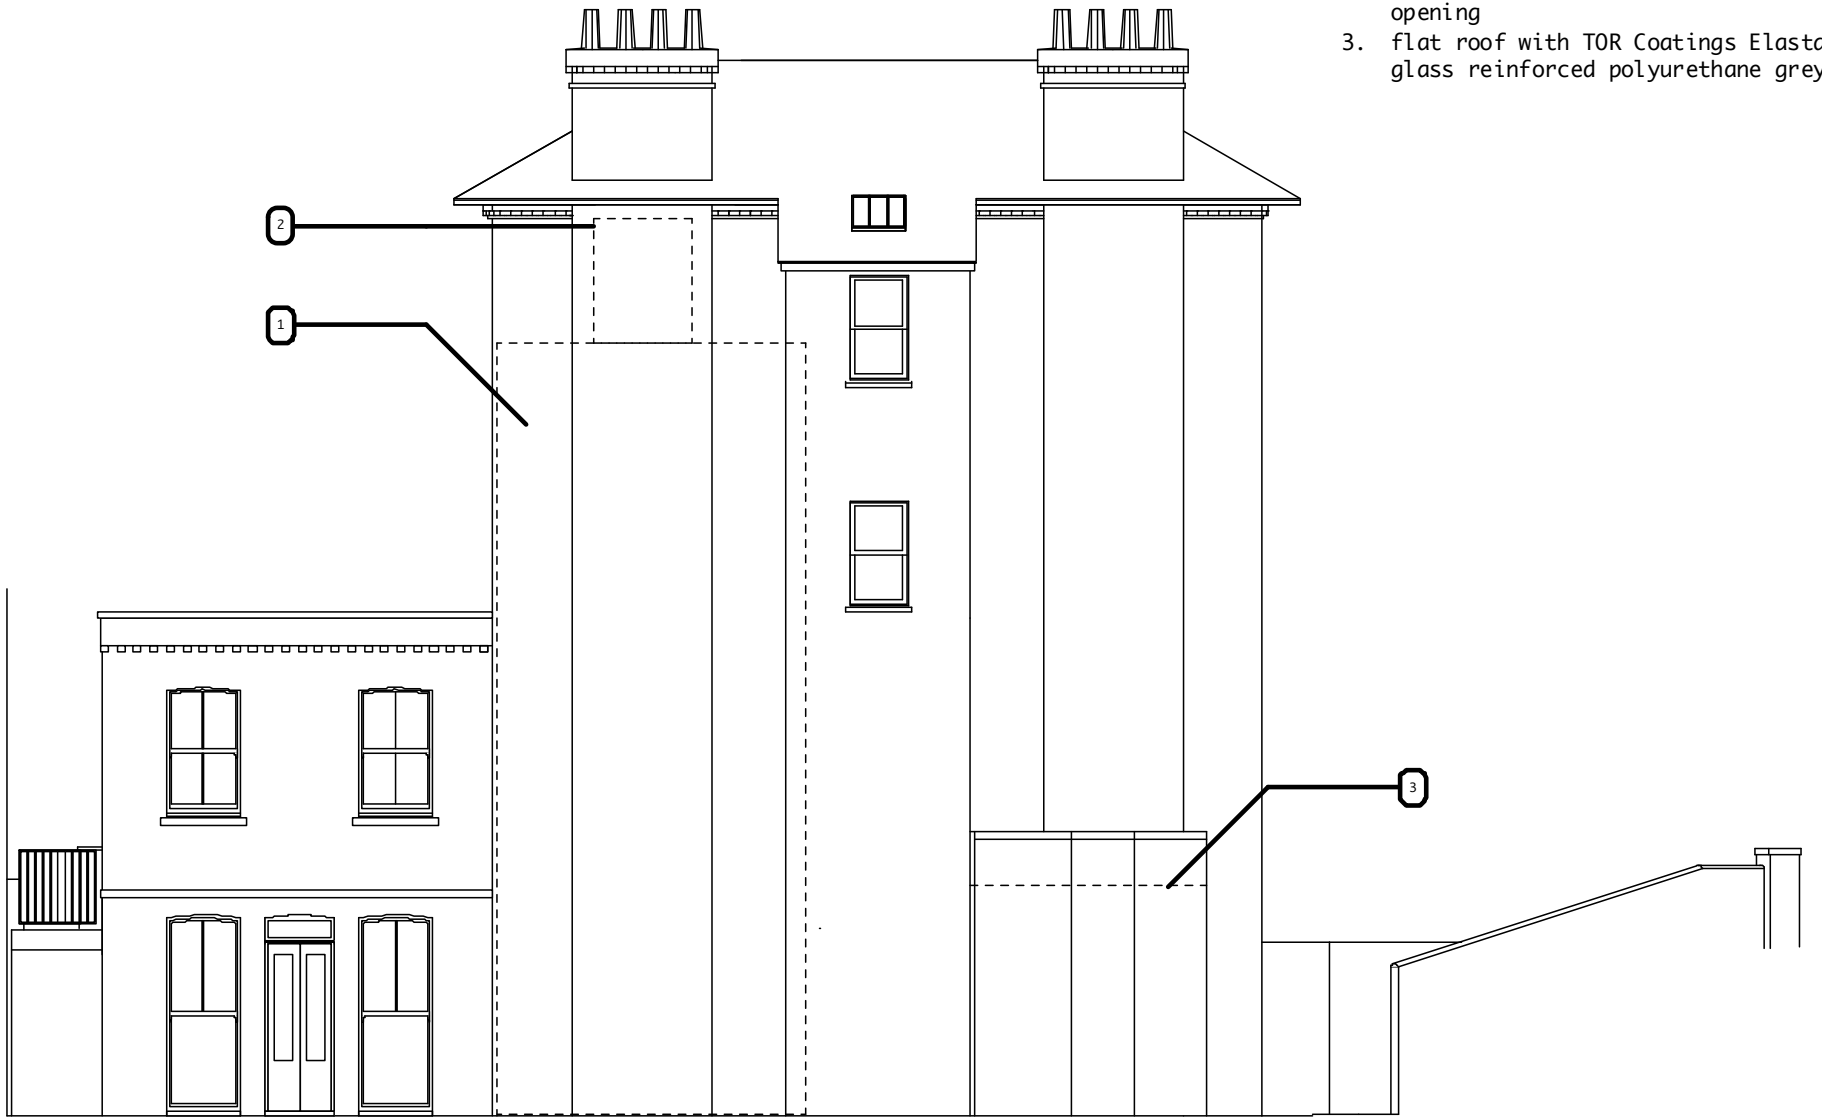
EAST ELEVATION

1. south east corner extension removed and rear wall reinstated
2. chimney breast reinstated without opening
3. flat roof with TOR Coatings Elastaseal glass reinforced polyurethane grey

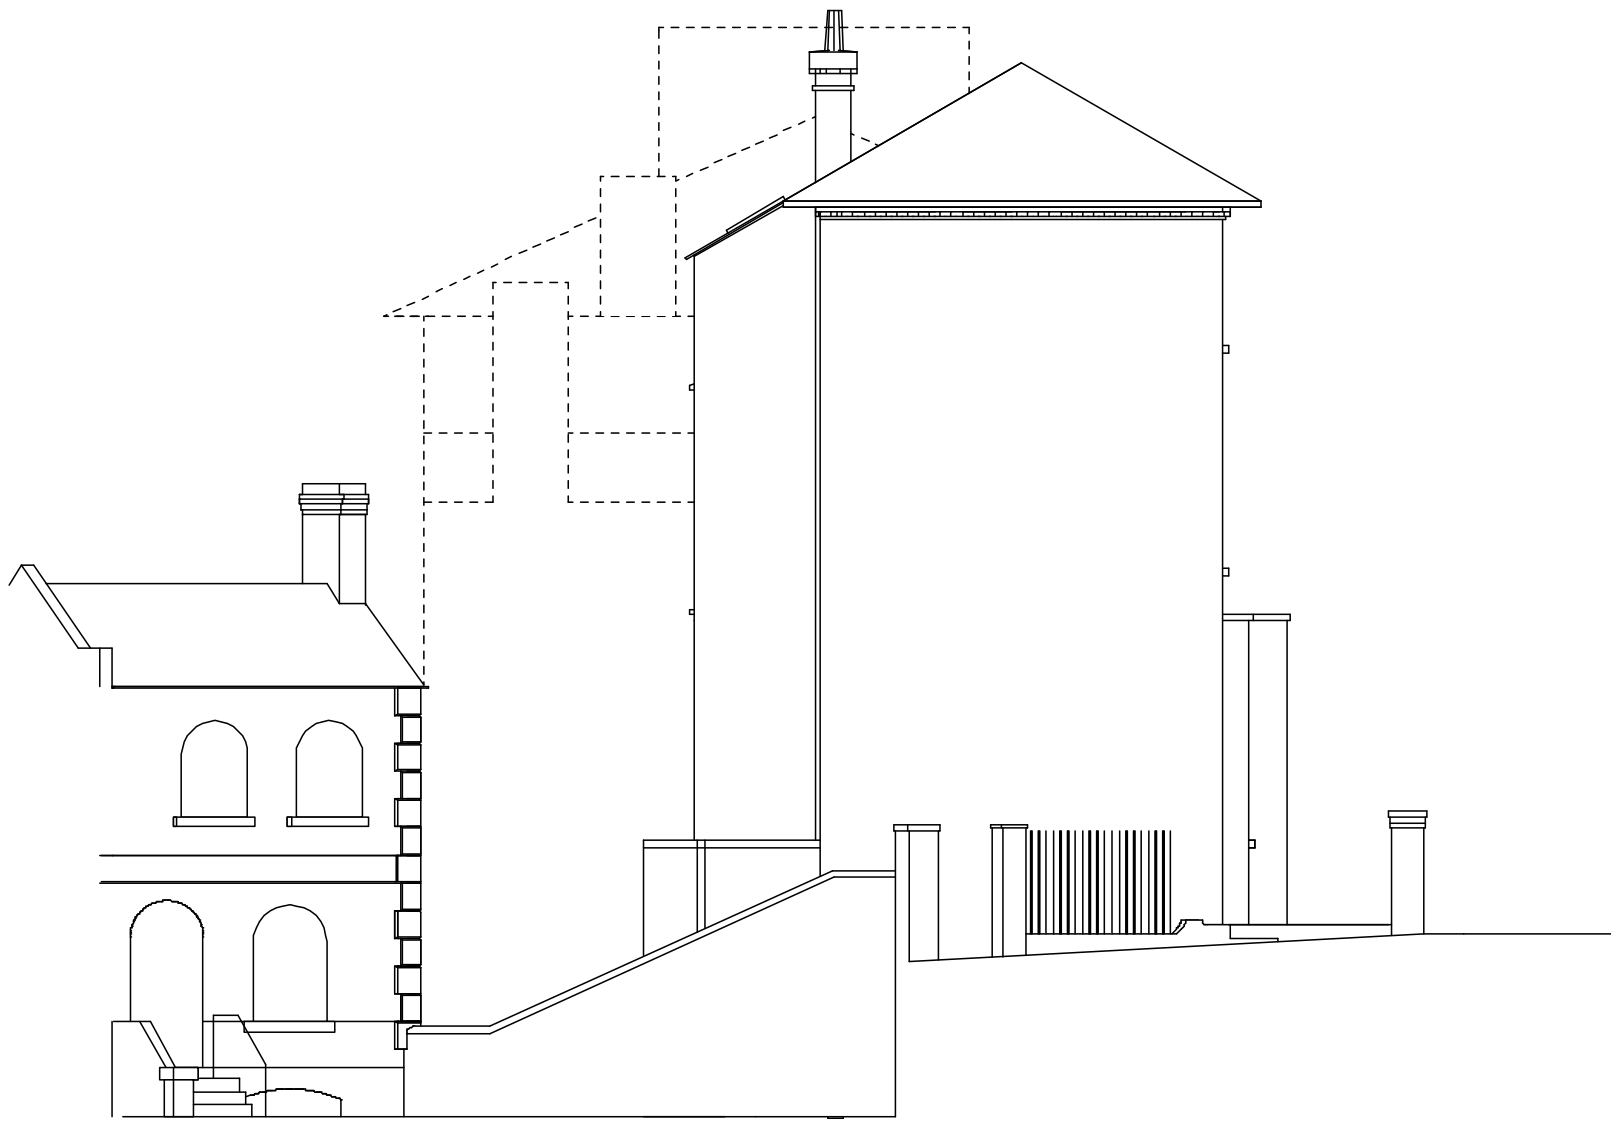
NORTH ELEVATION

Notes  
 1. south east corner extension demolished
