**FOR PLANNING**

JOB TITLE		
Christ Church Hampstead		
DRAWING TITLE		
West Elevation		
Proposed Repairs		
JOB No	DWG No	REV
537A	D06	A
DRAWN BY	SCALE (AT A1)	DATE
JMc	1:100 (1:200@A3)	Dec14

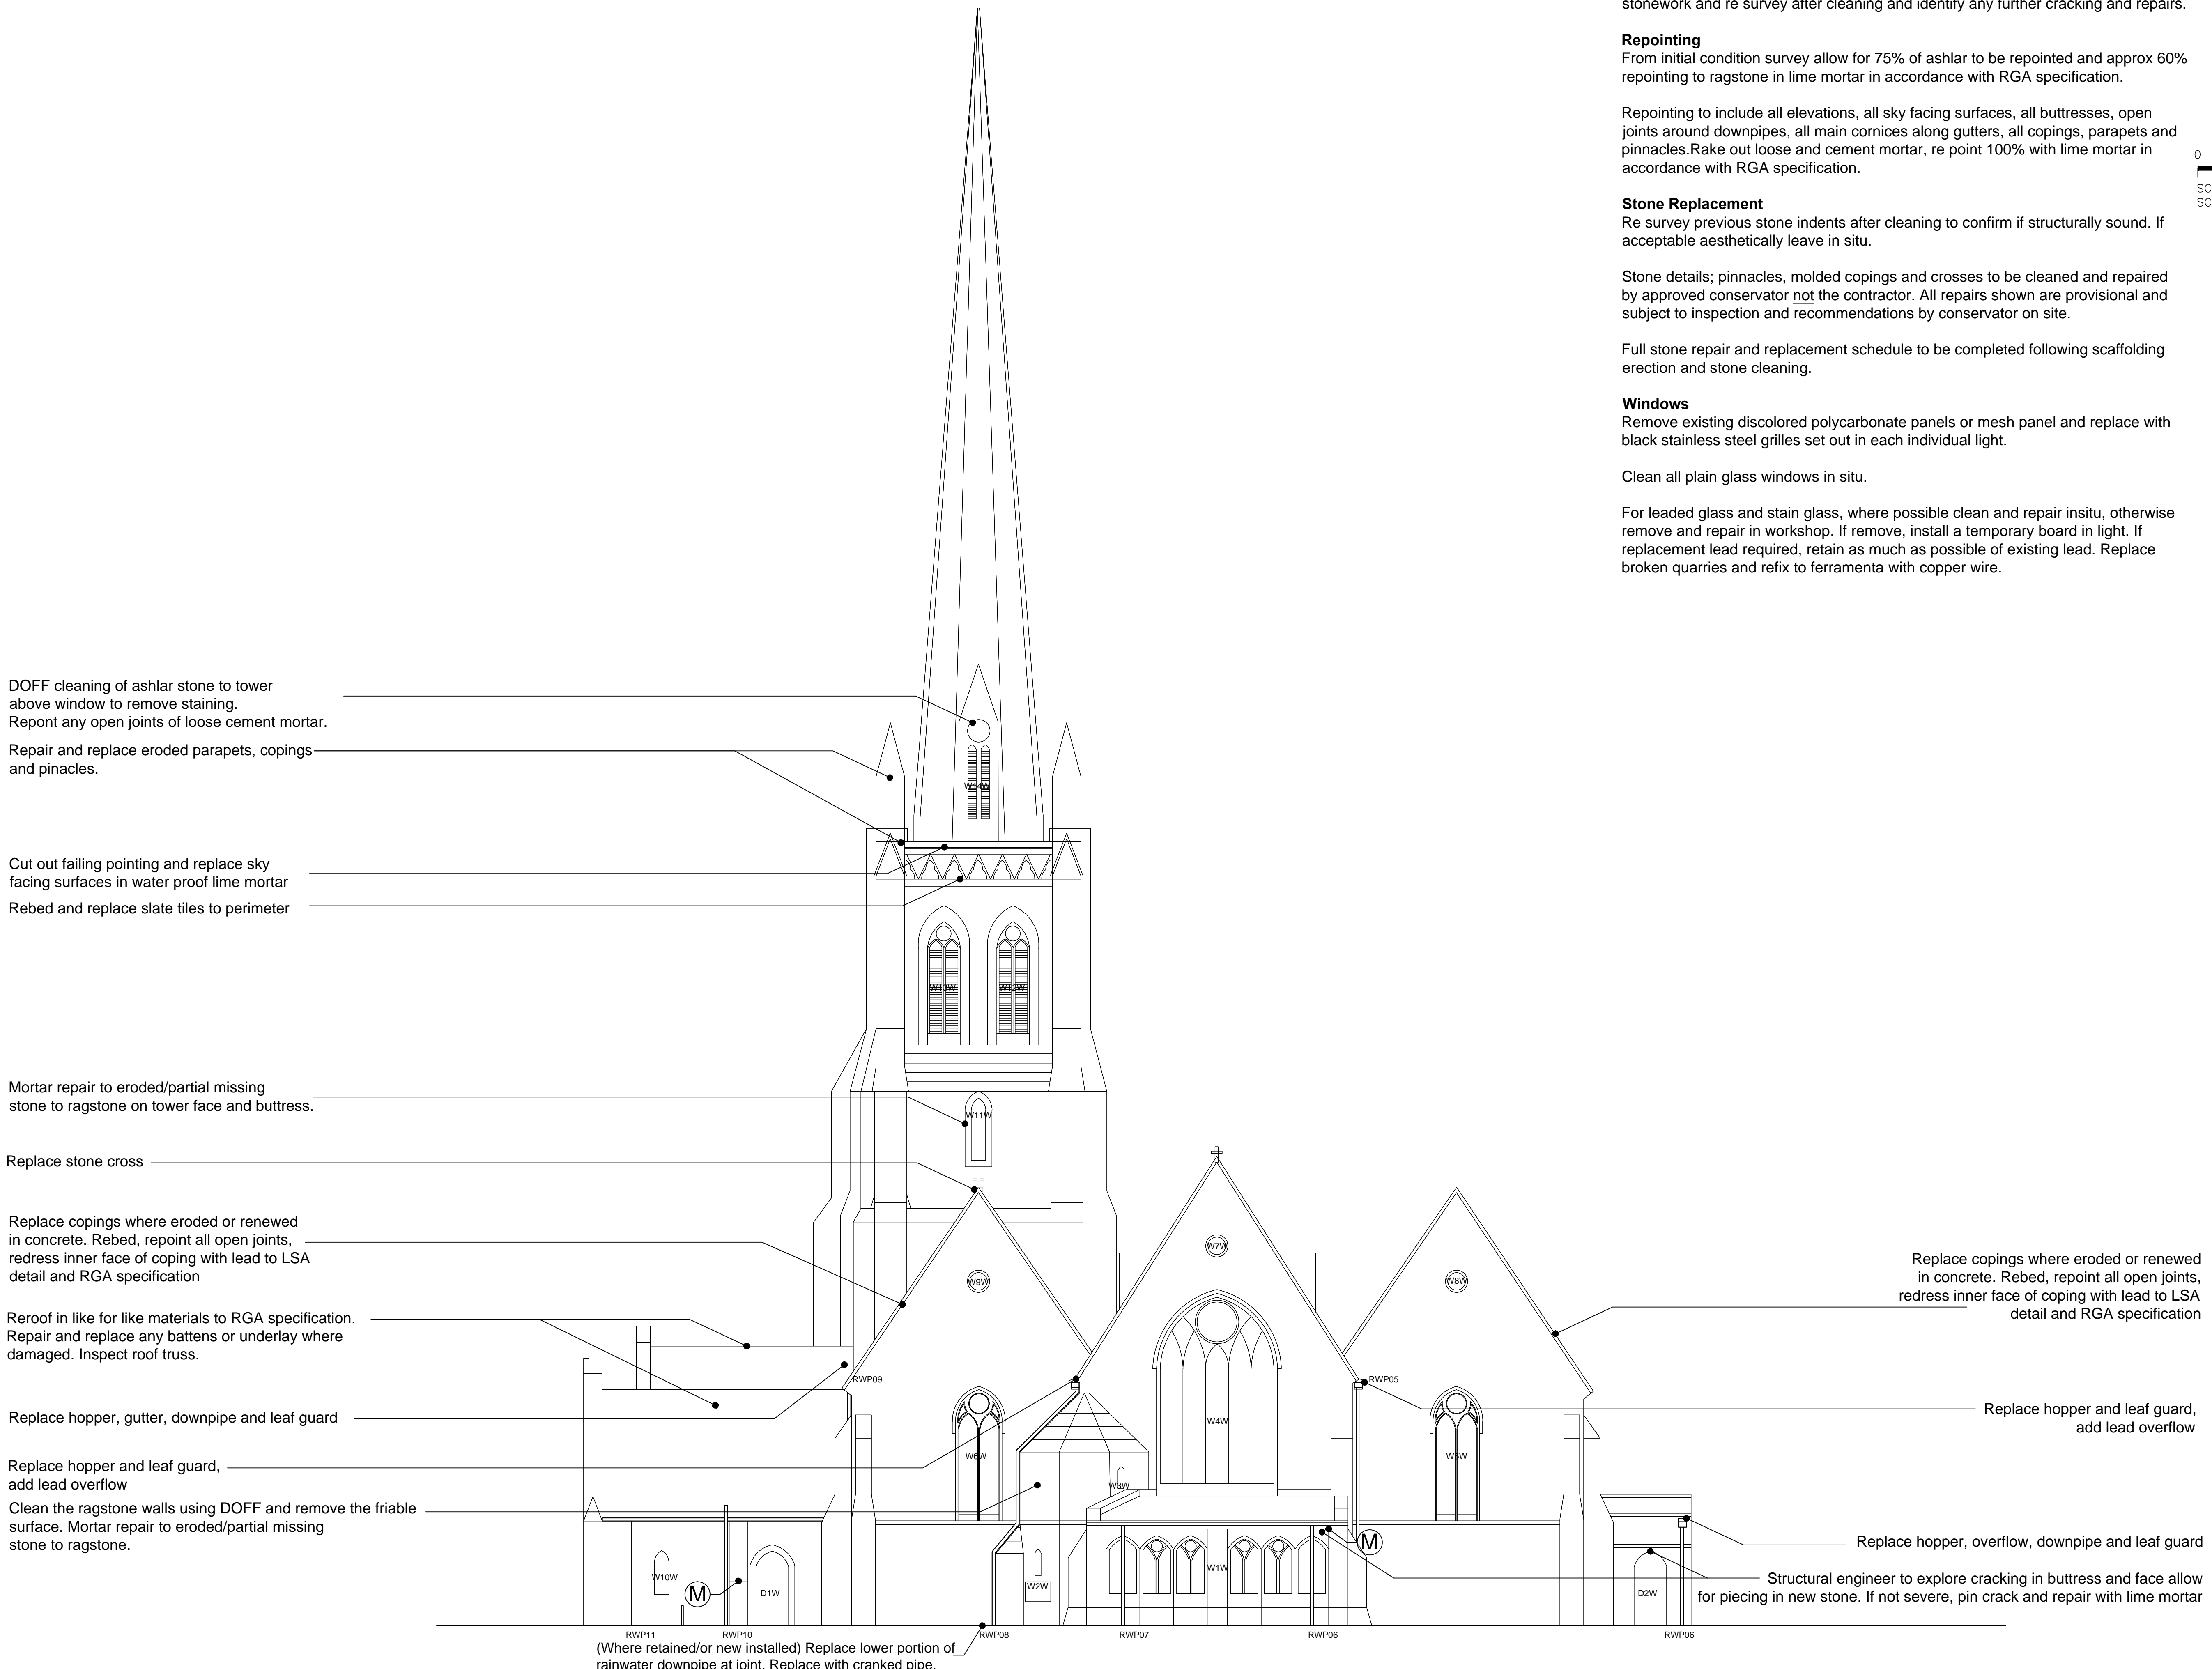
**(M)** Missing Stone - mortar repair or key in replacement stone

Mortar repair to eroded/partial missing stone to ragstone on tower face and buttress.

Clean the ragstone walls using DOFF and remove the friable surface. Mortar repair to eroded/partial missing stone to ragstone.

Structural engineer to explore cracking in buttress and face allow for piecing in new stone. If not severe, pin crack and repair with lime mortar

DOFF cleaning of ashlar stone to tower above window to remove staining. Repoint any open joints of loose cement mortar.  
Repair and replace eroded parapets, copings and pinnacles.

Cut out failing pointing and replace sky facing surfaces in water proof lime mortar  
Rebed and replace slate tiles to perimeter

Replace stone cross

Replace copings where eroded or renewed in concrete. Rebed, repoint all open joints, redress inner face of coping with lead to LSA detail and RGA specification

Reroof in like for like materials to RGA specification. Repair and replace any battens or underlay where damaged. Inspect roof truss.

Replace hopper, gutter, downpipe and leaf guard

Replace hopper and leaf guard, add lead overflow

Replace hopper, overflow, downpipe and leaf guard

(Where retained/or new installed) Replace lower portion of rainwater downpipe at joint. Replace with cranked pipe.
