**41 HIGHGATE WEST HILL, N6 6LS – ALTERATIONS TO SECOND FLOOR ROOM S07 (LIBRARY)**

**1. INTRODUCTION**

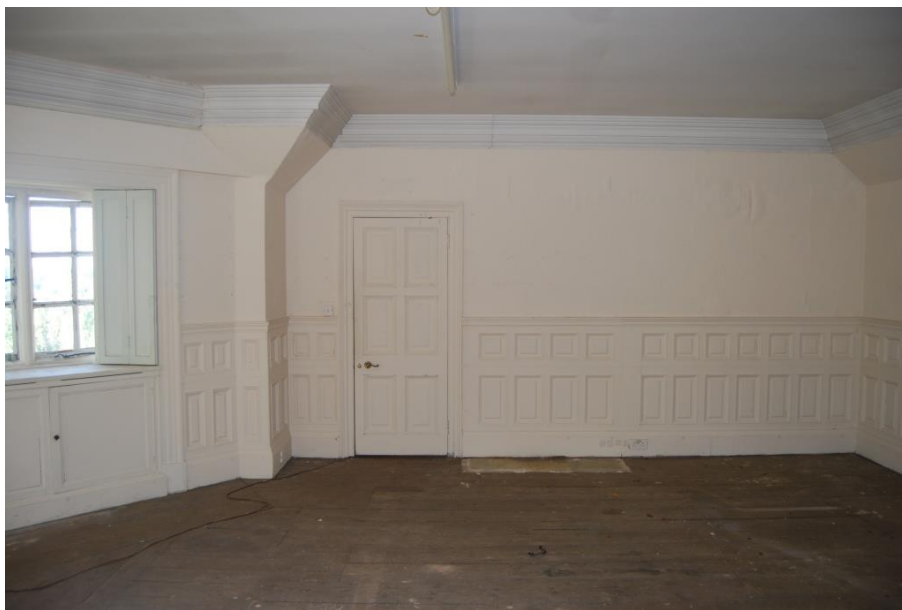
Photo A – An image of the floor in S07 which has been patched up with plywood to conceal the previous fireplace hearth. The wall panelling is irregular in this zone to conceal the previous fireplace opening.

- 2.6. There had, previously been a fireplace within this room, although there is no record of when this was removed, and what it looked like, as this was prior to the occupation of the site by the current owners. However, the flu to the fireplace has been retained, and it is the intention that where it has been damaged it will be repaired, lined, cleaned, and reset on the new line of the wall (please refer to photo A and B). A new fireplace will be inserted along this elevation, which will be in keeping with the character of the room.

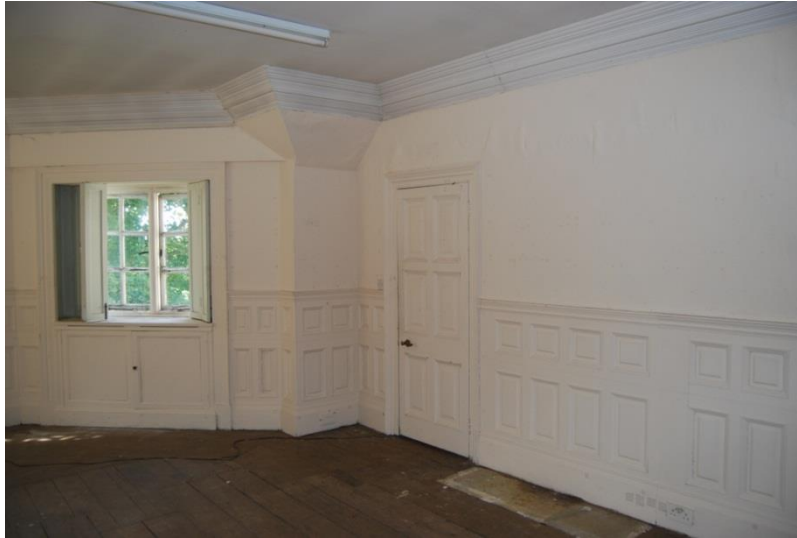
Photo B – A zoomed in view of the patched up floor where there previously was a fireplace.
