**2013/2481/P**

Information relating to the discharge of condition 4 – Bird/bat box types and locations

Building T5  
SK 892  
Bird/bat box locations

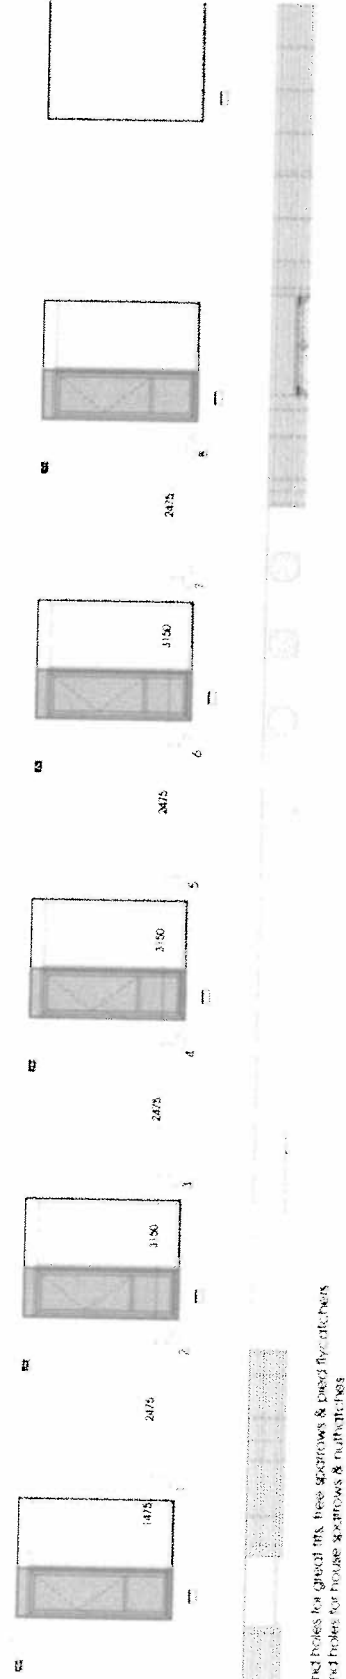
- 9. 80mm crescent hole for swifts
- 10. 80mm crescent hole for swifts
- 11. 80mm crescent hole for swifts
- 12. 70mm crescent hole for bats
- 13. 80mm crescent hole for swifts
- 14. 70mm crescent hole for bats
- 15. Area 1A on West facade to match locations indicated above 1A 2.5 stretchers from end

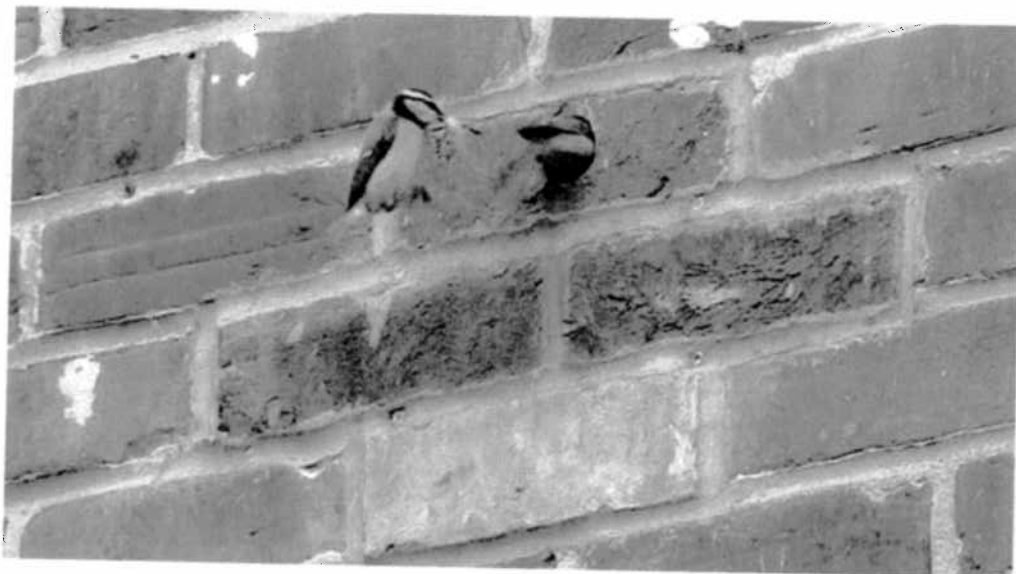
**SK\_P5**

*High level: Bat/Swift*

*Low level: Sparrows, Nuthatches, Pied flycatchers*

Bird and bat box types: Bird brick house - Laid into stretcher bond brickwork.  
To be read in conjunction with SK\_891+892
