BASEMENT IMPACT ASSESSMENT

**231 GOLDHURST TERRACE
LONDON**

REPORT REF: ZS 3170

NOVEMBER 2014

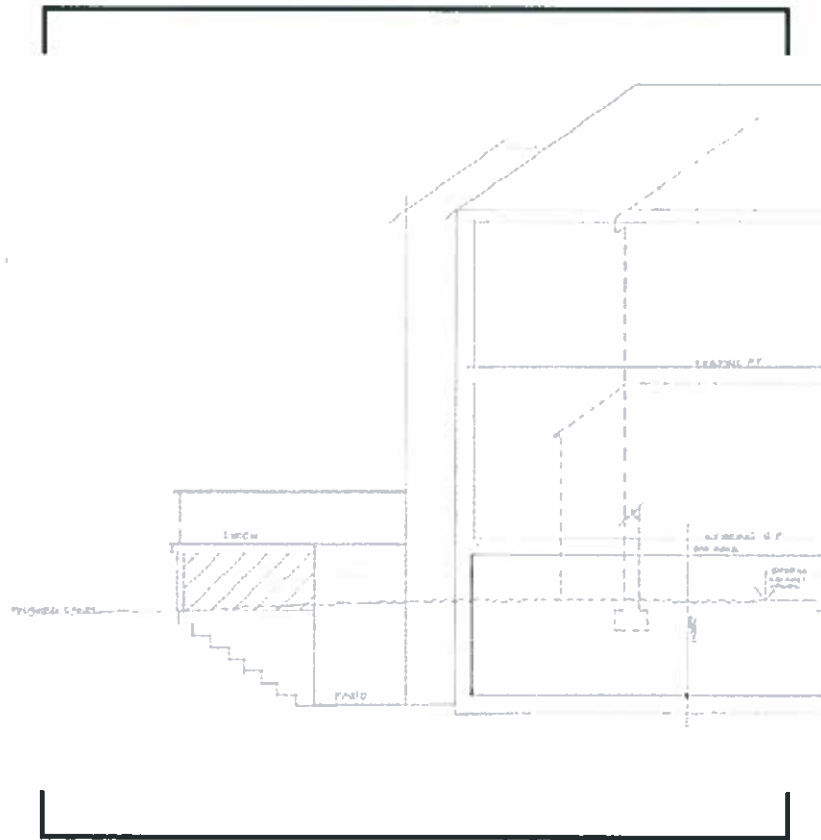
Figure 4 Proposed Rear Section

It is proposed to extend the house to the rear and construct a basement beneath the house and part of the rear garden.

The site lies around National Grid Reference 525893^E 184006^N at a height of around 30m above Ordnance Datum. A Site Location Plan is presented as Figure 1 and a Site Plan is presented as Figure 2A and an Existing Rear Elevation Photo as Figure 2B. The Existing Rear Section is presented as Figure 3 and the Proposed Rear Section as Figure 4. The Proposed Rear Elevation is presented in Figure 5.

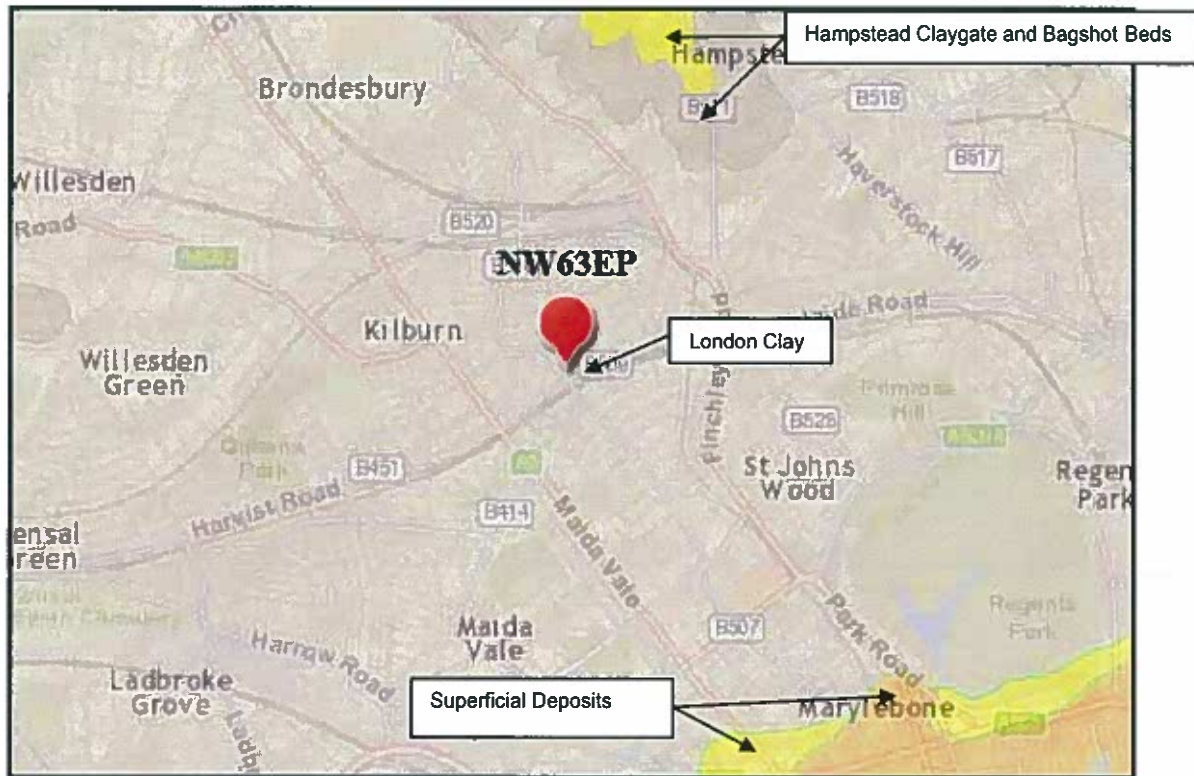
Figure 6 Geological Plan

The published 1:50,000 scale British Geological Survey (BGS) geological map of the area (Sheet 256 “North London”) shows the site to be underlain by the London Clay Formation (up to 85m thick) of the Eocene geological epoch. The London Clay is underlain by further clays, sands and chalk. An extract of the BGS Geological Map is provided in Figure 6 below.

The London Clay is shown not to be overlain by any superficial deposits. Given the historical development of the site and surrounding areas, there may be made ground present on the site.

No geological faults are shown to be present within close proximity to the site.

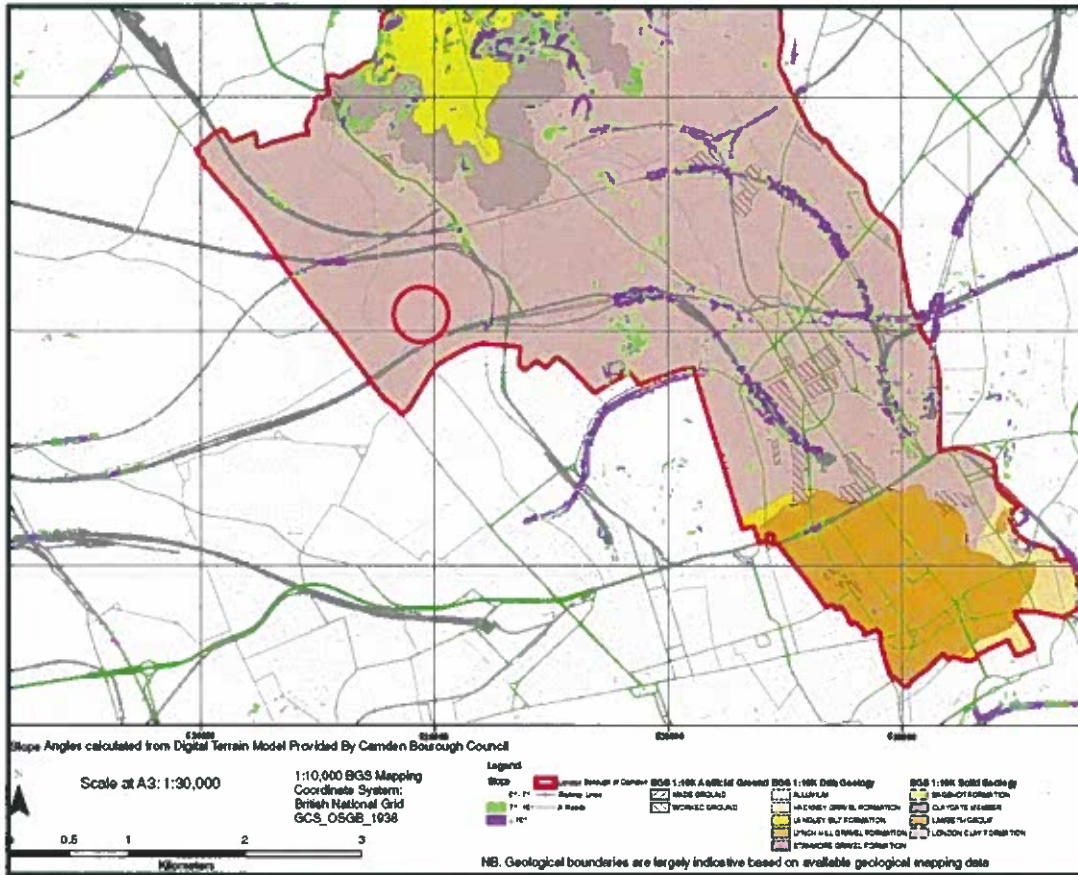
Figure 7 Landslip Plan

The site is shown not to be within an area of significant landslide potential as shown in Figure 7 Landslip Plan. (reference Figure 17 of Arup Report for London Borough of Camden "Guidance for Subterranean Development", 2010). This is reinforced by the low slope angles recorded during the site walk over and the geology of the London Clay with no overlying deposits.

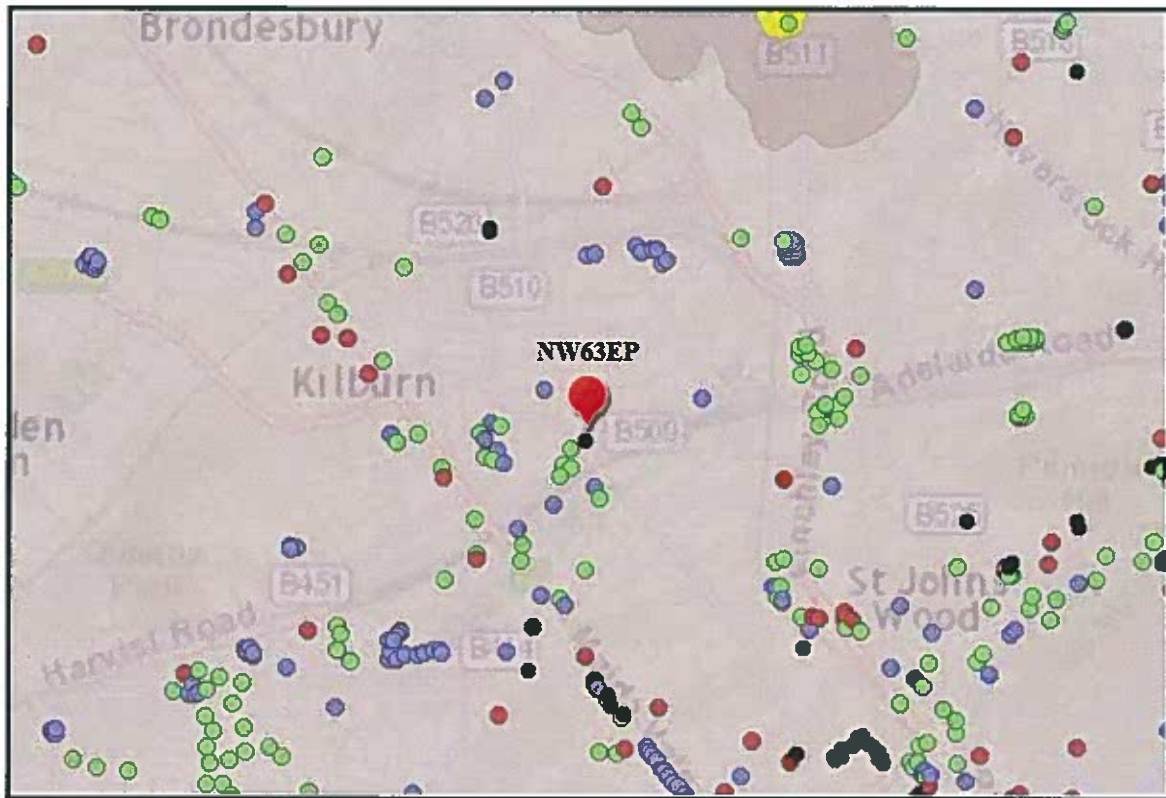
Figure 8 Local Borehole Plan

BGS Reference	Depth bgl in m	Brief Summary of Ground Conditions	Water Supply
TQ28SW11	85	London Clay to 85m sand thereafter	RWL 40m
TQ28SE360	45.72	London Clay	
TQ28SE46	177	London Clay to 81m, sand to 96 and Chalk thereafter	Water details not recorded

These boreholes confirm the geology of the area surrounding the site and confirm that any local water abstraction wells are from generally >100m depth into the Chalk aquifer.

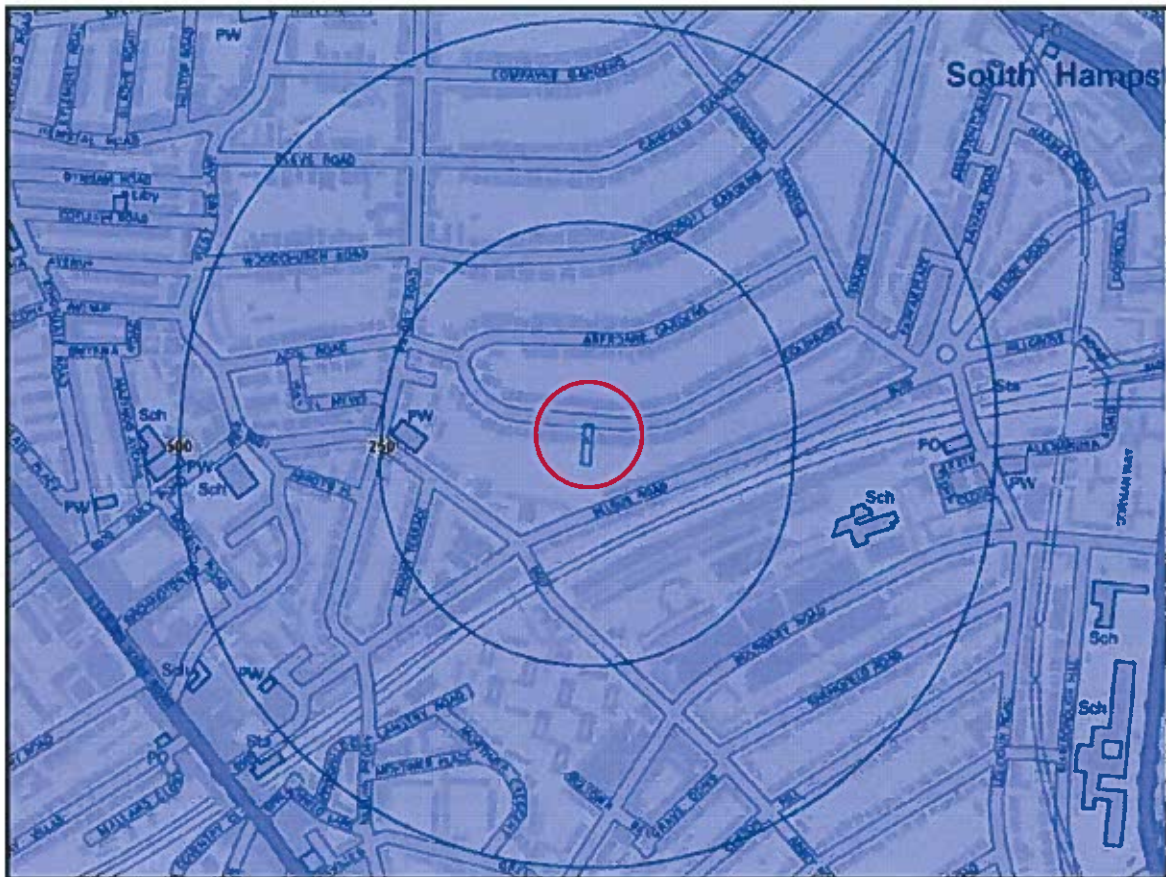
Figure 9 Hydrogeology Plan

The above referenced geological map indicates the site to be underlain by the London Clay Formation, which is relatively impermeable. The Environment Agency have designated the London Clay Formation beneath the site as an "Unproductive Aquifer" which means the strata has a low permeability and negligible significance to water supply or base flow to rivers. Permeability of the London Clay varies from 5×10^{-6} to 1×10^{-10} m/sec. (BS 8004, 1986). The site does not lie on a Groundwater Vulnerability Zone.

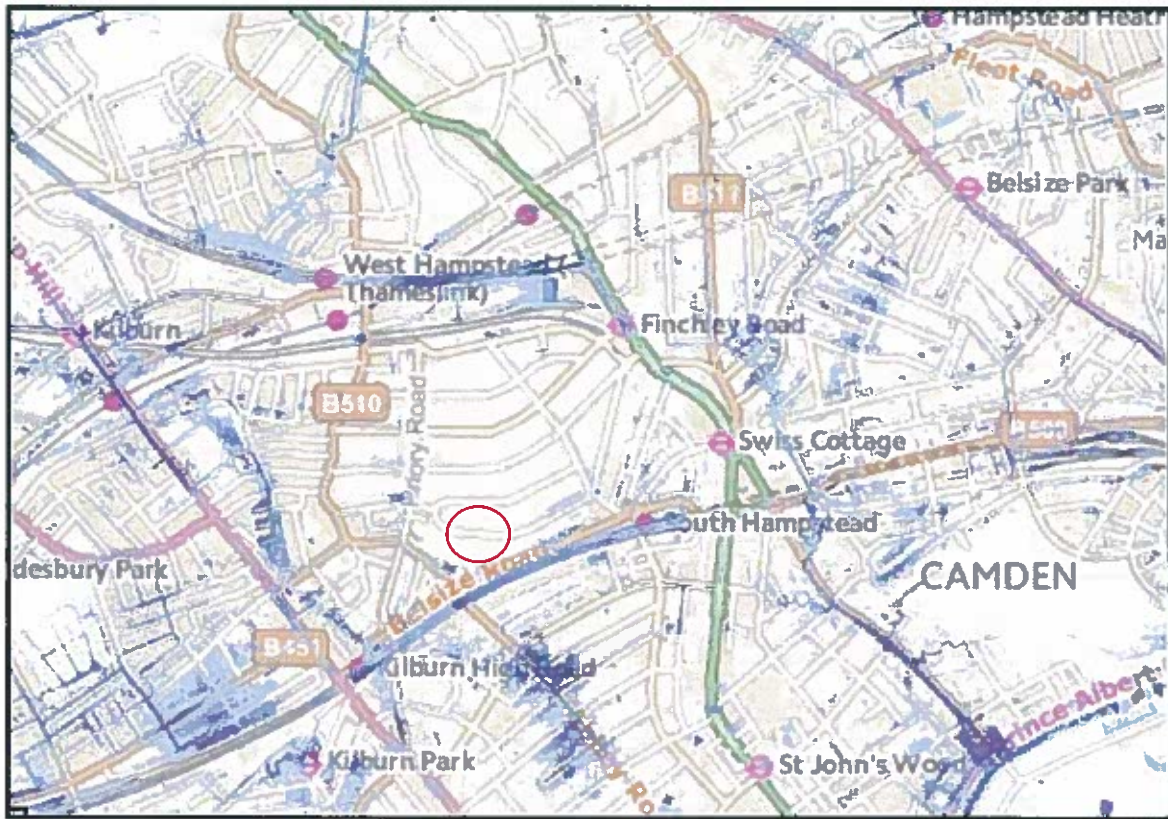
Figure 10 Risk of Flooding from Surface Water (EA 2014)

The recent Environment Agency map reproduced in Figure 10 indicates a very low risk from flooding from surface water.

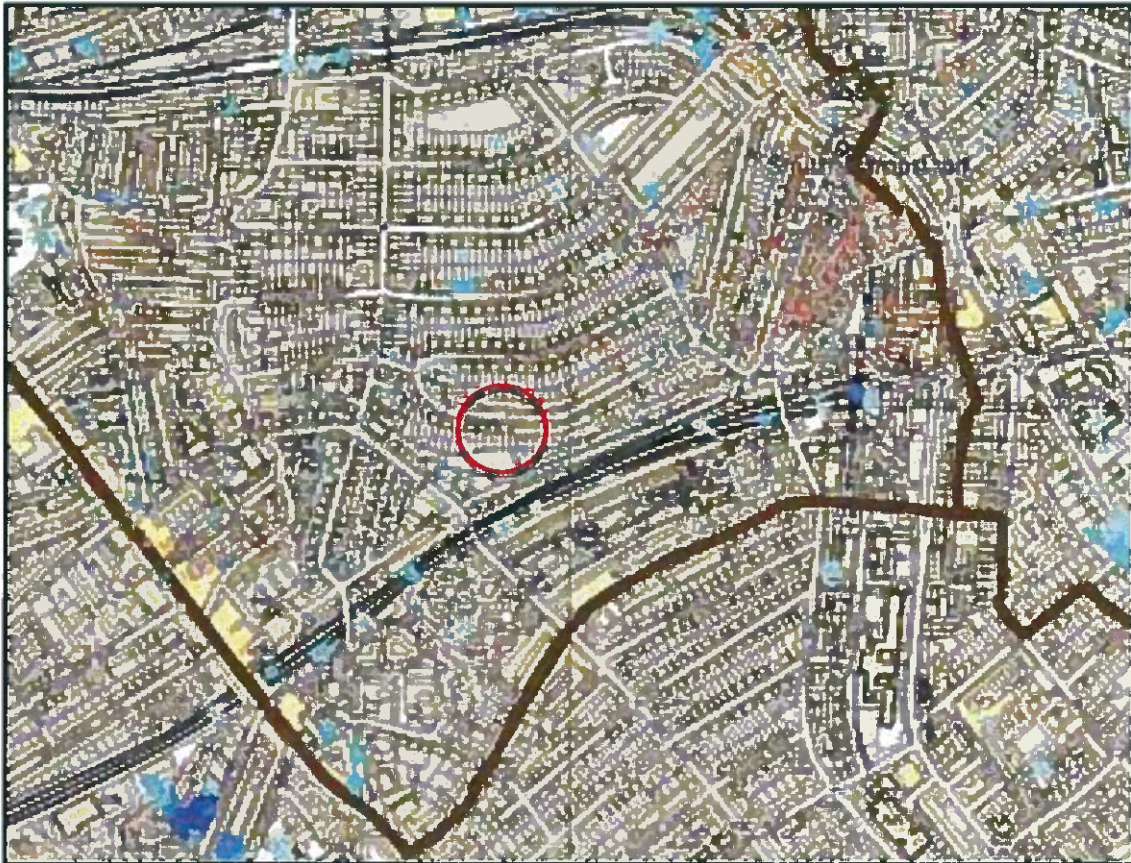
Figure 11 Detailed Surface Water Flood Risk

This map indicates potential flows and areas of ponding for a flood event with a 1.33% chance of happening once in any year.

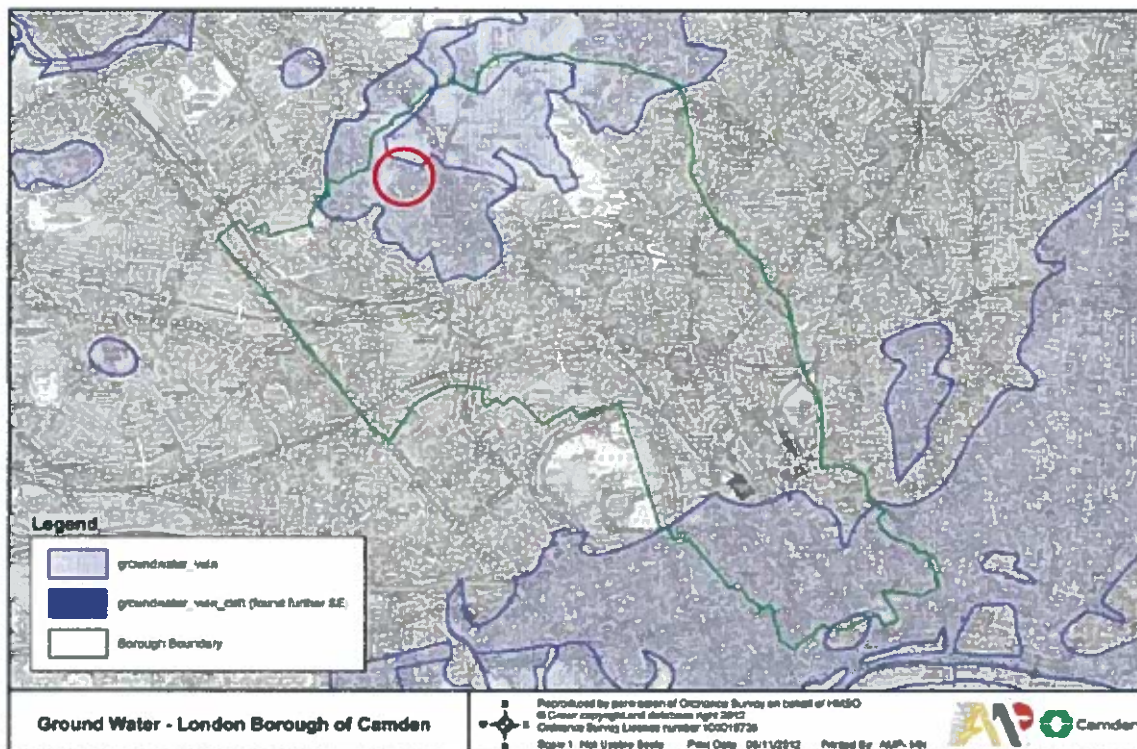
Figure 15 EA Risk of Flooding from Groundwater

The Environment Agency Map reproduced in Figure 15 indicates there is no risk of flooding from groundwater on the site.

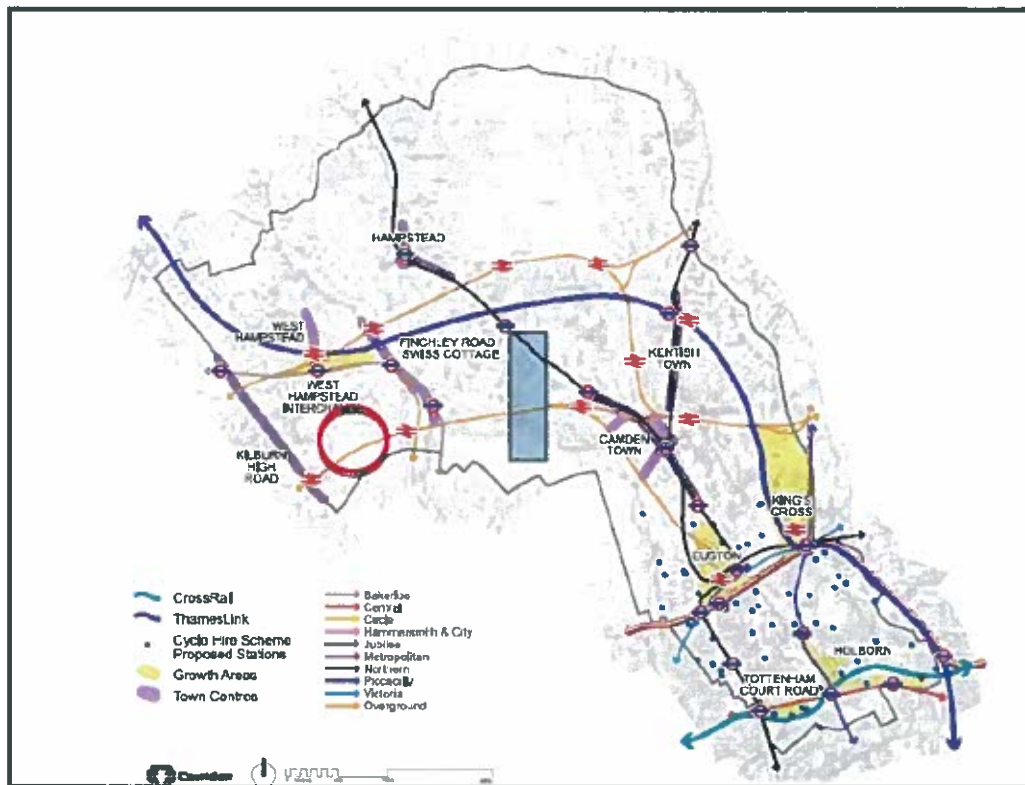
Figure 17 Transport Infrastructure

The map in Figure 17 reproduced from the Camden Geological, Hydrogeological and Hydrological Study (Figure 18) indicates there is no transport infrastructure beneath the site.

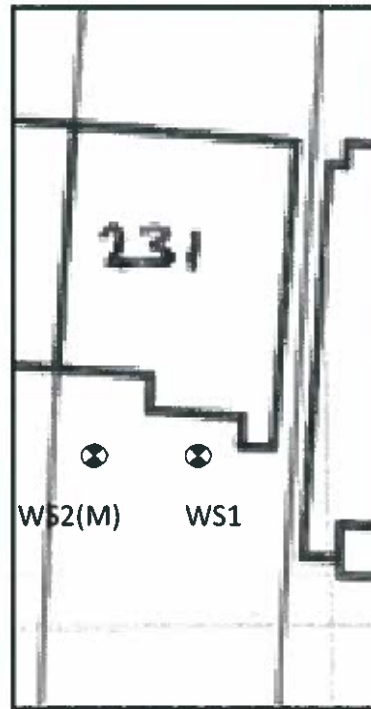
Figure 18 Borehole Location Plan

All exploratory points were marked out on site by reference to existing physical features on the site.

Borehole results are presented in Table 6 and in Appendix C. Geotechnical Test Results are presented in Table 7 and Table 8 and Appendix C.
