8 THANET STREET, LONDON WC1H HERITAGE STATEMENT

June 2015

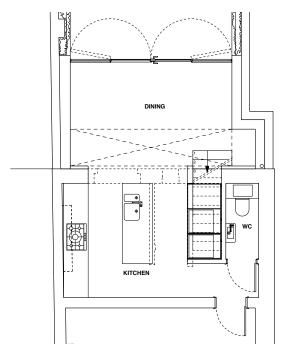
fig3. Proposed rear of lower ground floor

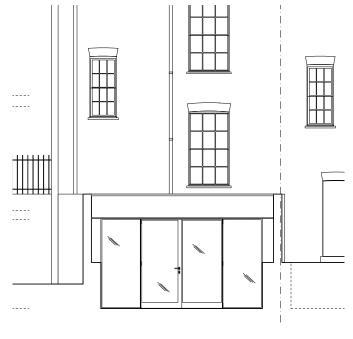
fig4. Proposed elevation of rear extension.

This extension will extend towards the back of the garden from the rear elevation. Due to the proposed excavation of the garden to the level of the lower ground floor, the height of the extension will be half a storey above the existing ground level. It will therefore have little impact on the surrounding context.

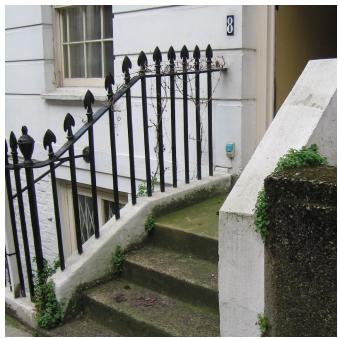
fig7. Fanlight above front door

heads; fanlights (nos. 8, 10, 13 & 15 patterned) and panelled doors (No.8, C20). Gauged brick flat arches to recessed sashes; 1st floor with cast-iron balconies (except No.17). INTERIORS: not inspected.

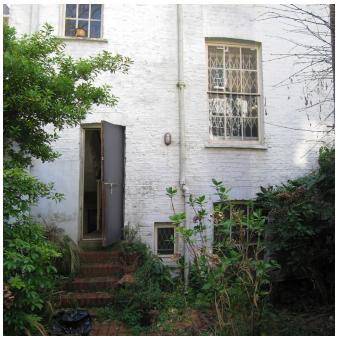
fig14. Rear garden

The existing garden finishes are of a modern nature have no positive impact on the existing listed building, therefore their removal would not have a detrimental impact on the property. The excavation is planned to leave the existing garden walls unaffected and in place. This excavation will not be detrimental to the existing building.

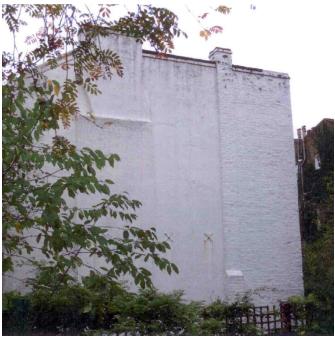
fig22. Side elevation

The current render is in poor condition and needs to be repaired in order to prevent damage to the building. This render would be replaced with render to match the current render.
