Proposed Front Elevation

Proposed Rear Elevation

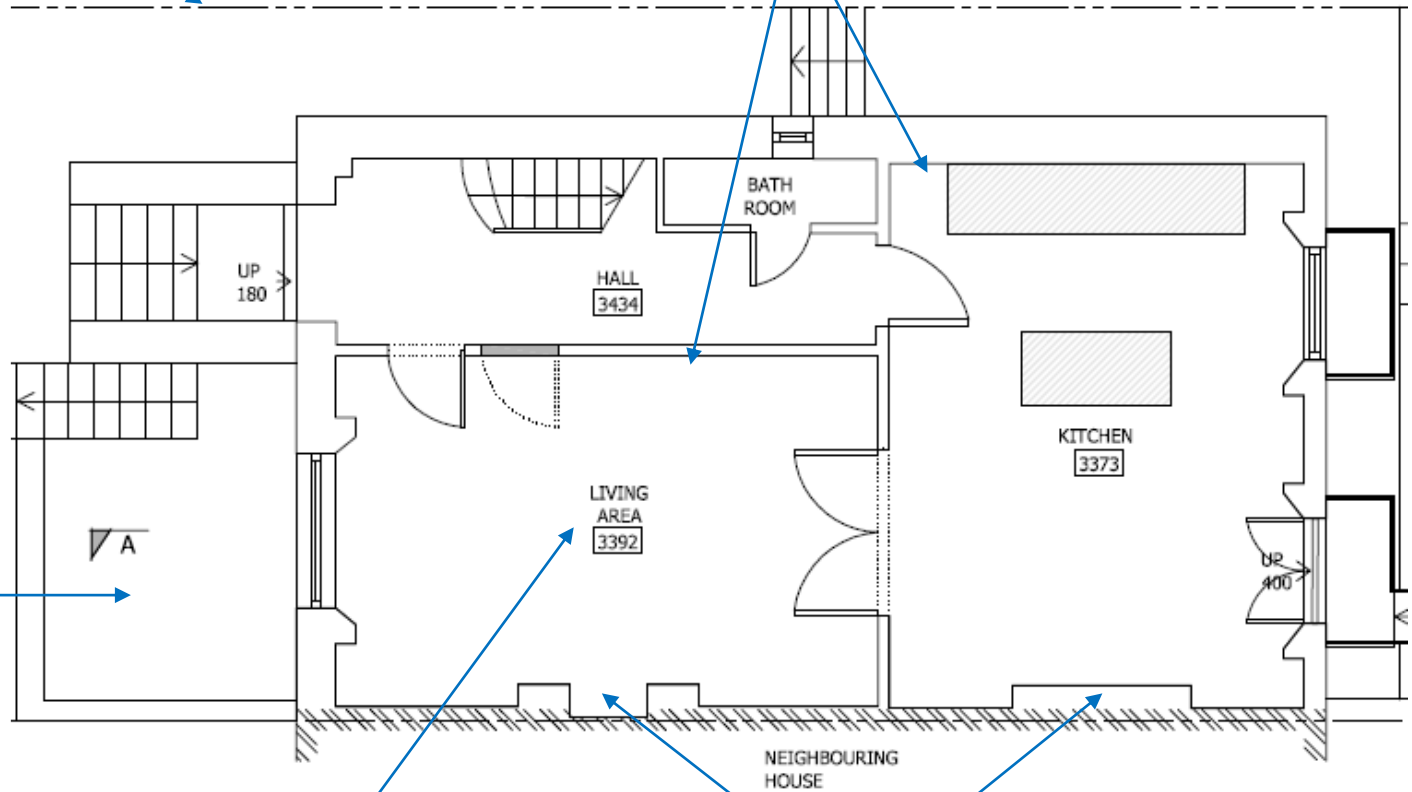
Repair of damaged wall

Restoration of original
coving/replacement of
damaged coving to match
original

Repair of
damaged front
courtyard area

Central ceiling light reinstated

Fireplaces to be reinstated to
match original

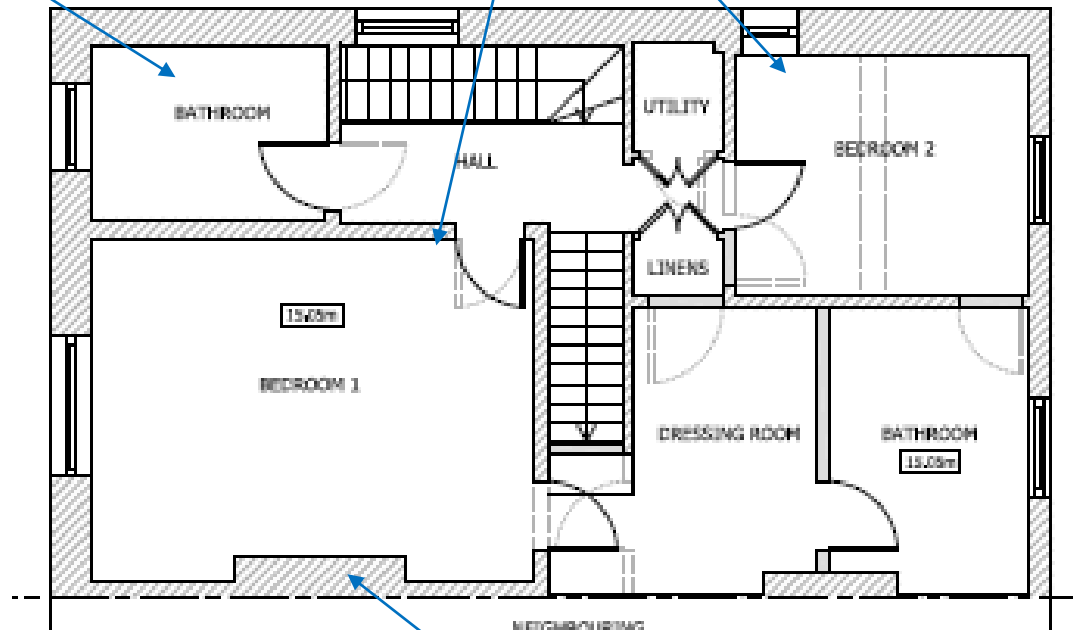
Restoration of original
coving/replacement of
damaged coving to match
original

Repair of damaged floor joists

Fireplace to be reinstated to
match original

Repair of all cracks to the walls of the house

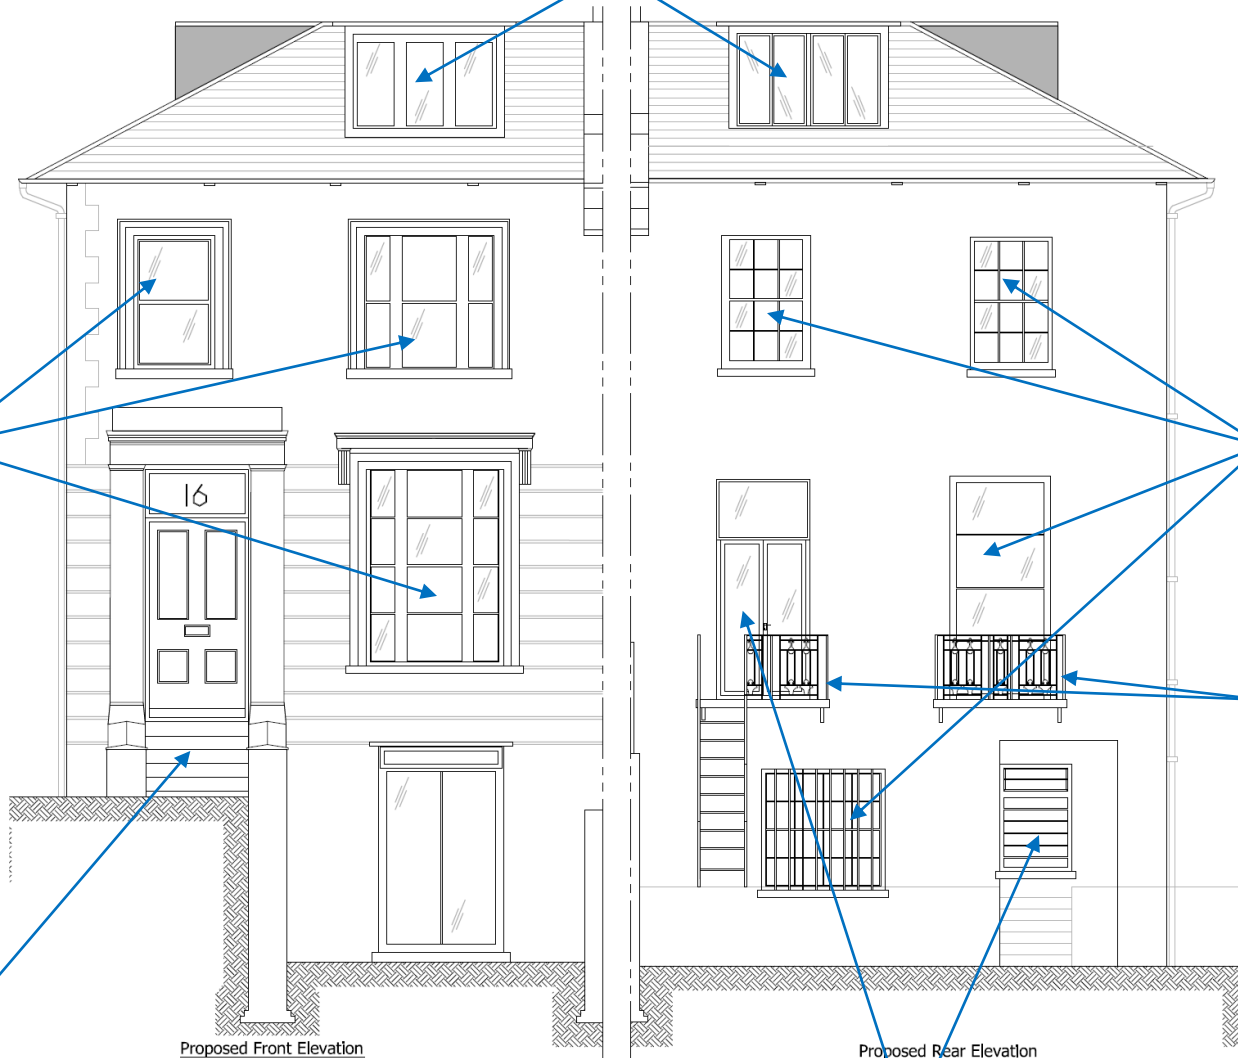
Repair of existing dormer windows

Restoration and repair of original sash windows

Restoration and repair of original balconies

Steps to be reinstated in stone to match original style

Repair of existing windows

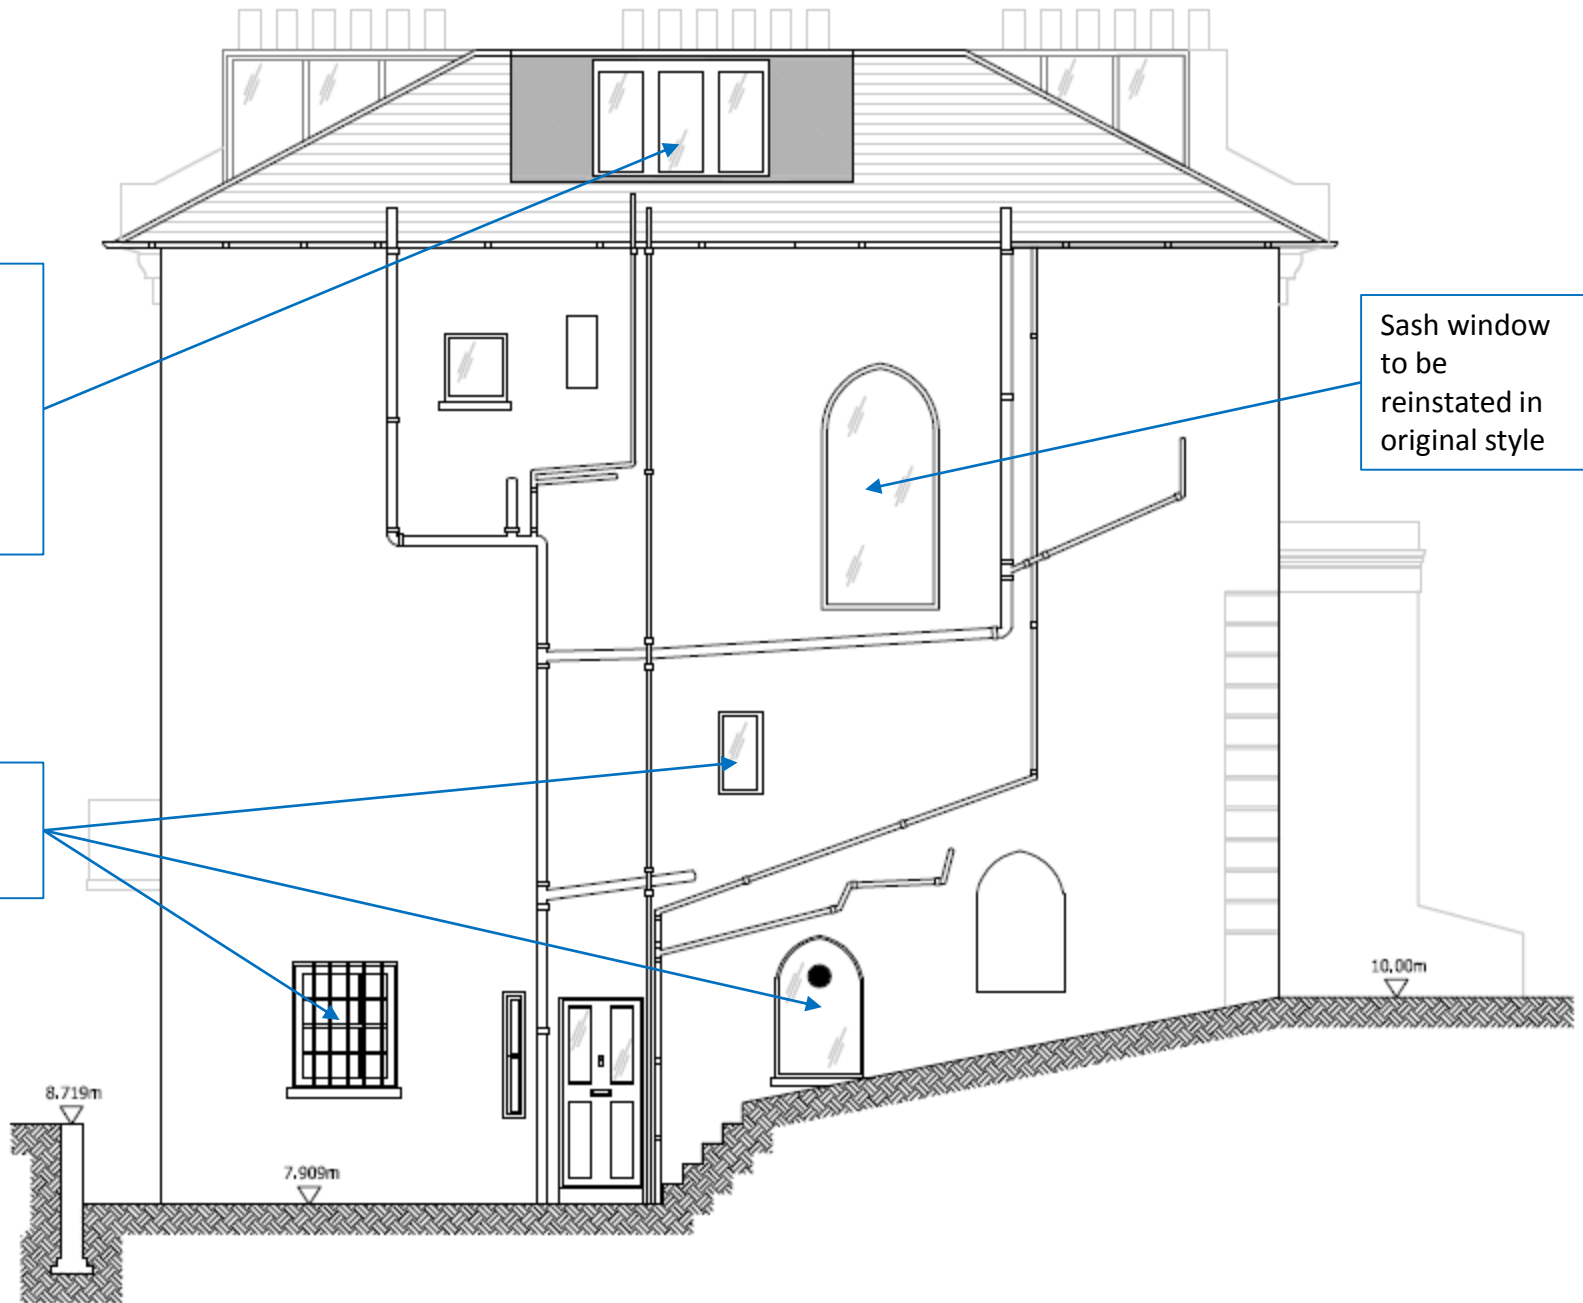
Extension of
dormer
window to
match
adjacent
property in
style

Repair of
existing
windows

Sash window
to be
reinstated in
original style
