Camden Stables Market
London
NW1
United Kingdom

**Camden Stable Market
Provender Stores**

Drawing Title
**PROVENDER STORES
UNAUTHORISED REMEDIAL WORKS
-Proposed Ground floor double doors**

Drawing No
B-WP-02

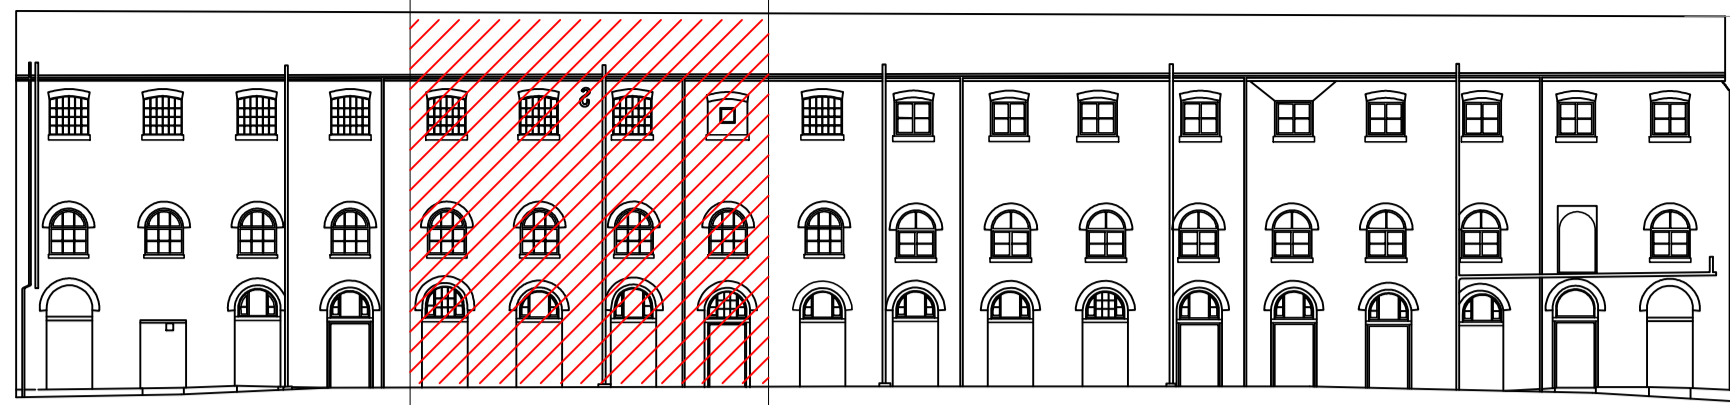
SOUTH ELEVATION

Windows of this type highlighted in red are proposed to be altered as part of this application. Those not hatched are to be refurbished. The hatched area is that part of the building affected by fire damage.

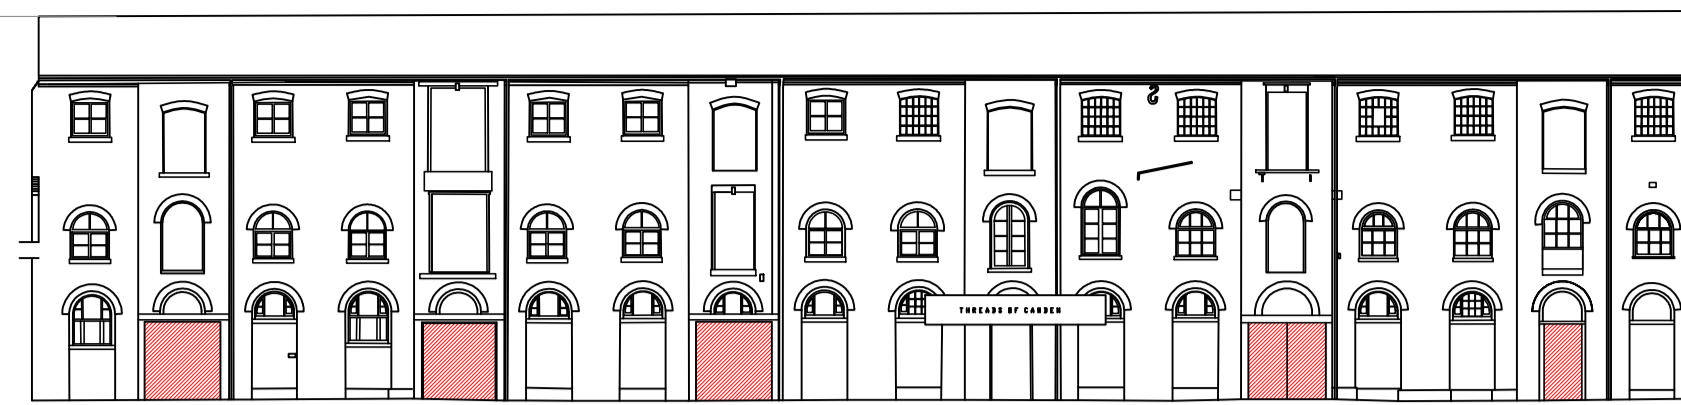
NORTH ELEVATION

Windows of this type highlighted in red are proposed to be altered as part of this application. Those not hatched are to be refurbished.

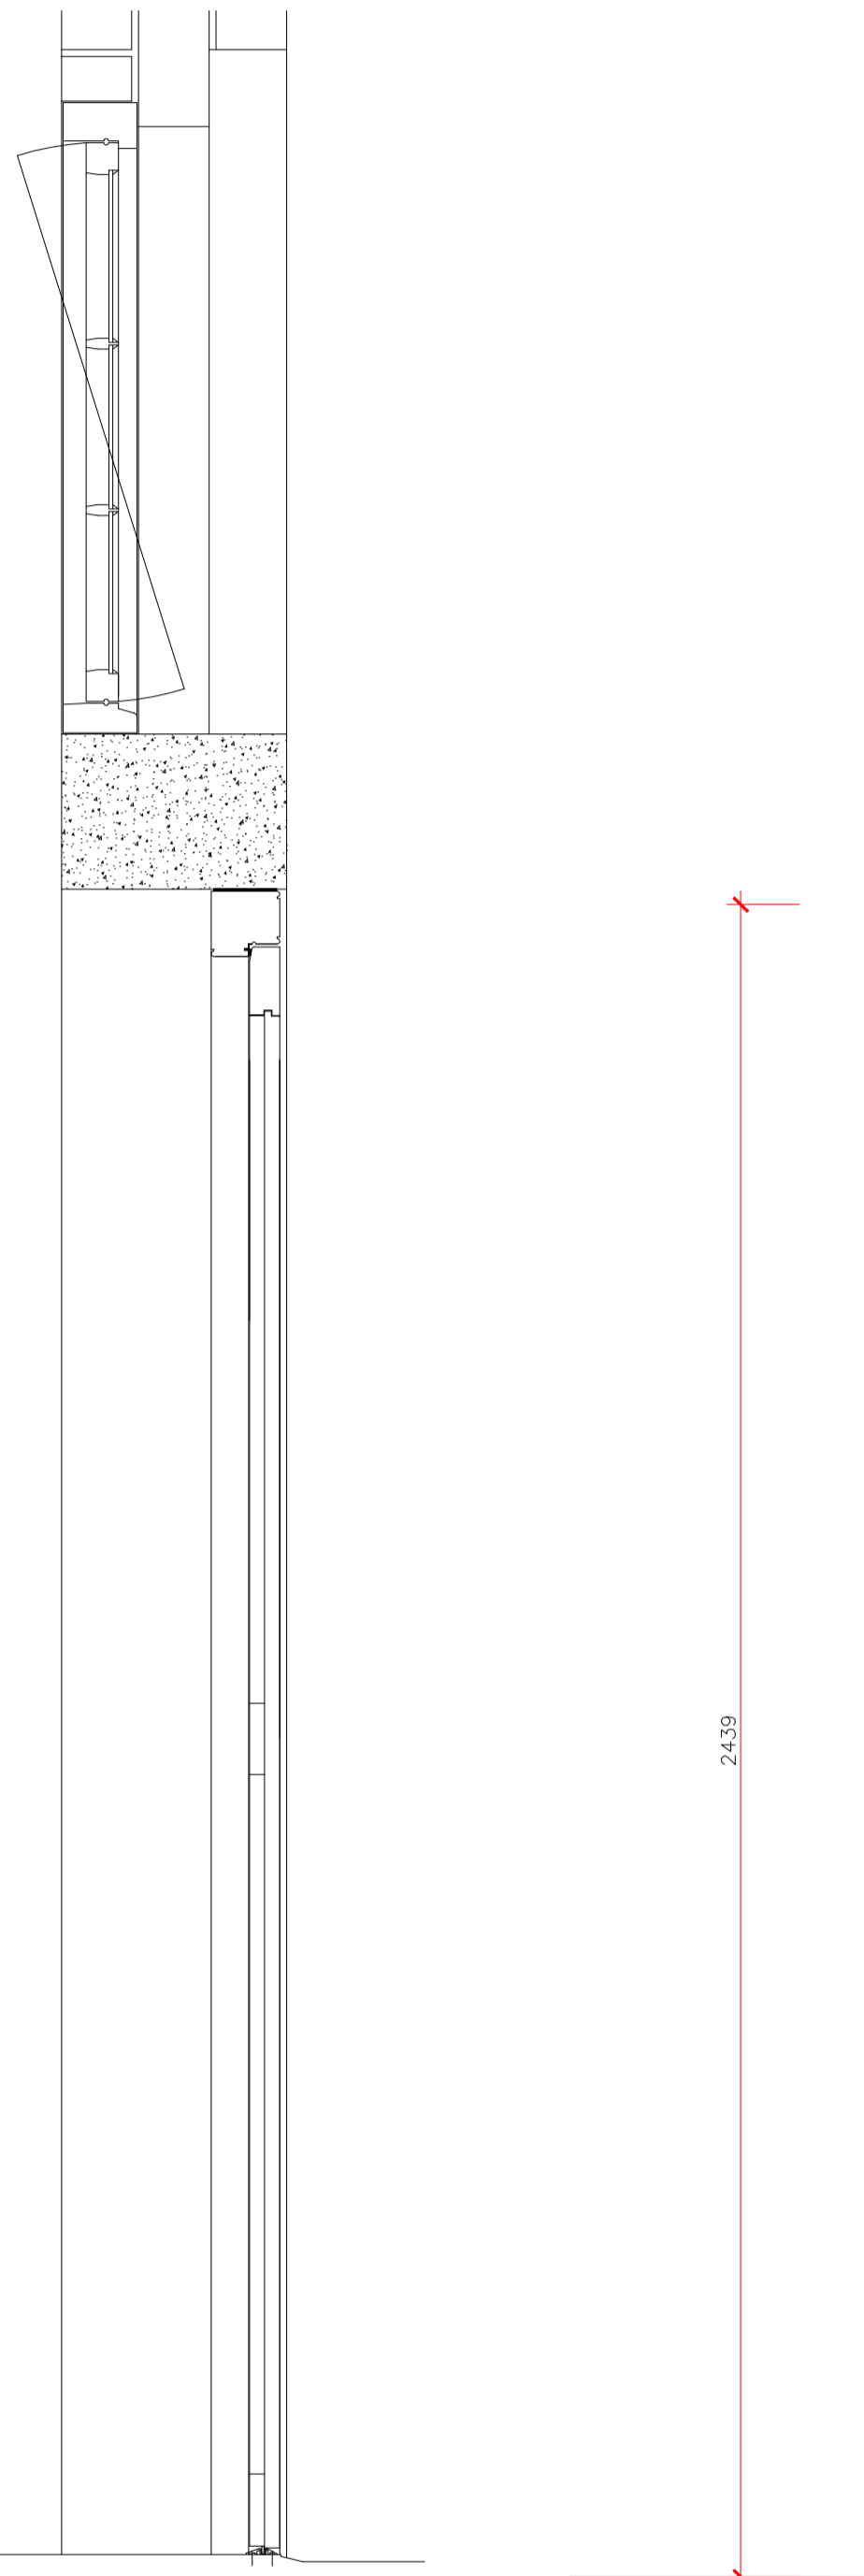
Section

**Proposed Ground floor double doors -
Scale 1:10**

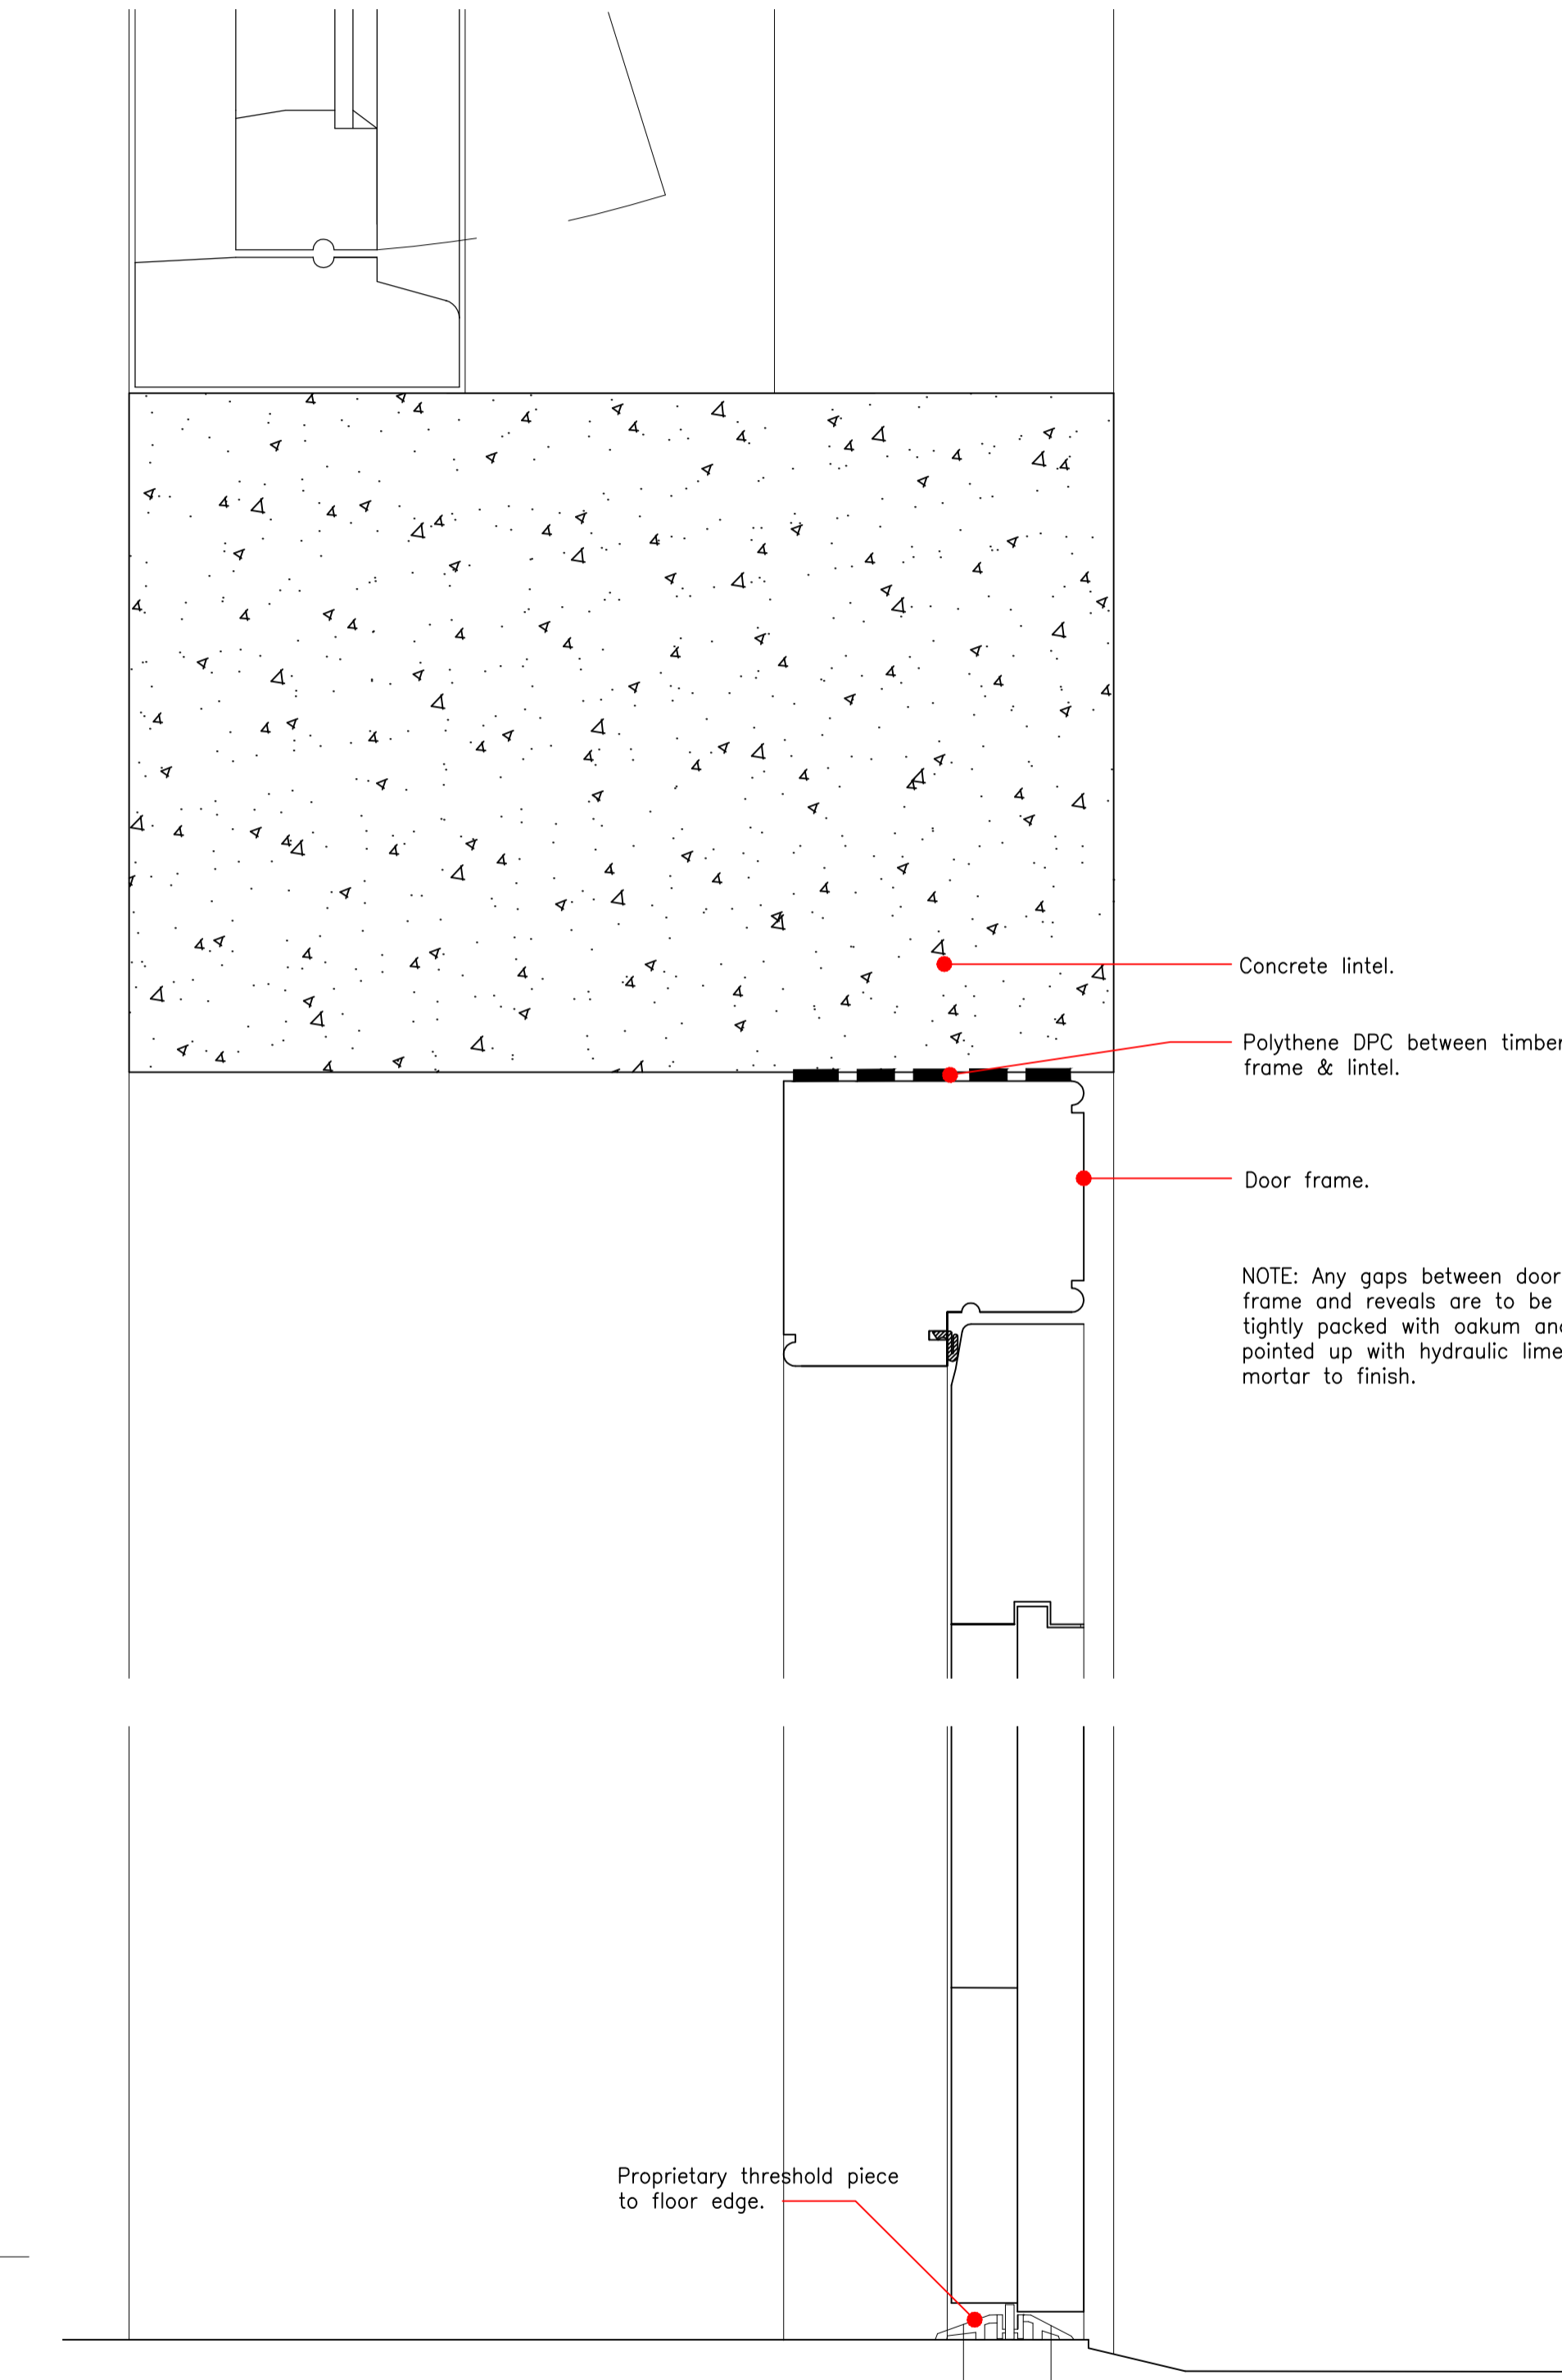
S-D01

Item number
Door
Elevation

Area indicating location of fire damage in May 2014

Note: All structural opening sizes to be checked and confirmed prior to any manufacture.
