**56 PARKWAY
 LONDON NW1
 BRICKCOURSE MONITORING RESULTS**

REF: G4972-M1

**56 PARKWAY
 LONDON NW1**

CRACK MONITORING RESULTS

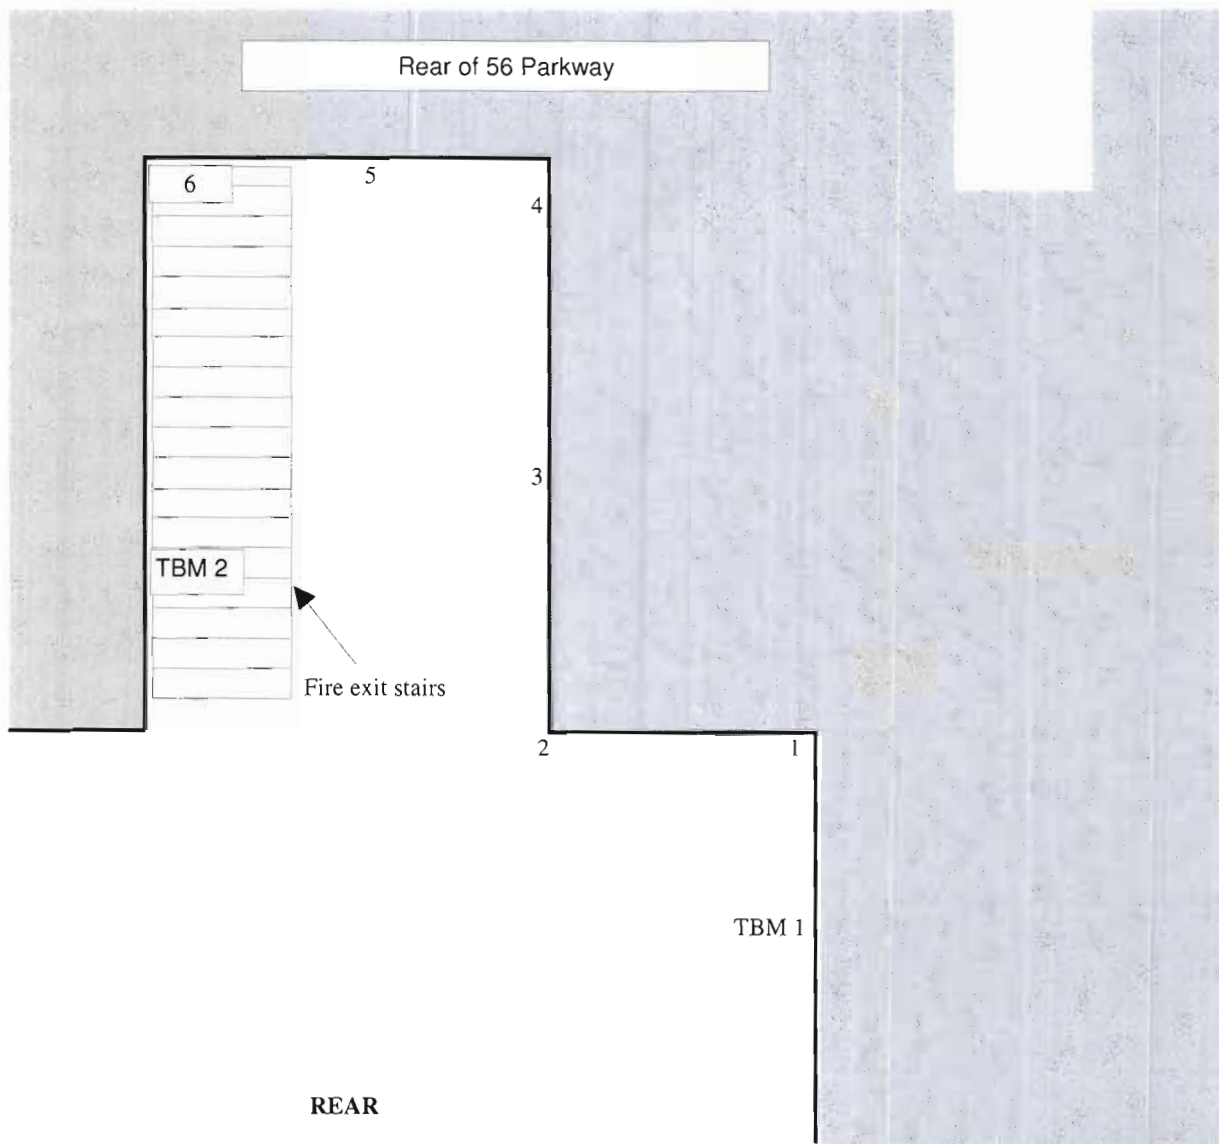
Station ID	REDUCED LEVEL (metres)							RANGE mm	O/A mm
	DATES OF MONITORING SURVEY								
	03/10/14	05/11/14	15/12/14	15/01/15	20/02/15	16/03/15	14/04/15		
1	10.0864	10.0856	10.0866	10.0872	10.0879	10.0882	10.0883	2.7	1.9
2	9.8966	9.8957	9.9042	9.9093	9.9122	9.9137	9.9137	18	17.1
3	9.9344	9.9329	9.9358	9.9384	9.9399	9.9407	9.9413	8.4	6.9
4	9.9428	9.9407	9.9409	9.9411	9.9423	9.9426	9.9434	2.7	0.6
5	9.7684	9.7659	9.7653	9.7653	9.7662	9.7664	9.7672	3.1	-1.2
6	9.8006	9.7988	9.7968	9.7961	9.7967	9.7970	9.7977	4.5	-2.9
TBM 1	10.0000	10.0000	10.0000	10.0000	10.0000	10.0000	10.0000		
TBM 2	9.7636	9.7622	9.7609	9.7607	9.7621	9.7627	9.7635

Maximum
 Minimum
