15-190.02

July 2015

Project Name	3 Aldred Road, London, NW6 1AN		
Project Title	Ground Investigation Report		
Client	Private Client on behalf of Pawlik + Wiedmer		
Project Number	15-190.02		
Version	ISSUE 1		Date
Prepared by	Orlando Blackwell BEng (Hons) MSc (Eng)	Principal Engineer	30/06/2015
Prepared & Checked by	James Burkitt BEng (Hons) CEnv MRICS	Managing Director	01/07/2015

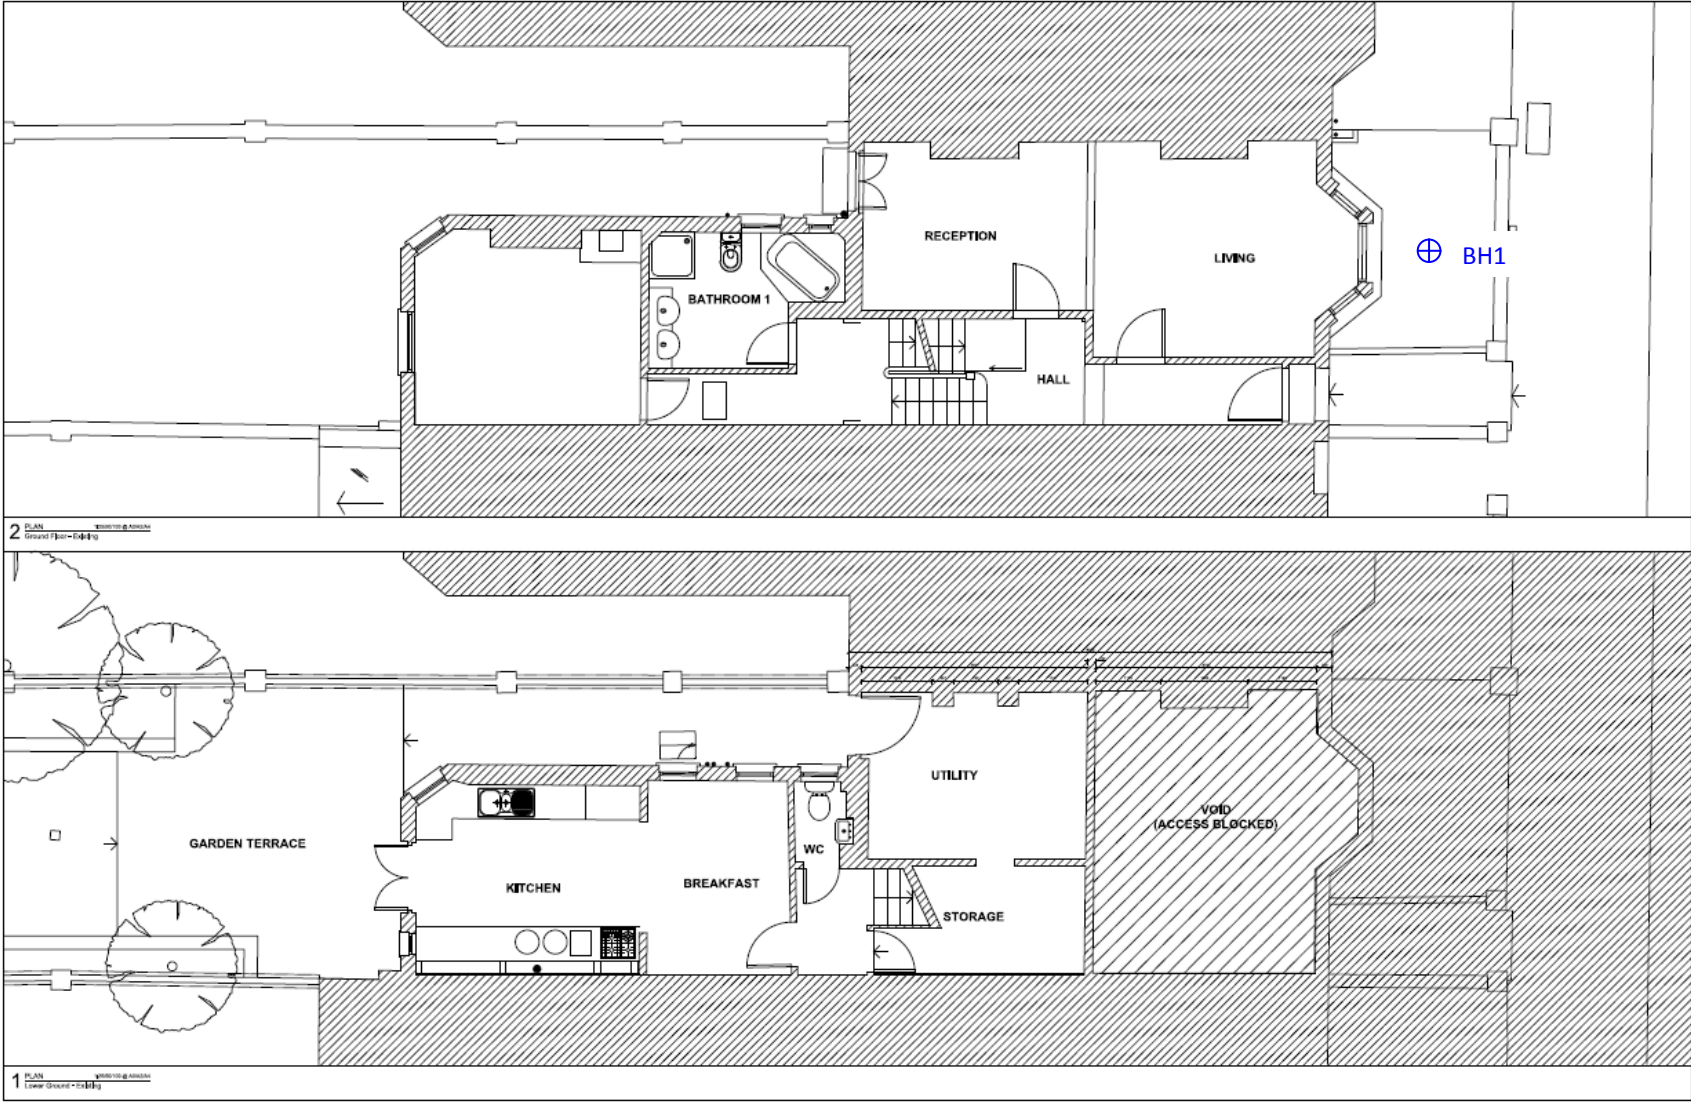
Figure 1 is enclosed as a Borehole Location Plan.

Given the orientation and limited access to the site it was only possible to complete one borehole. BH1 was drilled within the frontage at pavement level approximately 1.60m above the lower ground floor.

⊕ Window Sample Borehole Location
