Record of Site Visit with Charlie Rose 18 December 2013

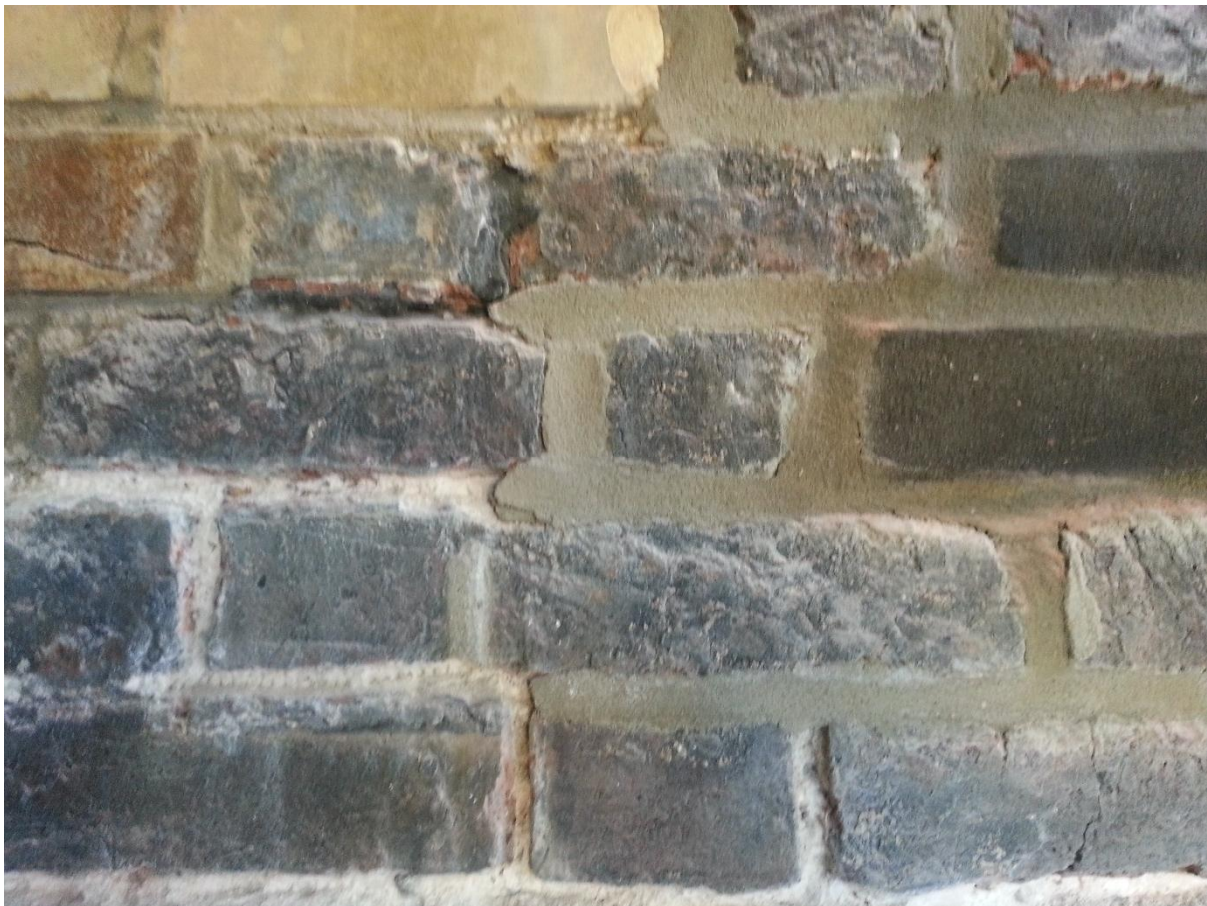
We viewed the samples and chose the one below as being not too dark and not too light. This picture also illustrates plastic repairs and stained bricks. The ultimate colour of the dried out mortar is the colour to the left of the sample. The aim is to get pointing generally thinner than in this sample.

We discussed the rear pointing and how to balance out the need to protect the building from the weather but not over-do it in such a way that the mortar was too thick so as to dominate the brick. We agreed that plastic repairs with lime mortar over the face of very damaged bricks, stained to blend in, was an acceptable approach to the very many damaged bricks. We agreed that the yellow section of brick would be stained to tone in. Pointing would be with lime mortar and as thin as possible where the condition of bricks allowed.

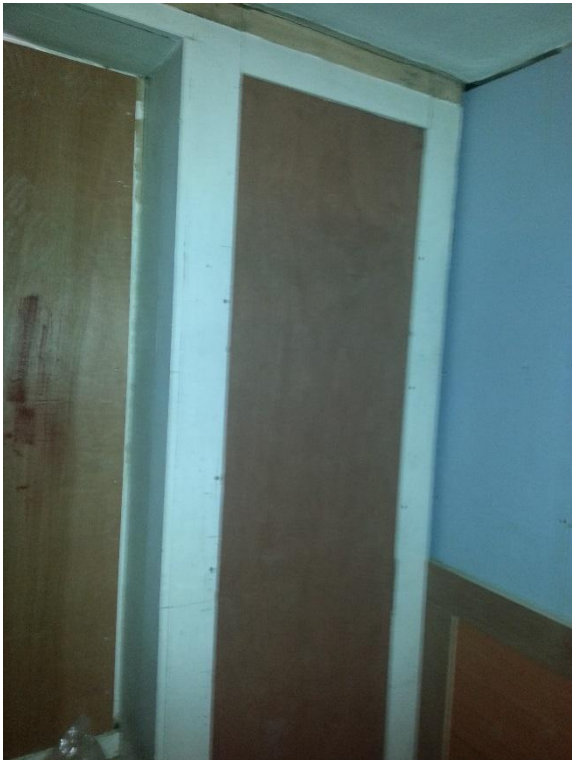
1. Where we are replacing what was asbestos, we will use ply as shown on sample below

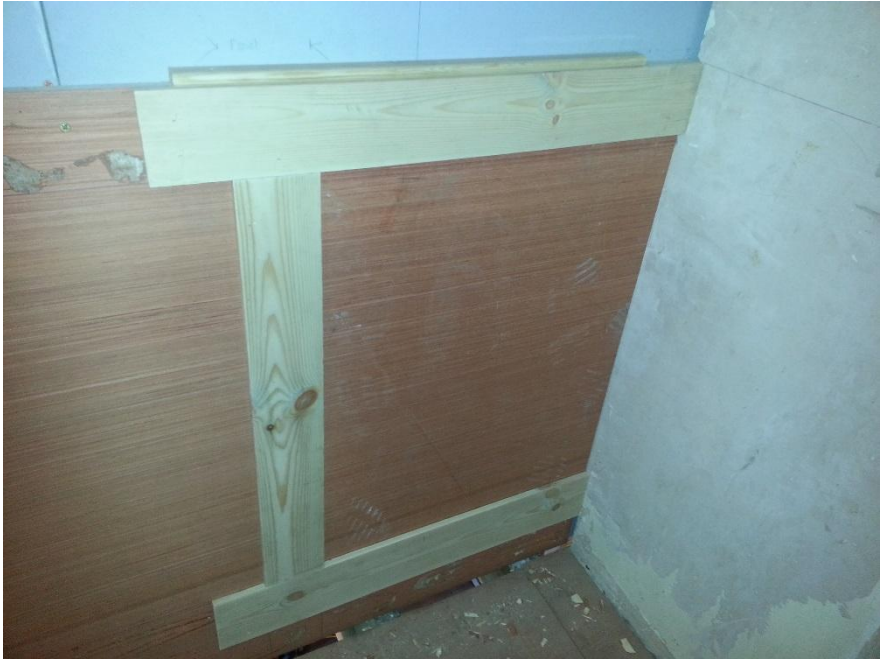
2. Where building entirely new panels on top floor we would use ply with soft wood stiles and mouldings to get the best finish as shown in sample below.
