25 Bedford Sq. London, WC1A 2NS

THE BEDFORD ESTATES

Proposed Condenser Support

1:100 @ A3, 1:50 @ A1		06/15
DRAWN BY RE	•	си∈ск <u>е</u> д вү
215058	D-301	R≦V

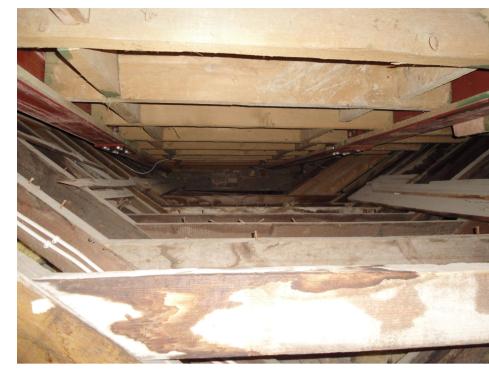
Figure 1 - Existing valley structure within loft space

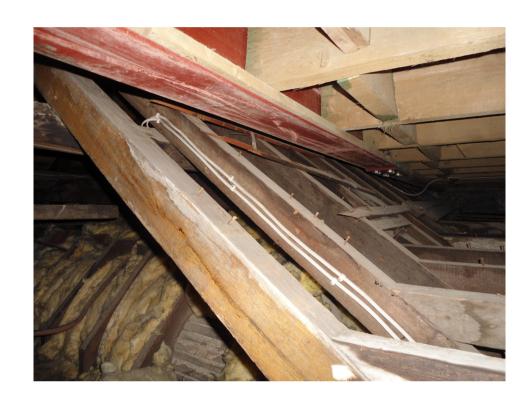
Figure 2 - Existing steel beam supports within loft space

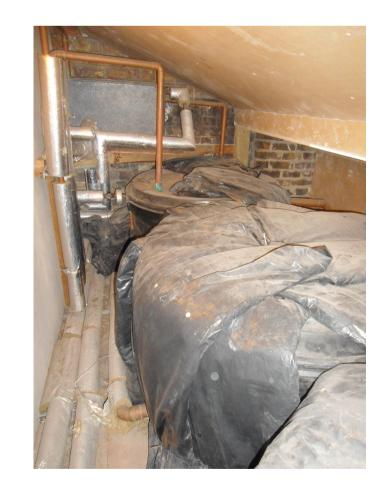
Figure 3 - Existing Water Tanks within Roof

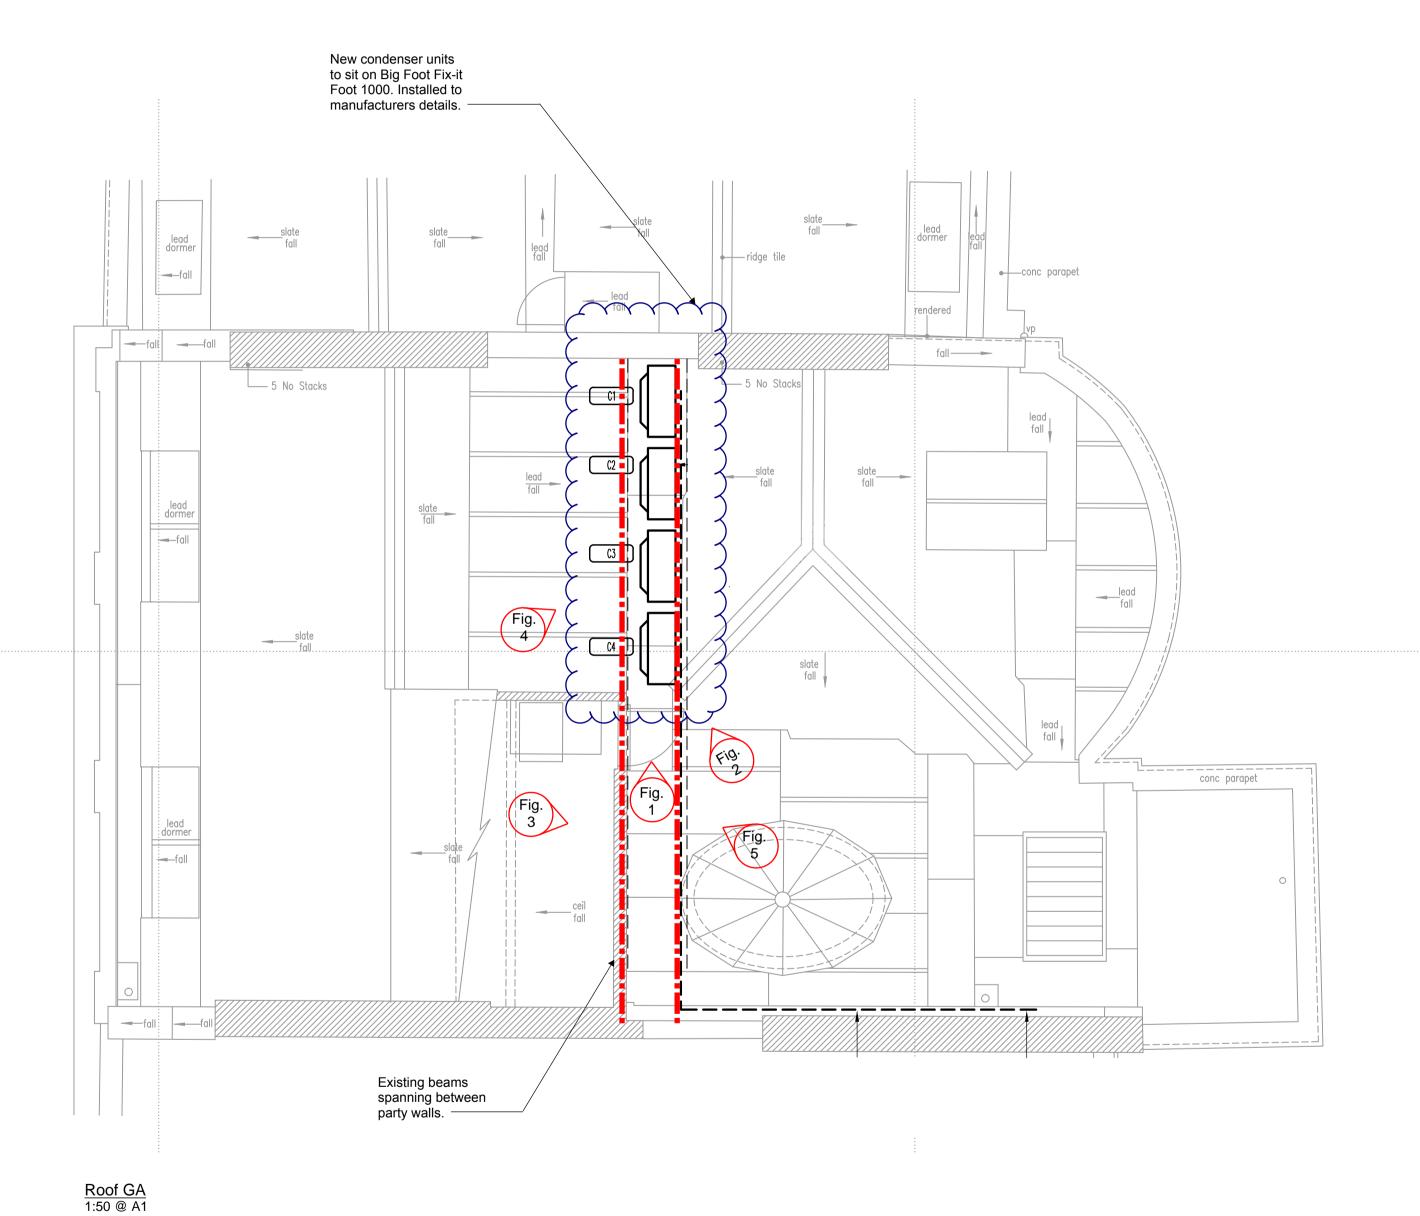
Existing Beam

Figure 4 - Proposed Condenser Location in existing valley

Refer to TPS drawings and details for proposed service installation.
Big Foot Fix-it Foot 1000 to be installed as per manufactures instructions. No structural strengthening of existing building is required.

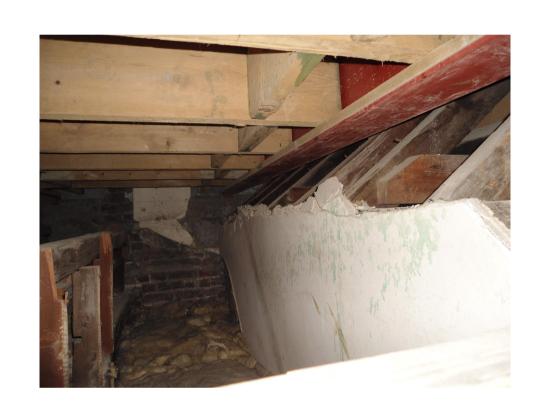
Figure 5 - Existing steel within loft space and original stud wall from 3rd floor level

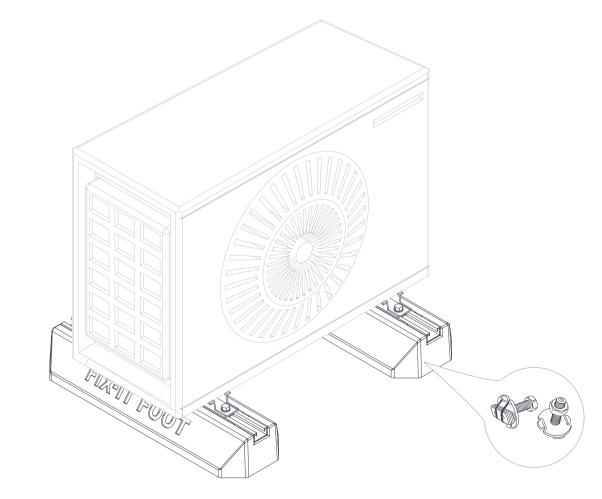
Proposed Big Foot Support Detail
