15055 / 152 Royal College Street, NW1 0TA

July 2015 / Basement Impact Assessment

Rev	Date	Description
-	27 July 2015	Submission for inclusion in planning application

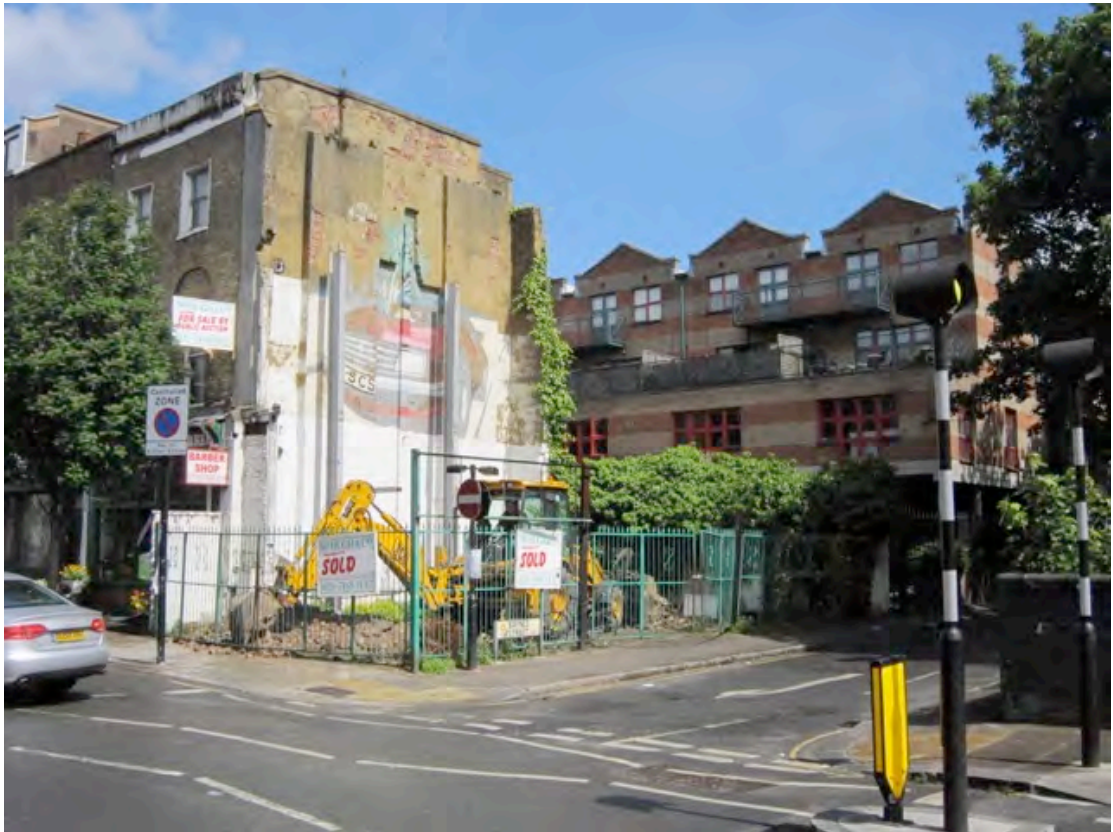
The site is level and vacant and its surface is mostly hardstanding, photo below taken looking North.

The vertical steel sections on site are the remnants of an advertising hoarding.

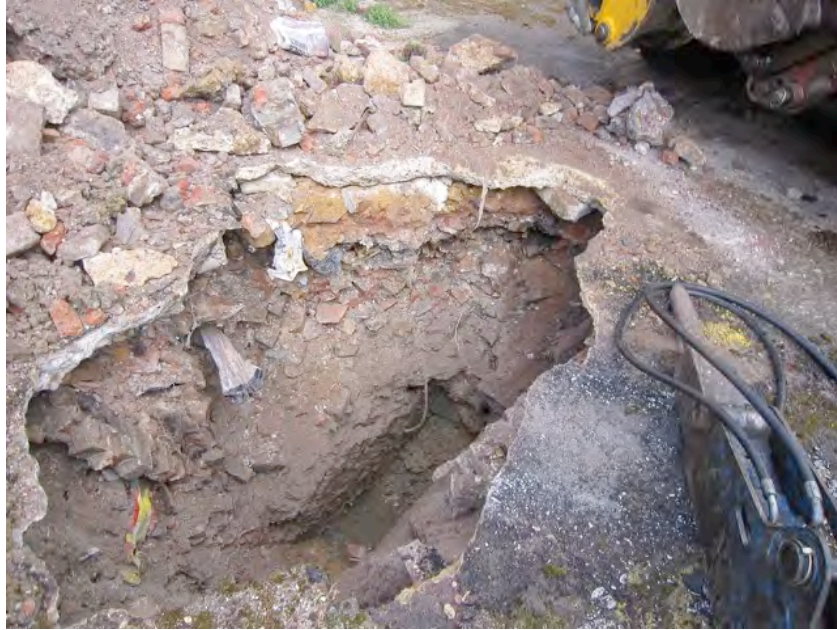
In May 2015 two trench trial pits were undertaken on site to establish the depth of the clay and the depth of the historic basement. Mixed made ground containing bricks was found to a depth of around 2.3m, with firm virgin clay below. The trial pits were mostly dry, apart from a small amount of perched water, partly due to the rain at the time (photo below).

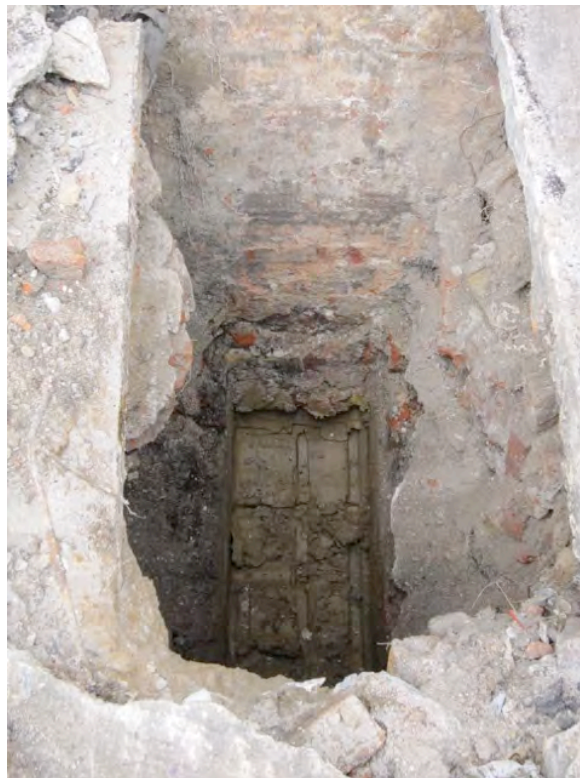
The trial pit to the gable wall of #154 found the formation level of the foundation to be at a depth of 2.1m (photo below).

Prior to our fieldwork the Client had identified the presence of a basement below the adjacent building along Royal College Street [approximately 2m depth bgl]. In TP3 the foundations of the adjoining building were noted to comprise a brick corbeled footing with the underside at a depth of 2.1m, bearing within the London Clay. A hand shear vane test in this clay indicated a medium strength classification.

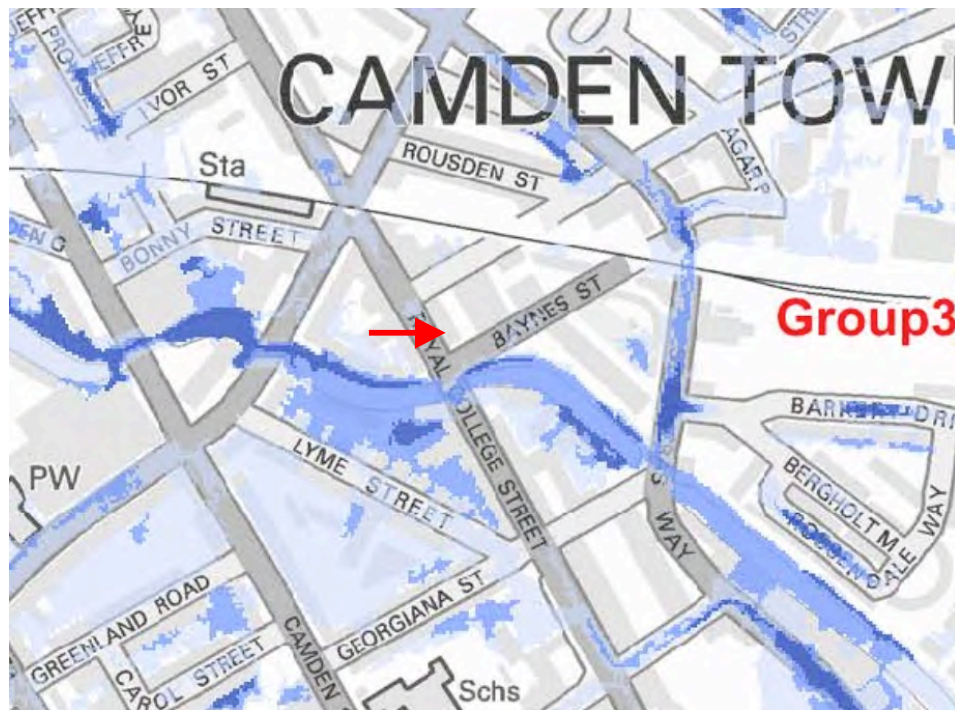
The site is located within the Environment Agency (EA) Flood Zone 1, as is the whole of the London Borough of Camden. With reference to URS' Strategic Flood Risk Assessment (SFRA) report for Camden, the site is located in an area of very low risk to surface water flooding (< 1 in 1000 years - extract below).

URS' report, in 5.2.6, suggests the Low, Medium and High bands of surface water flood risk may be substituted in place of EA Flood Zones, 1,2 & 3. The EA exception test is therefore not appropriate and the Planning Practice Guidance (Table 3 Flood Risk Vulnerability and Flood Zone 'compatibility') designates the site as being appropriate to contain a basement.

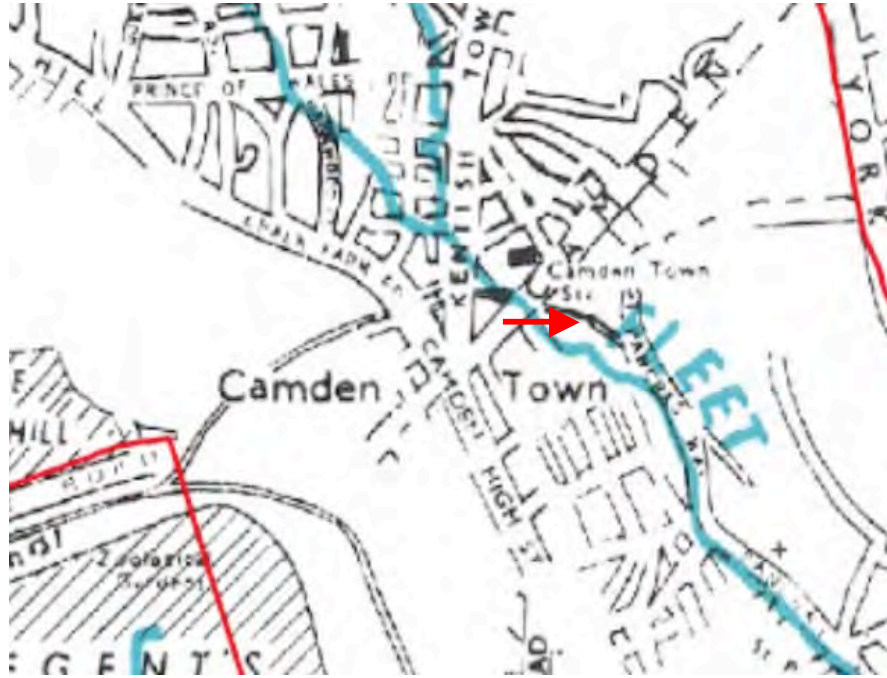
Lost Rivers of London map, by Nicholas Barton. Site near the Fleet

The Lost Rivers Of London map by Nicholas Barton (below) shows that the river fleet ran close to the site. However another historic map (also below) suggests the river was further South. URS' report states 'The River Fleet became entirely enclosed in the 19th Century and is now fully incorporated into the TWUL sewer network²⁷, eventually out-falling into the River Thames under Blackfriars Bridge'.

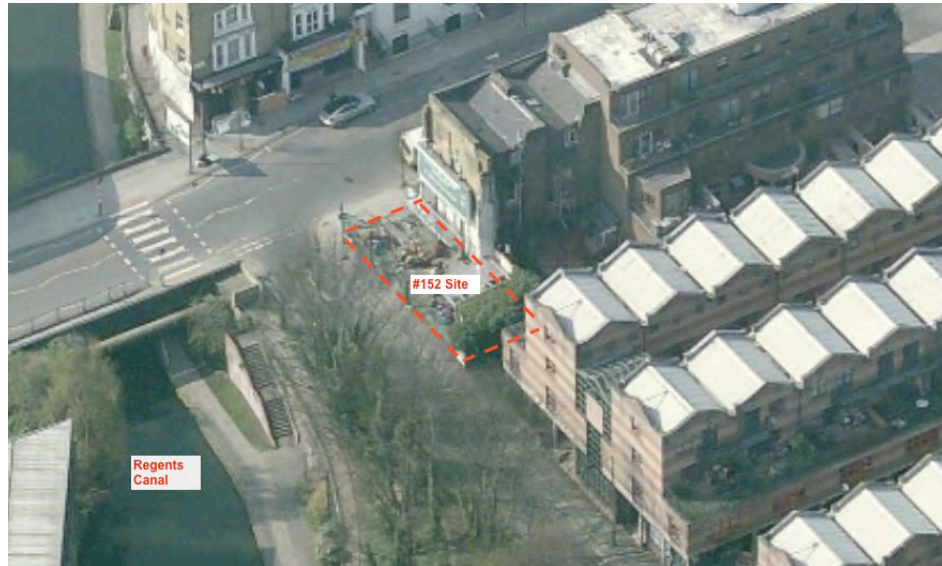
With reference to the below photo, the canal is over a storey below the #152 Royal College Street site and therefore the canal water level will be below the proposed basement level.

Some large deciduous trees are located on the South side of Baynes Street, near the canal, approximately 9m from the site edge (see photo above). The trees appear to be Sycamore/Maple, which accordance to NHBC guidance can reach a potential mature height of up to 22m. Considering this tree height and distance, for clay of high volume change potential NHBC advise a minimum foundation depth of around 1.65m, therefore much shallower than the proposed basement formation depth of around 3m.

6. Is the lowest point of the proposed excavation (allowing for any drainage and foundation space under the basement floor) close to, or lower than, the mean water level in any local pond (not just the pond chains on Hampstead Heath) or spring line.	No	The Regents Canal is over a storey (~3.5m) below the site ground level. Refer to photo in section 4.0 of this report.
