Christ Church Primary School
Hampstead, London NW3

Heritage Statement

By Malcolm Fryer Architects

Revision A - March 2015 (addenda to consent 2014/5699L&P)

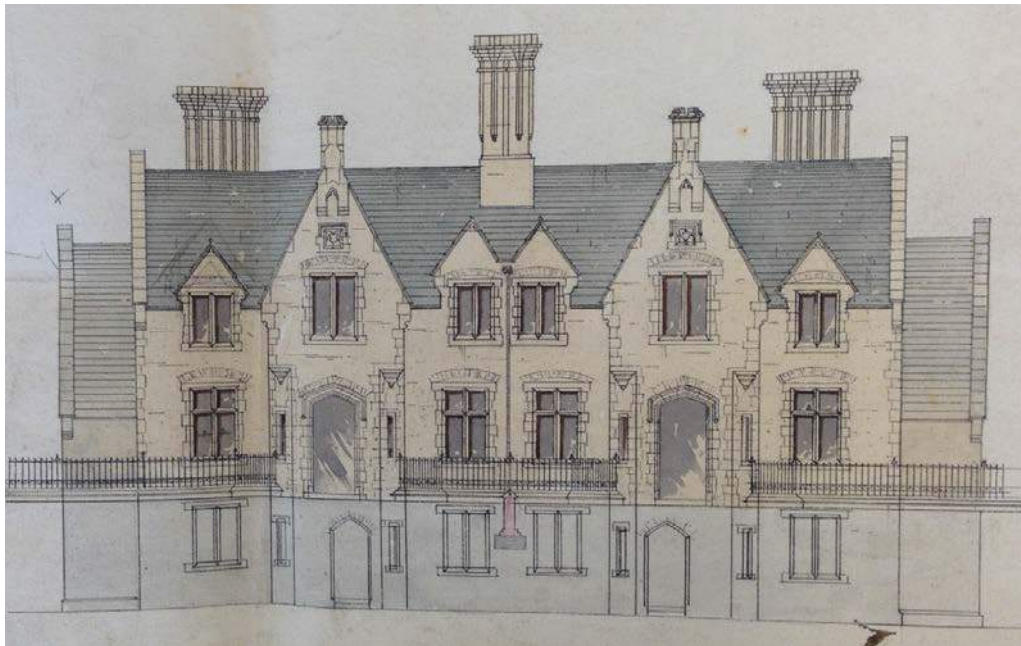
West Elevation, WG and E Habershon 1854, showing the School Houses

All the doorways were arched, with those to the schoolhouses carved with drip moulds and ball flower decoration. The doors were timber with decorative wrought iron hinges, notably those to the schoolhouse entrances. The windows were designed with stone mullions and transoms, flat headed with brick relieving arches above. The windows to the principal spaces – the schoolroom and classroom - had tracery heads. It should be noted that the design of the windows to the main schoolrooms was altered during the construction phase. Instead of the three identical windows shown in the design drawings, the central window was built as a more prominent gabled dormer window.

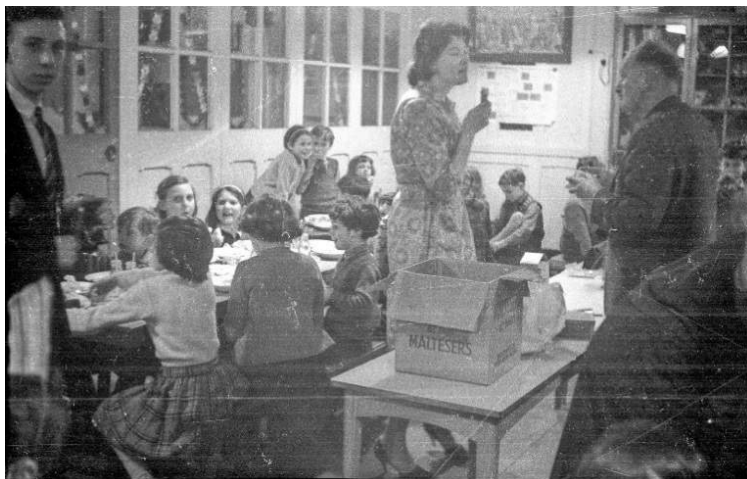
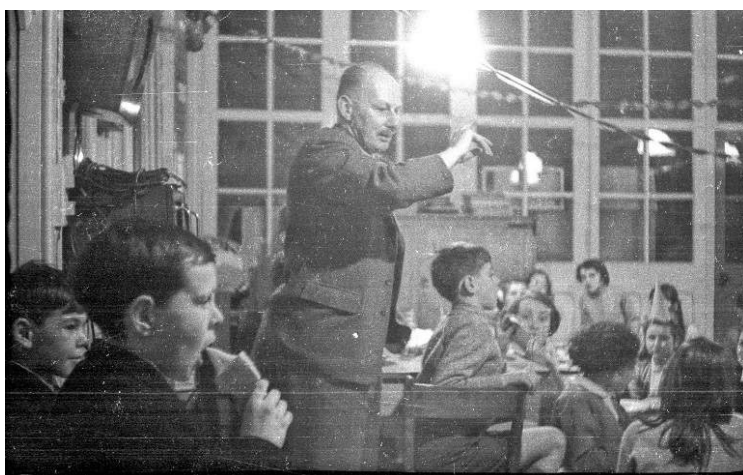
Photos (N.D) showing the glazed partition constructed in the original girls schoolroom in 1906

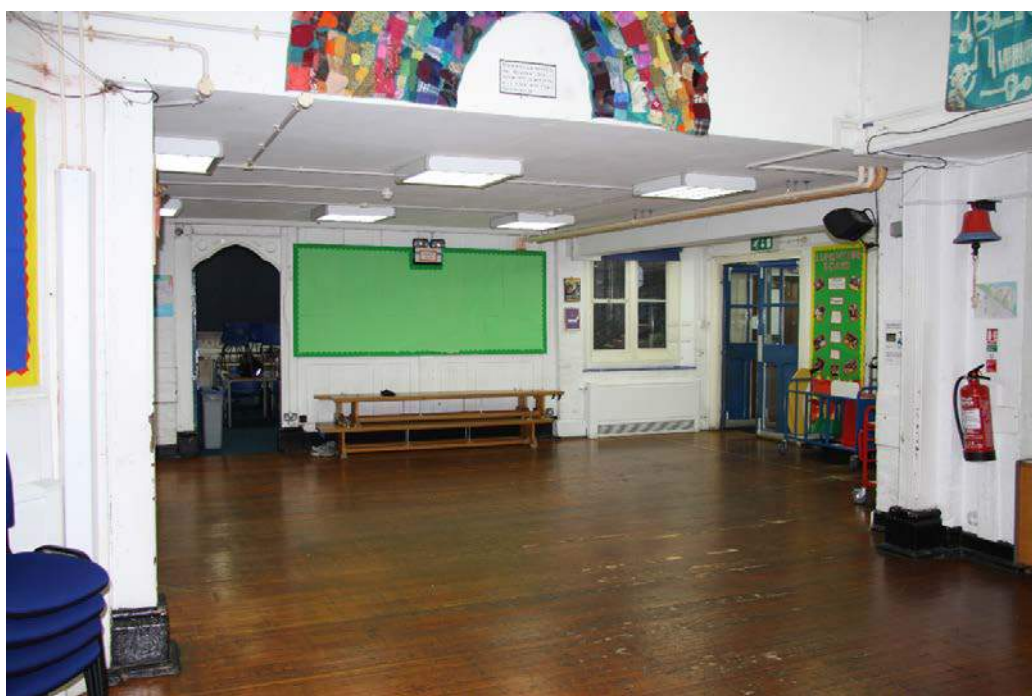
The Main Hall facing south with original gothic screen and door

The original chimney breast, with back to back fireplaces was in the centre of the two schoolrooms and is still a feature in the **Main Hall**. The spine wall that separated the girls' and boys' schoolrooms to the west of the chimney breast also survives intact. The gothic timber screen to the east, however, has been removed to create the main hall, which runs perpendicular to the original orientation of the schoolrooms. The north half of the hall, originally the east end of the girls' schoolroom, retains its original height, and the large tracery window that lit the room can be seen on the east wall. Unfortunately, at the west end of the girls' schoolroom a mezzanine was added.

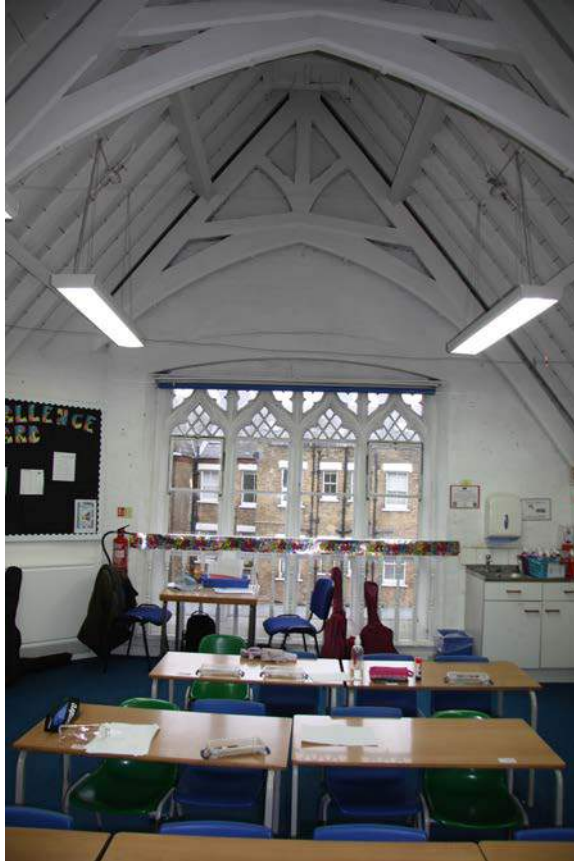
Year 5 Classroom, mezzanine level. The tracery window with triangular panes was the original east window of the boys' schoolroom.

The new mezzanine level contains the **Year 4 and 5 Classroom** and **Staff Room**. The 1850s timber roof structure is exposed, and the tracery windows, the upper part of the 1850s windows, contain the original triangular panes.

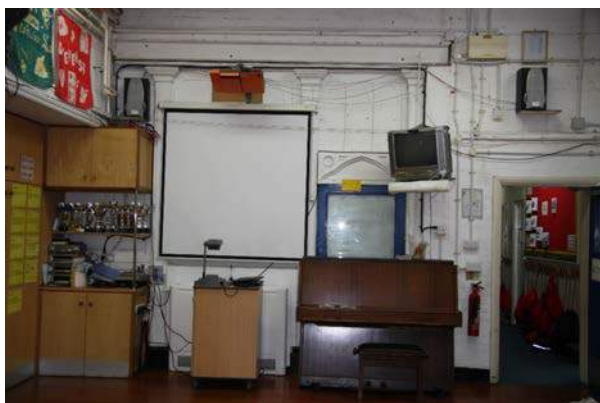
Gothic screen in Main Hall obscured by equipment

Returning to the main hall and looking to the north and south, the original gothic timber panelled screens can be seen with brick relieving arches above. The timber lintel to the north screen has been replaced in steel. Regrettably, this screen is covered in unsightly wires and service conduits.

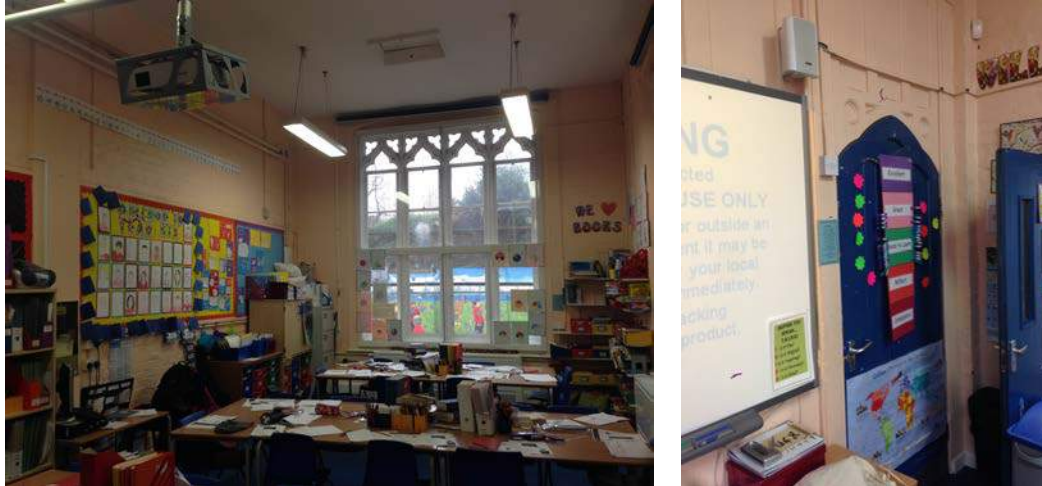
Year 6 Classroom. The room was enlarged in 1888 and the window reinstated without its original diamond panes of glass.

An arched doorway in the south gothic screen leads into the **Year 6 Classroom**. In the 1850s this was the boys' classroom and it was extended in the 1888 works; the window from the original classroom was reinstated but without the diamond panes of glass. This classroom contained a gallery of stepped seating that was removed at the end of the nineteenth century.

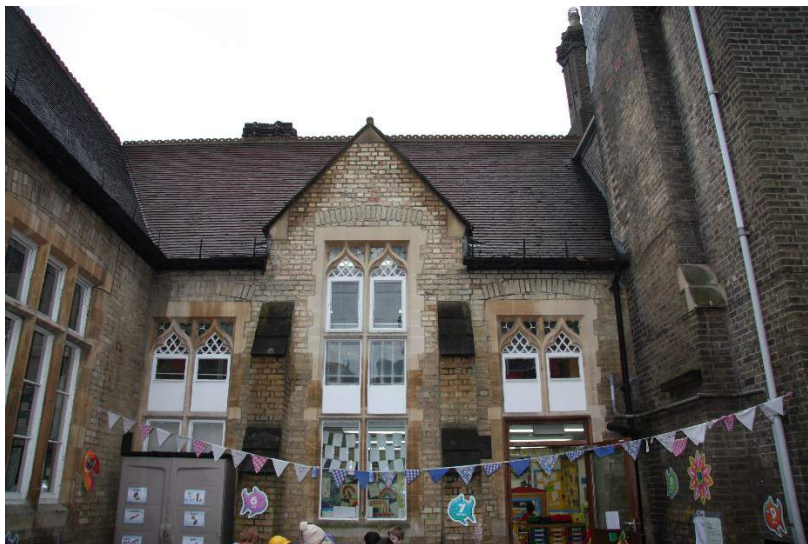
North Elevation of the school. A new door was inserted in place of windows in the 1990s and the glazing replaced some of the panes of glass when the mezzanine was constructed.

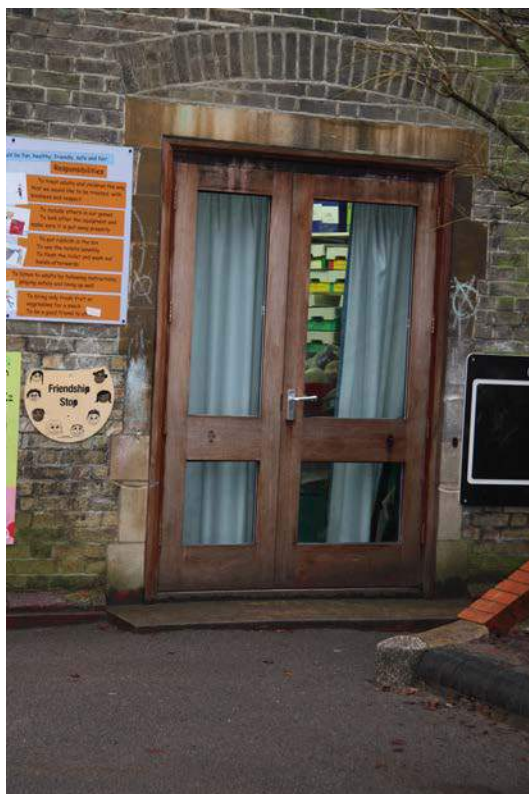
Left: Doors from Reception Classroom (originally lower level of mistress' house) into north playground, inserted in place of a window in 1974.

The nineteenth century windows were designed with stone transoms and mullions and cast iron sub frames, some of which were opening. The details of the windows varied. Some had tracery heads with diamond panes of glass and the windows to the Year 3 classroom were detailed with timber mullions and transoms on the inside face. The windows have also been considerably altered in various ways, as for example the addition of secondary glazing. Where the mezzanine was inserted some of the glass was replaced with opaque panels. Furthermore, a number of the windows have been converted into doors in the 1960s.

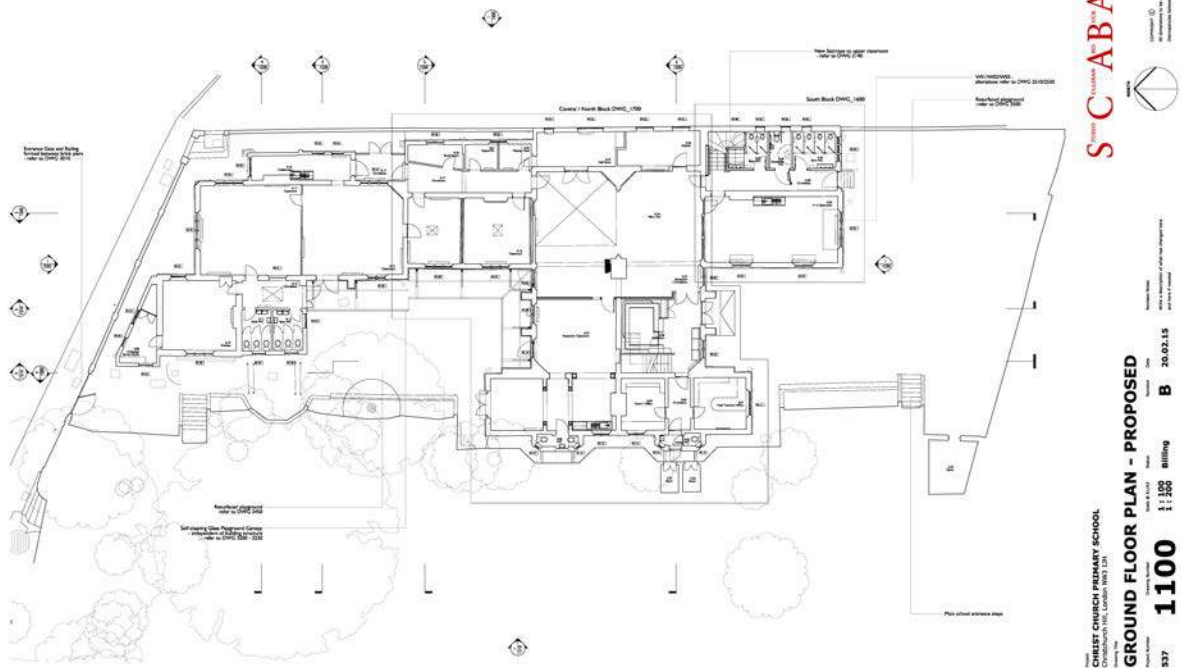
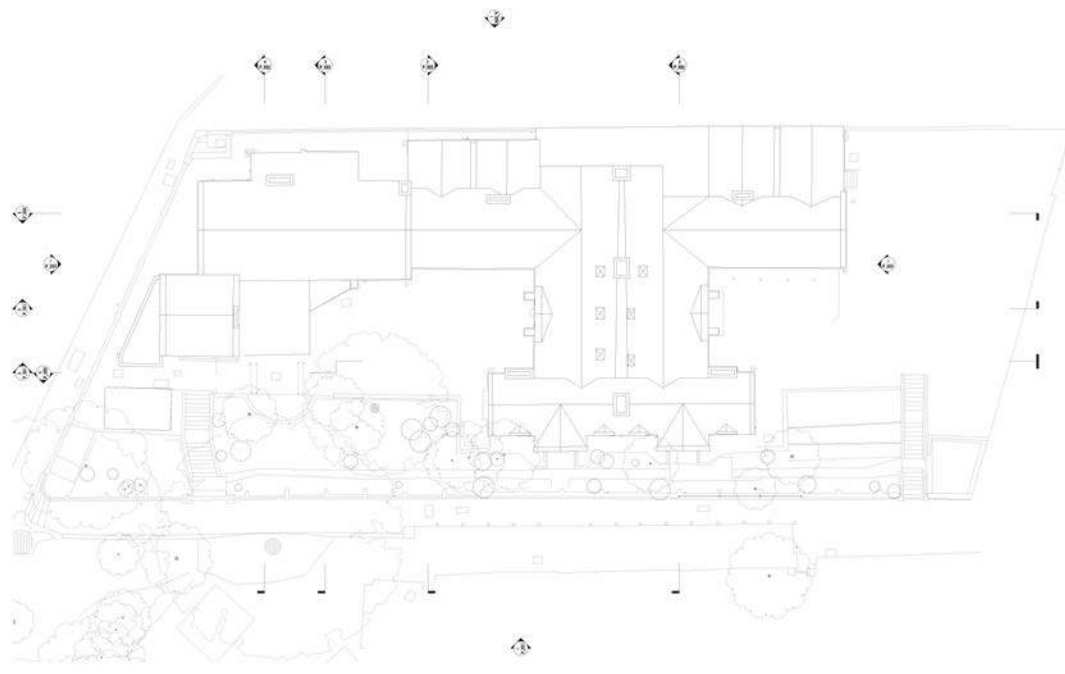
Ground floor plans as existing and as proposed
