HERITAGE STATEMENT

Vine House, 6 Hampstead Square, Hampstead, NW3 6UP

Grade II Listed Building (List Entry Number 1378721)

DOCUMENT REF: AH15/19

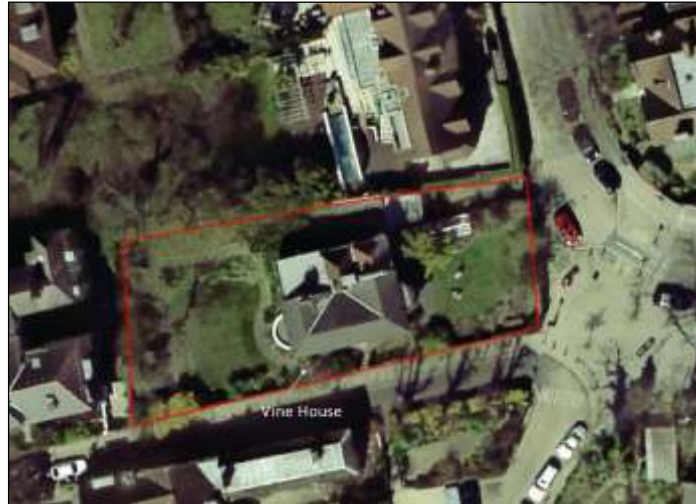
Plate 1 Site location

- 2.1.1 Vine House is situated in Hampstead Village within the northern margins of the historic core of the settlement. It occupies a brick-walled corner plot defined to the south by Hampstead Square and to the east by Holford Road. To the north the boundary is defined by a 4-5m high brick wall shared with the neighbouring property *High Close* which fronts Holford Road. To the east a 3m high wall is shared with the neighbouring properties of *Northcote House* and *Northcote Mansions* (Plate 1).

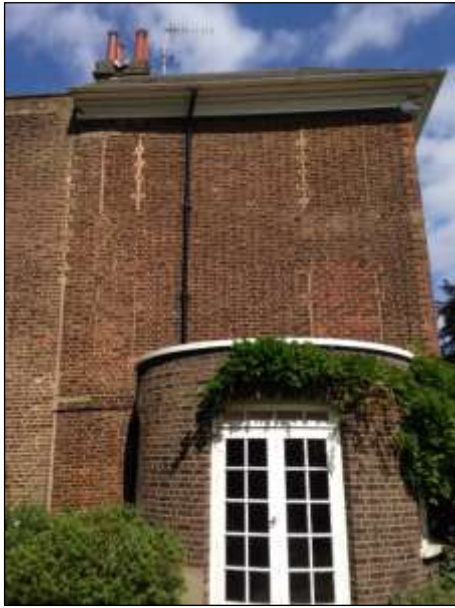
Plate 3 - Front half of west elevation

- 2.2.4 The upper portion of the west elevation is visible from the road on the approach from Heath Street. The front half is of repointed early 18th century brown brick with four blind windows, with a full-sized pair towards the front and a narrow pair towards the rear (Plate 3). A plain brick band continues from the main façade at first floor height. The roofline is of low pitch with corniced eaves and brick chimney stack. A later (1930s) single storey bow window with French doors gives access from the garden.

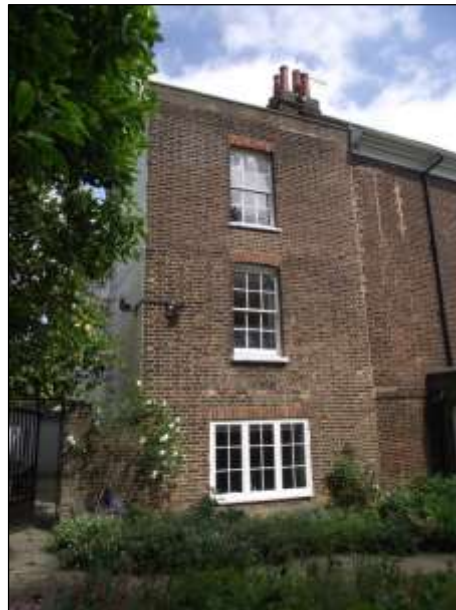
Plate 4 - Rear half of west elevation,
extension with later flat roof

- 2.2.5 The rear half of the elevation represents a later extension to rear of the Queen Anne house (Plate 4). At ground level is a wide casement window with a straight brick head. The first and second floor windows are concealed box sashes with six over six arrangements with a segmented brick arch and straight brick head, respectively, and appear to date to the late 18th/early-19th century. The roof on this half of the elevation is a flat roof with a parapet constructed from 20th century bricks.
- 2.2.6 At least four phases of structural development can be observed on this elevation; the Queen Anne house being extended to the rear, its windows blocked up, a later early 20th century addition of a bow window

being inserted on the ground floor, and a later still amendment to the roof of the extension to create a flat roof with parapet.

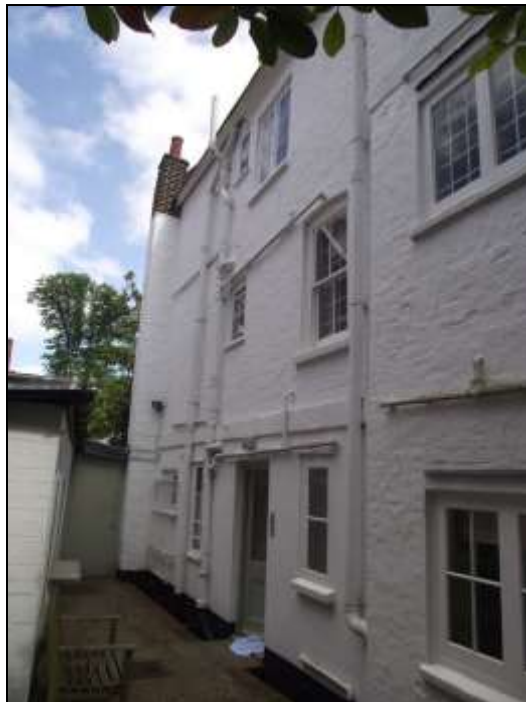
Plate 5 - North elevation with painted brick work and window insertions

- 2.2.7 This is the rear of the house. During the early 17th century when the house was first built this would likely have been a yard area used for storage and carrying out the daily services of washing etc. There may have been a few informal buildings here; it was not unknown for kitchens to be located in separate buildings to the rear of the main property. Today this yard area is taken up with two ranges which extend from the main house. The whole elevation is of painted brick with a mixture of modern wooden and plastic casement and sash lights on all floors (Plate 5). The random window insertions for ancillary rooms and bathrooms and a number of drainpipes give this side of the house an informal feel in keeping with its hidden aspect at the rear of the property. To the left is a double-pitched range with wide plain brick banding at first floor level. To the right is a separate bay with only two windows (ground and first floor). This bay is flat roofed, although it did once have two narrow pitches (see below). Together the two halves of the elevation represent two separate phases of rear extension to the main 18th century house.

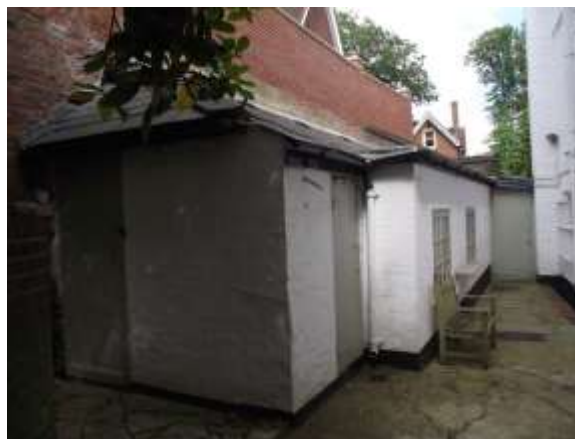
Plate 6 - mid 19th century brick built outbuilding with later additions

- 2.2.16 To the rear of the property there is a single-story painted brick-built building currently in use as a garage (Plate 6). The first phase of the structure dates to the mid-19th century when it was likely built as a wash house and outhouse to service the main house. The small flat roofed extension with timber casement windows was added in 1928 (see below) by which time it was in use as a garage. It is currently used for parking and storage and is in good repair.

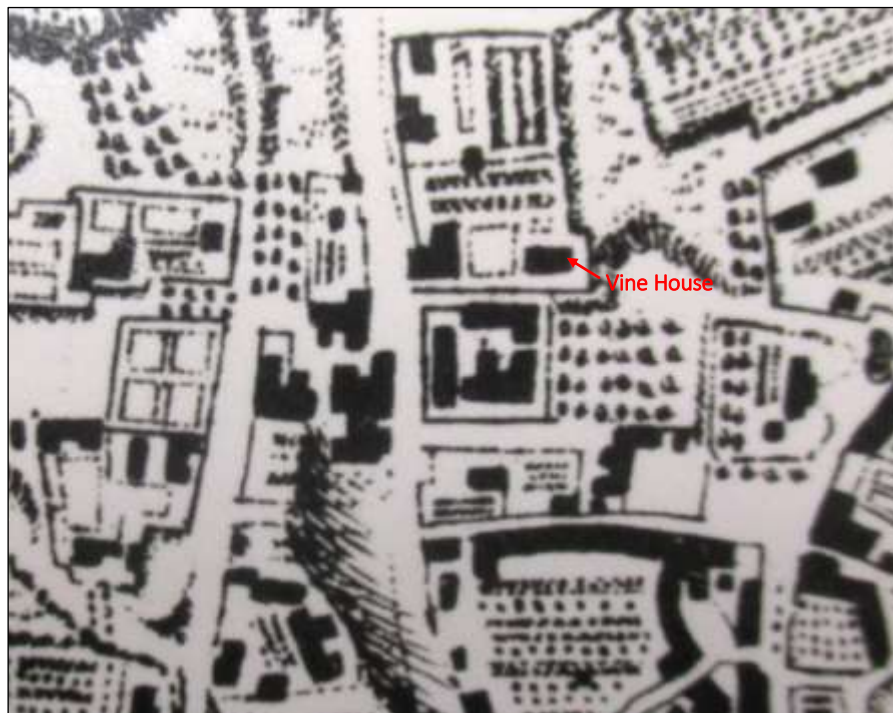
Plate 7 - 1746 John Rocque - *The Country Ten Miles Round London*

- 3.2.4 The earliest depiction of Vine House in any detail is the 1746 Rocque Map of *The Country Ten Miles Round London* (Plate 7). To the south the burgeoning settlement of Hampstead is laid out around its historic core of the High Street.

- 3.2.6 To the rear of the house the plot was laid to garden with a more formal square set out between the House and the property fronting Heath Street (Northcote House). To the immediate east the cartographers observed enough of a slope to indicate with hachures a hill or sloping land, which extended around the southern boundary of the Vine House plot with orchards laid to the south.

- 3.2.13 The outline of the house shown on this map appears larger and squarer than on the preceding Rocque map, which shows a building with a definite rectangular plan. When compared with the present day dimensions of Vine House, the 1762 extent of the building matches almost exactly. This suggests that by this date the original Queen Anne building had been extended to the rear (northern elevation).

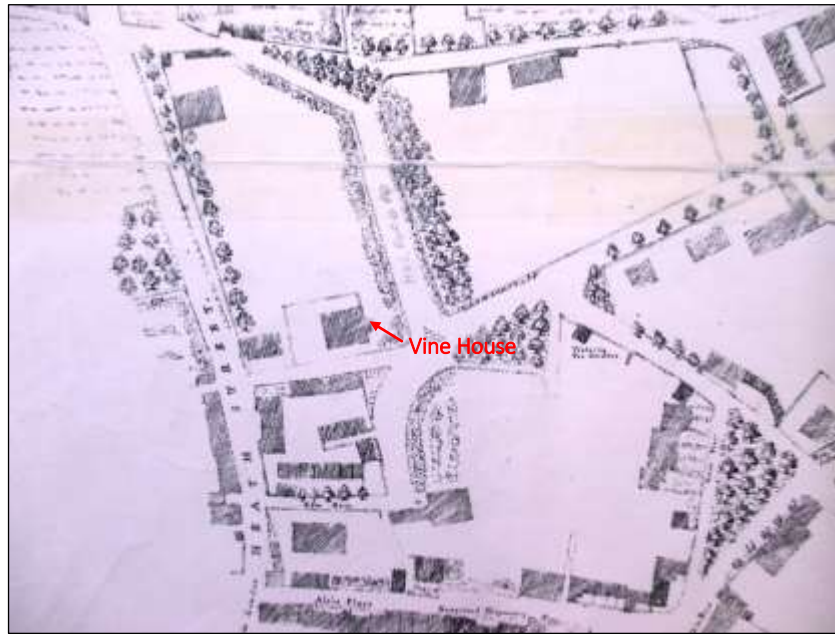
Plate 9 - 1847 Plan of the Parish of St John (LBCALSC)

- 3.2.14 Whilst this area of Hampstead was covered by the first tranche of Ordnance Survey cartographers in the early 1800s (British Library OSD 152, 1807), the earliest 19th century depiction of Vine House at a large enough scale is the 1847 *Plan of the Parish of St John* (Plate 9). By this time the line of Holford Road, to the east of Vine House had been formalised. The plan is a basic sketch showing the outline of buildings but no other real details appear within the plots, save for boundary walls and trees/shrubs. The plan of Vine House is square but with the addition of the canted, semi-circular bay window to the east elevation.

- 3.2.15 It is likely that the impetus for this addition came as the landscape around Vine House continued to change. Views to the south, from the property's principal elevation, had become more built up as the settlement at Hampstead expanded. However, the prospect to the east was still relatively undeveloped and open. It is likely that, through the addition of the window, the owner sought to incorporate these more open views into the living space of the house. The exact date of this addition is not known however slightly curved or 'bow' windows became a feature of the Regency period and so it is reasonable to assume that the window may have been added in the first decades of the 1800s (not in the late 19th century as stated in the Listing description).

- 3.2.17 The garden wall enclosing the house and separating it from the plot to the north and east is shown and continuing along Hampstead Square to the south. Whilst there is no clear indication that access is taken from Holford Road the gap between the house and the southern boundary wall would indicate perhaps an entrance or approach to the house from this side. The shape of Hampstead Square as it is today is now clearly recognizable as the lozenge (not square) of land marked by the junction of Holford Road and Cannon Street to the north and the eastern end of Elm Row to the south.

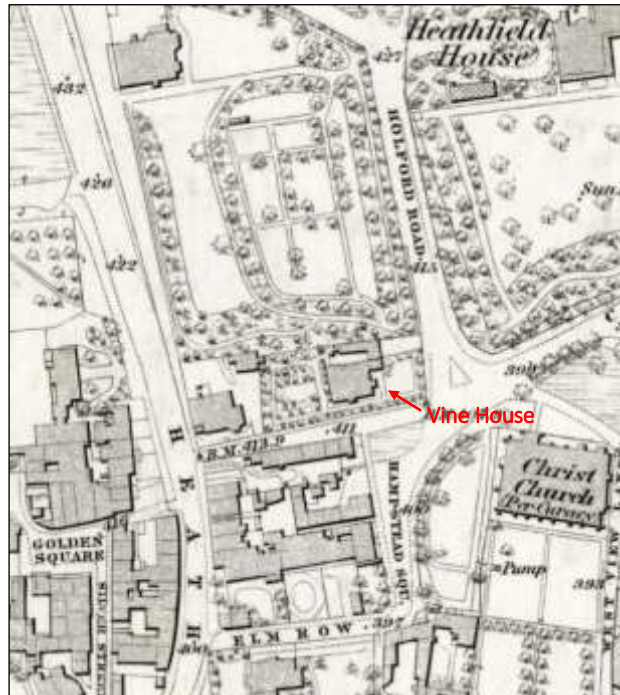
Plate 10 - 1866 Ordnance Survey Map First Edition

- 3.2.18 Just 13 years later in 1866, the very detailed Ordnance Survey plan at the scale of 6 inch to one mile gives far more detail as to the development of Vine House, its gardens and surroundings (Plate 10).

- 3.2.19 For the first time since 1762 buildings are shown to the rear of the house, with an L-shaped block adjoining a glass house on the house's east elevation. To the east and west of the house the gardens are laid out with paths and lawns in a similar configuration to that of the present day. Access to the property was now from Holford Road with no gateway through the garden wall on to the south shown as yet, although for the first time a porch over the doorway is detailed, likely a result of the mapping scale. To the north of Vine House lay the extensive formal gardens of the neighbouring property. For the first time Hampstead Square is named, its eastern side being formalised by the construction of Christ Church in c.1850.

- 3.2.25 Around this time the property was recorded by the government's Valuation Office Survey (The National Archives IR 121/5/7, c.1910-c.1914) which mapped the extent of the buildings and grounds. The ancillary buildings to the rear are recorded as a '*Wash-house*'. The plans confirm the extent of the present day garage and outhouse. The layout of the building and grounds depicted in the plans is identical to that of the 1866 Ordnance Survey Plan.

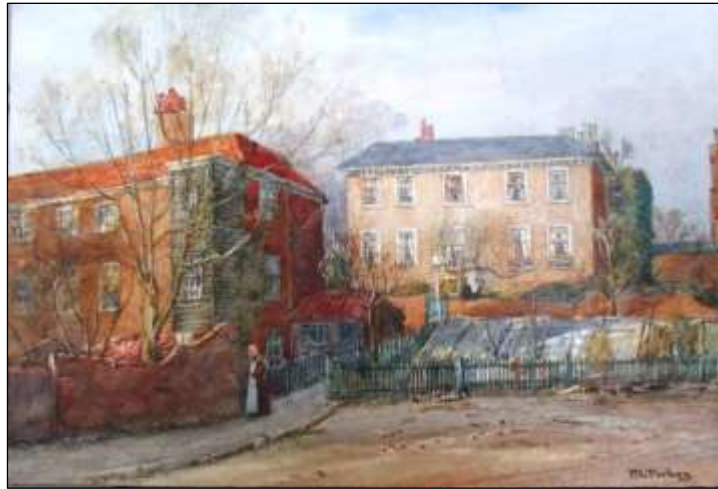
Plate 11 - Vine House painted by P.L Forbes in 1904 - 'The Home of Newman Hall' (reproduced with the permission of LBCALSC).

- 3.2.23 The earliest complete visual representation of Vine House is a watercolour by local artist Patrick Lewis Forbes (1860-1939) dating to 1904, painted as 'The Home of Newman Hall' (Plate 11). In this painting the

main south front of the property is depicted in relative detail and appears nearly identical to its appearance today.

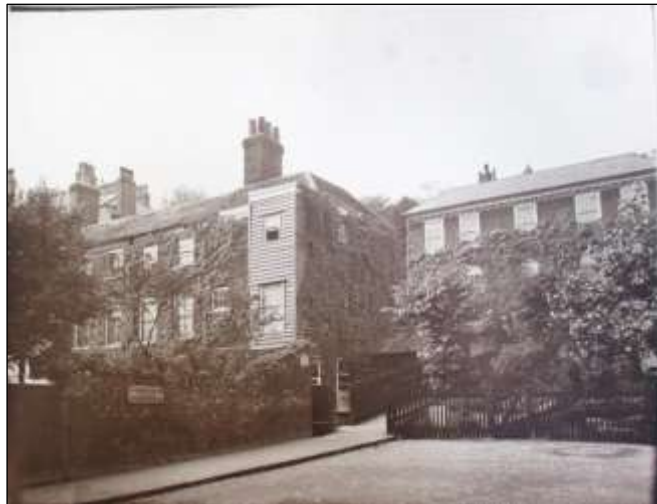
Plate 12 - Early photograph dating to 1910 of Hampstead Square showing Vine House (reproduced with the permission of LBCALSC)

- 3.2.24 The earliest photograph located of Vine House dates to 1910 where a part of its south front is captured in a photograph of '*Hampstead Square*' (Plate 12). Apart from the ivy which in the intervening years since it was painted by Forbes has encroached on the façade, the frontage looks very similar to today. The general lack of trees in the square emphasises the height and prominence of the front of the house on the higher ground.

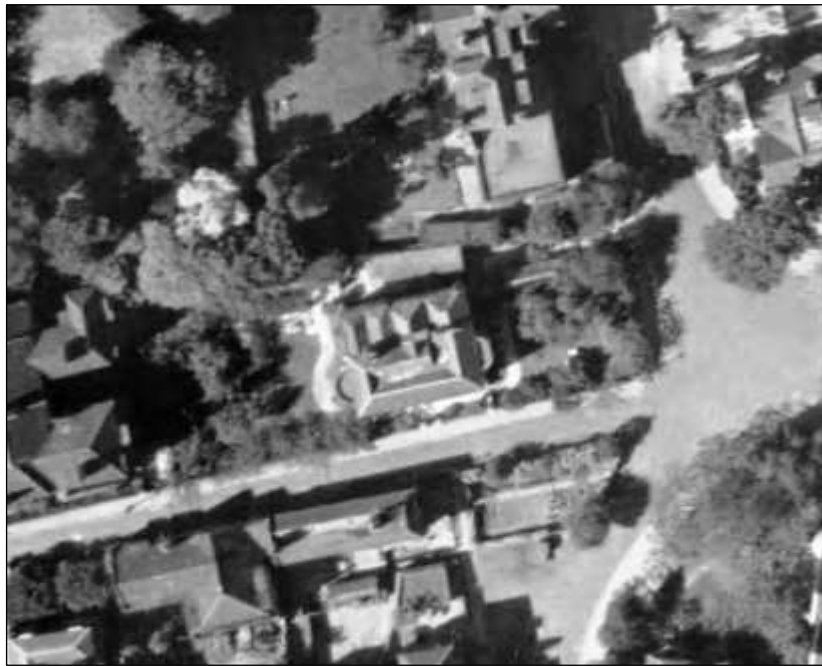
Plate 14 - 1944 aerial photograph of Vine House showing roof layout (Getmapping 2015)

- 3.2.29 The final significant documented change to the fabric of the house took place in 1952 when extensive works to the roof were undertaken by the owner, a Mr George William Augustine Burnside (*Hampstead and Highgate Express* 11 January 1952). A comparison of the roof layout shown on a 1944 aerial photograph of the house with that of a modern aerial photo show the extent of the works (Plate 14 and Plate 15). Whilst from the ground the changes did not affect the roofline, behind the ridge the entire central gully, including a possible dormer window have been removed and replaced with a shallow pitched slate slope. The flat roof of the rear extension was likely also created at this time with the removal of the two narrow pitches seen on the 1944 photo. In real terms this work resulted in the almost total replacement of the late Georgian roof on the oldest part of the house. This roof in itself was a replacement of a likely steeper-pitched tile hung roof more typical of early 18th century design.

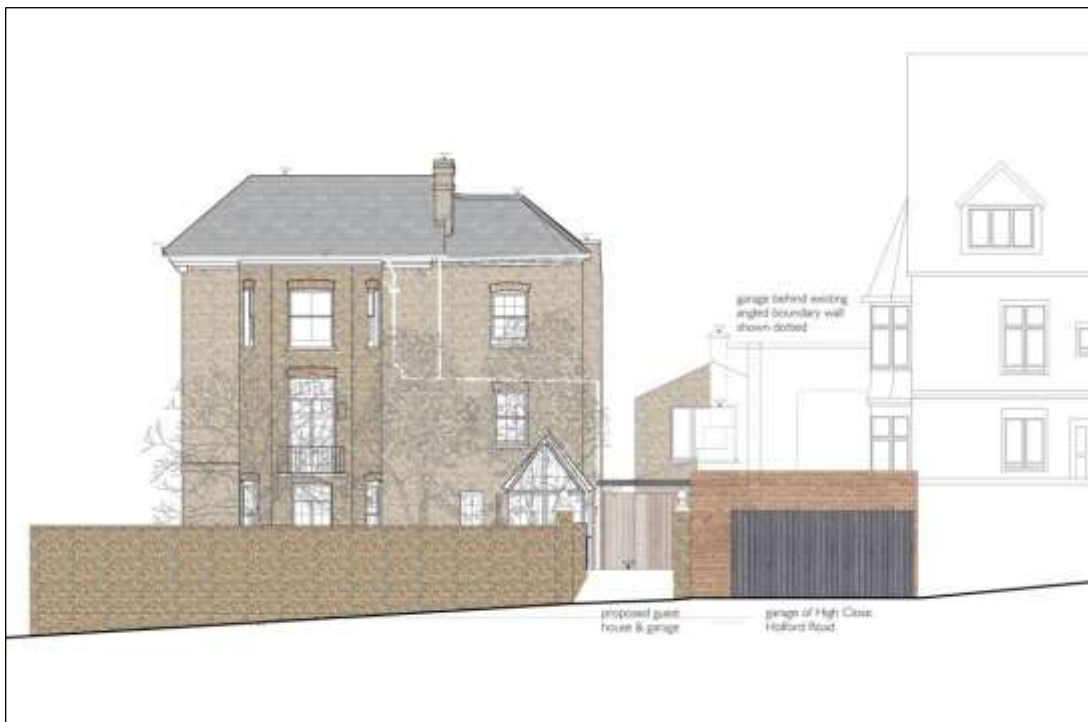
Plate 5 - East elevation showing proposed roofline of new garage building

- 5.1.3 Vehicular access would be through garage doors on the eastern end as it is at present with pedestrian access through a door in the southern elevation. The existing sloping carport canopy which is a wire-toughened glass in aluminium and timber frame would be replaced by a flat canopy made from toughened glass in either a corten steel frame or dark grey powder coated steel. The structure would be cantilevered from thin (8mm diameter) suspension rods anchored in the high retaining boundary wall.

- 5.1.5 Detailed plans of the proposed works are found in the Design and Access Statement (Jonathan Freegard Architects, 2015); a diagram of the east elevation from the Statement is included here for reference (Plate 16).

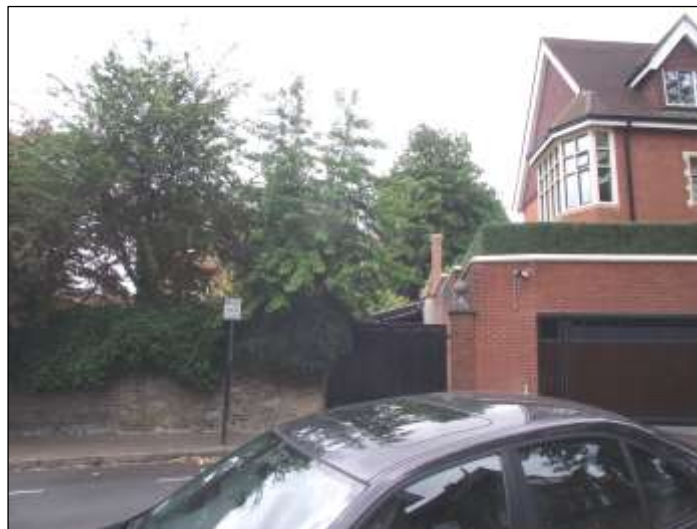
Plate 17 - View of east side of Vine House and existing garage and carport from Holford Road

- 5.2.7 At present when viewed from Holford Road the east elevation of Vine House can be seen (in the winter months) (Plate 17).

- 5.2.8 Behind the closed gates (which are to remain) the top of the existing car port is also visible. It is of heavy and unrefined construction and adjoins the high, engineered brick boundary wall to north which extends a few metres above the existing structure. Immediately upslope of Vine House is the south end of the Neo-Georgian edifice of *High Close* originally built in 1884 as a home for nurses and later extended in the early 20th century; it is now a residential property.

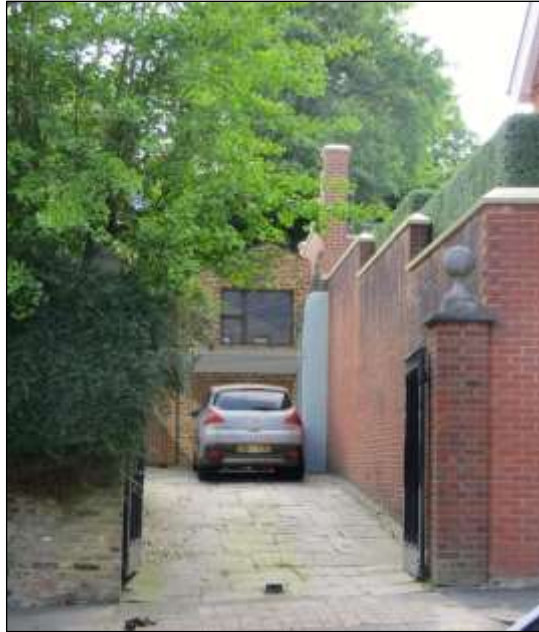
Plate 18 - CGI view of the proposed gable end of the new garage

- 5.2.9 With the new building in place this view would change slightly in that above the level of the (now flat) roof of the carport would be the gable end of the new garage with a window. The use of local, reclaimed building materials means that the façade is in keeping with the environment and sympathetic to the aesthetic of Vine House. However, at the same time the refinements of the modern design of the building

mean that it is clearly a separate and distinct phase of development, ensuring the historic legibility of Vine House as the principal building is maintained and conserved.
