SIR JOHN SOANES MUSEUM OPENING UP THE SOANE PH 4

WILD ANTE ROOM

DRG NO. 506MP4/DD016A

(13mG/12) EAST WALL

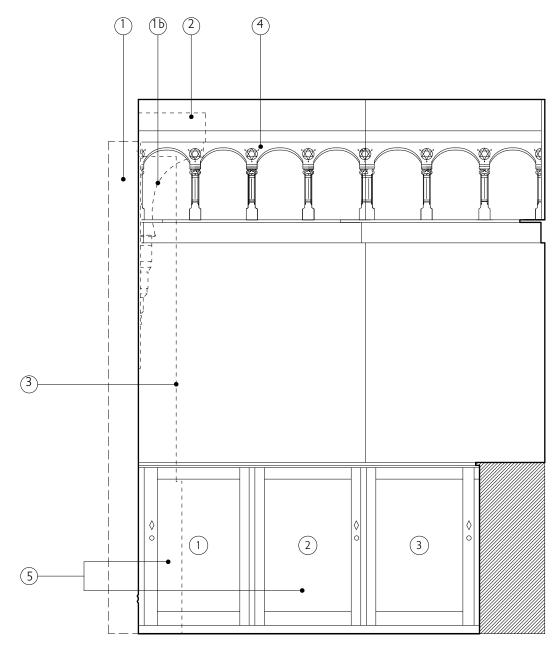
EAST WALL

- $\bigcirc{1}$ Existing decorative brackets to the East & West side of the north opening to be carefully dismantled and set aside. Soffit board and mouldings to the return wall (South Wall of the adjoining Soane Ante Room) to be removed. Existing opening to be infilled in second hand stock bricks and both surfaces plastered in three coats of lime plaster. Decorative brackets to be fixed to the North Wall of the Wild Ante Room in the positions indicated on this drawing (item 1b). See drawing no. 506MP3/DD033 for details.

- 2 New decorative entablature over the re-positioned brackets to be installed (using the removed soffit board, if possible) to match the Moorish style adopted by Wild in creating this space in 1889. See detailed drawing no. 506MP4/DD033 for details.

- 3 Existing bookcase currenting in the recess on the North Wall of the Soane Ante Room to be repositioned to this new location, by Others.
- Existing architectural elements of the ceiling (high-level shelf, frieze, decorative ceiling ground and rooflight to be retained, un-altered).

- (5) For works to the East Wall cabinets, see drawing no. 506MP4/DD035. Allow for Builder's work in connection with the removal of the radiator within cabinets 1 & 2.
