FIRST FLOOR

1435 - P075

Dining Room//Existing//Plan_1:20

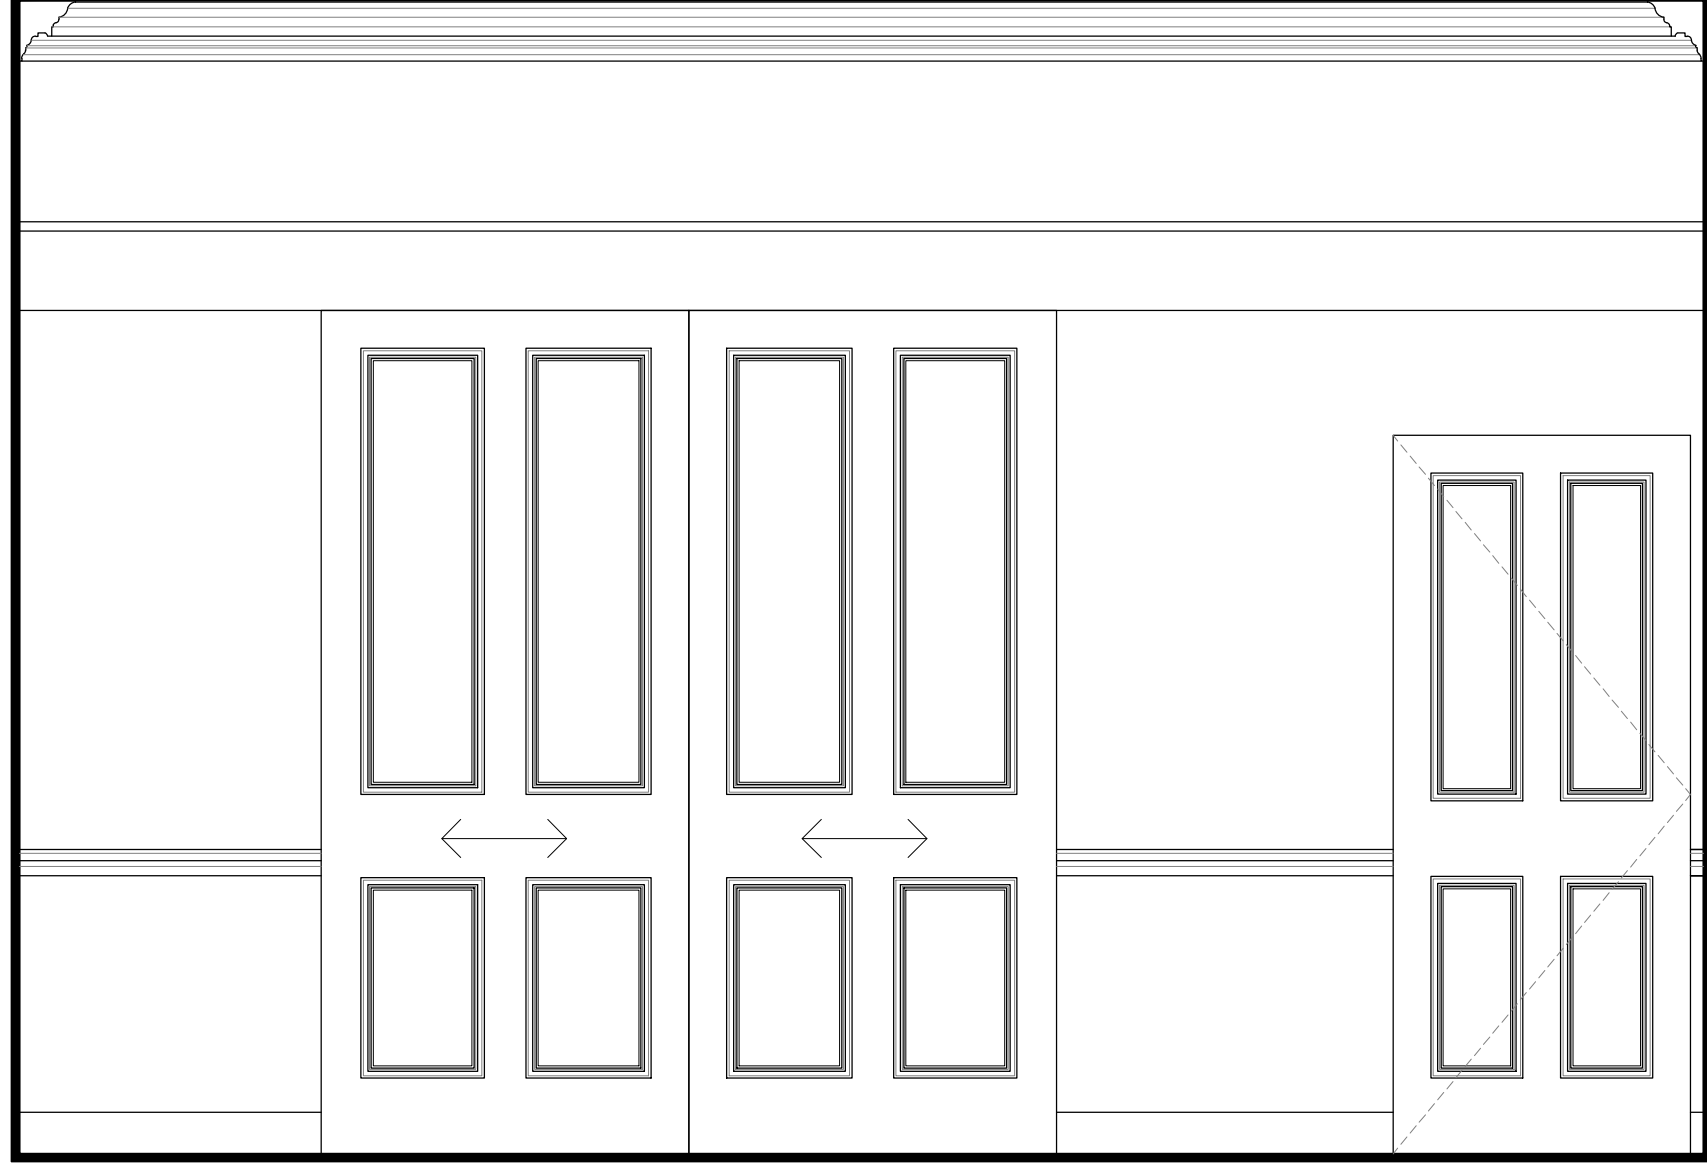
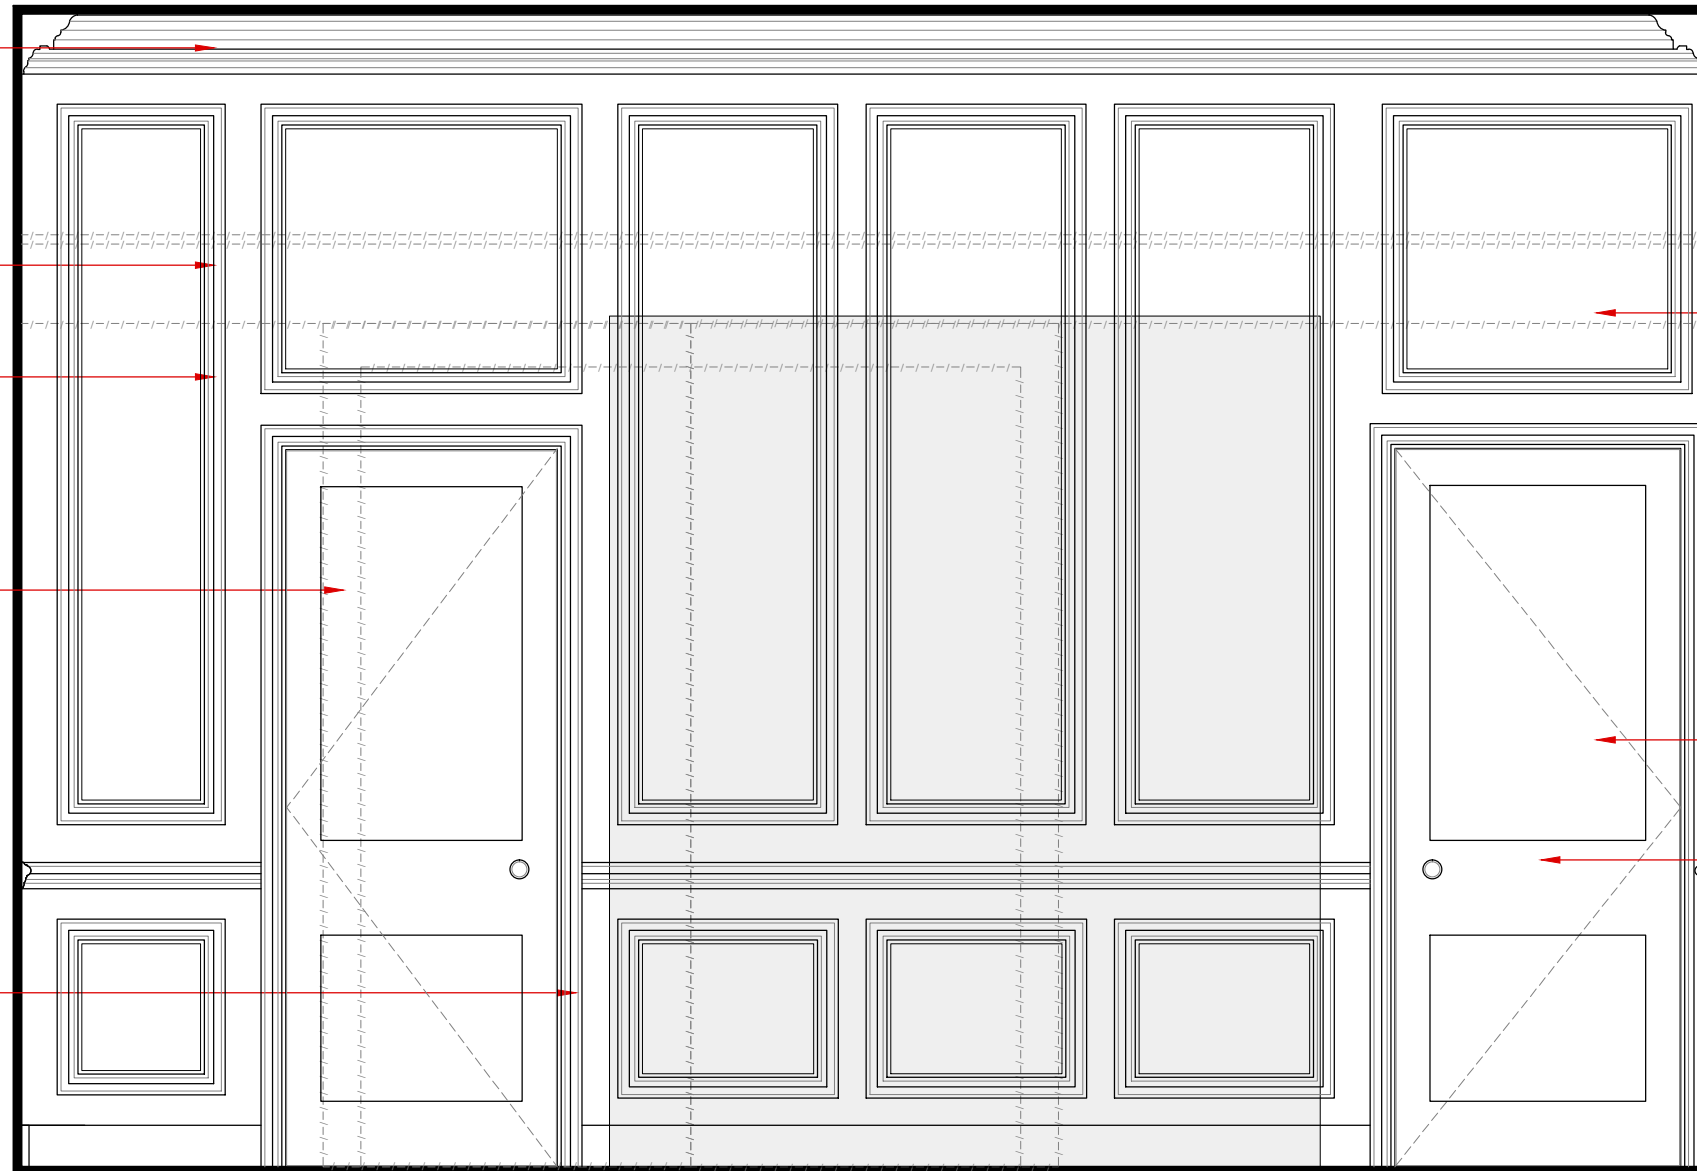
Dining Room//Existing//Elevation 1_1:20

Re-run existing cornice profile formed on new wall panelling.

Existing sliding door and mechanism removed. Opening to be filled.

Proposed bolection panelling to upper section of wall to match window elevation

Proposed doorway and door to match D.1.06.

Proposed kitchen furniture.

Proposed bolection wall panelling throughout. Panelling to be placed behind fixed units.

Existing doorway checked to ensure full architrave

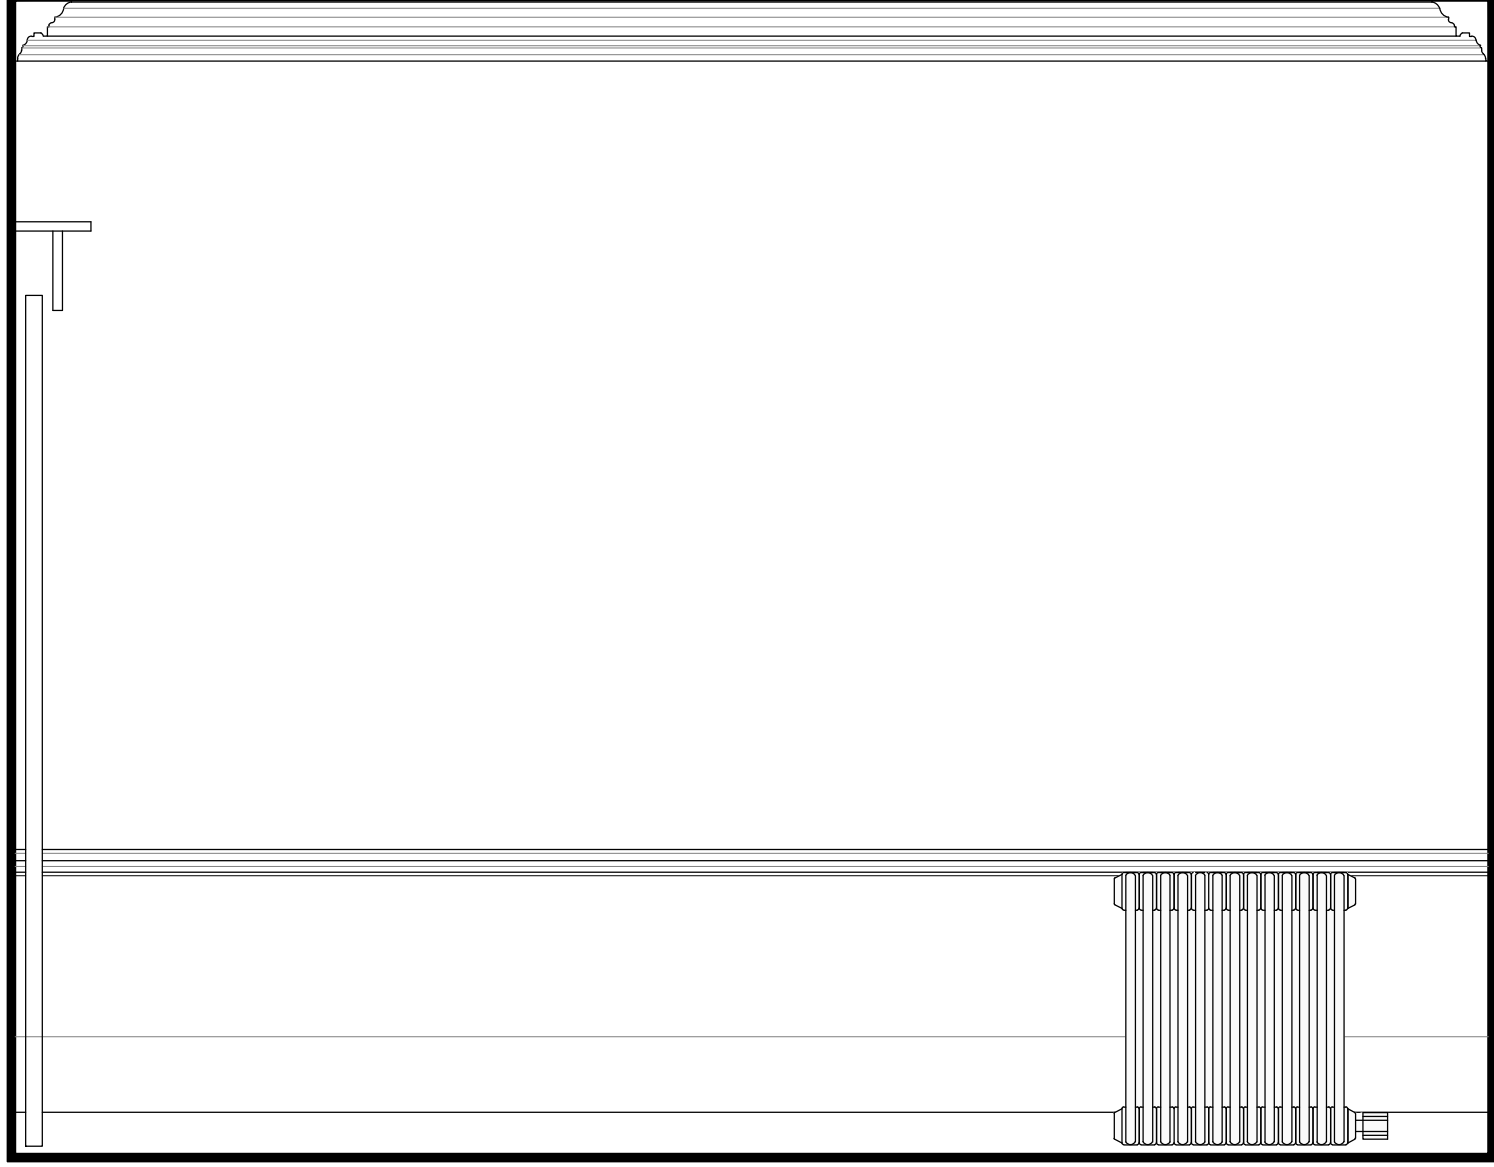
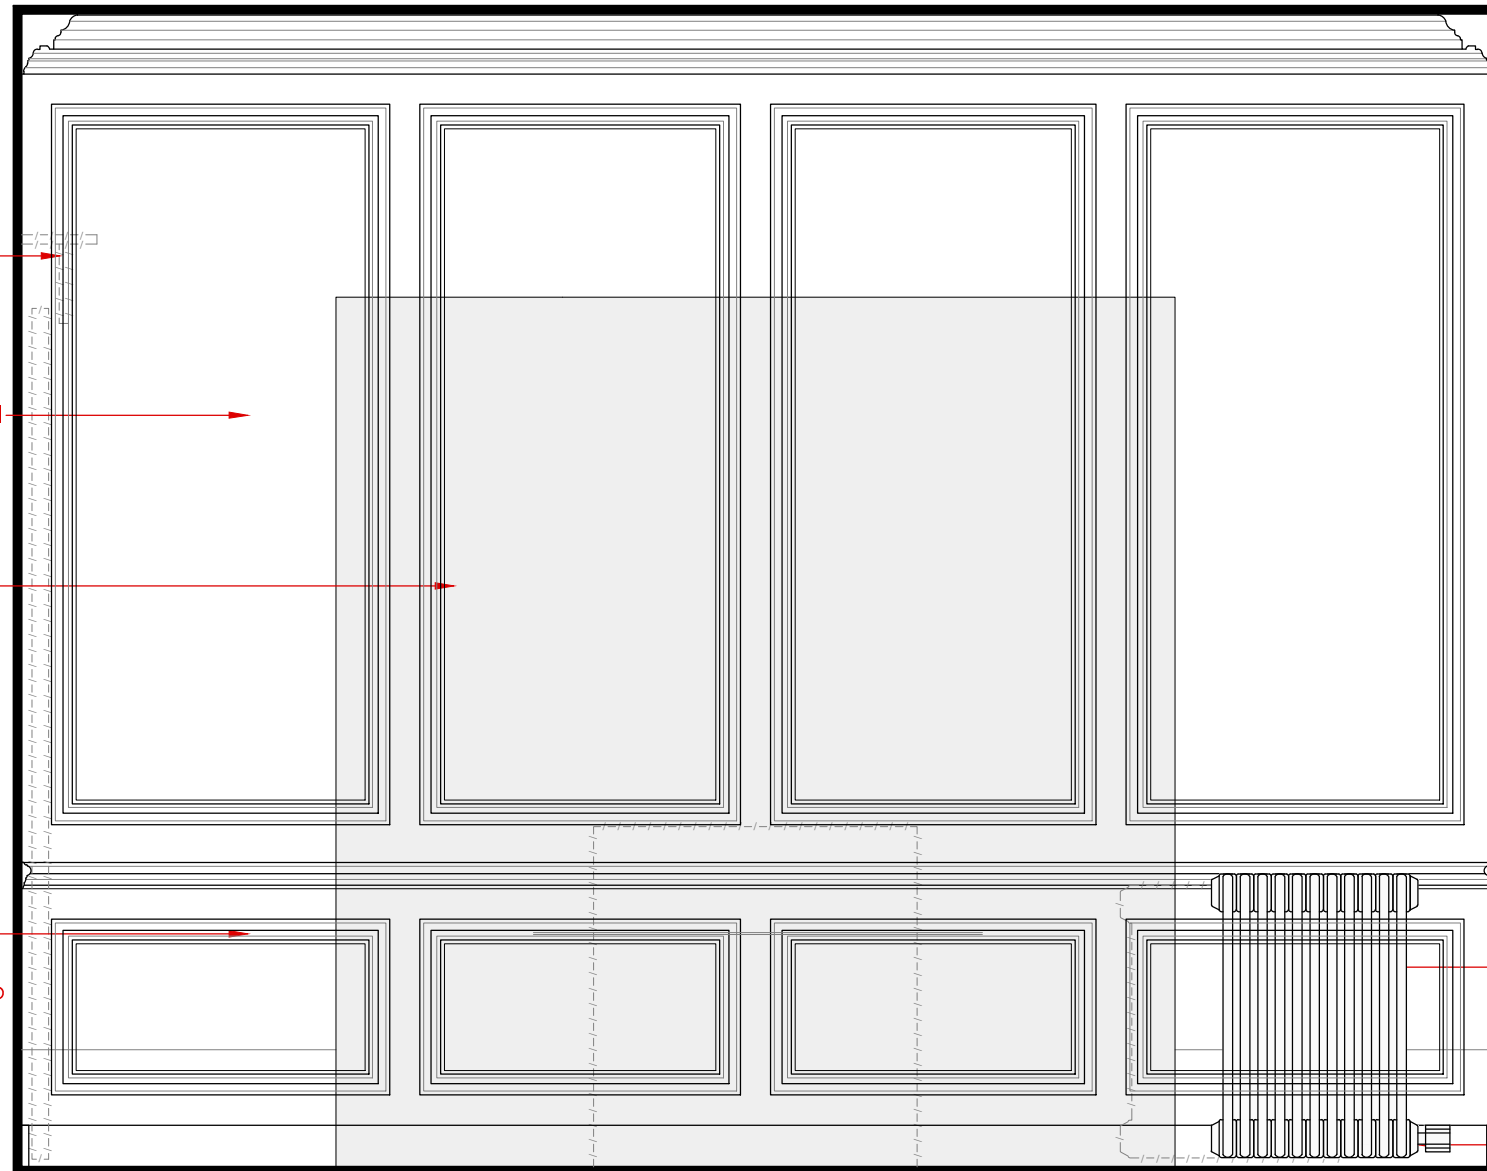
Dining Room//Existing//Elevation 2_1:20

Existing sliding door and mechanism removed.

Proposed bolection wall panelling throughout. Panelling to be placed behind fixed units.

Proposed kitchen furniture.

Existing plain lower panelling to be removed and replaced to match upper panelling.

Existing radiator and pipework removed. Panelling repaired where necessary.

Existing skirting to be reused.

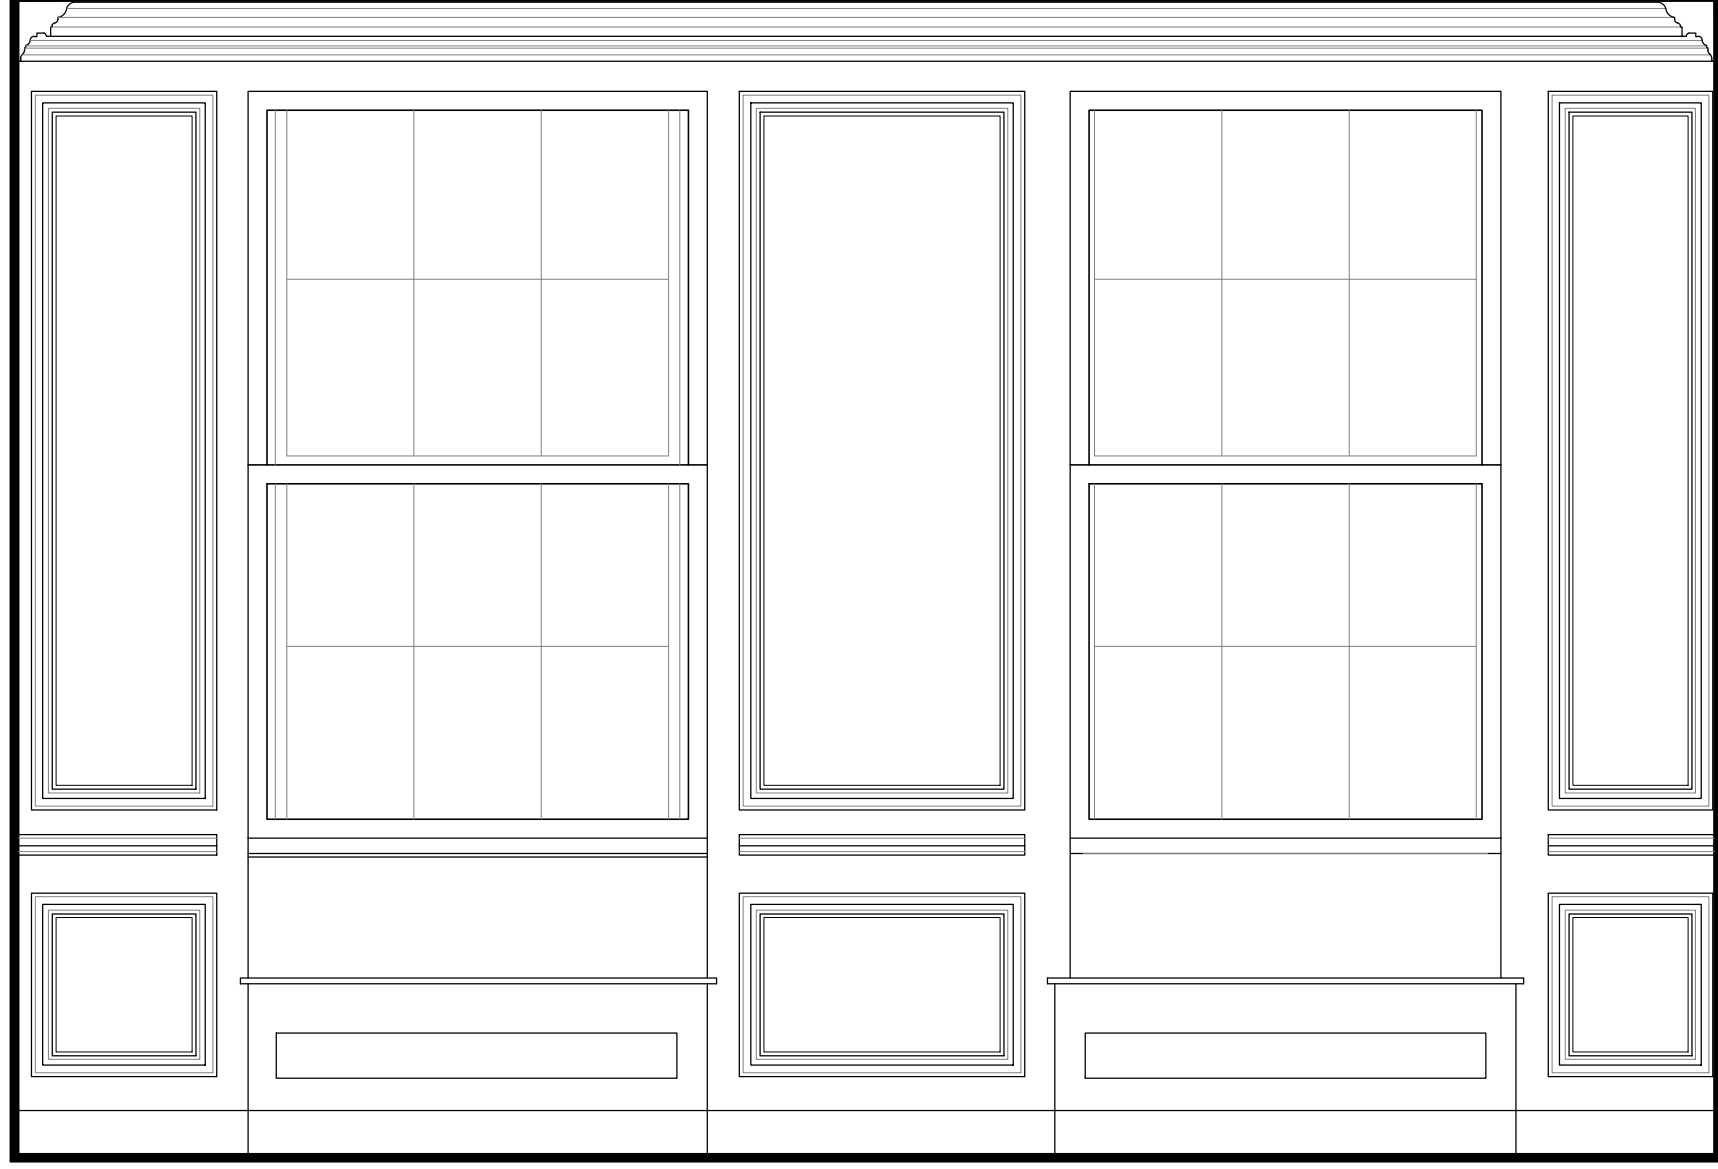
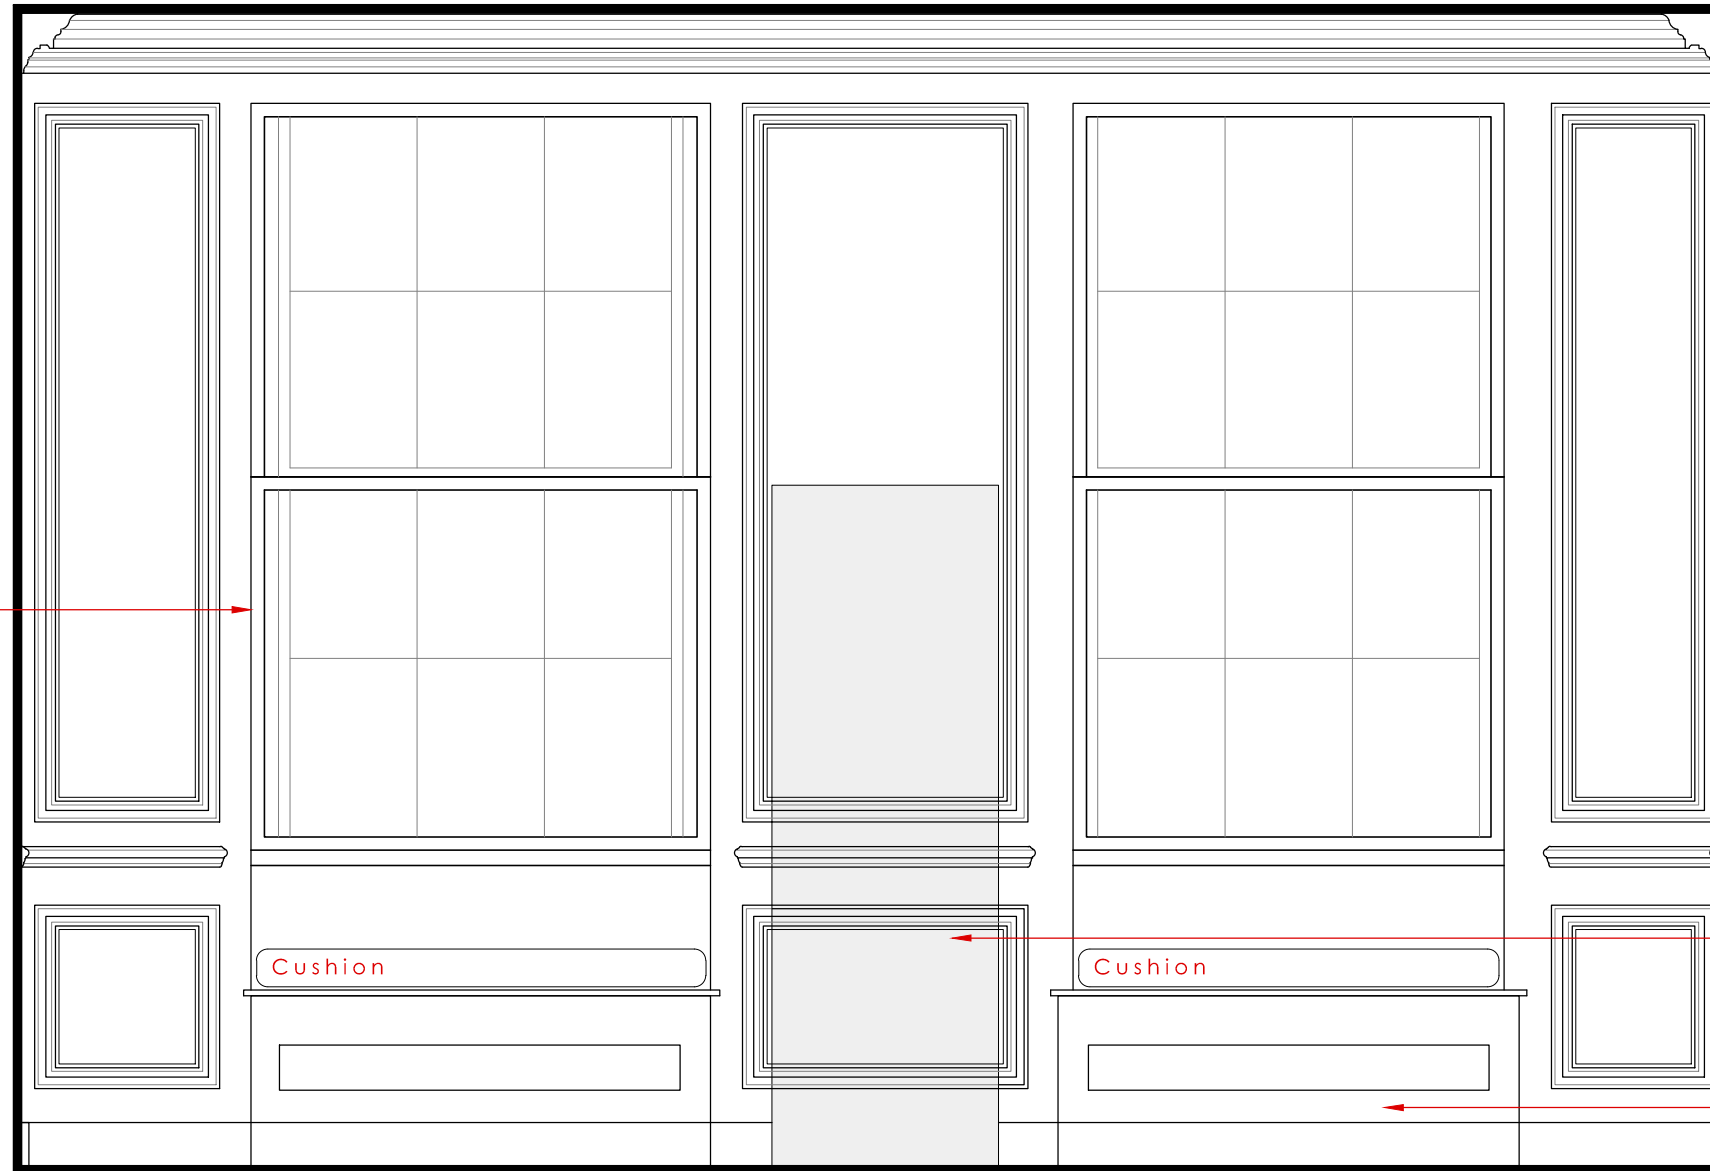
Dining Room//Existing//Elevation 3_1:20

Existing secondary glazing removed and replaced with new.

Proposed kitchen furniture.

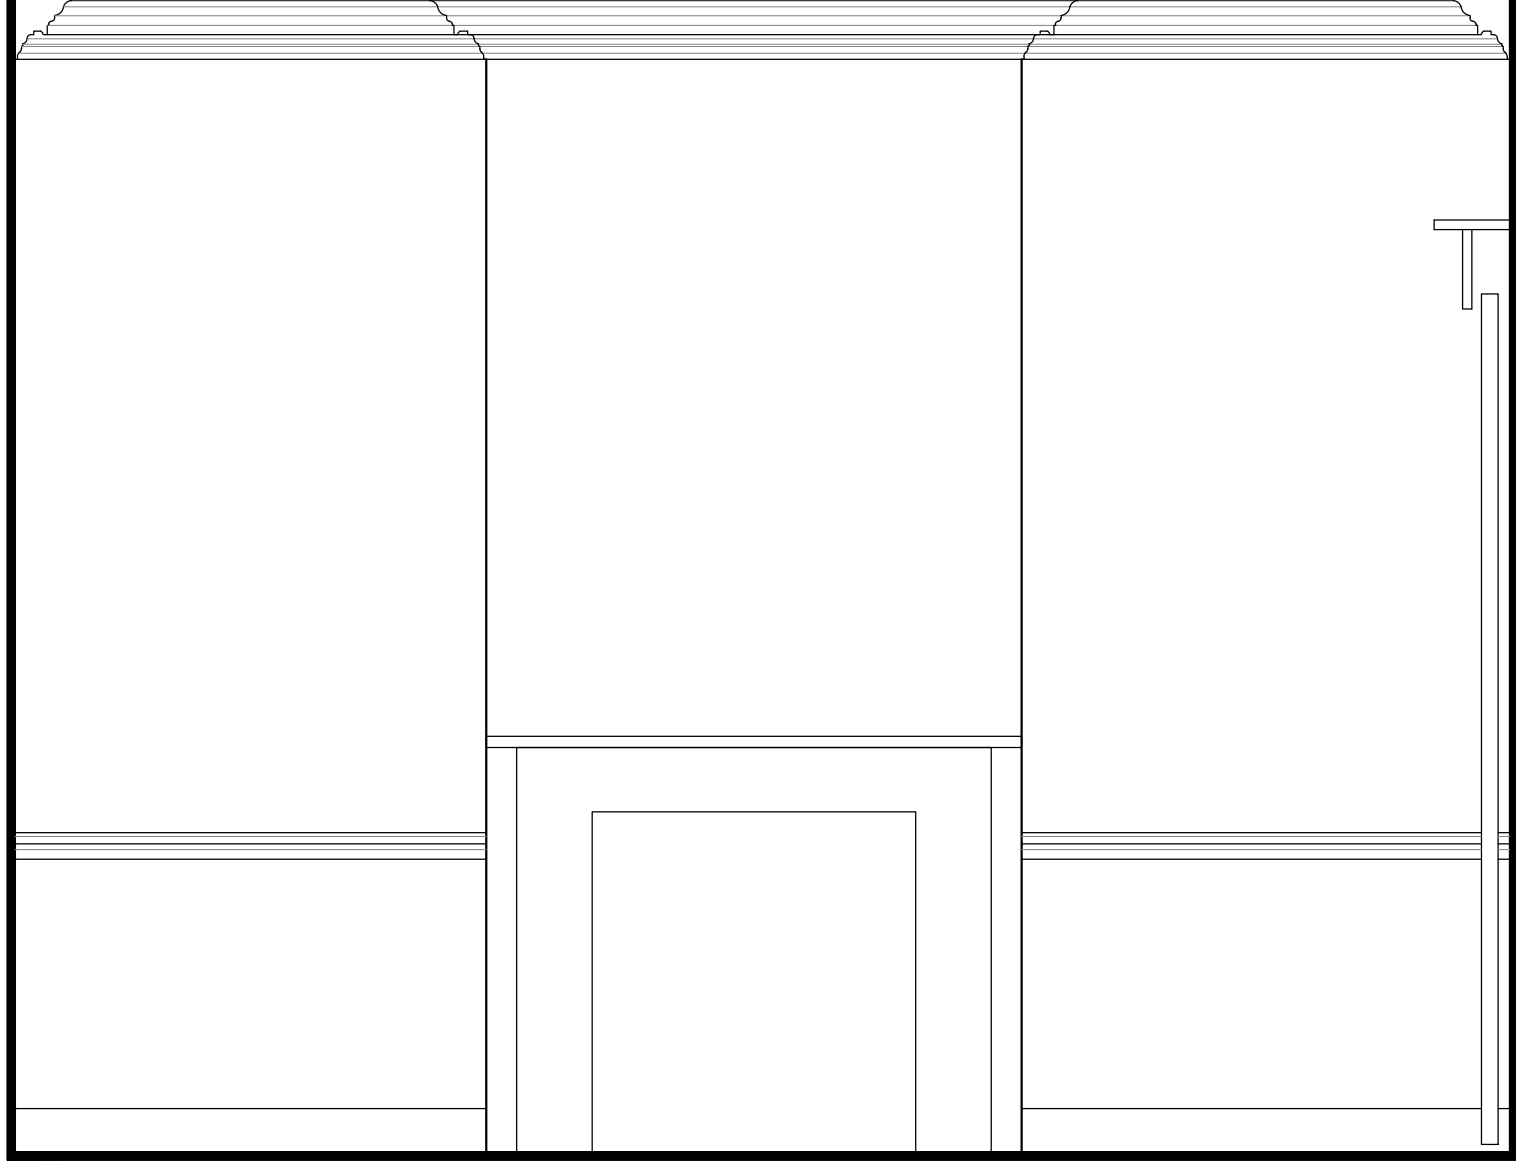
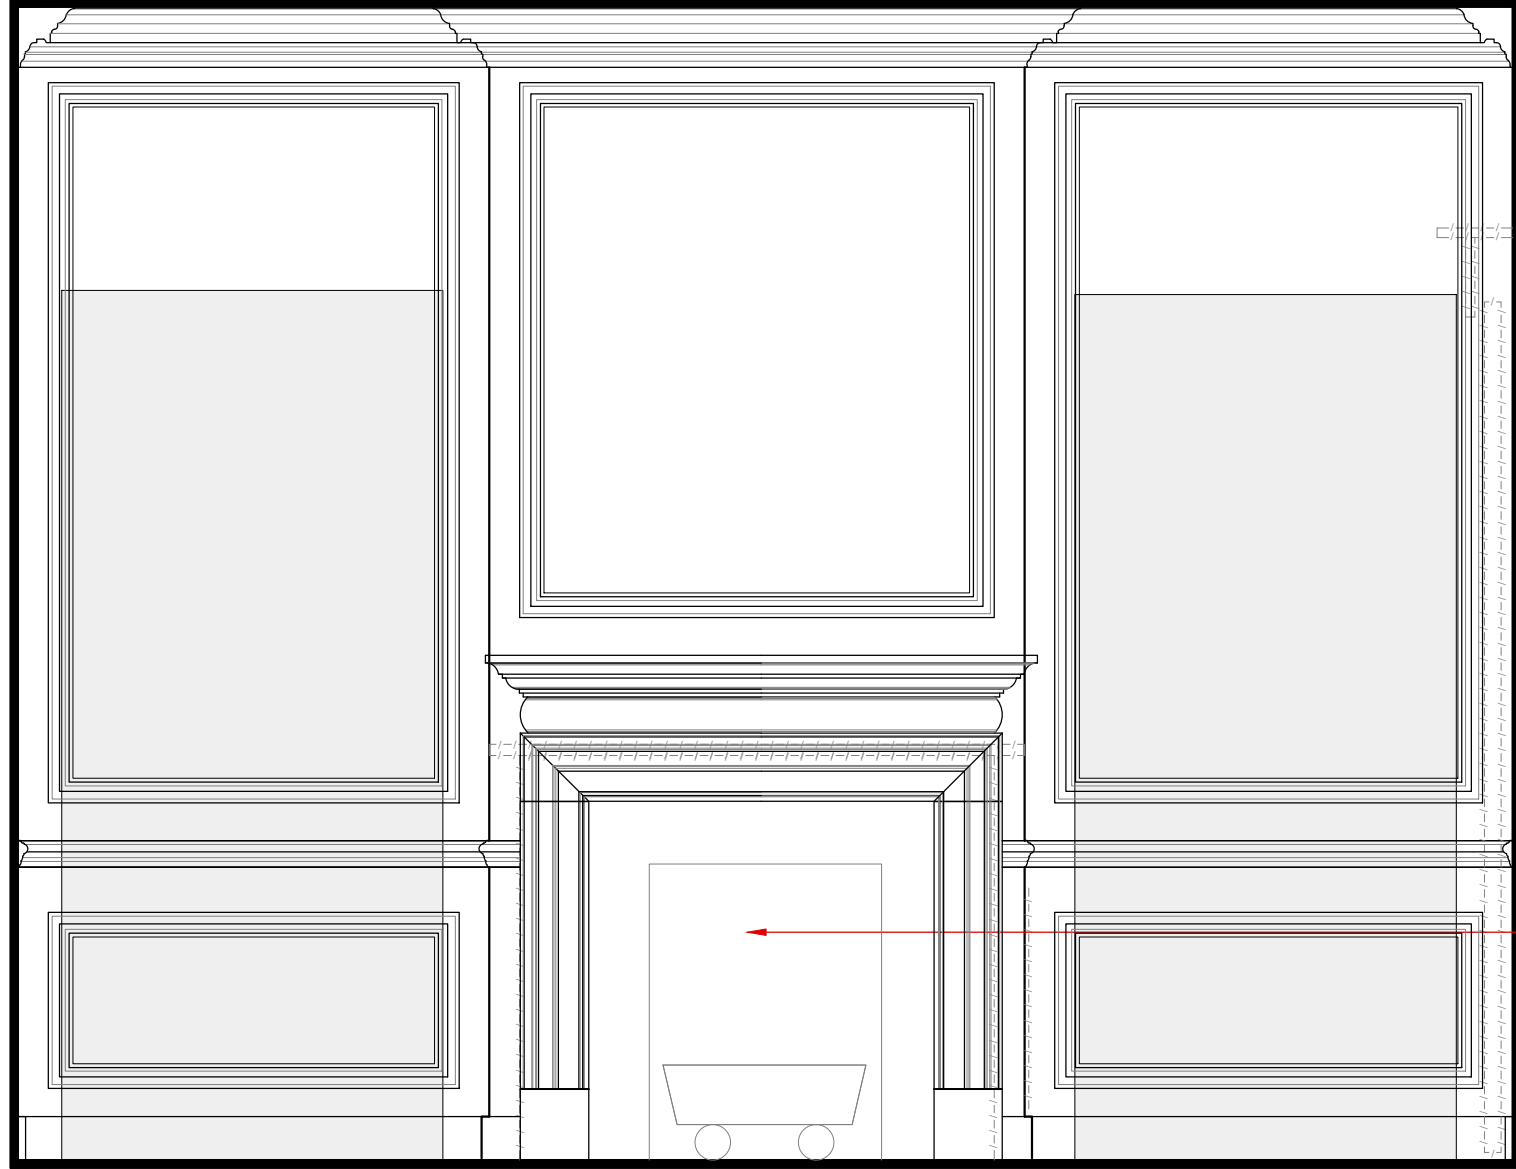
Dining Room//Existing//Elevation 4_1:20

Existing fireplace removed and replaced.

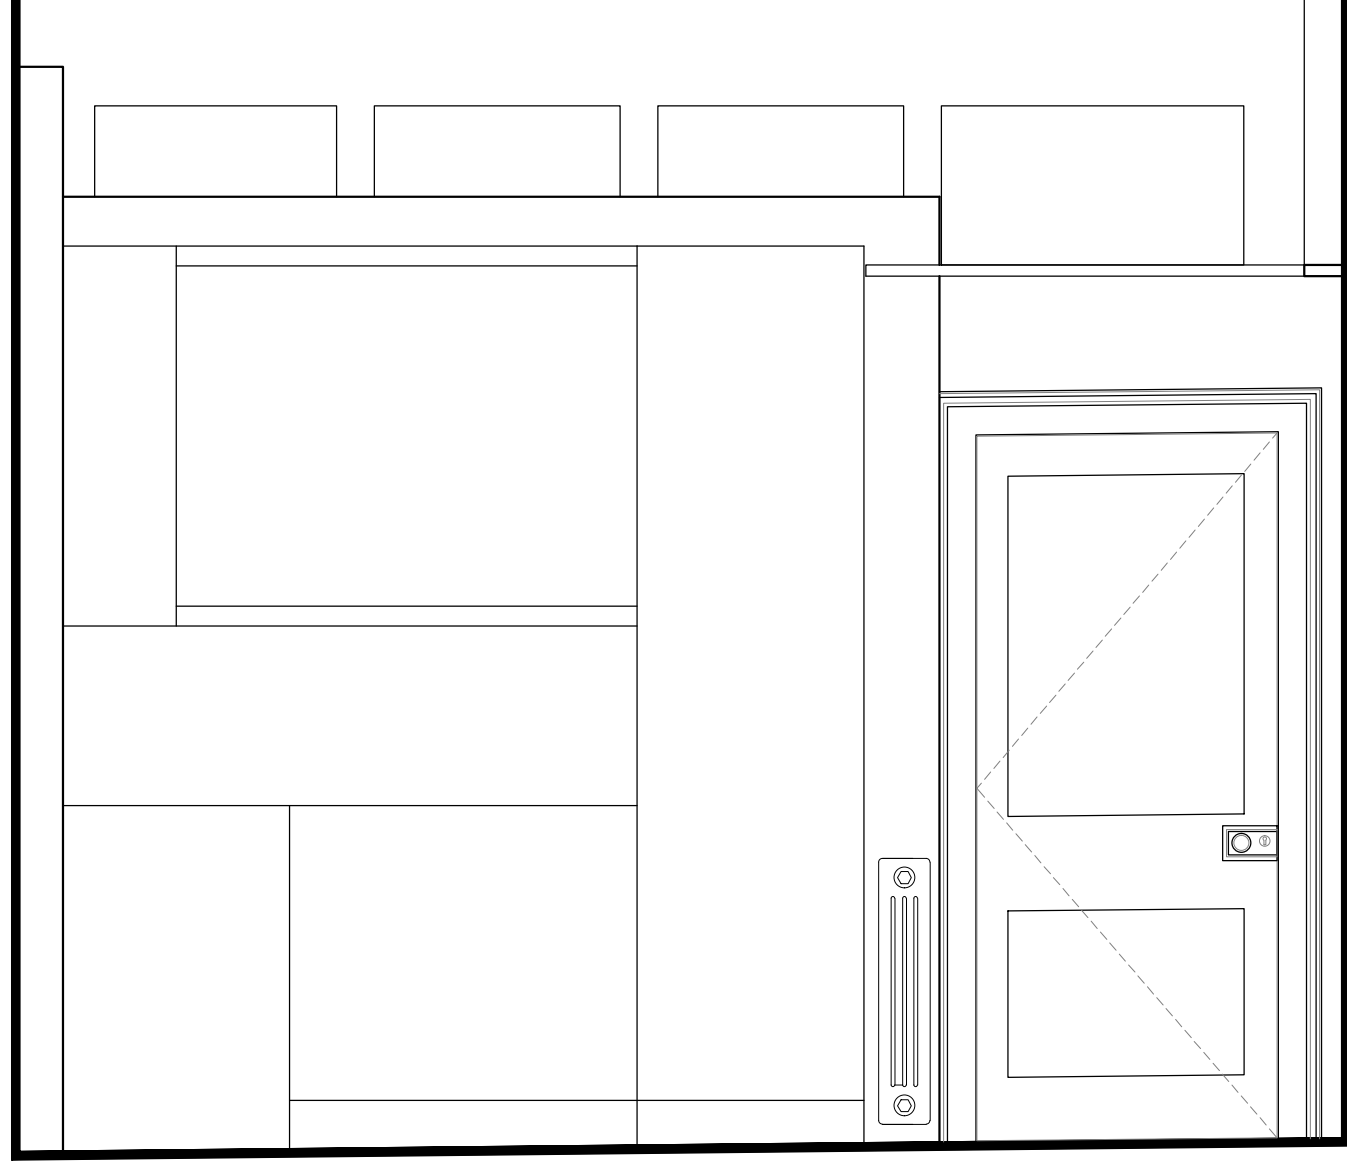
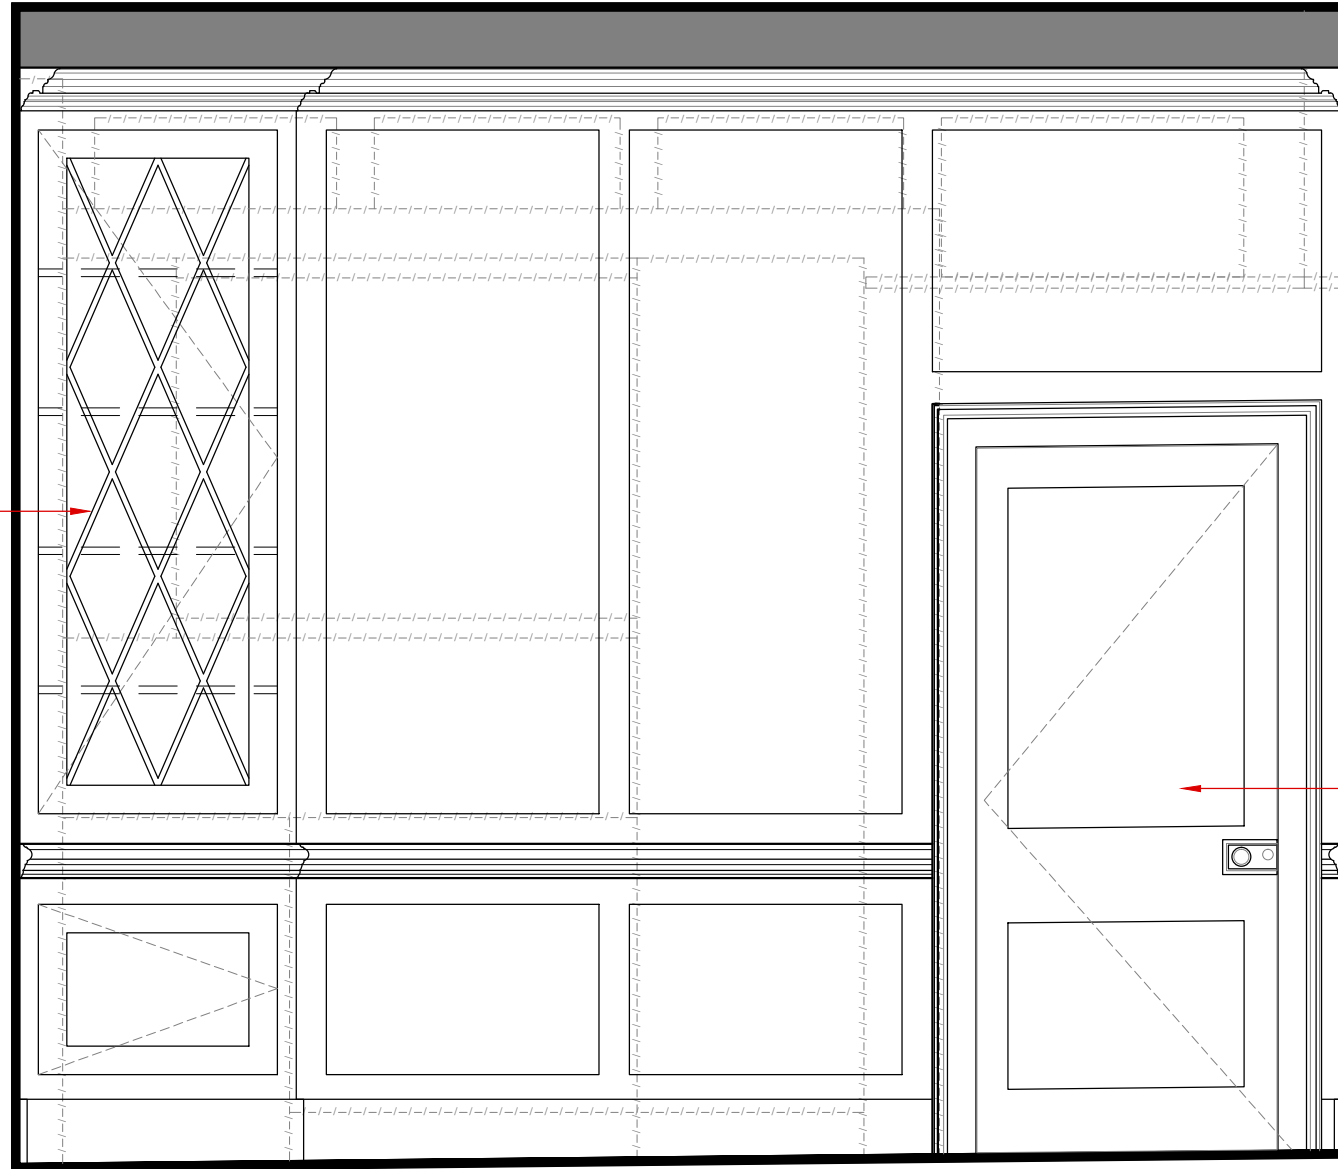
Kitchen//Existing//Elevation 2_1:20

Proposed corner
cupboards to be
incorporated into
panelling design.

Existing original door
retained.

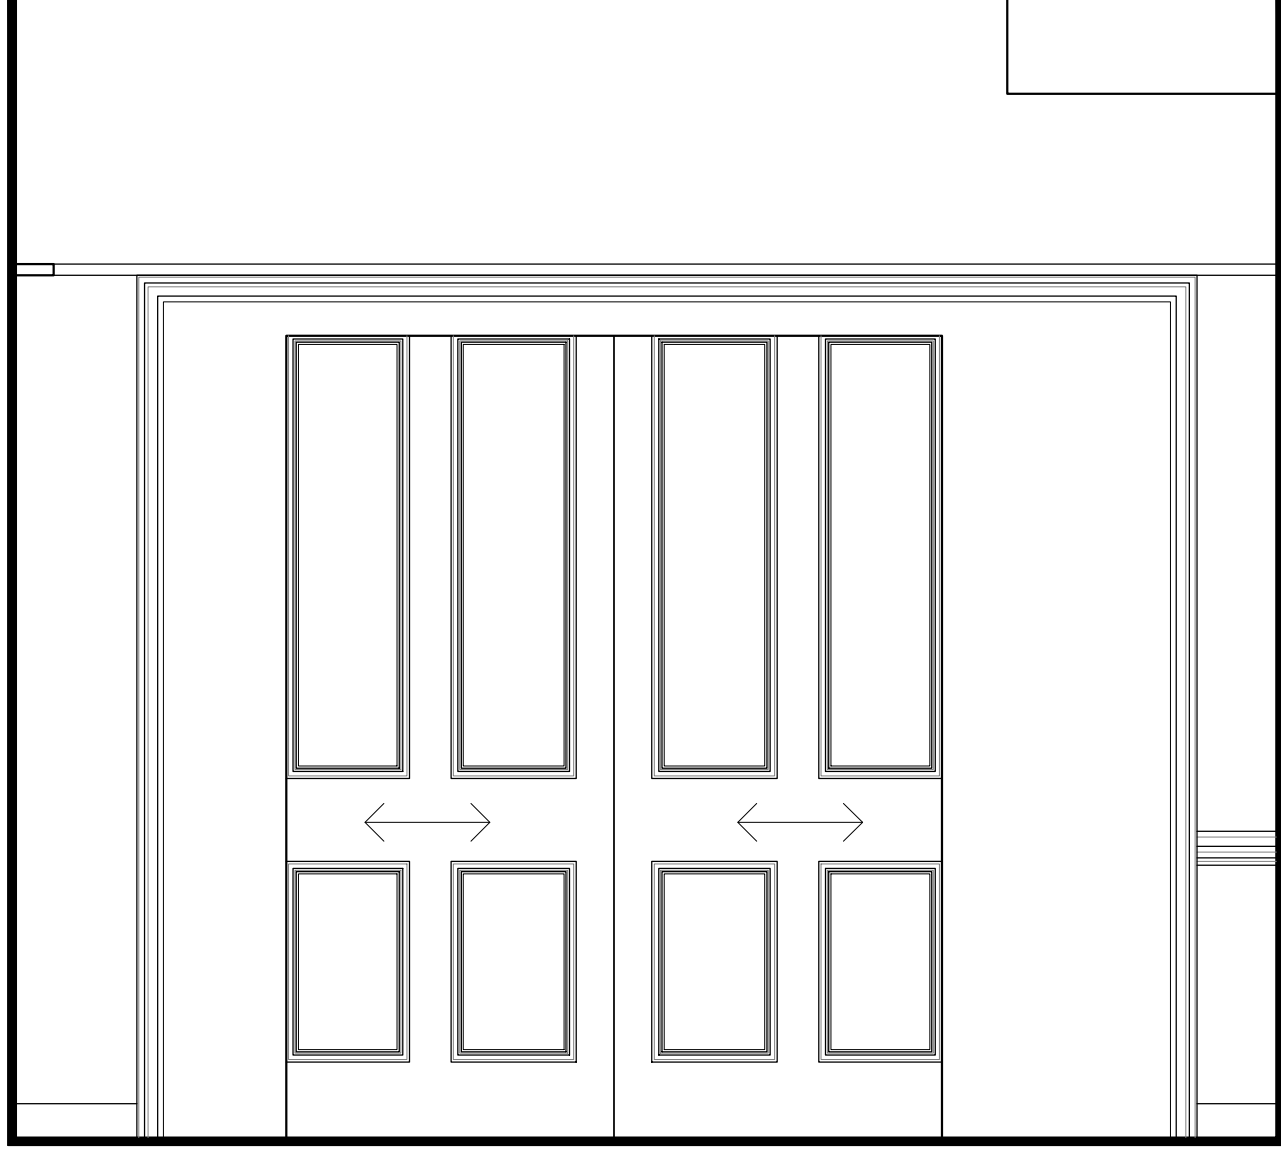
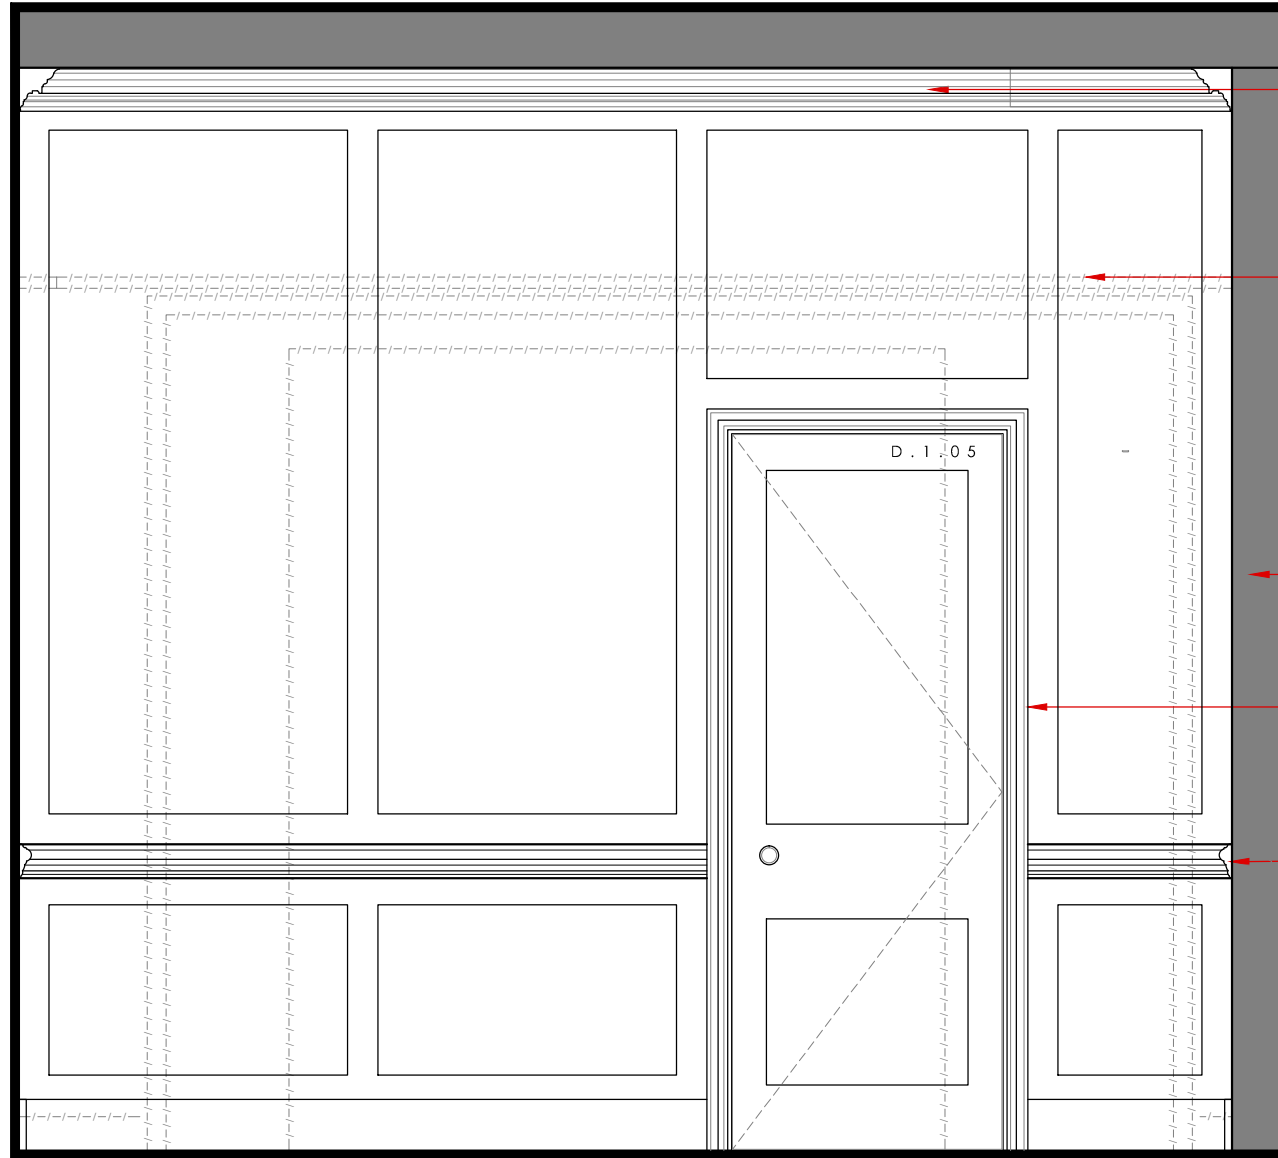
Kitchen//Existing//Elevation 3_1:20

Cornice to match existing within Kitchen area.

Existing panelling removed around sliding doors and new simple wall panelling throughout. No moulding to be used.

Proposed service run. Wall to be set back 50mm from chimney breast on both sides.

Proposed door and architrave to match D.1.06.

Proposed simple rail to match existing with breakfast room.
