FIRST FLOOR

1435 - P075

Dining Room//Existing//Plan_1:20

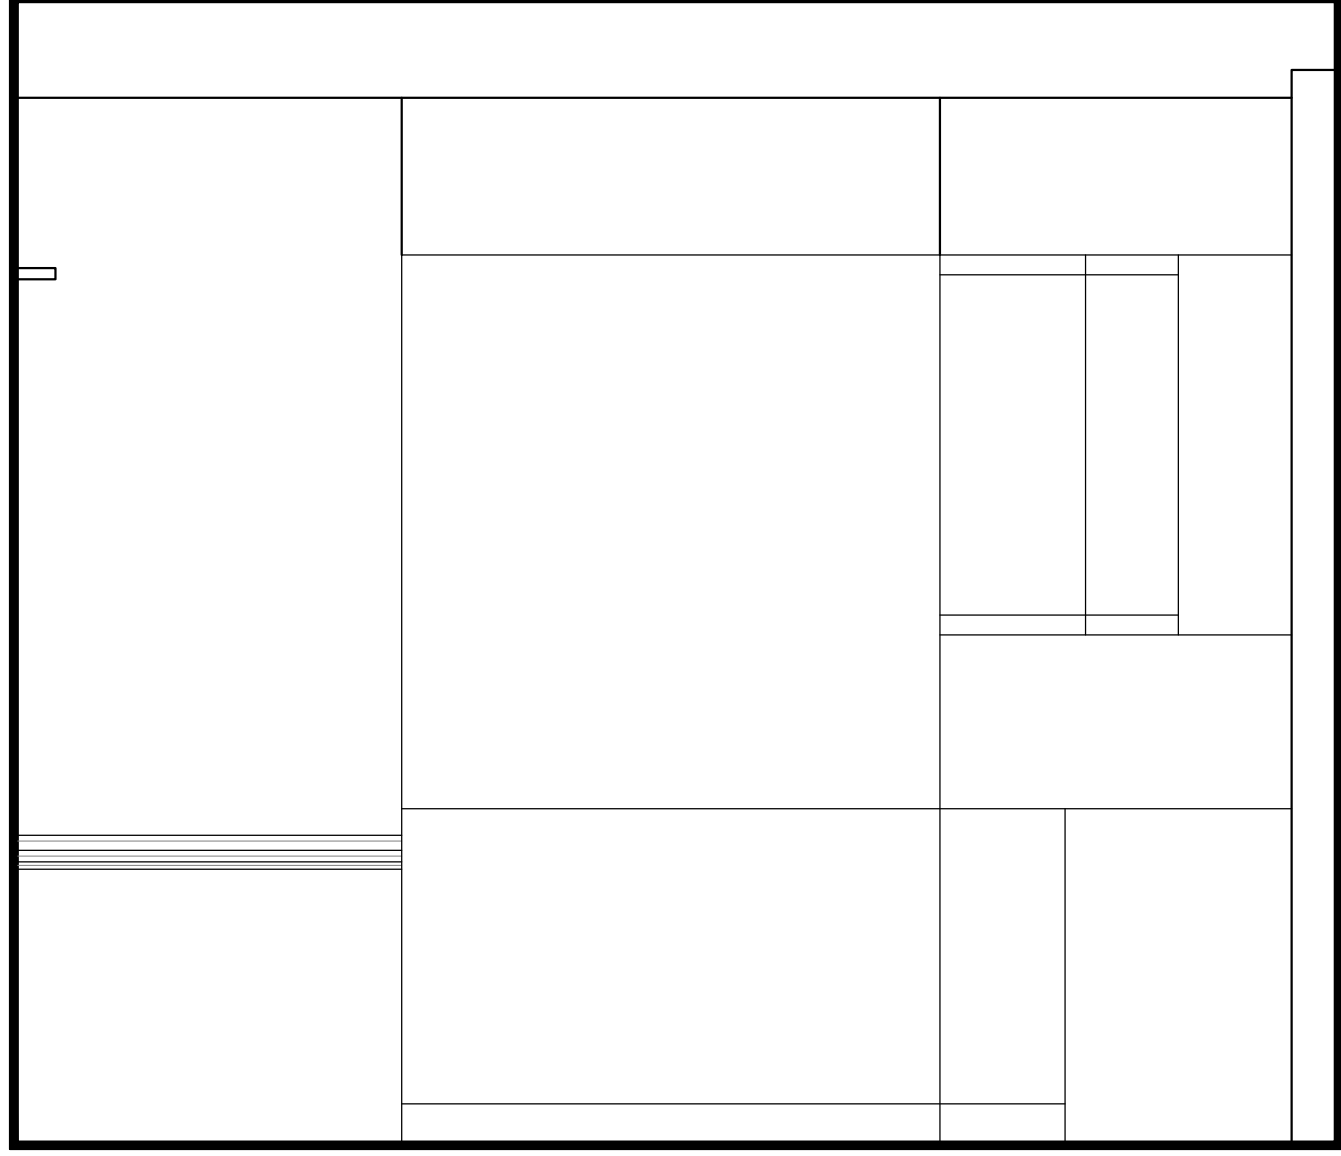
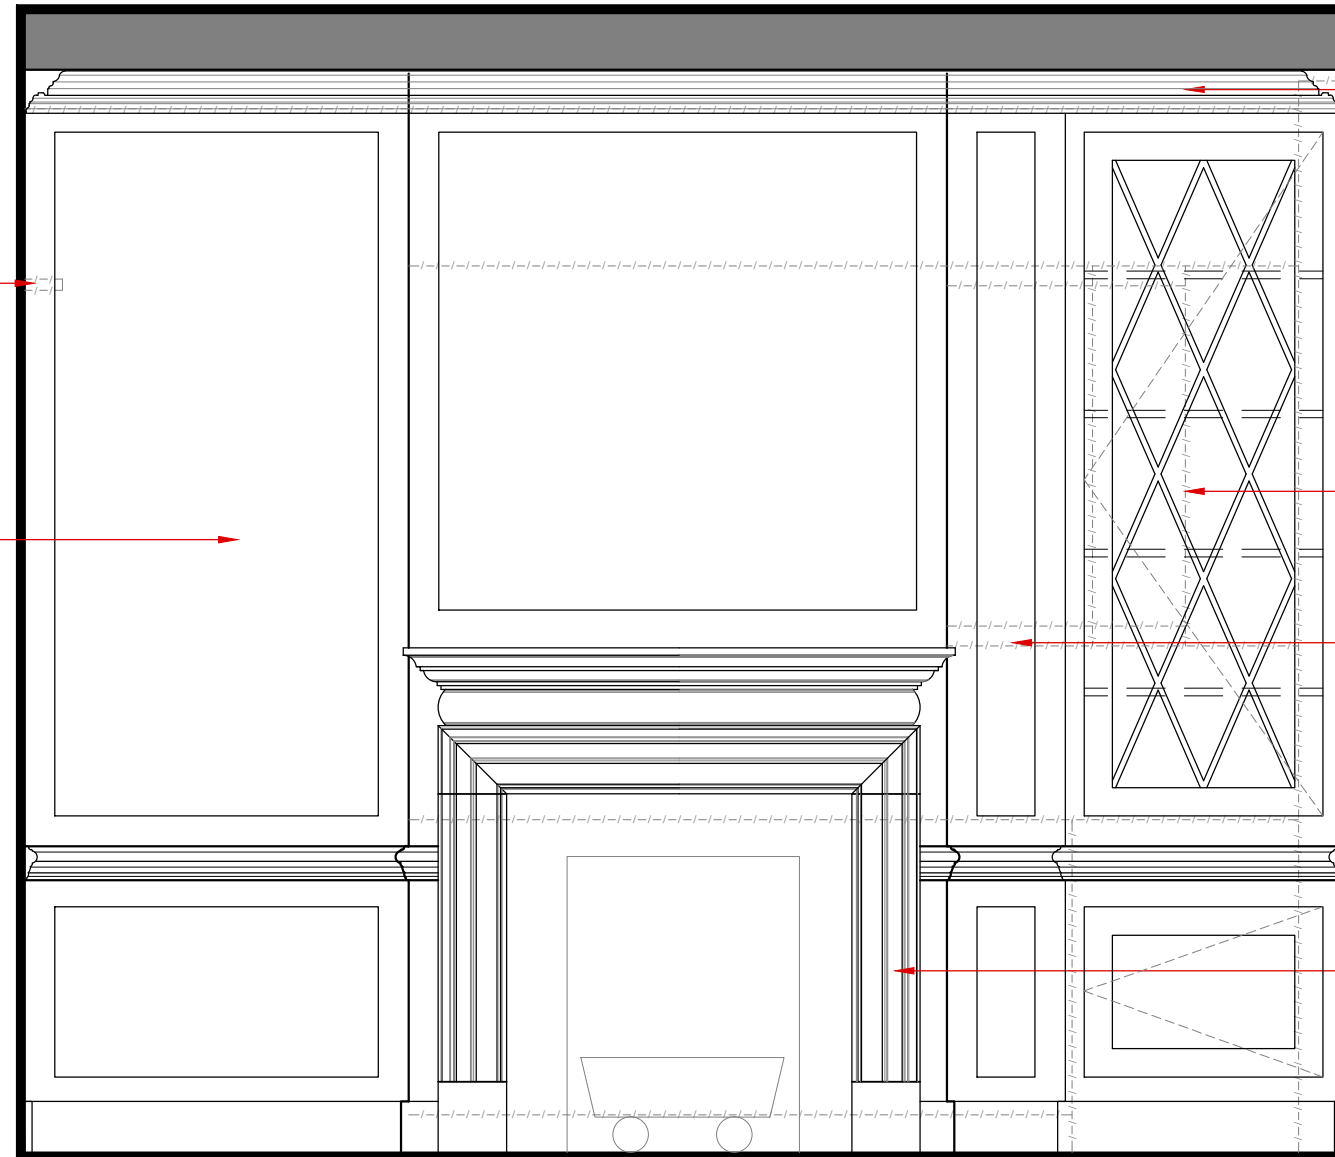
Kitchen//Existing//Elevation 4_1:20

Existing shelf to be removed.

Proposed service run. Wall to be stepped back from chimney breast.

Proposed cornice to be fitted around proposed joinery.

Existing kitchen units removed.

Existing cupboard removed and fireplace reinstated with new hearth and surround.

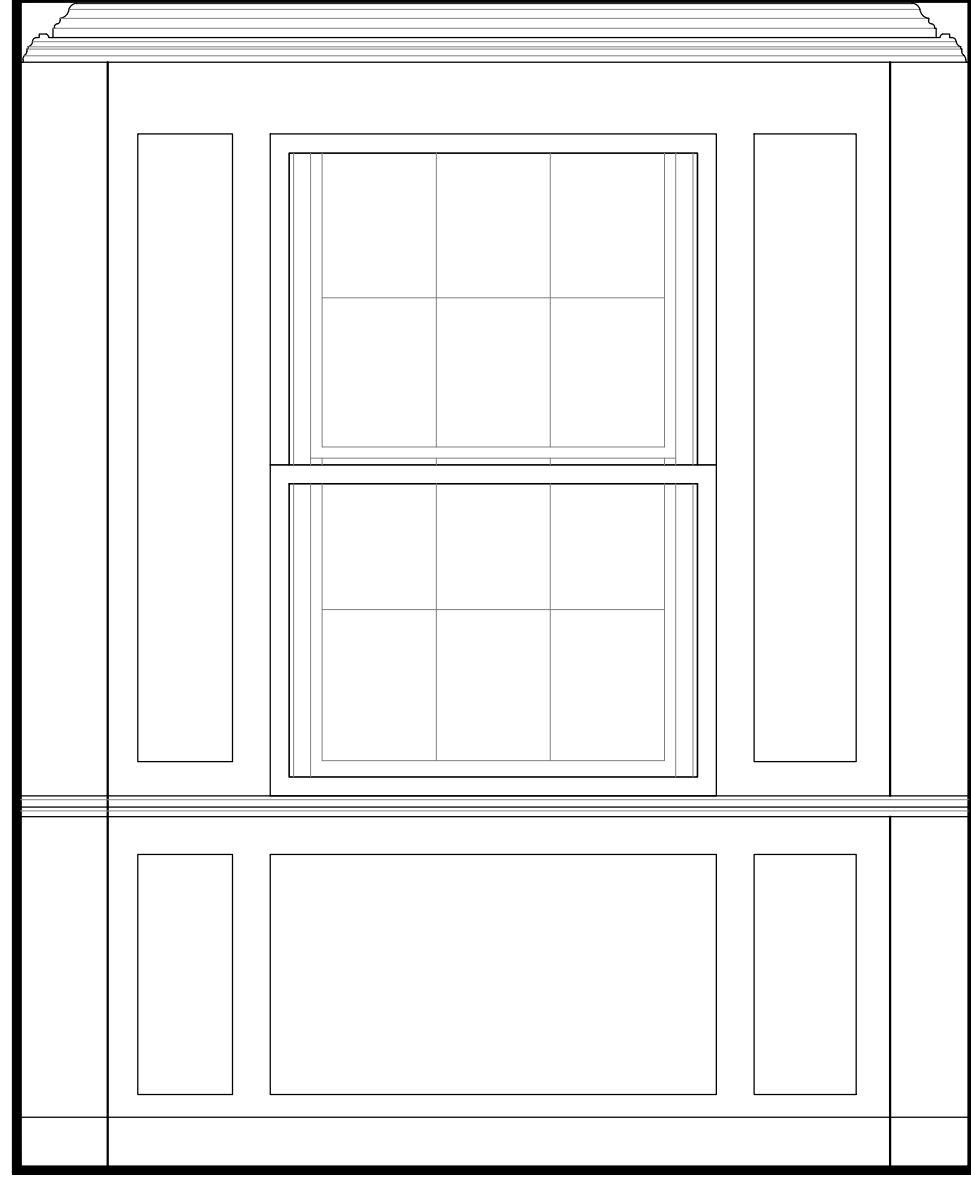
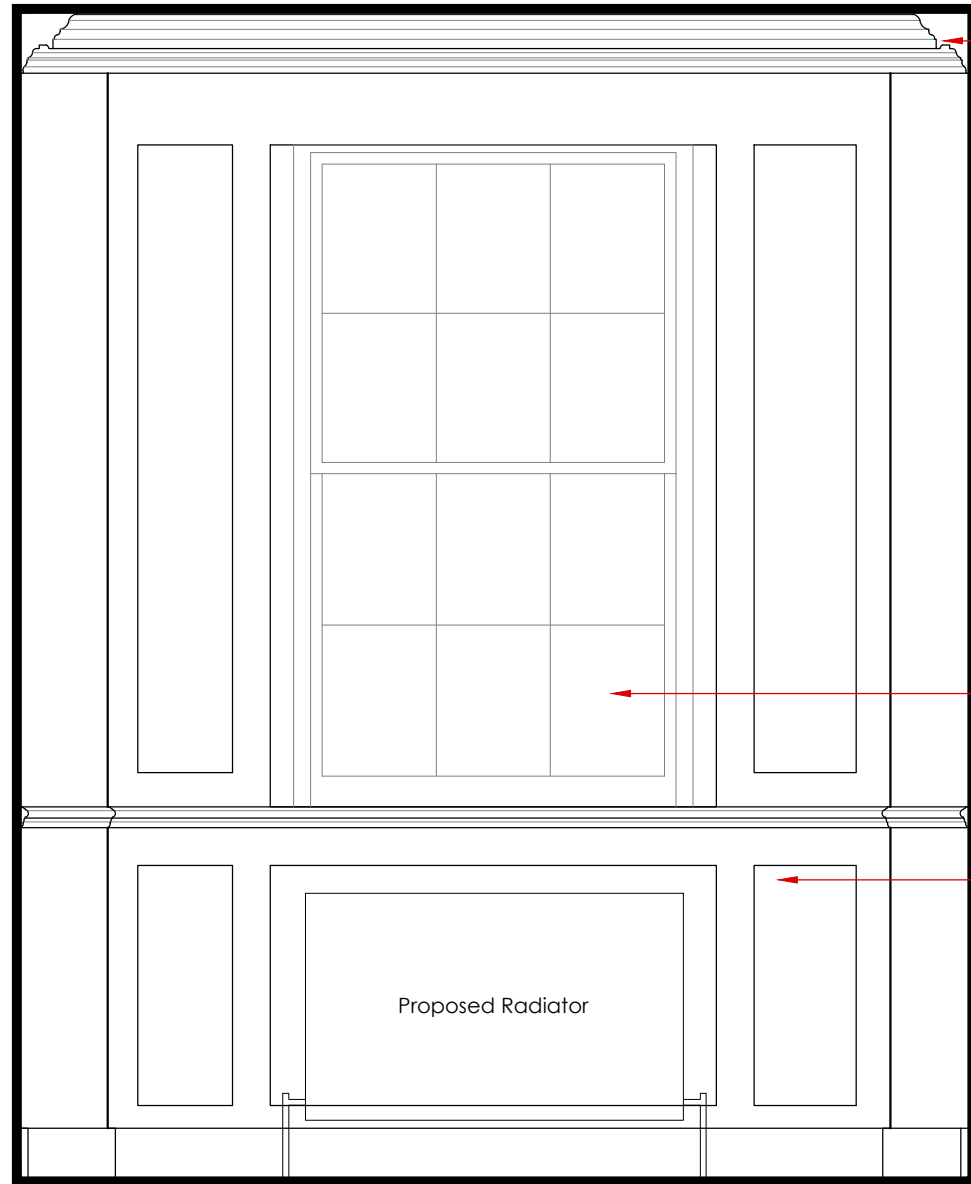
TV Room//Existing//Elevation 1_1:20

Existing cornice to be retained.

Existing secondary glazing removed.

Existing simple panelling to remain.

Proposed Radiator

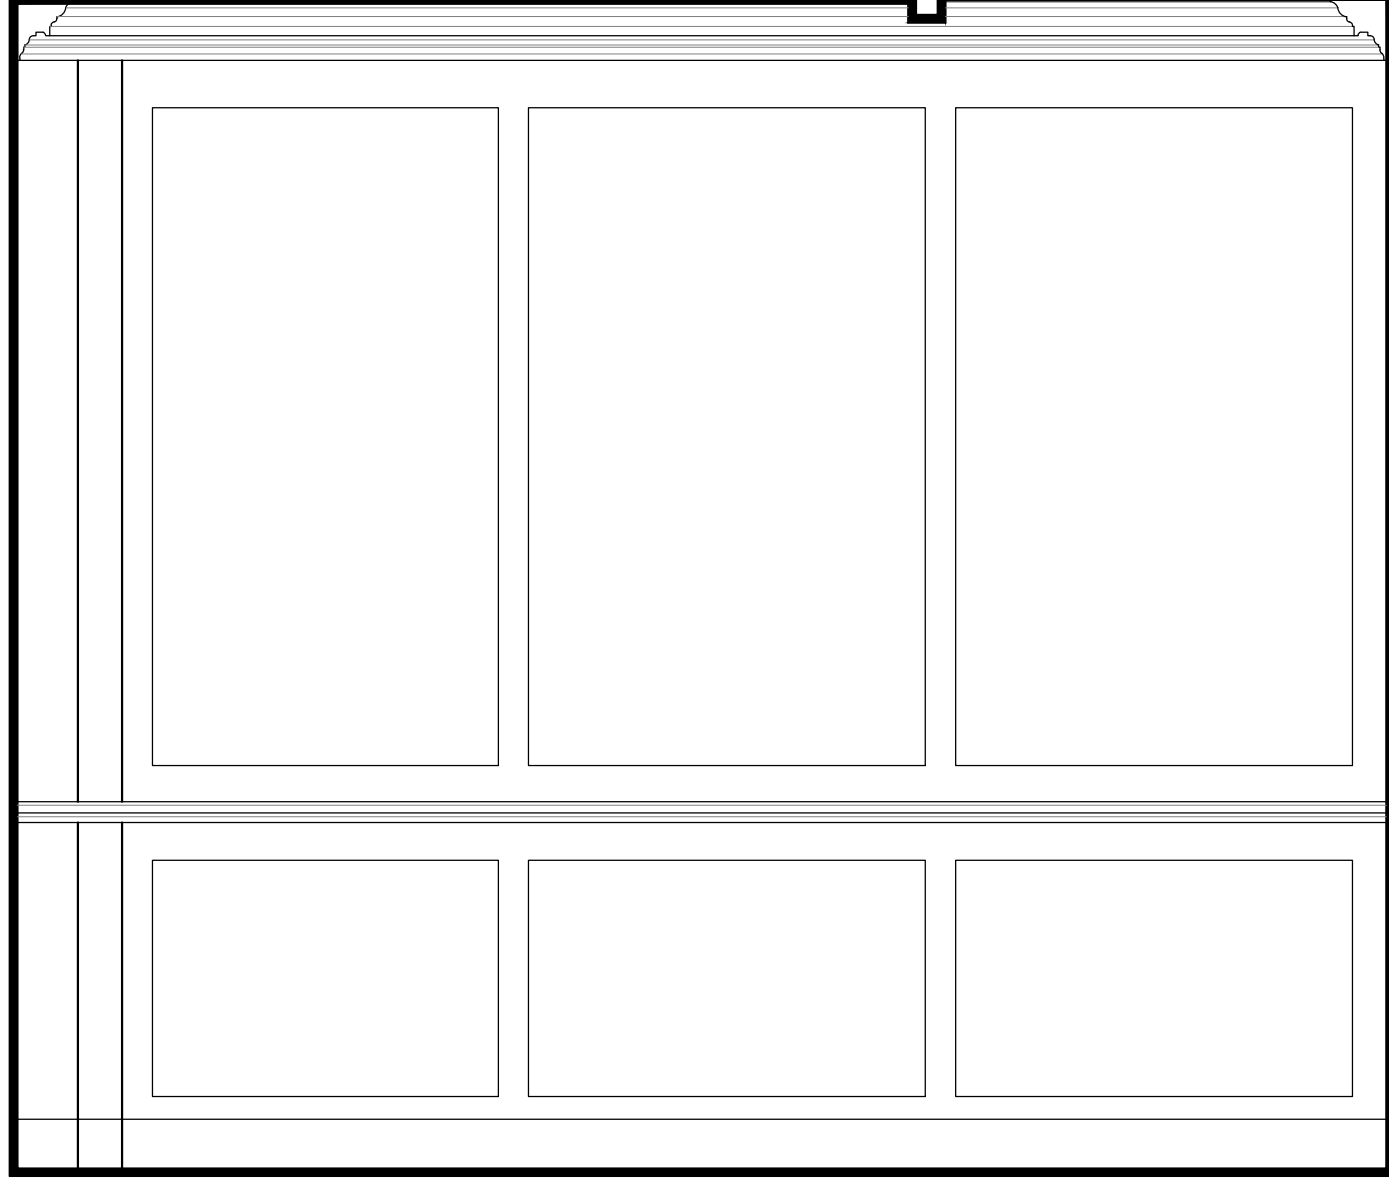
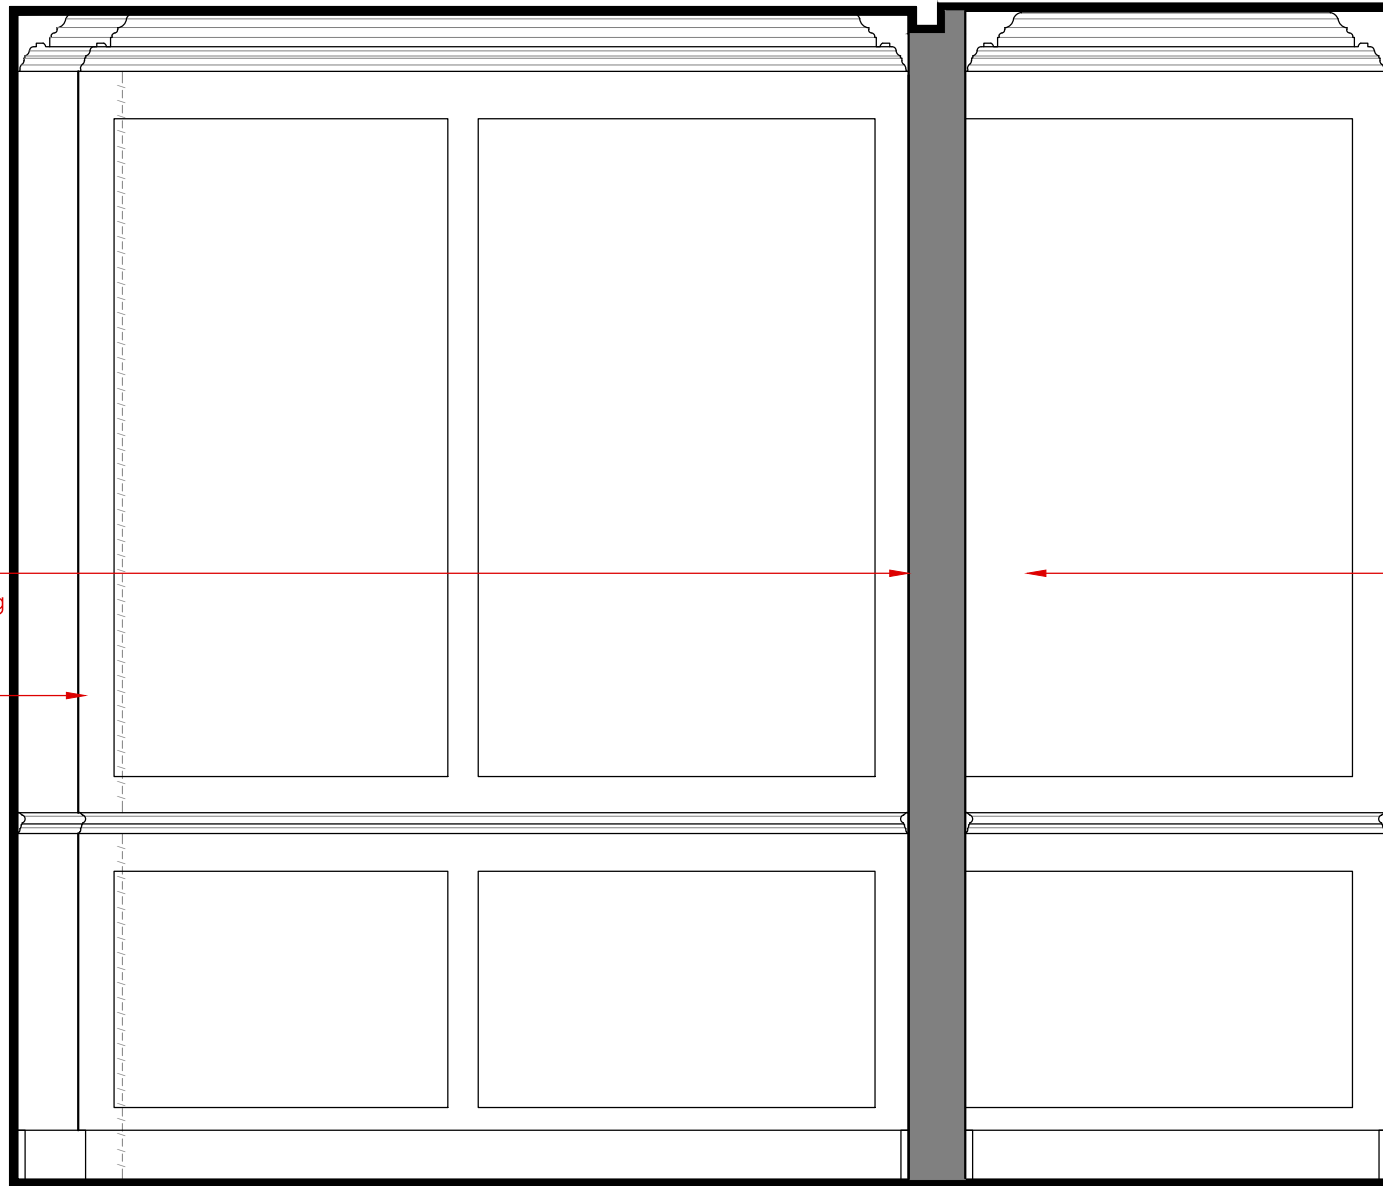
TV Room//Existing//Elevation 2_1:20

Proposed timber stud wall. Existing panelling to be unaffected.

Remove boxing and pipework. Adjust panelling to suit.

Existing panelling retained.

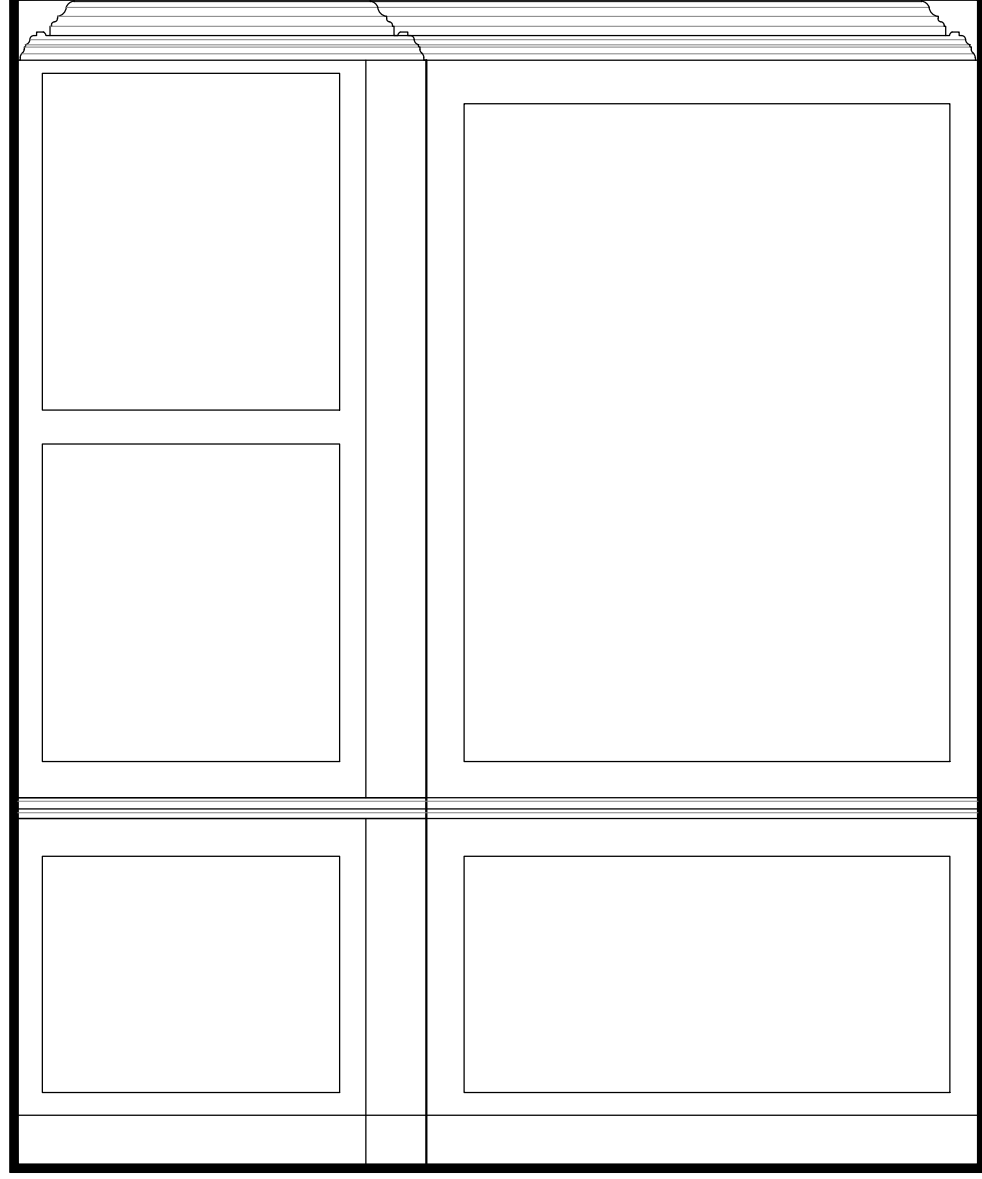
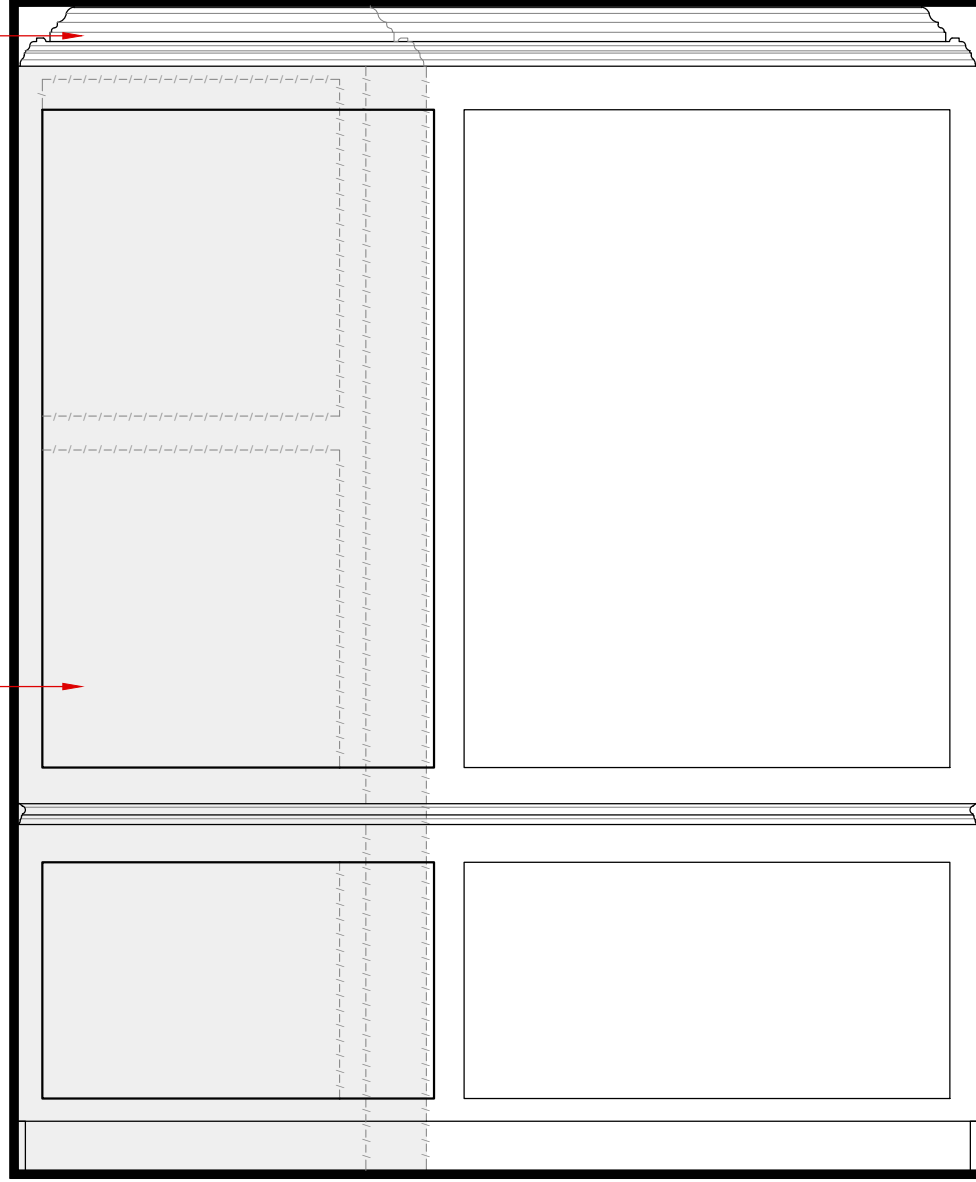
TV Room//Existing//Elevation 3_1:20

Proposed cornice
across new wall to
match existing.

Proposed timber
studwall with panelling
to match existing style.

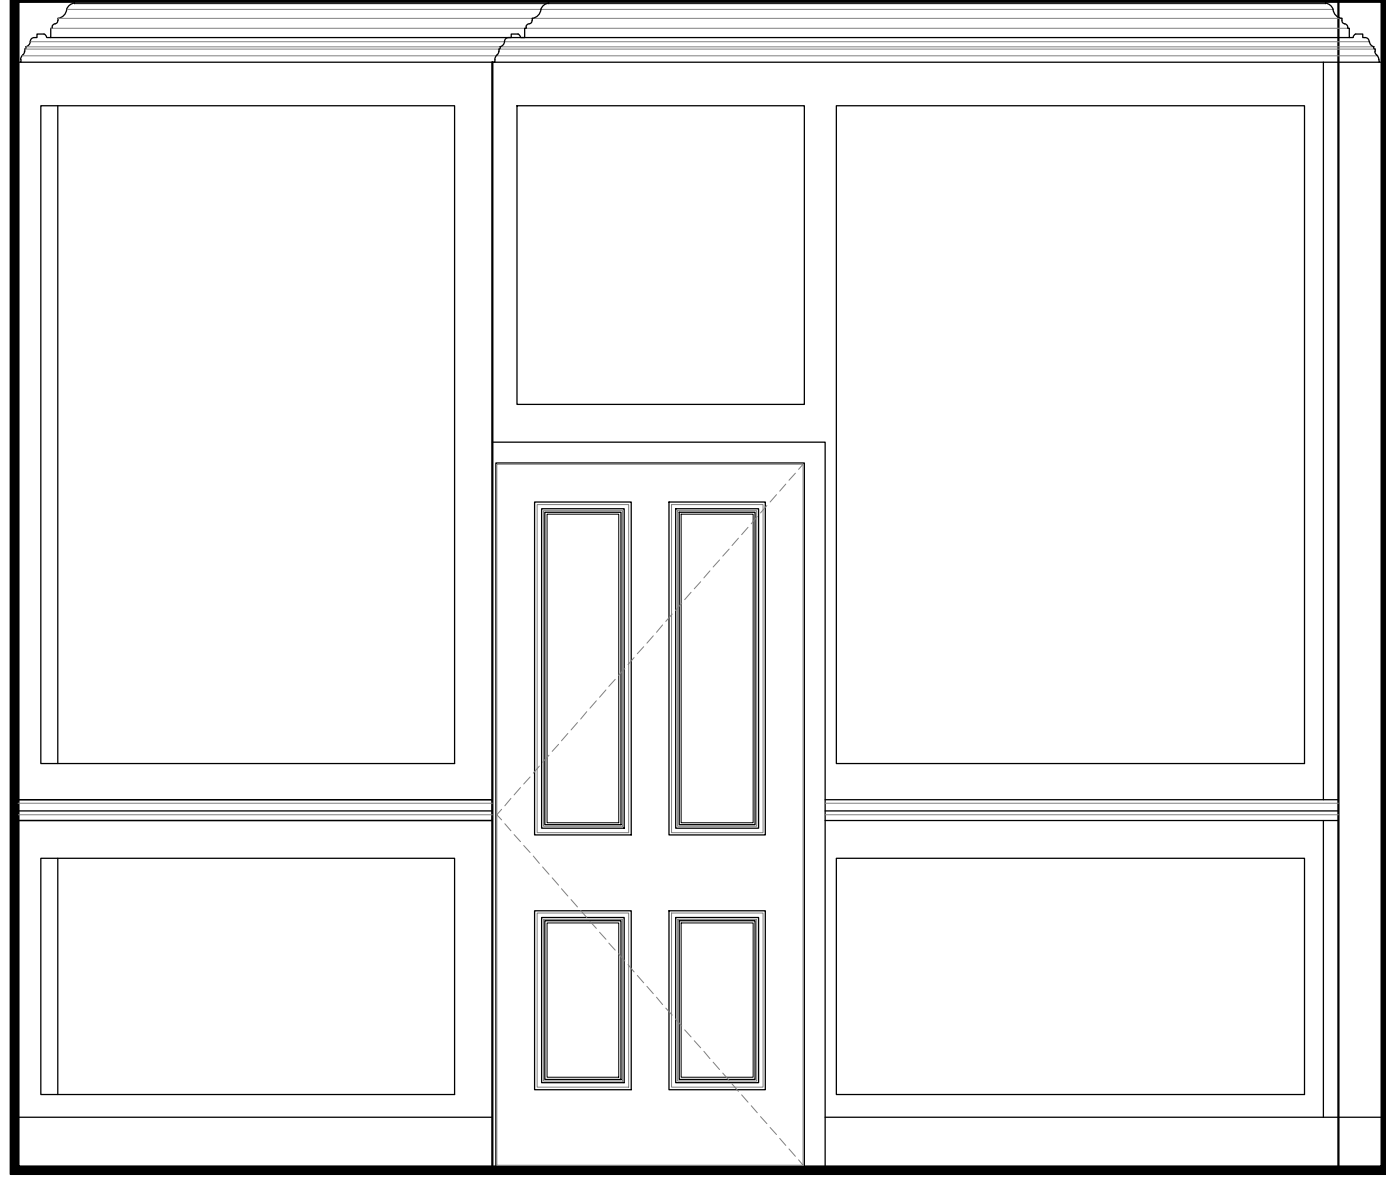
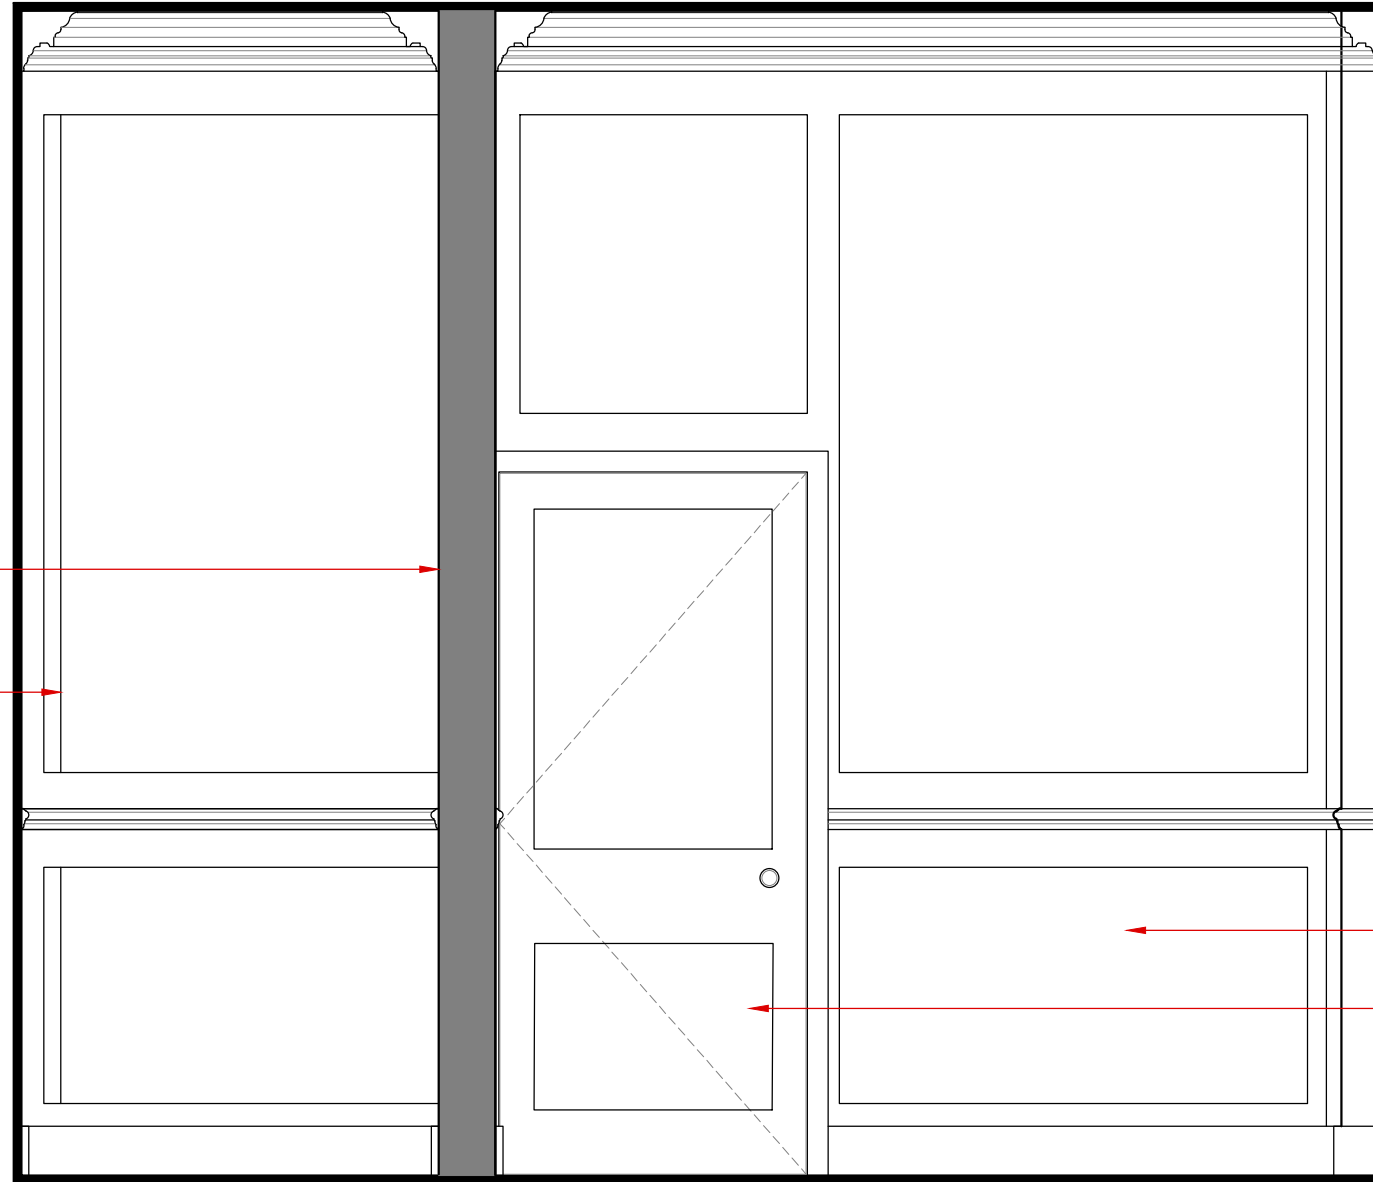
TV Room//Existing//Elevation 4_1:20

Proposed timber stud wall. Existing panelling to be unaffected.

Existing panelling to remain.

Existing panelling to be retained.

Door to match D.1.06.

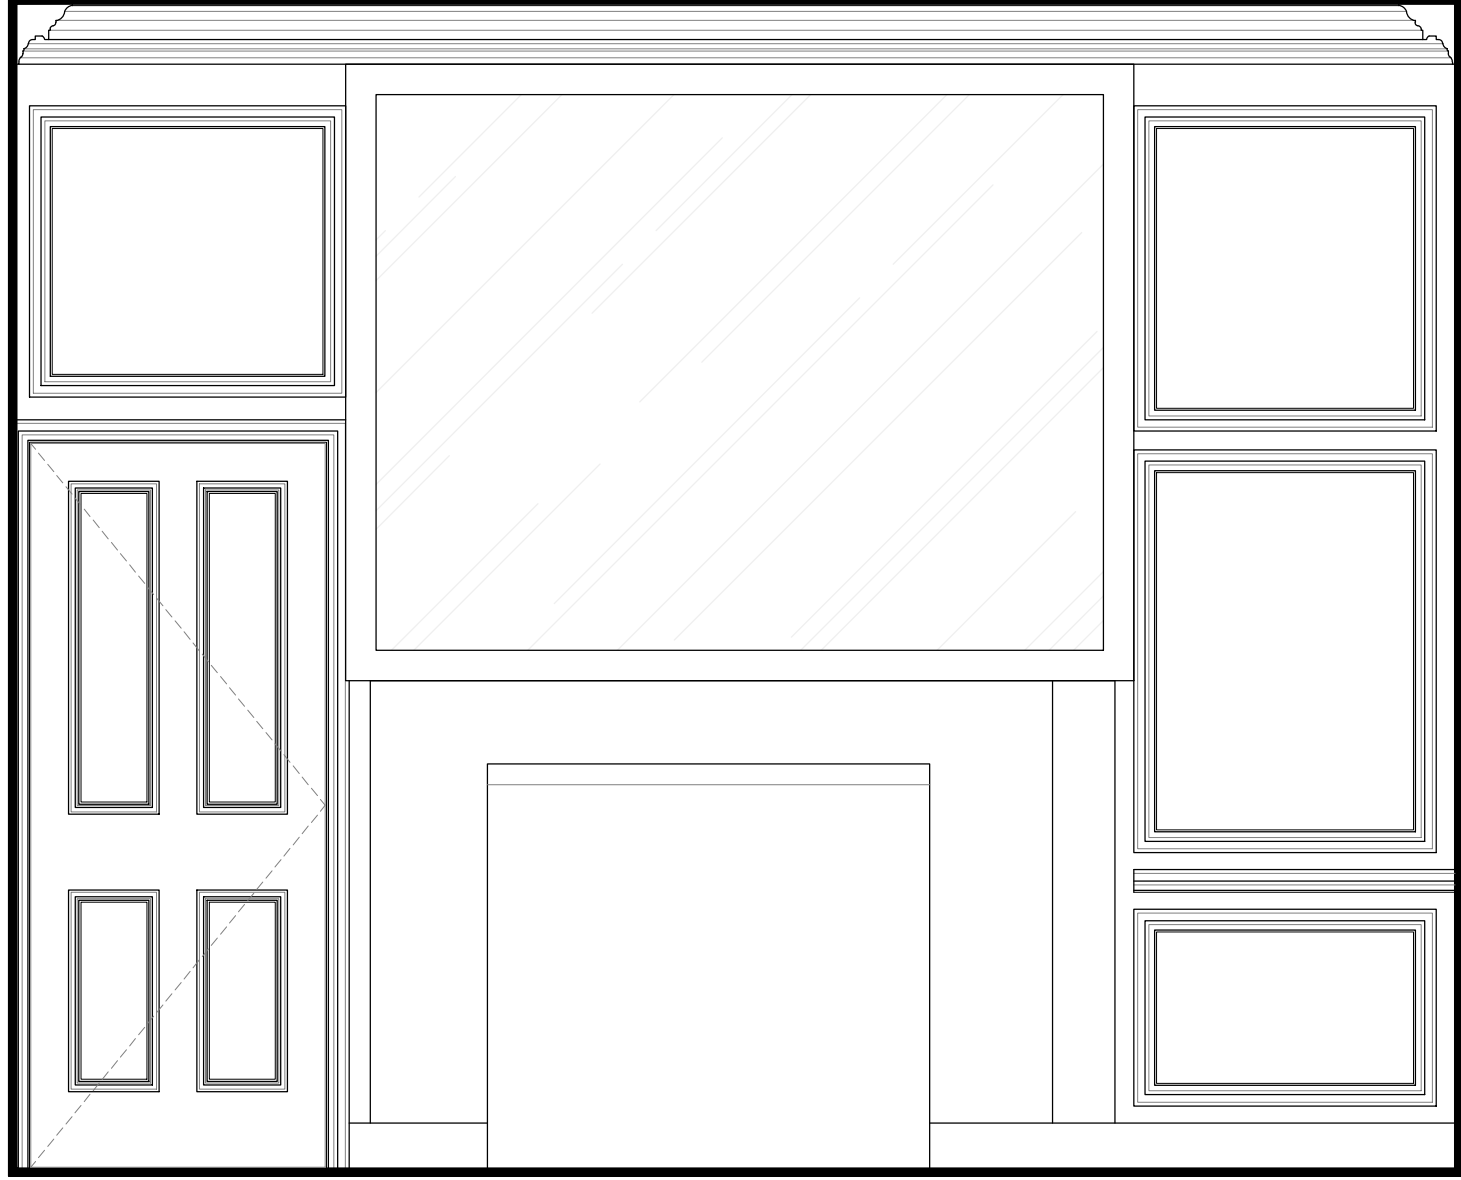
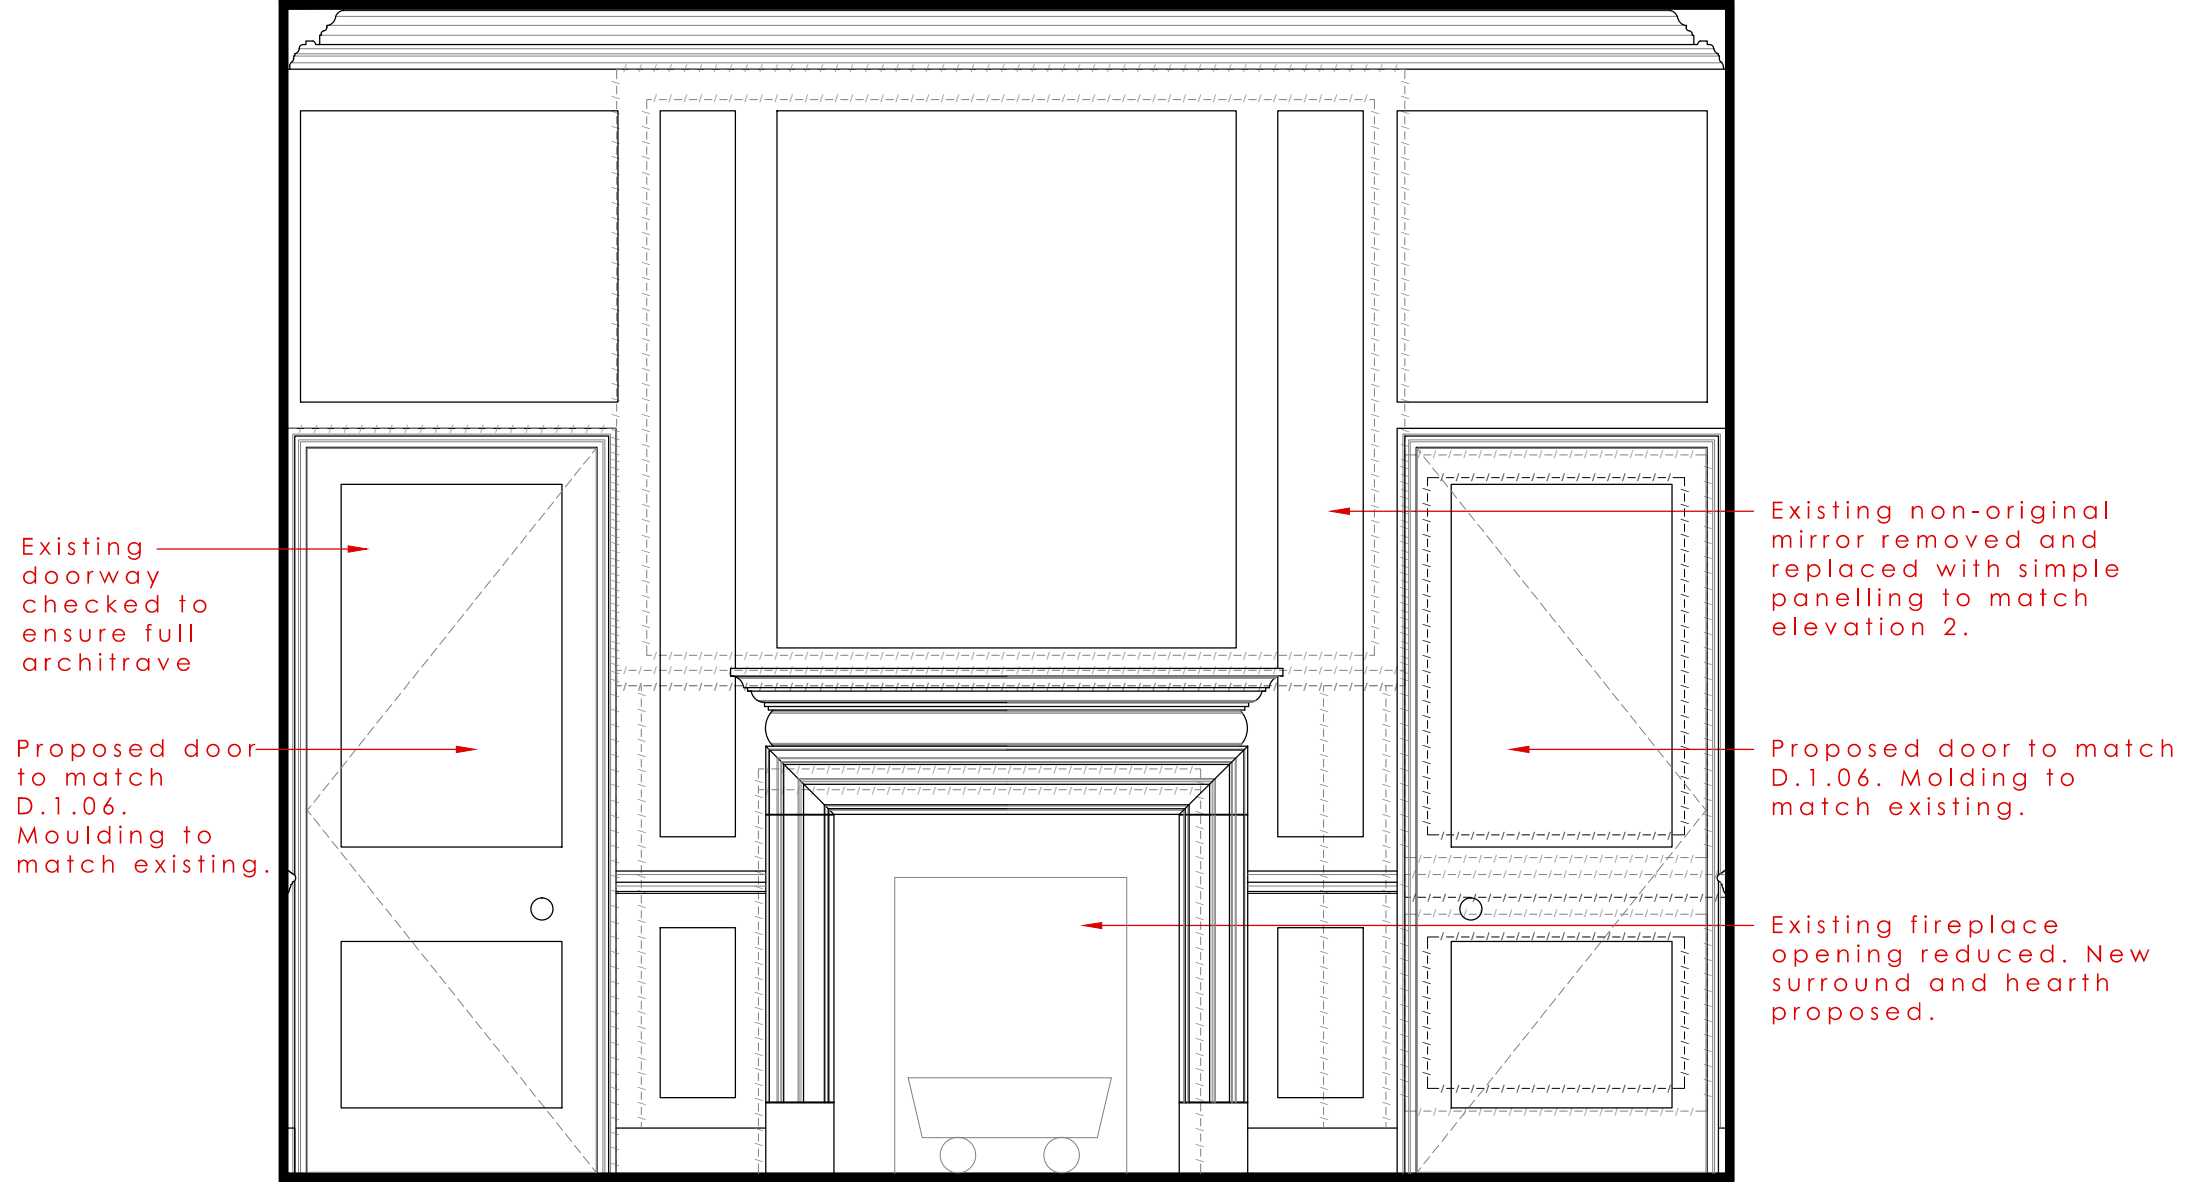
Drawing Room//Existing//Elevation 1_1:20

Existing doorway checked to ensure full architrave

Proposed door to match D.1.06. Moulding to match existing.

Existing non-original mirror removed and replaced with simple panelling to match elevation 2.

Existing fireplace opening reduced. New surround and hearth proposed.

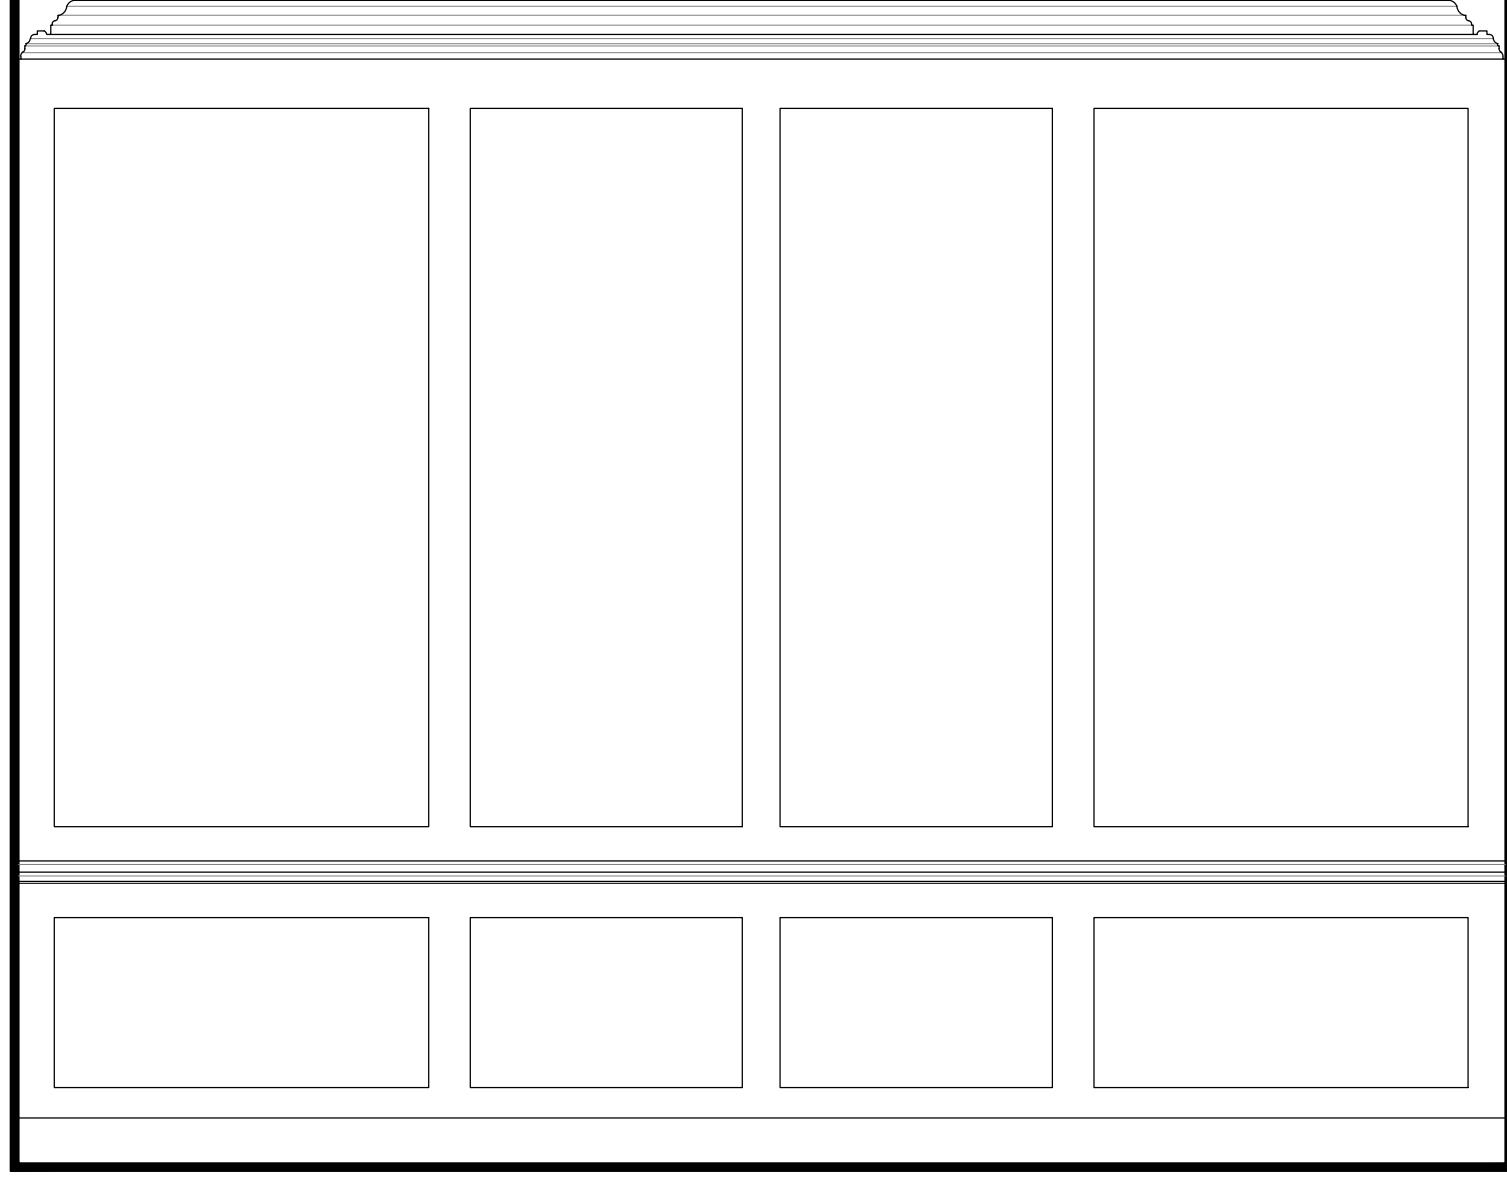
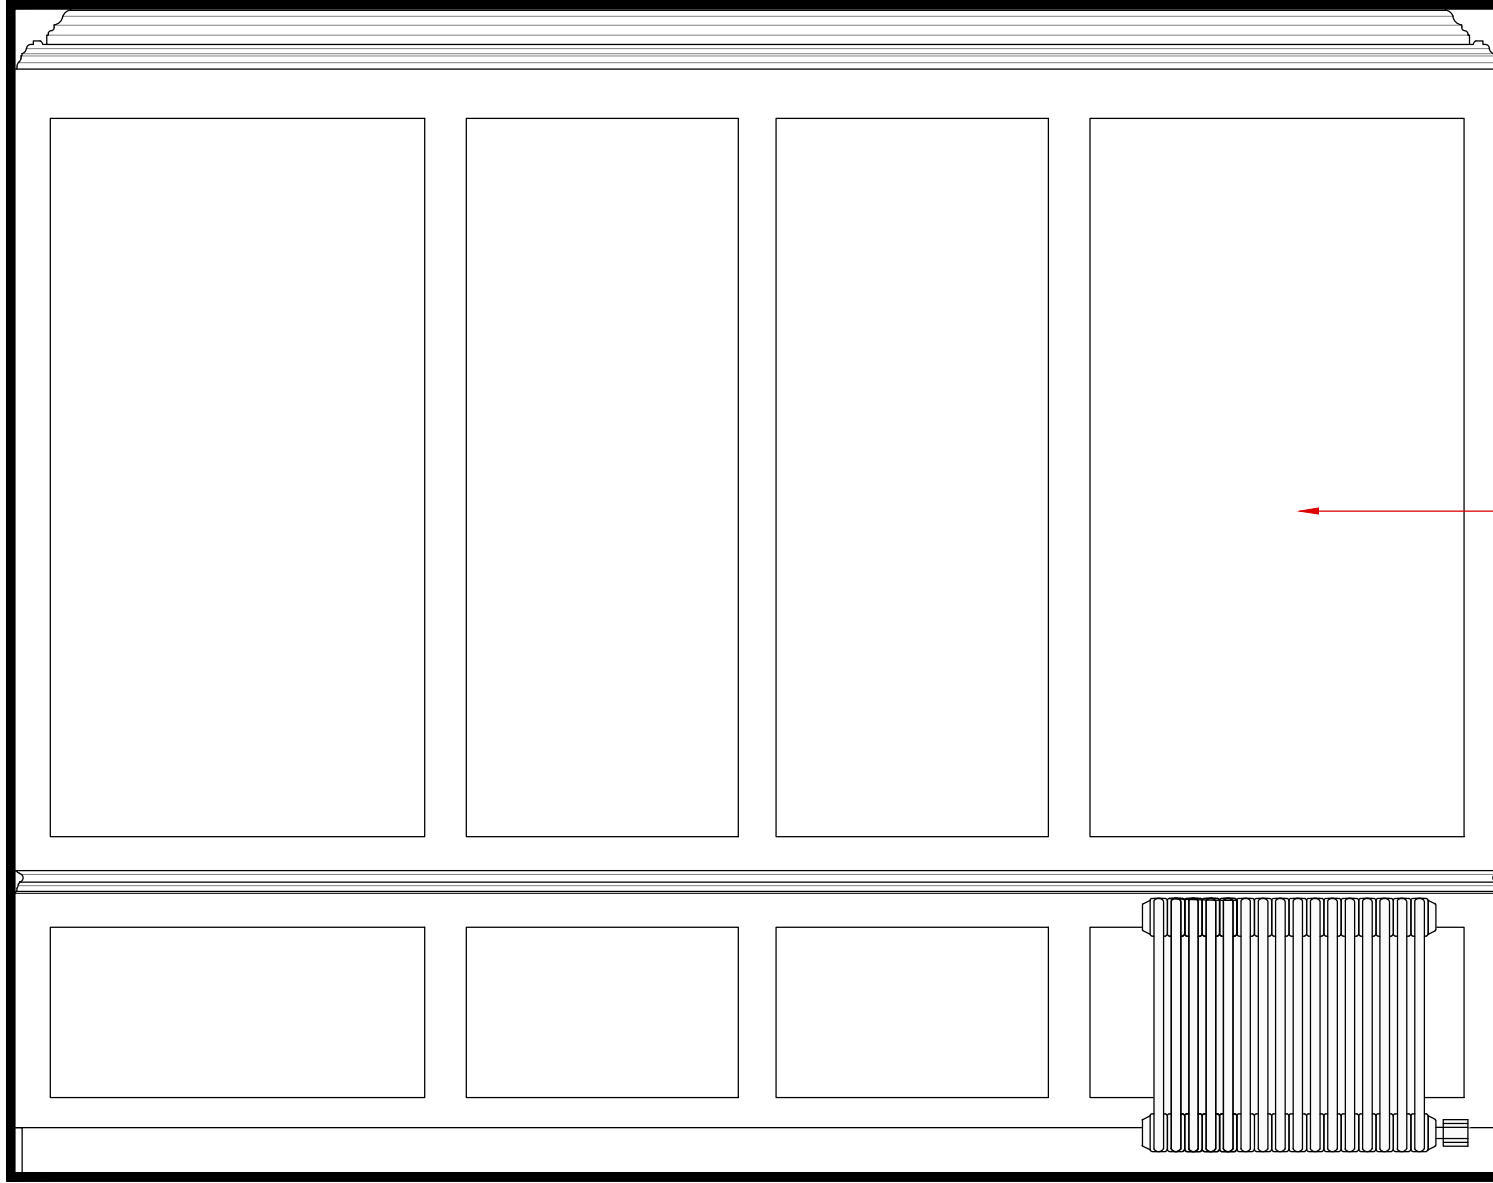
Drawing Room//Existing//Elevation 2_1:20

Existing simple
panelling to remain.
