FIRST FLOOR

1435 - P075

Dining Room//Existing//Plan_1:20

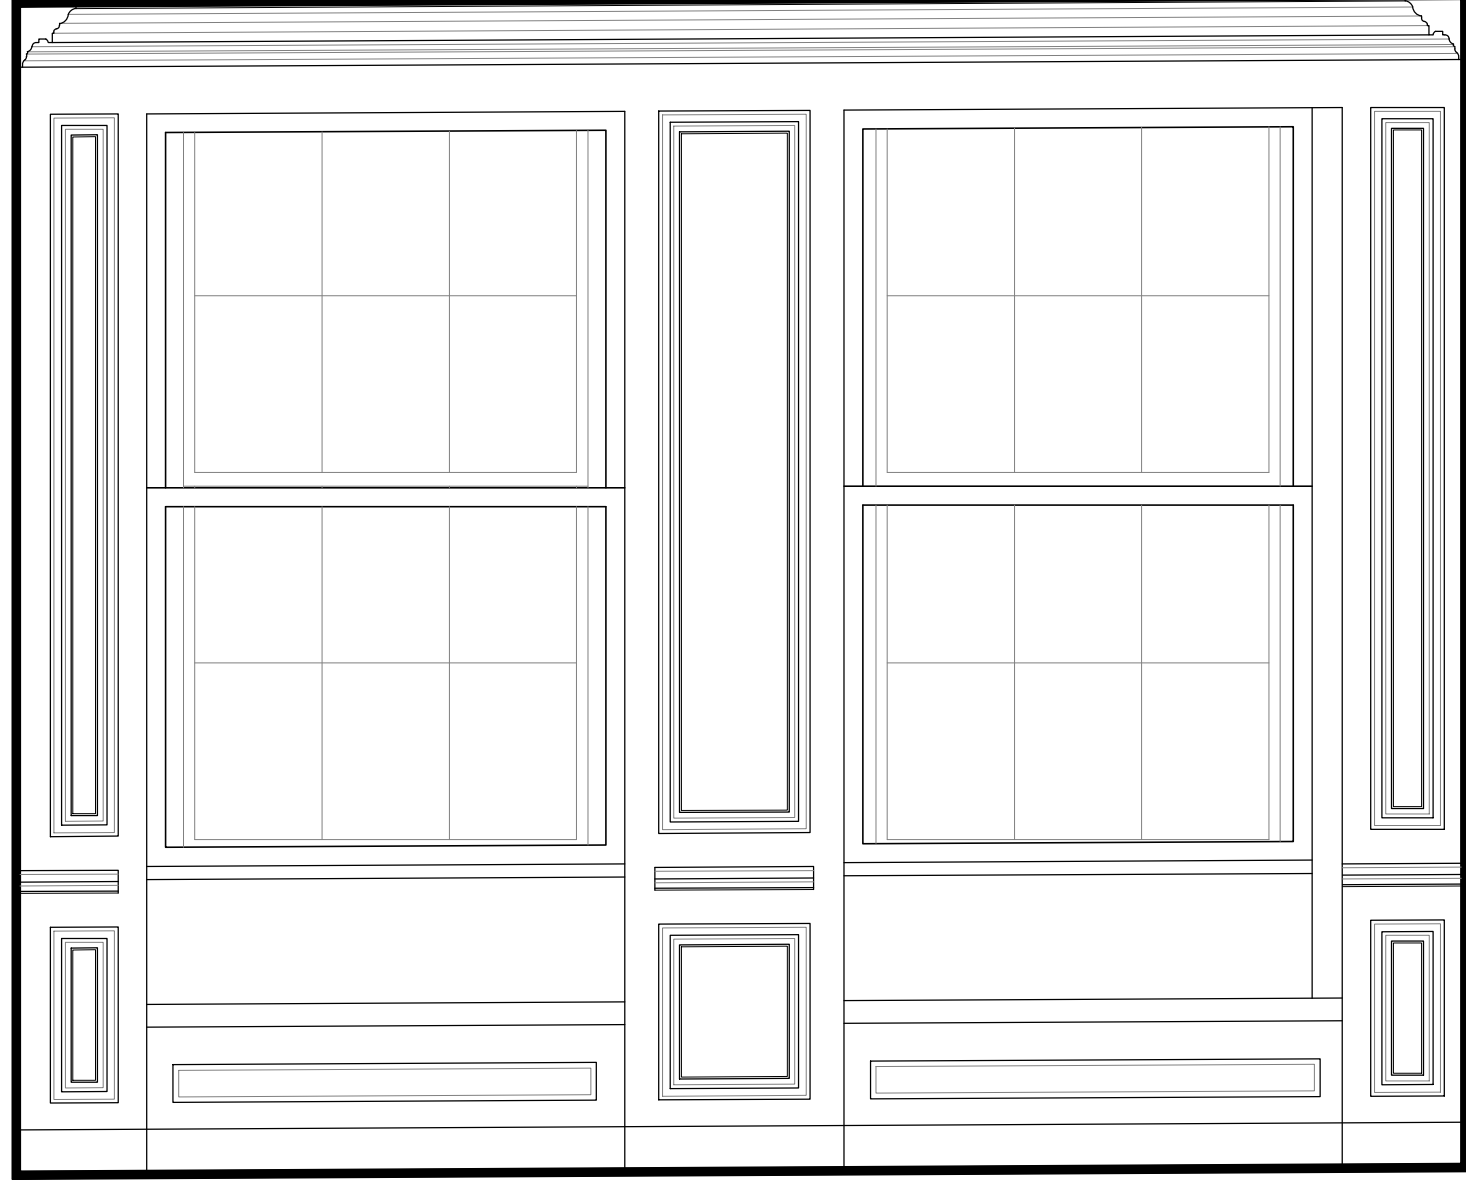
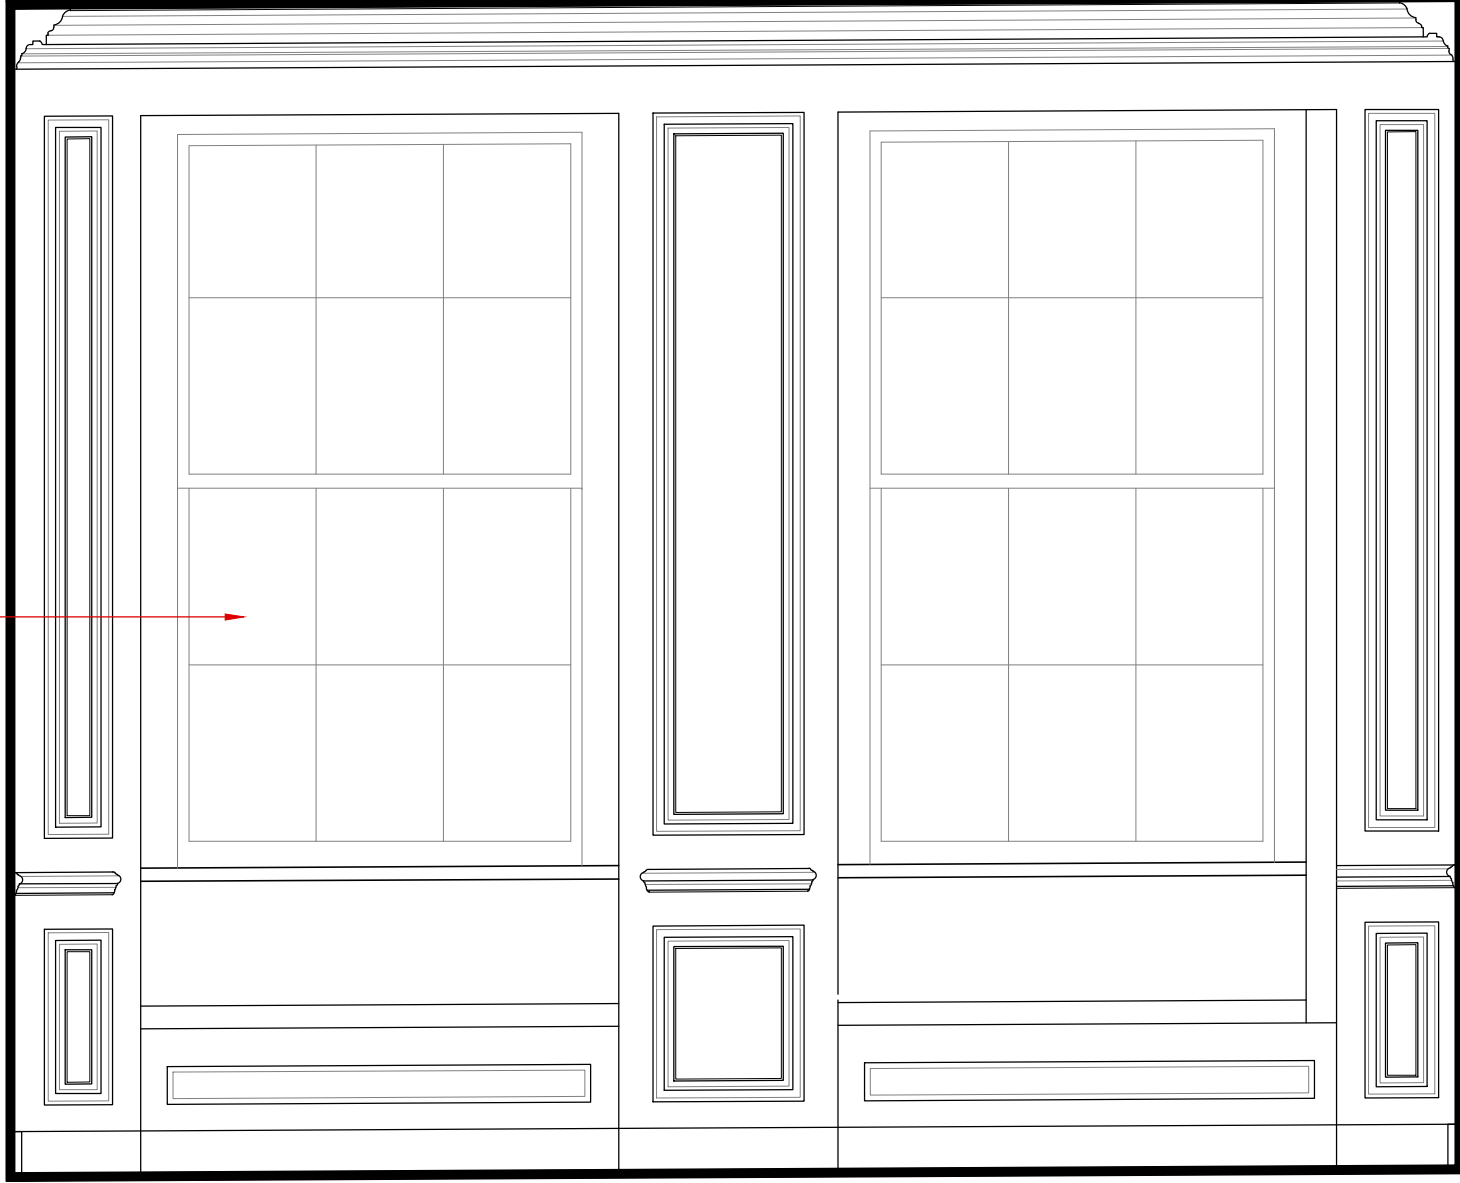
Drawing Room//Existing//Elevation 3_1:20

Existing secondary
glazing removed and
shutters reinstated to
match existing.

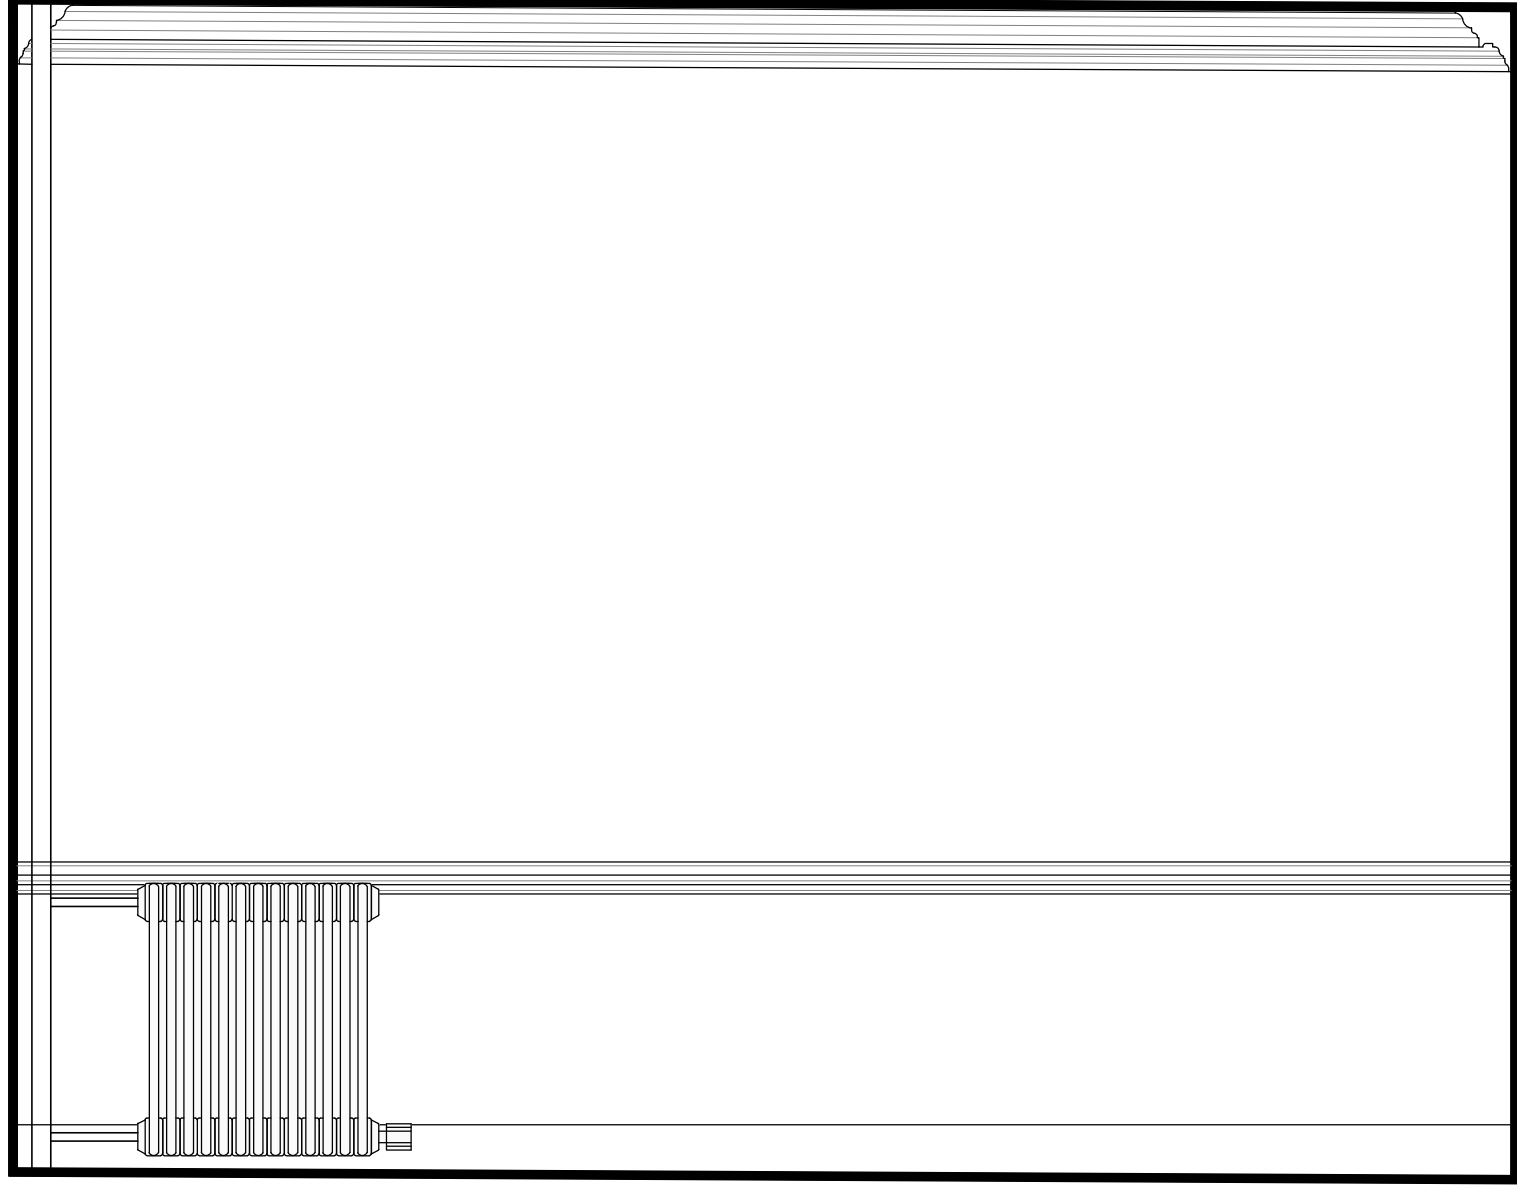
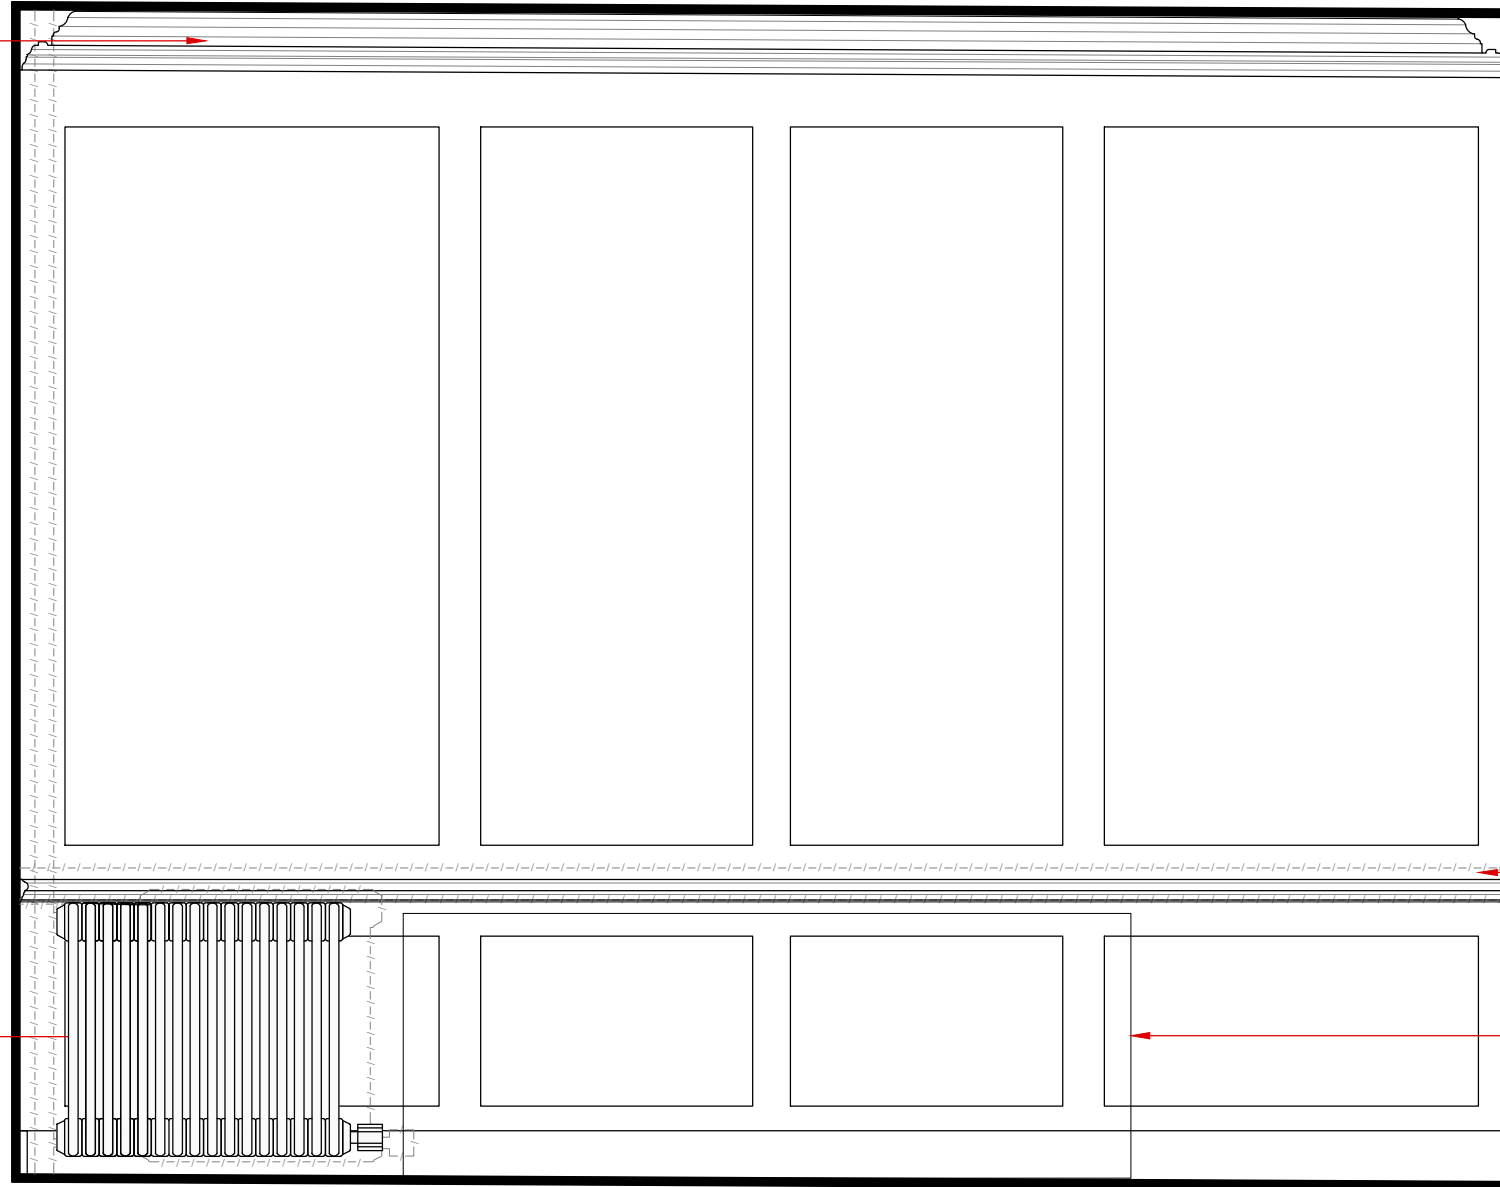
Drawing Room//Existing//Elevation 4_1:20

Existing cornice to be retained.

Existing radiator and pipework removed.

non-original dado removed and replaced with simple panelling to match elevation 2.

Proposed freestanding unit.
