ARBORICULTURAL IMPACT ASSESSMENT

Arboricultural Impact Appraisal and Method Statement

42 Phoenix Road, Camden

27 October 2015
15048-AIA-MW

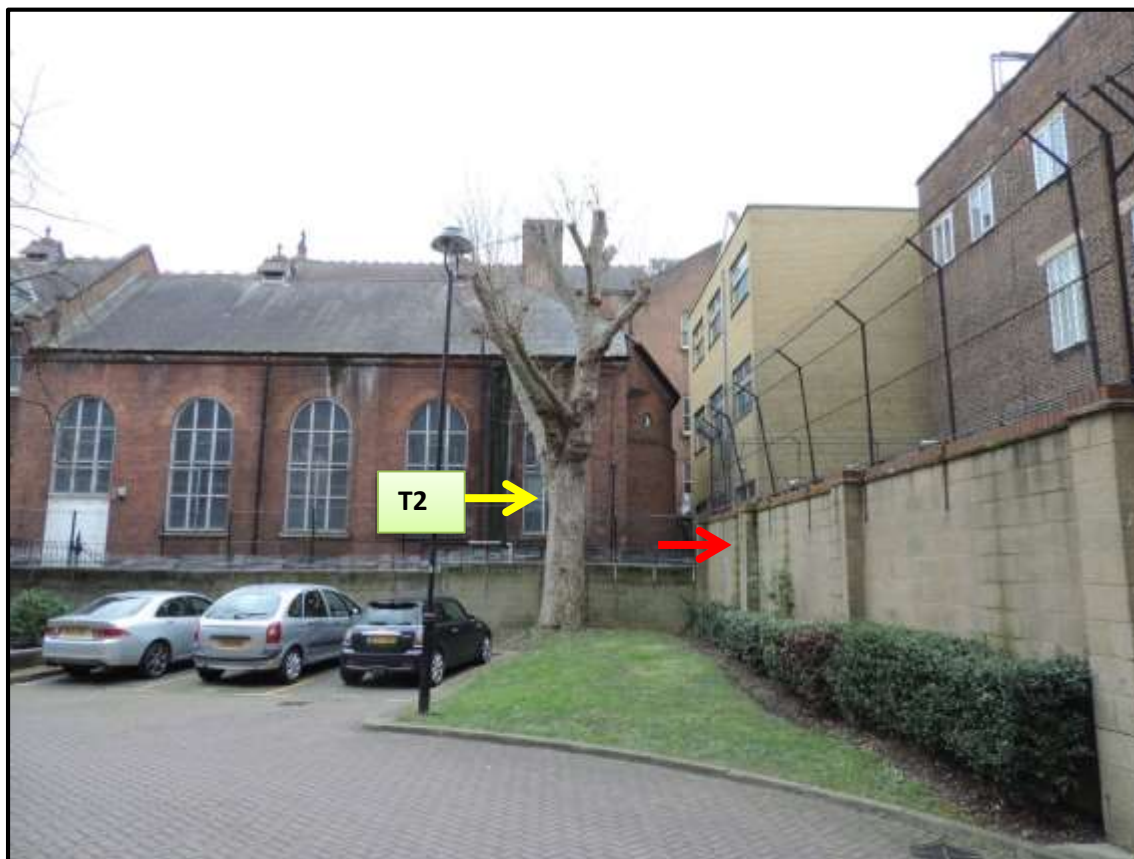
Image 2: The existing boundary wall (red arrow) is likely to be providing a deep barrier for root growth

In terms of T2, the RPA of this tree is presumed to extend into the area proposed for the basement and there is the potential for some roots to be present. However, a deep barrier is likely to have been formed by the existing boundary wall foundations so I believe significant roots are not likely to be growing there. On this basis, I have adjusted the annotated extent of the RPA to take account of what I believe is a reasonable interpretation of where their roots are. The most conducive area for rooting appears to be confined to the surrounding soil and grass areas in Charlton House which can be protected during the construction process (See Image 2 and the attached tree protection plan BT2). As a precaution, before basement works begin, I believe that it would be feasible to first establish the extent of root growth through exploratory digs on the inside edge of the existing boundary wall to ensure there will be no adverse impact on the tree from the proposed excavations. If any significant roots are exposed it may be possible to carefully cut them back to the line of the proposed basement without adversely affecting the trees health or stability (see guidance in Appendix 3, paragraph 7). If sheet piling is the preferred method for installing the basement foundations, further detail as part of a

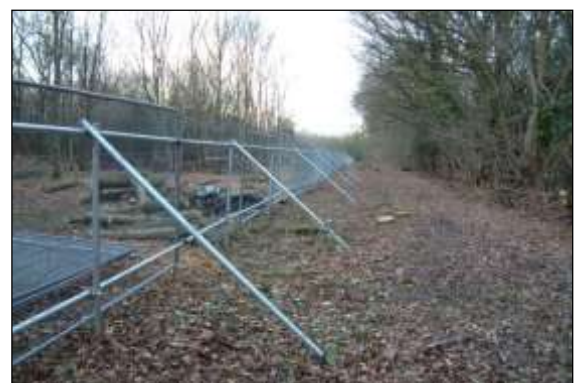
Photo 2: Heras fencing wired to scaffold braced posts is a robust and effective interpretation of the BS specification.

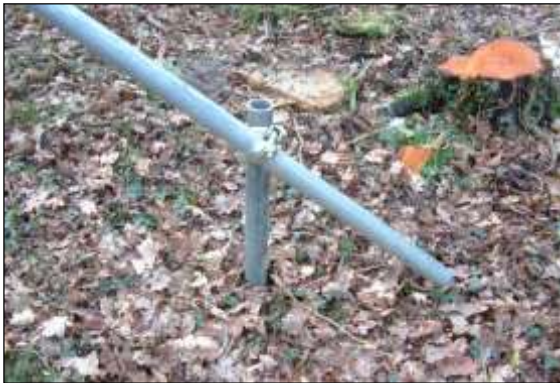
Photo 3: Close up of bracing detail, essential for increasing the stability of the vertical framework.

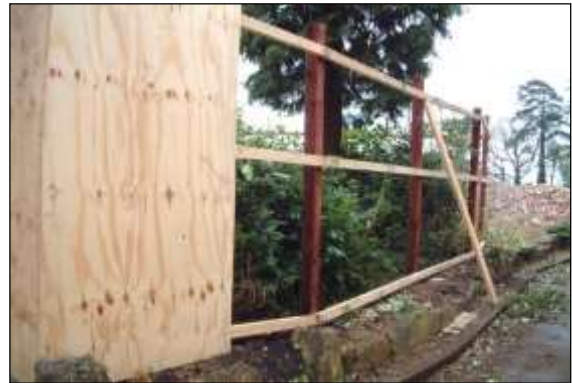
Photo 4: Board specification on secure wooden posts is a suitable alternative to the standard braced scaffold design.

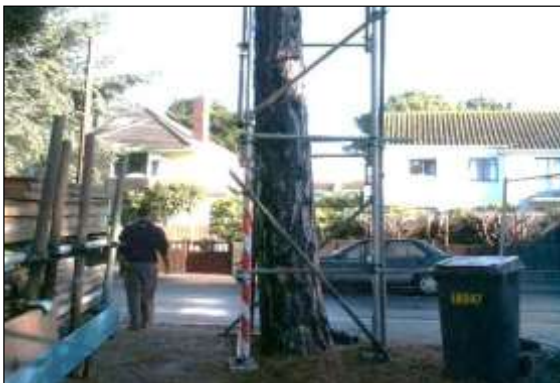
Photo 5: A scaffold braced framework surrounding the trunk reduces the risk of accidental impact.

Where individual trunks or branches are vulnerable to impact damage, a framework of scaffold or wood can be constructed to provide protection (photos 5 and 6).

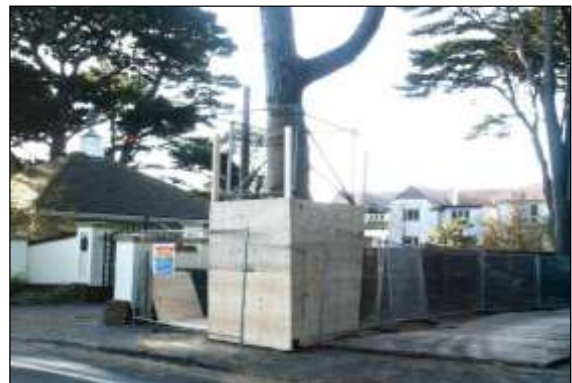
Photo 6: Board secured to scaffold framework adds another layer of protection for vulnerable trunks and branches.

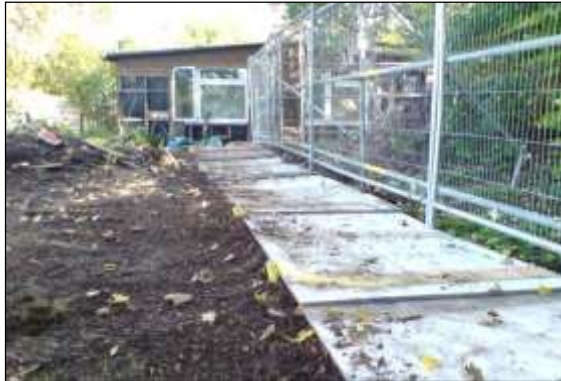
Photo 7: Heavy-duty plywood set onto a compressible woodchip layer and pinned into position is suitable to spread the loading from pedestrian access.

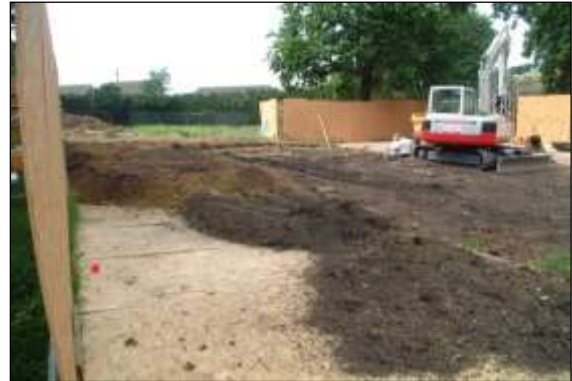
Photo 8: Spreading soil excavated from footings is an effective way of buffering the plywood surface from the wear of light vehicles.

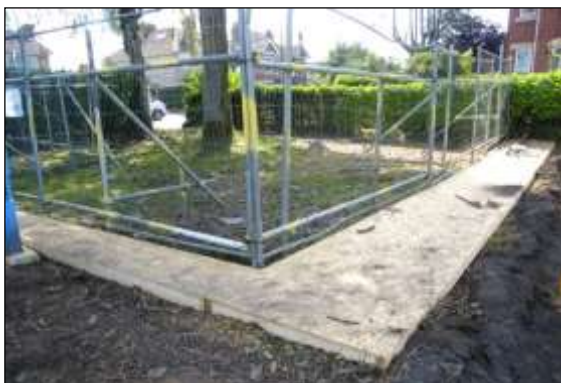
Photo 9: Plywood fixed to a wood frame is another effective method of protecting soil from pedestrian compaction.

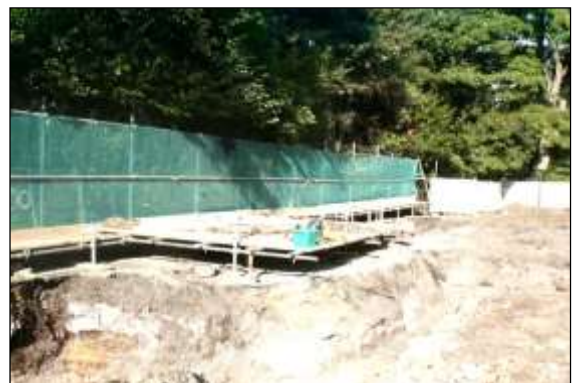
Photo 10: A scaffold framework attached to the main scaffold fencing can be used to support either scaffold planks or plywood to create an elevated platform with a gap beneath.

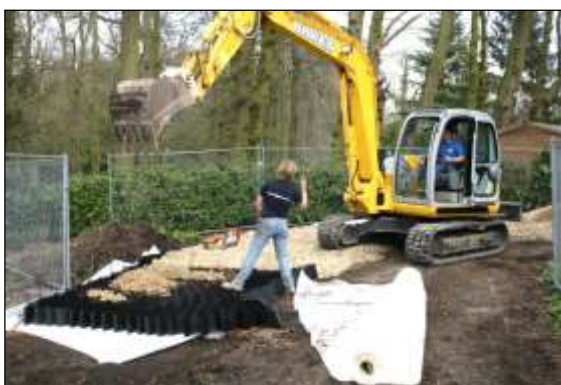
Photo 11: Cellular products are a very effective means of providing ground protection where heavy vehicle use is expected. Here, it is being used to temporarily widen an existing road, to be removed once the construction is finished.

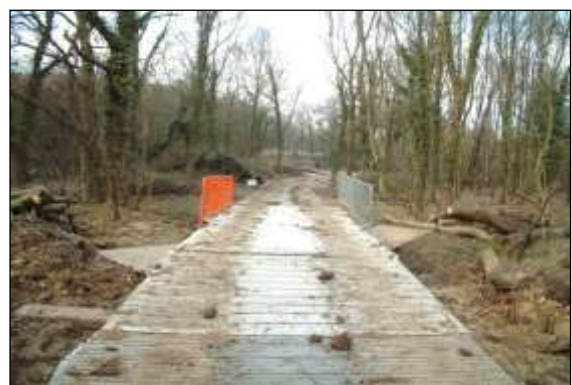
Photo 12: Custom designed sectional tracks can be joined to support very heavy traffic use through sensitive areas.

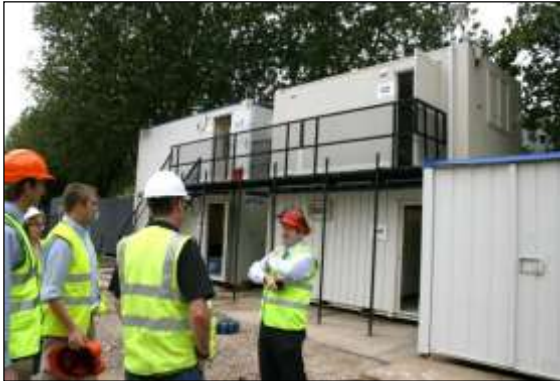
Photo 13: A combination of retaining existing surfacing and using temporary construction cabin accommodation can be a very effective means of preventing damage to sensitive areas.

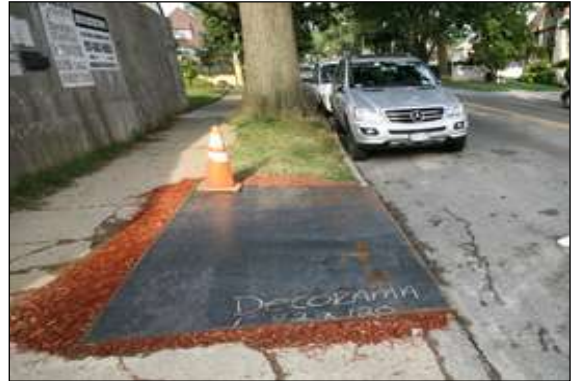
Photo 14: Steel plates can be an effective way of temporarily reinforcing weak surfacing over a construction access during the development activity.

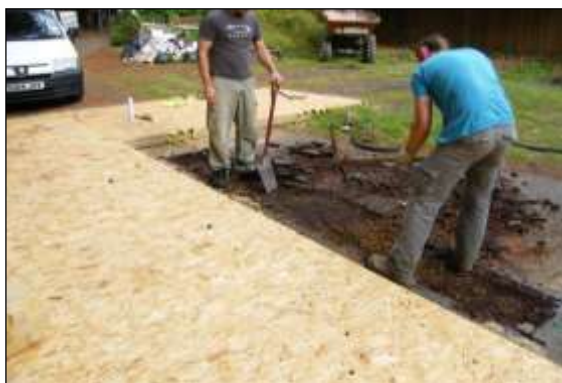
Photo 15: Careful hand-digging using conventional tools is acceptable for exposing roots in RPAs.

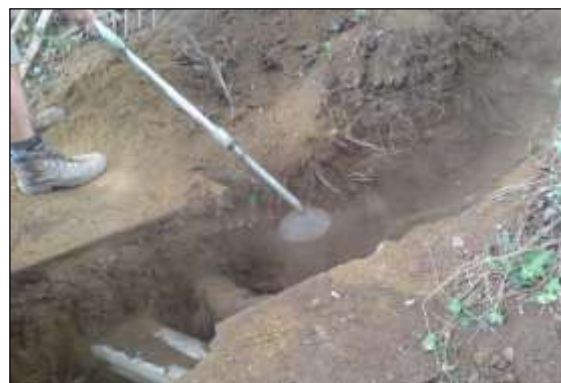
Photo 16: Air spades are very effective at exposing roots and services with minimal damage.

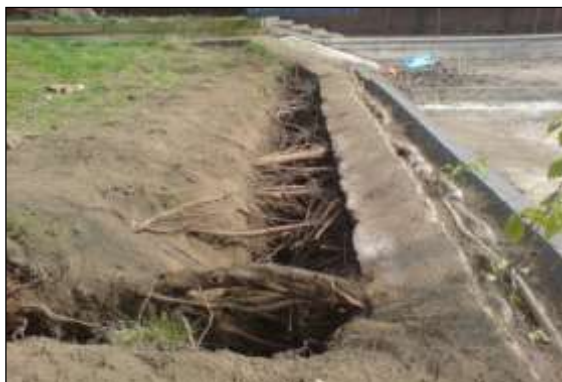
Photo 17: Air spades are particularly useful where roots are very dense.

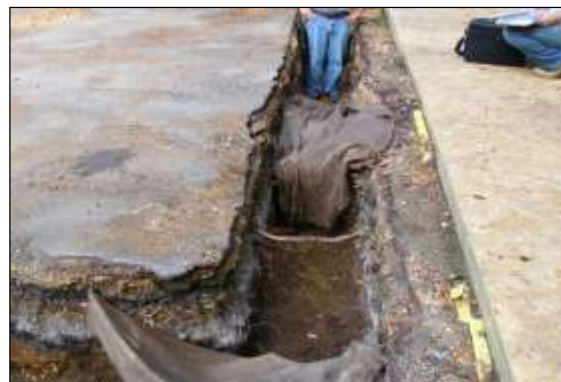
Photo 18: Exposed roots must be protected from light, drying out and extremes of temperature by covering with hessian sacking and boards until they can be covered back with soil.

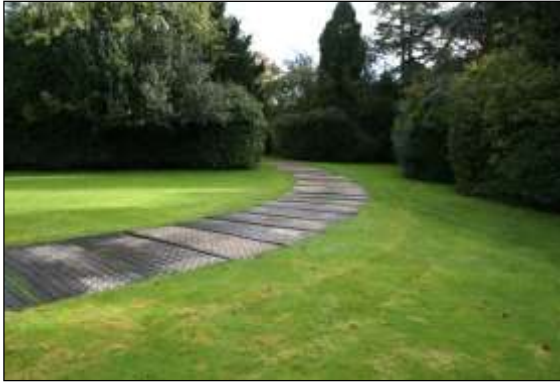
Photo 19: Ground protection must be used where repeated foot or vehicle traffic could cause compaction in sensitive RPAs. It can be as simple as plywood for pedestrians, but must be more robust for vehicles.

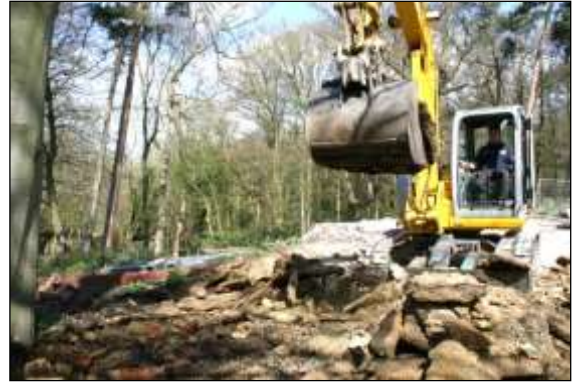
Photo 20: Machines with a long reach can be used to lift out heavy surfacing and structures as long as the machine sits outside the RPA and the exposed surface is protected before there is any further access.

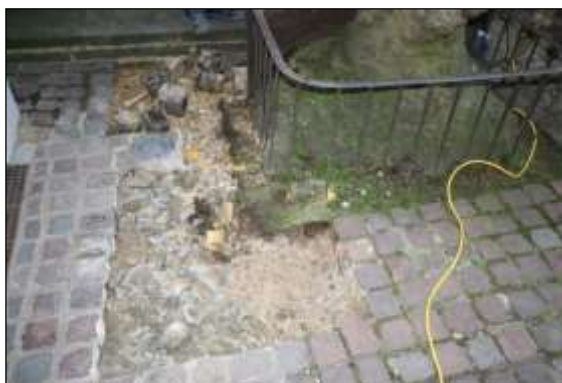
Photo 21: Careful lifting of cemented-in sets round this tree allowed them to be re-laid on a permeable sand base, improving the water input into the soil around the trunk.

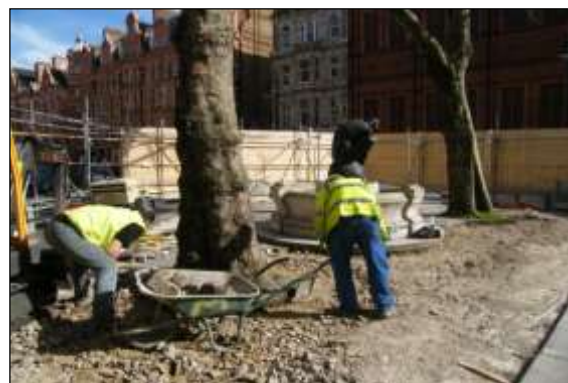
Photo 22: These trees had impermeable surfacing right up to their trunks, which had to be removed by hand before installing new structures.

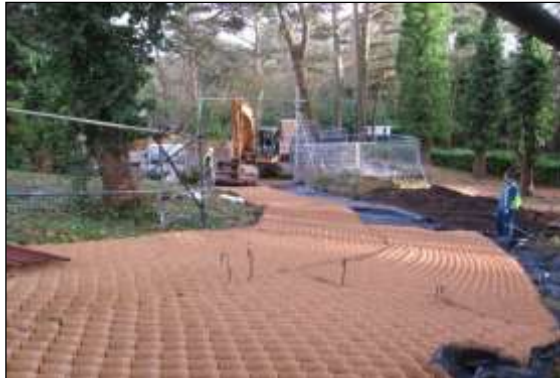
Photo 24: The three-dimensional cells are opened up, spread across the area to be surfaced and pinned in place ready for the stone filling.

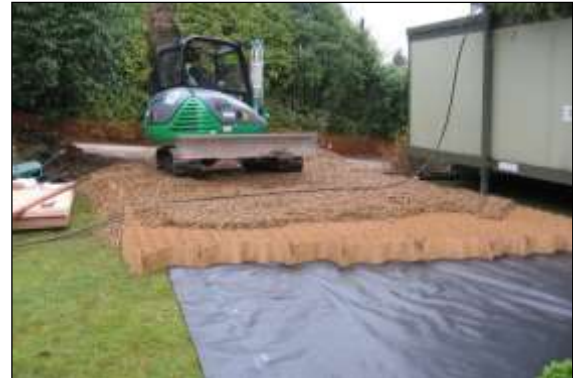
Photo 25: The stone-filled cells spread the load of traffic and the geotextile membrane on the ground prevents migration of the stone into the soil profile.

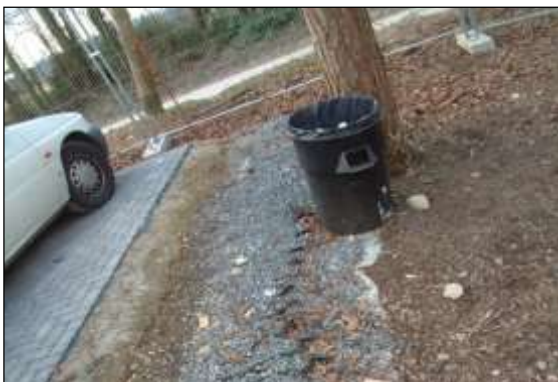
Photo 26: A conventional concrete haunching can be used to retain new surfacing as long as it is not dug into a trench - here is it placed on top of the CellWeb layer.

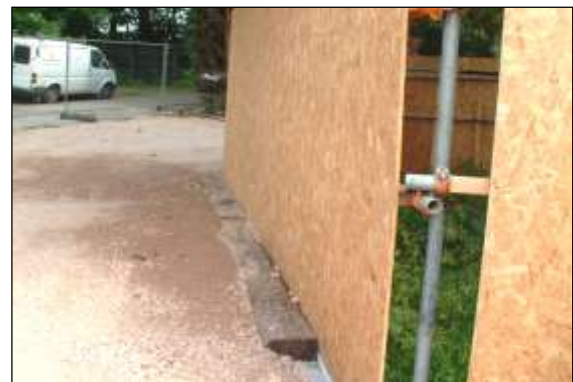
Photo 27: Although this is only a temporary surface, railway sleepers pinned into the ground can be used to retain the edges of new surfacing.

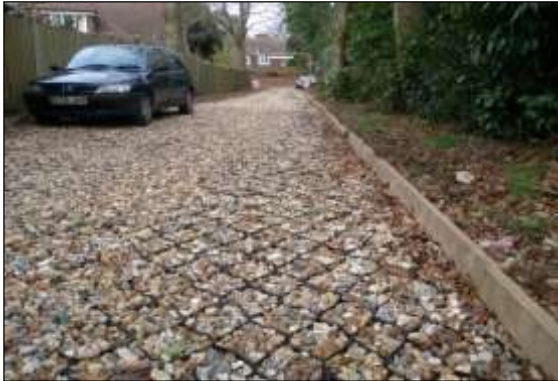
Photo 28: Wooden board pinned in place or held in position with backfilled topsoil can provide more informal and rustic surface edging.

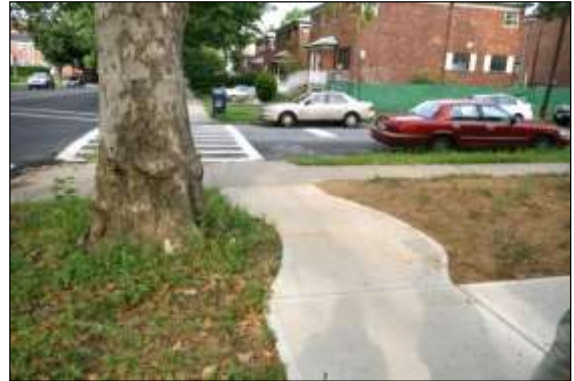
Photo 29: In some situations, it may be appropriate to cast a free floating concrete surface directly onto the soil surface provided provision is made to prevent soil contamination while the concrete is being poured, i.e. an impermeable membrane separating the concrete from the soil.

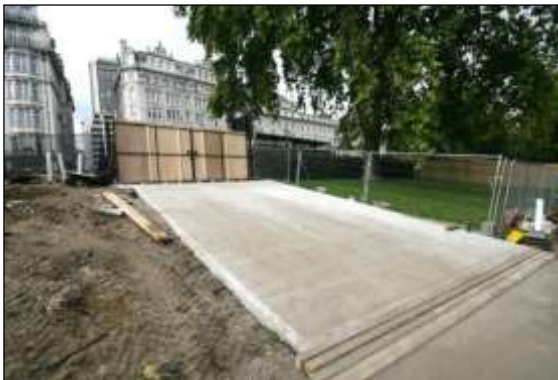
Photo 30: This temporary access for heavy construction traffic on the outer edge of a RPA is a concrete slab cast above ground level and will be removed when the project is completed.

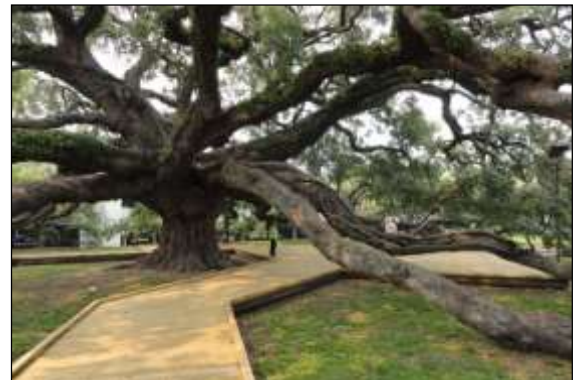
Photo 31: Board walks supported on posts or a light frame are another way of providing pedestrian access across sensitive RPAs.

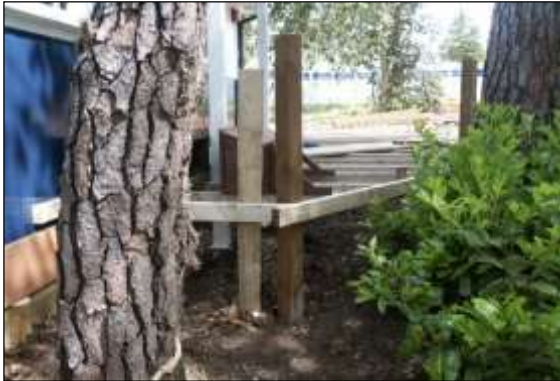
Photo 32: New surfacing can be supported above the ground on posts leaving the soil surface beneath undisturbed.

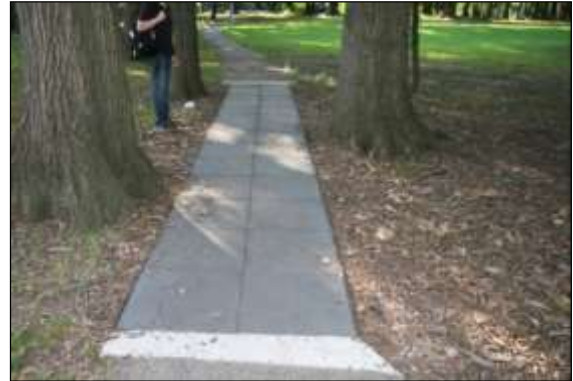
Photo 33: Where surfacing is needed close to rapidly growing buttress roots, a light metal frame with rubberised surfacing will allow the path to distort without cracking as the roots grow.

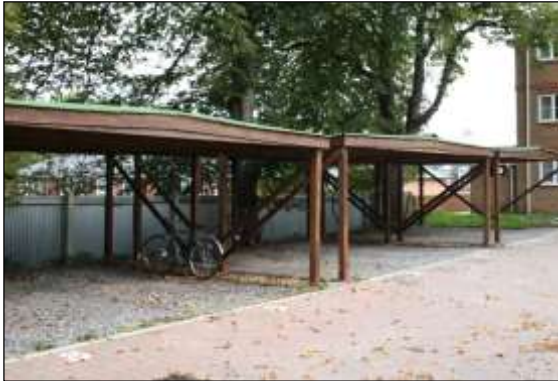
Photo 34: These carports are formed by wooden posts above a three dimensional cellular no-dig and load-spreading surface of permeable crushed stone.

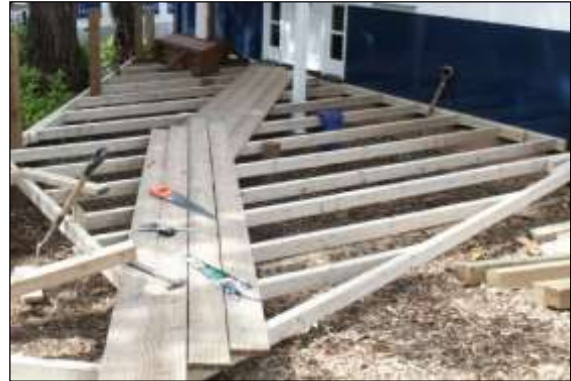
Photo 35: This deck supported above the ground on small posts provides a low-impact alternative to conventional stone patio surfacing in RPAs.

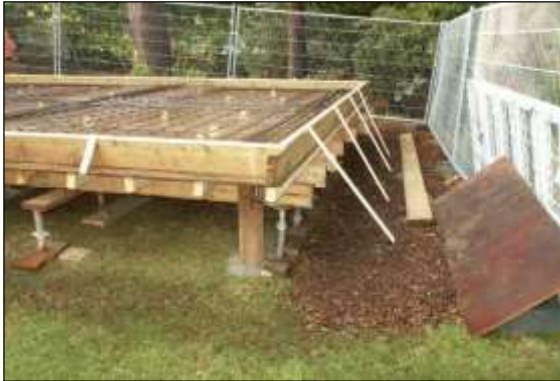
Photo 36: Small diameter piles (less than 150mm) are an effective means of supporting structures in RPAs with minimal disturbance.

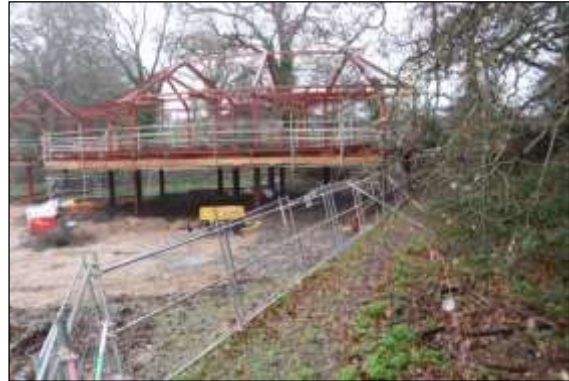
Photo 37: It is possible to support very large structures on piles within sensitive RPAs without any significant adverse impact on tree roots.

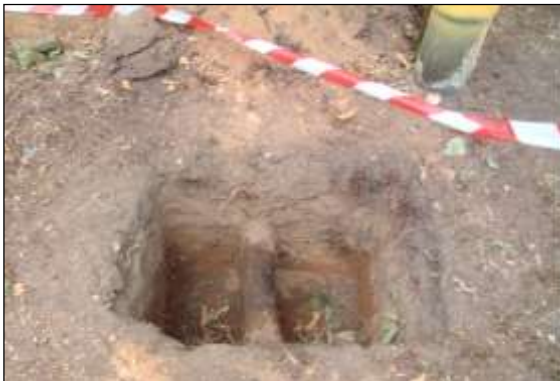
Photo 38: Where piles are proposed close to trunks, it is essential to excavate 50–75cm deep to see if there are any significant roots in the way, with provision to move the pile location if roots are found (note the pile was finally installed to avoid this root).

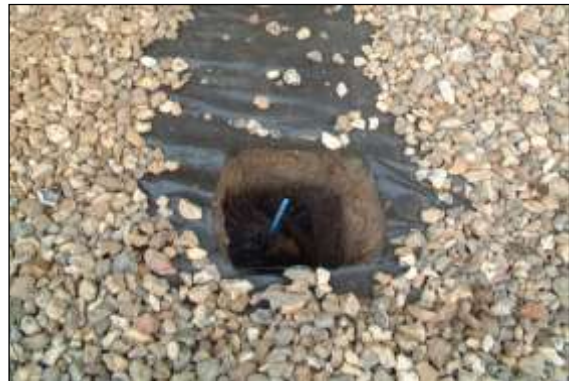
Photo 39: Ground protection must be used to spread the load of the piling rig once excavation has confirmed that no substantial roots are in the preferred pile location.

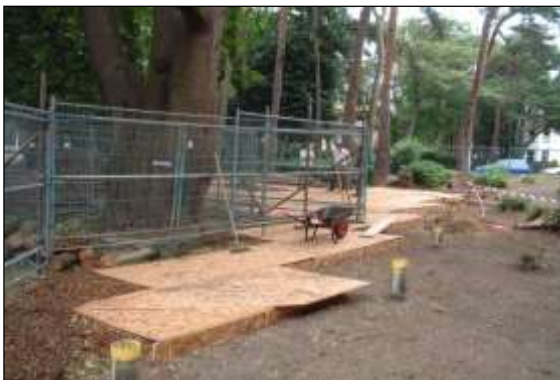
Photo 40: Once the piles have been installed (yellow tops), the ground protection to support the piling rig is removed ready to fix the void-former onto the bare soil, in advance of pouring the building slab.

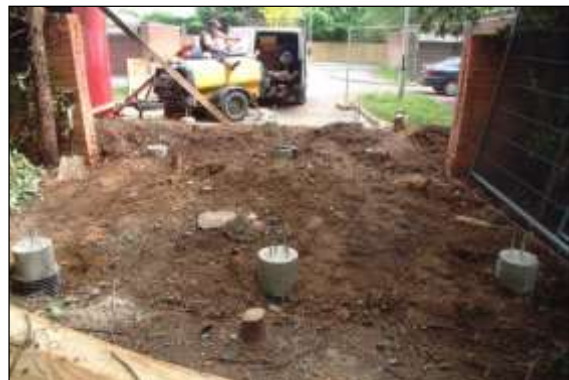
Photo 41: Piles can also be used to support bridges across sensitive RPAs, but the temporary ground protection has to be removed before the main structure is either imported in or cast on site.

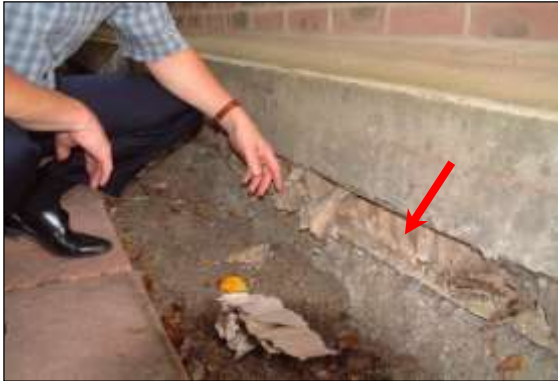
Photo 42: Where a slab is cast on site, a biodegradable void-former (red arrow) temporarily supports the weight of the liquid concrete until it sets. The void-former can then be wetted and washed away to leave a void or left to degrade naturally, both of which allow movement of air beneath the slab.

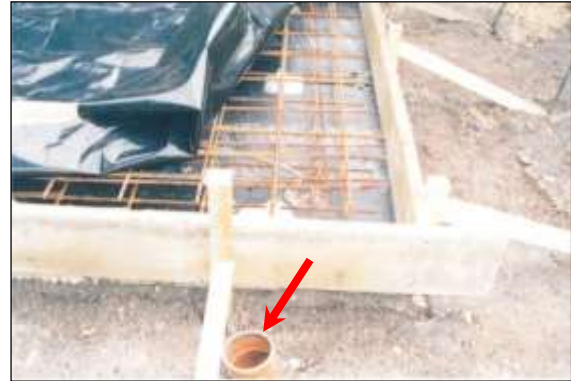
Photo 43: This reinforced base slab for a double garage has drainage provision (red arrow) beneath the structure to redirect roof runoff to supply roots with water.

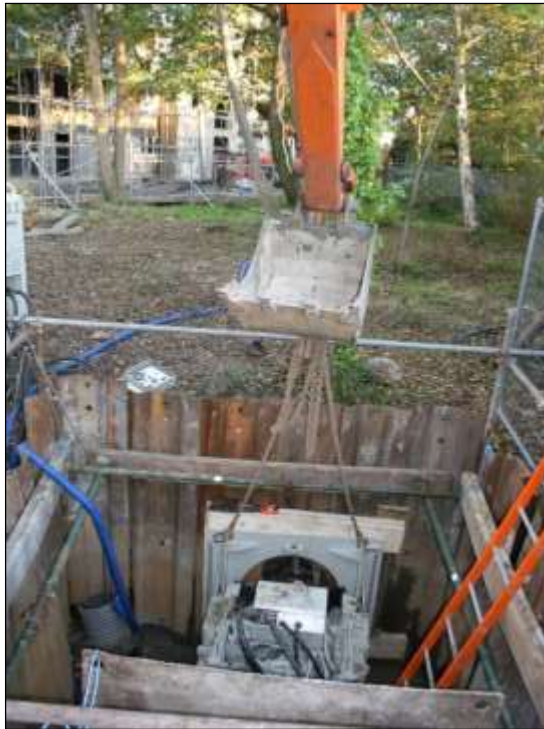
Photo 44: If possible, thrust boring is the preferred option for installing service routes through the RPAs of important trees, but there has to be space at the start and finish to dig substantial working pits.

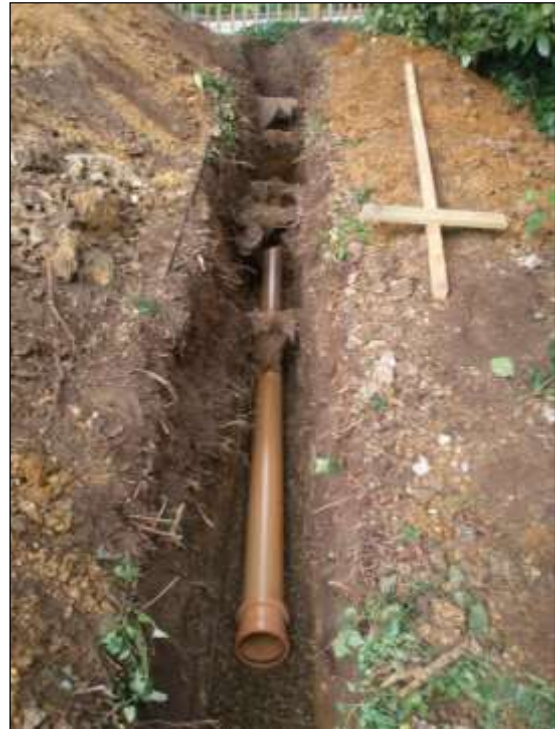
Photo 45: Continuous trenches dug by hand so that important roots can be retained (with the service ducting threaded beneath) is an effective means of minimising damage (note the ground protection boards with soil piled on top on the left).

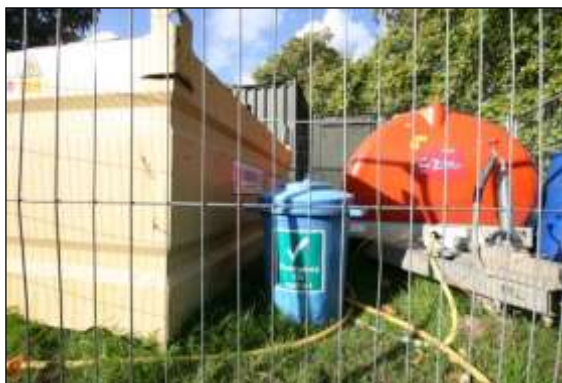
Photo 46: Where fuel or other chemicals are stored on site, it is now standard practice to have emergency spillage kits available to restrict the environmental impact of accidents.

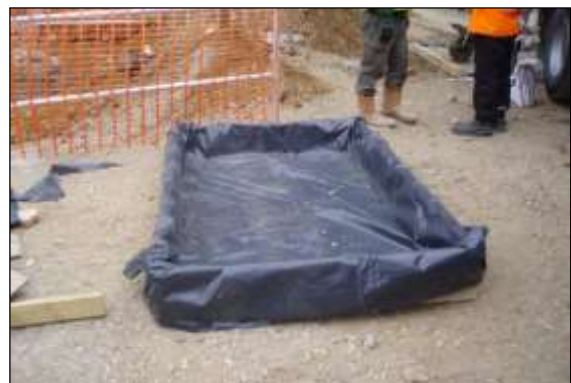
Photo 47: Soil bunding or a supporting framework covered in heavy-duty plastic sheeting is essential where there is a risk of spillages contaminating RPAs. This specifically applies to cement mixing areas and vehicle washing facilities.

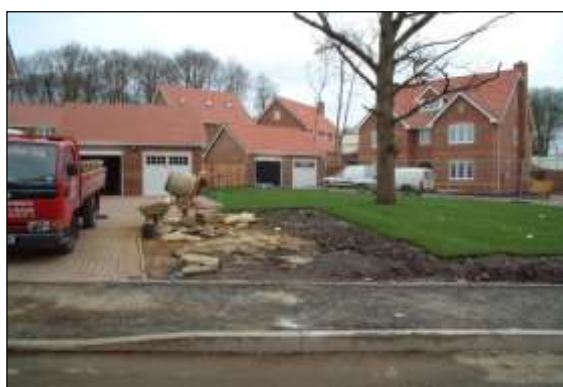
Photo 48: The RPA of this tree was not effectively protected during construction and excessive compaction of the soil meant it died soon after this turf covered up the damage.

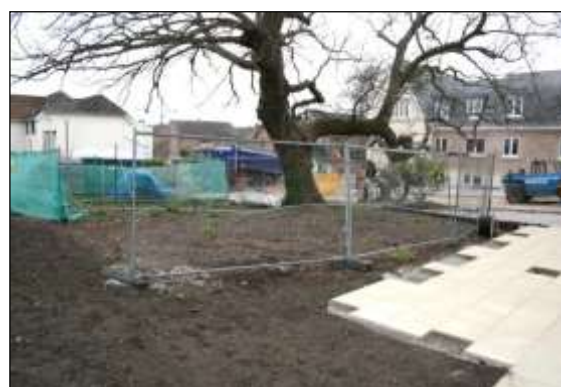
Photo 49: This tree had tarmac parking within its RPA that was removed and replaced with an organic mulch near the trunk and limited no-dig surfacing on the outer edges of its RPA.

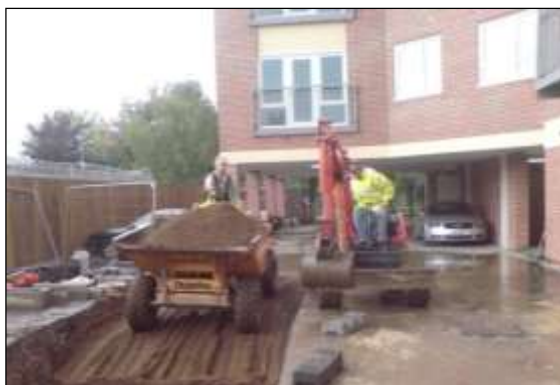
Photo 53: Structural tree soil retains sufficient structure for tree roots to grow, even when compacted.

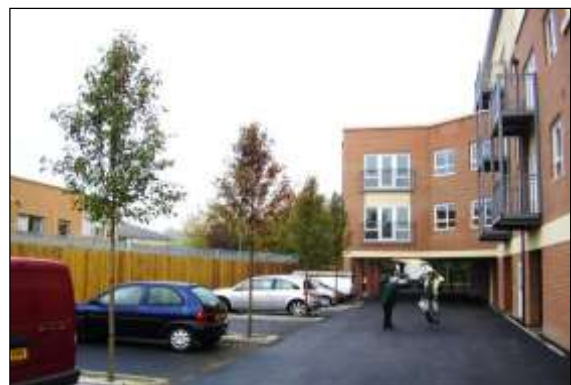
Photo 54: It allows trees to be successfully established in areas of extensive hard surfacing, with very little, if any, loss of parking space

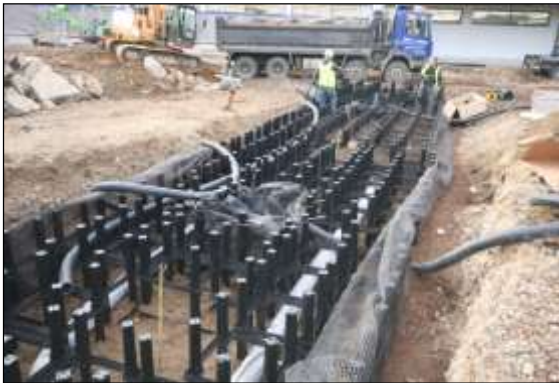
Photo 55: The individual Silva Cells can be assembled in layers and service ducting threaded through before filling with soil and fitting the reinforced tops.

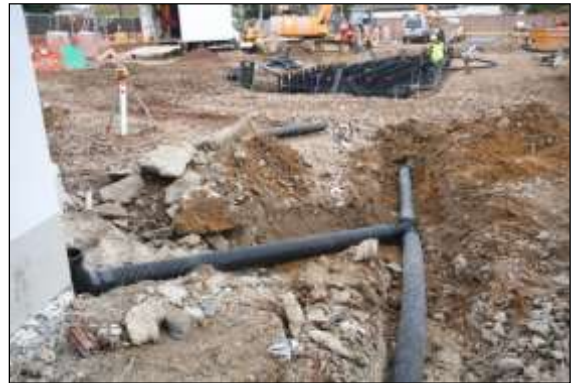
Photo 56: Drainage from adjacent buildings can be directed into Silva Cells, significantly buffering rainwater runoff from urbanised areas.

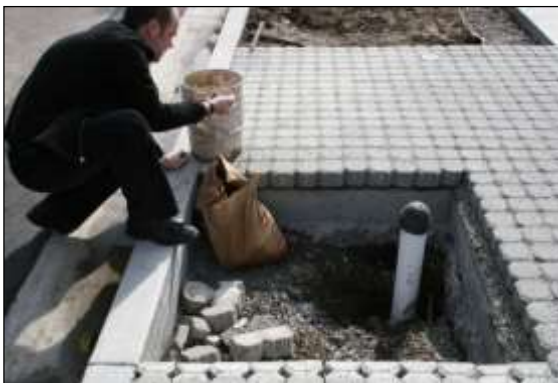
Photo 57: The finished surfacing is profiled to leave the tree pit open, ready to be filled with good quality topsoil and the new tree.

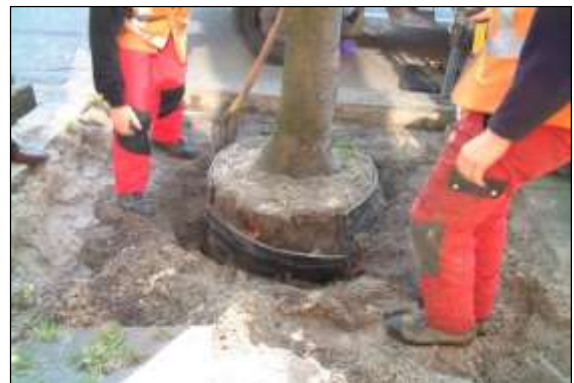
Photo 58: This excavated tree shows the root deflectors that were installed when it was planted seven years previously. The product has deflected roots downwards and prevented damage to the adjacent surfacing. Note that this is a permeable sandy soil and the roots were able to grow beneath the bottom of the deflectors.
