Arboricultural Method Statement (AMS)

For 71a Dartmouth Park Road, London NW5

Ref: TH1119

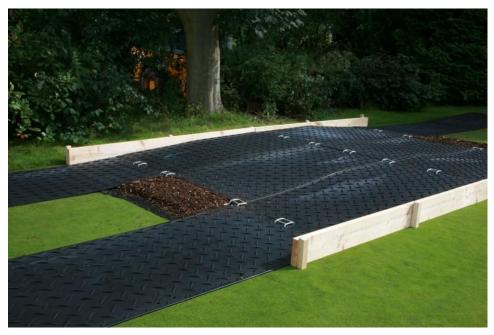
Figure 1: An example of ground protection

Temporary ground protection shall be placed in the areas shown by blue diagonal lines on the TPP, and shall comprise a geotextile membrane (eg *Terram - see link below*), topped with a **minimum** depth of 100mm compressible fill (such as wood chip); these are the base layers.

For the main, top layer: In the event that only pedestrian access is required over the protected areas, then exterior grade (marine) ply boards shall be used (usually 2.4 x 1.2m in size).

If vehicular access is required, proprietary ground protection such as Greentek 'ground guards' (see link below) shall be used. These ground protection mats range in sizes from $2.4 \times 1.2m$ down to $1.8 \times 0.6m$. An example of this specification is shown in Figure 1.
