# **GEOTECHNICAL**

# for Subsidence Management Services

# 96 Haverstock Hill, Lower Belsize Park, London, NW3 2BD

# **SOIL ANALYSIS**

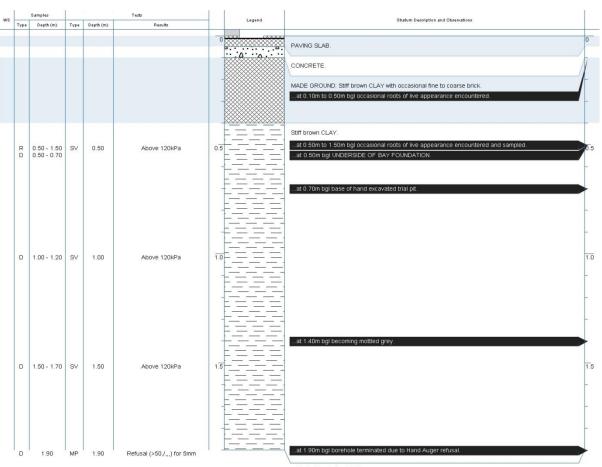
# TP/BH1 Foundation Detail and Borehole Log

## **Foundation Detail**

Bay foundation comprised of brick wall to 100mm bgl, bearing on stepped brickwork to 500mm bgl with a total projection of 200mm from the brick wall.

Underside of foundation (USF) was exposed to 150mm back from the face of the foundation.

End of borehole at 1.90m - Borehole completed by hand auger. Roots encountered to 1.50m bgl. Groundwater strikes no encountered.

Bay foundations were exposed and the underside of foundation (USF) confirmed to be 0.50m bgl in TP/BH 1.

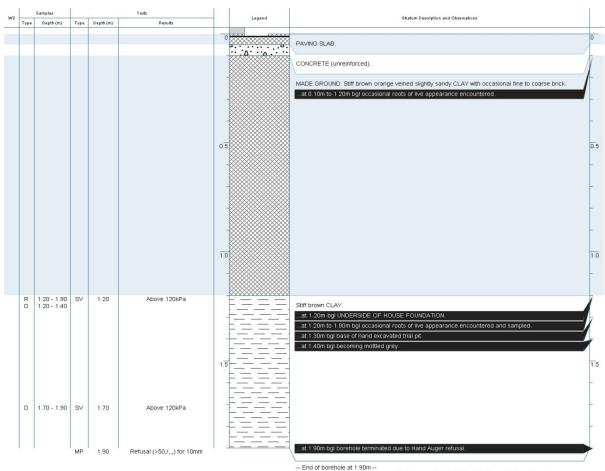
# TP/BH2 Foundation Detail and Borehole Log

## **Foundation Detail**

House foundation comprised of brick wall to 600mm bgl, bearing on concrete to 750mm bgl with a total projection of 50mm from the brick wall. In turn, bearing on stepped brickwork to 1200mm bgl with a total projection of 300mm from the brick wall. Underside of foundation (USF) was exposed to 100mm back from the face of the foundation.

-- End of borehole at 1.90m --Borehole completed by hand auger. Roots encountered to 1.90m bgl. Groundwater strikes no encountered.

House foundations were exposed and the underside of foundation (USF) confirmed to be 1.20m bgl in TP/BH 2.

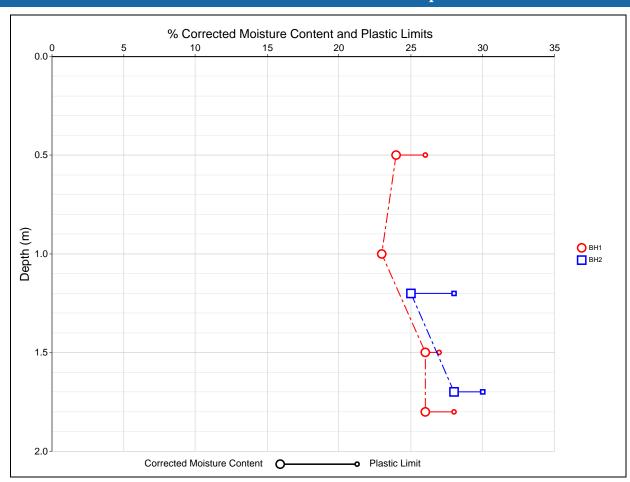
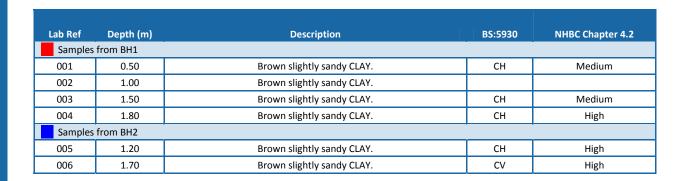
# **Corrected Moisture Content and Plastic Limits Graph**

Where appropriate moisture contents have been corrected to demonstrate the equivalent moisture content following the sample being passed through a .425 mm sieve for comparison with the Liquid & Plastic Limit. Where this is not available, uncorrected moisture contents have been used in the graph on the following page.

Lab Ref	Depth (m)	MC (%)	Corr MC (%)	LL (%)	PL (%)	PI (%)	% Passing .425mm
Samples fro	Samples from BH1						
001	0.50	24	24	62	26	36	100
002	1.00	23					
003	1.50	26	26	65	27	38	100
004	1.80	26	26	68	28	40	100
Samples from BH2							
005	1.20	25	25	69	28	41	100
006	1.70	28	28	71	30	41	100

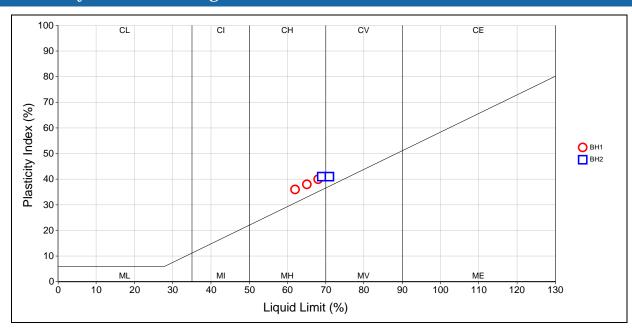
# **Plasticity Chart for Casagrande Classification**

The following provides a brief interpretation of the test results by comparison of the results to published classifications. The Atterberg Limit test may be used to classify the plasticity of soils; the plasticity classes defined in BS5930:1999 "Code of Practice for Site Investigations" are as follows.

CL (ML)	CLAY and CLAY/SILT of Low plasticity
CI (MI)	CLAY and CLAY/SILT of Intermediate plasticity
CH (MH)	CLAY and CLAY/SILT of High plasticity
CV (MV)	CLAY and CLAY/SILT of Very High plasticity
CE (ME)	CLAY and CLAY/SILT of Extremely High plasticity
0	The letter O is added to prefixes to symbolise a
	significant proportion of organic matter.
NP	Non-plastic

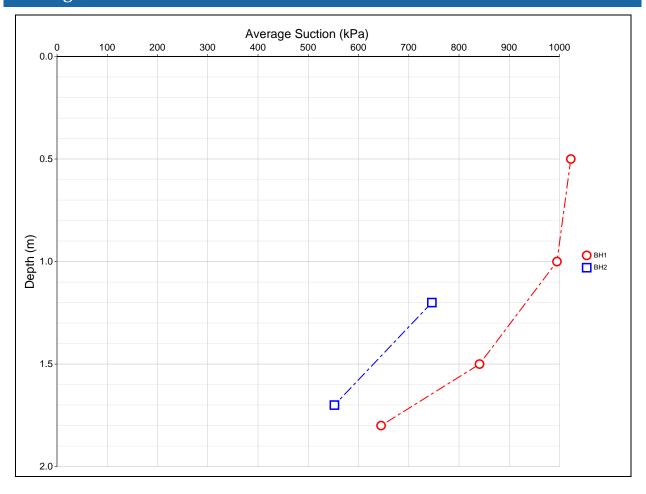
# Average Suction

Lab Ref	Depth (m)	Filter Paper	Bag Weight (g)	Bag + Wet Filter (g)	Bag + Dry Filter (g)	Oven Dry Filter (g)	Water Content (%)	Suction (kPa)	Average (kPa)
Samples	from BH1	<b>T</b>	4 200	1.789	1.679	0.272	20.640	006.044	
		Тор	1.308			0.372	29.610	996.041	1022.905
001	0.50	Middle	1.298	1.777	1.669	0.371	29.118	1068.656	
		Bottom	1.302	1.784	1.674	0.372	29.554	1004.017	
		Тор	1.298	1.777	1.666	0.369	30.122	925.559	995.576
002	1.00	Middle	1.295	1.770	1.664	0.370	28.687	1136.692	
		Bottom	1.301	1.780	1.669	0.368	30.130	924.476

1.50	Тор	1.293	1.780	1.666	0.373	30.579	866.885	841.326
003		Middle	1.292	1.778	1.663	0.371	30.997	816.522	
		Bottom	1.294	1.770	1.658	0.364	30.795	840.573	
		Тор	1.303	1.802	1.679	0.376	32.739	636.270	645.715
004	1.80	Middle	1.305	1.788	1.669	0.364	32.710	638.882	
		Bottom	1.299	1.780	1.662	0.364	32.462	661.992	
Samples	from BH2								
		Тор	1.295	1.774	1.658	0.363	31.938	713.569	746.576
005	1.20	Middle	1.299	1.785	1.669	0.370	31.360	775.209	
		Bottom	1.308	1.791	1.675	0.367	31.582	750.950

1.70	Тор	1.303	1.800	1.675	0.373	33.557	565.916	552.081
006		Middle	1.296	1.801	1.672	0.376	34.318	507.508	
		Bottom	1.301	1.789	1.667	0.366	33.352	582.818
