Kitchen restoration details

ALEXANDRA RD. ESTATE

drawing 1:1@A1 Restored sinks

drawn checked drawing number 2504_A_547

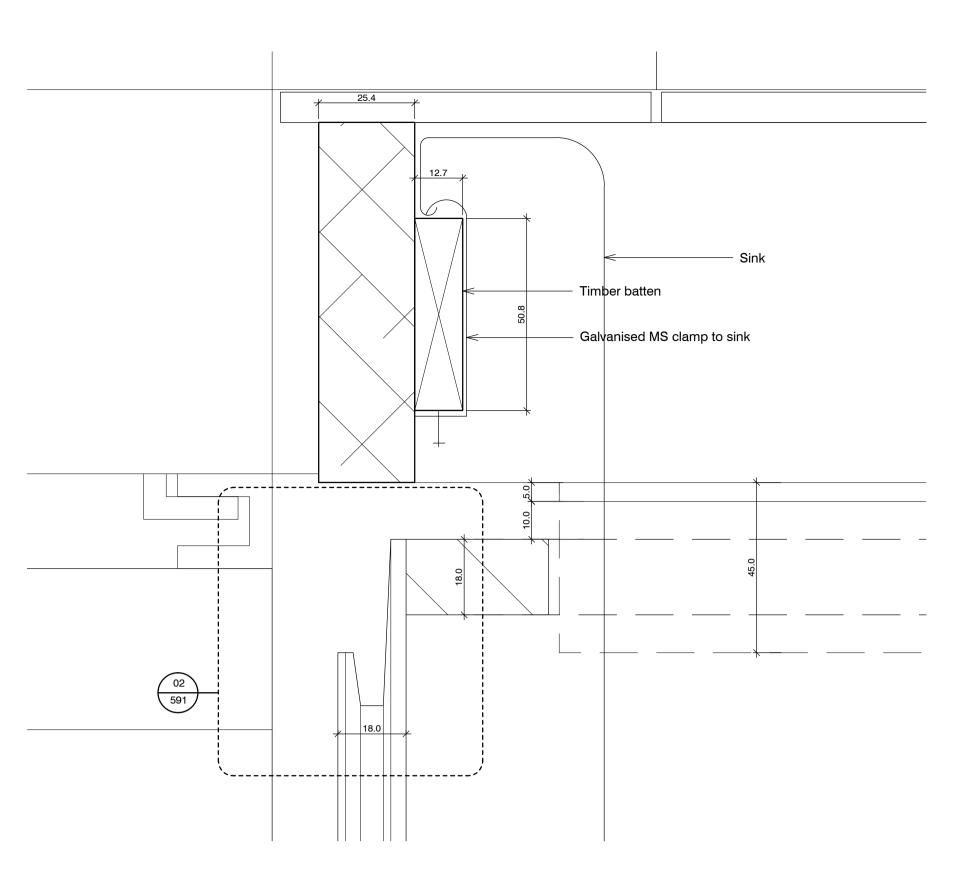
Section detail of sink at head

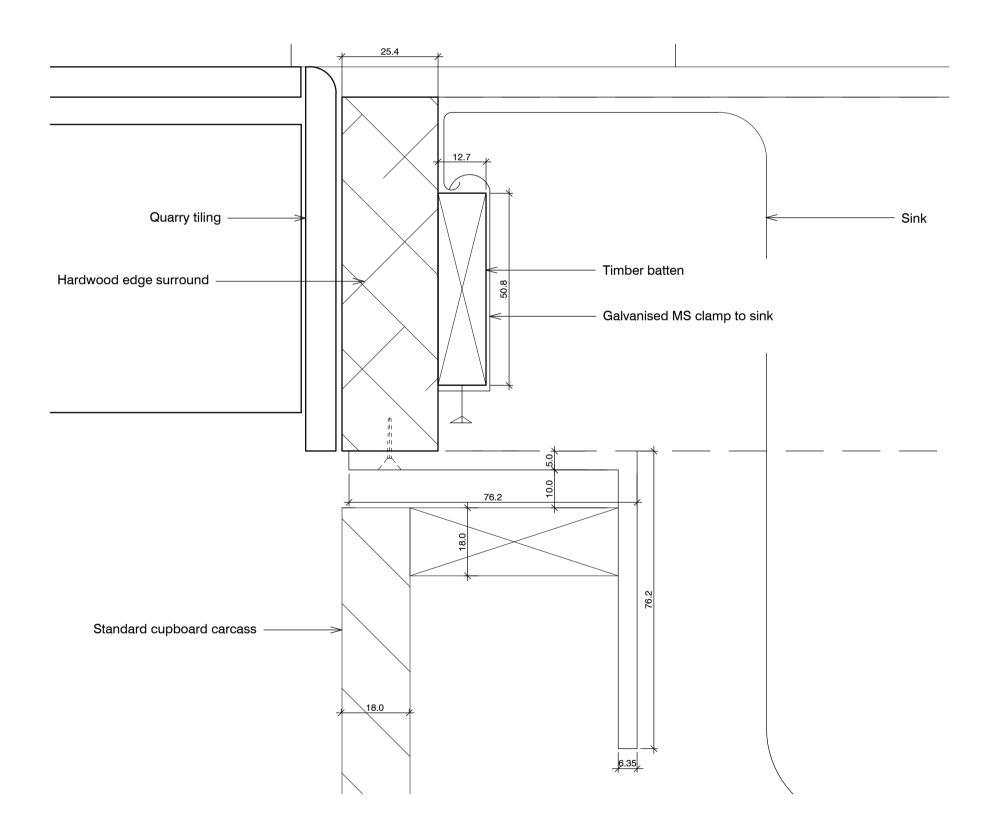
Section detail of sink at worktop edge

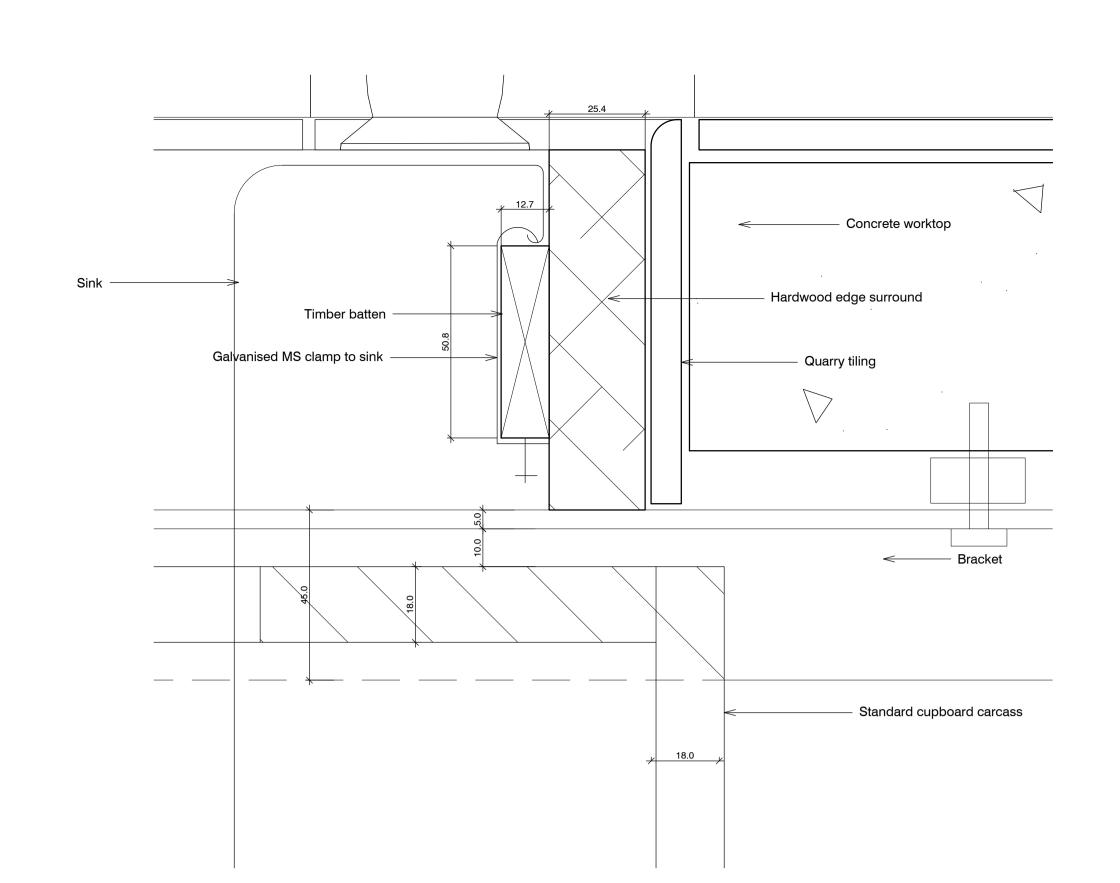
Section detail of sink at rear

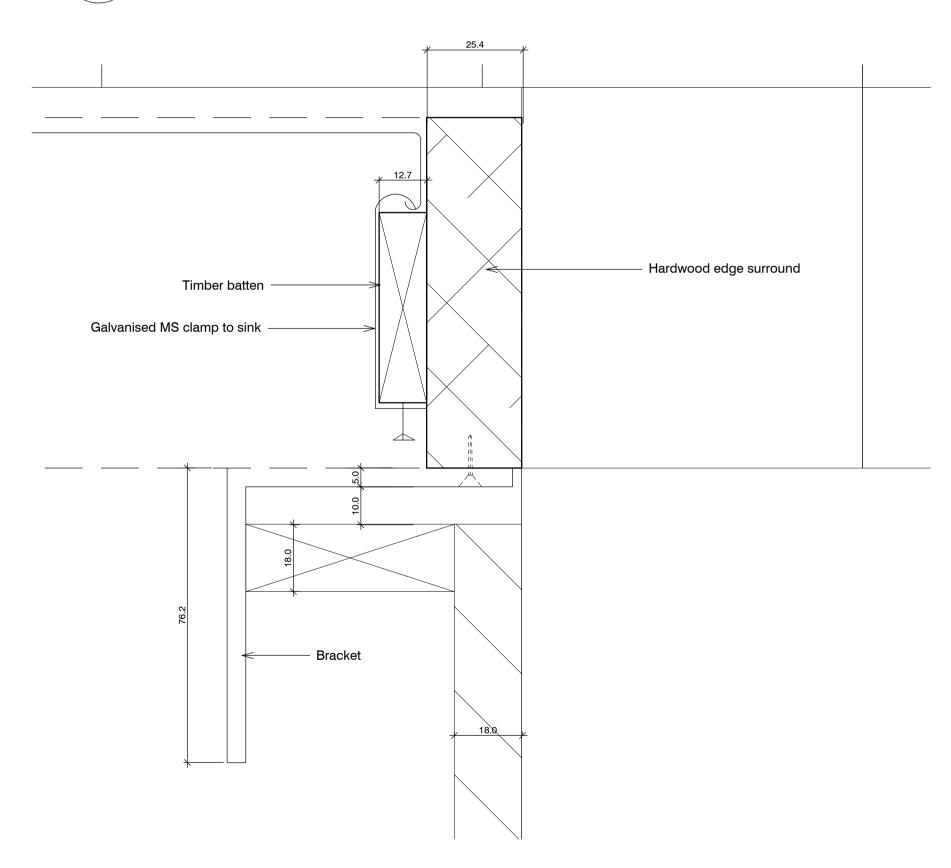
Section detail of sink at edge

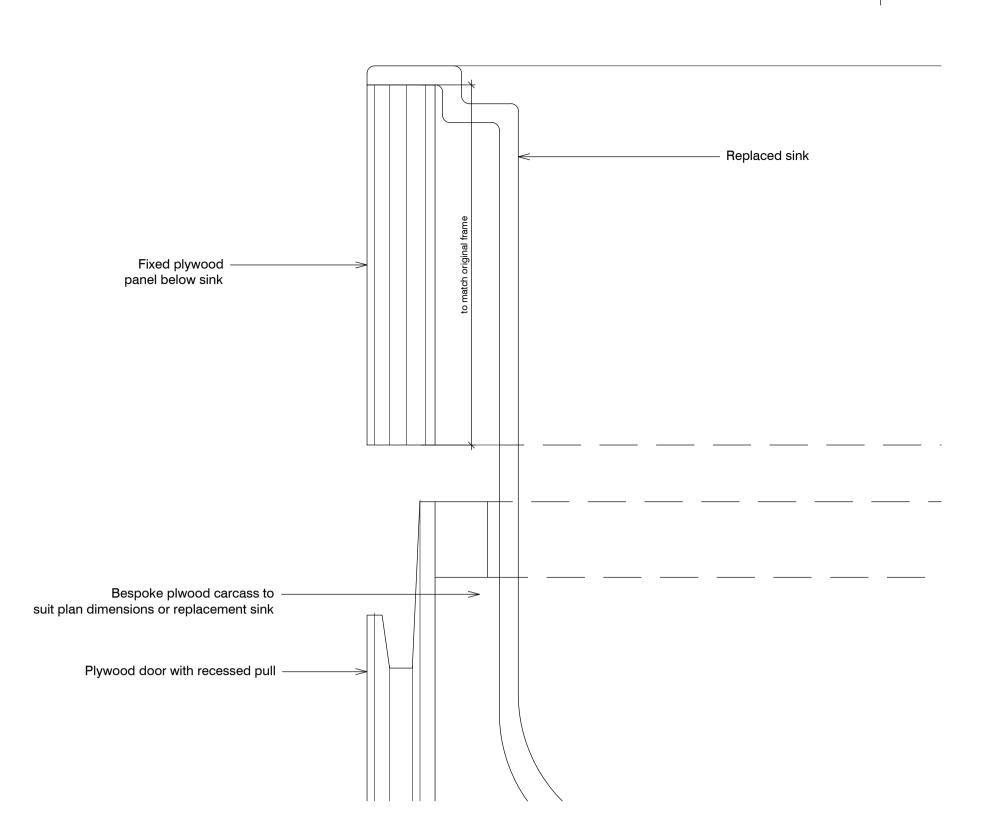
Section detail with sink replaced
