TREE SURVEY REPORT

In accordance with British Standard 5837 2012 'Trees in Relation to design, demolition and construction – Recommendations'

Site 10 Nutley Terrace, London, NW3 5SB

Project reference: DS14051501

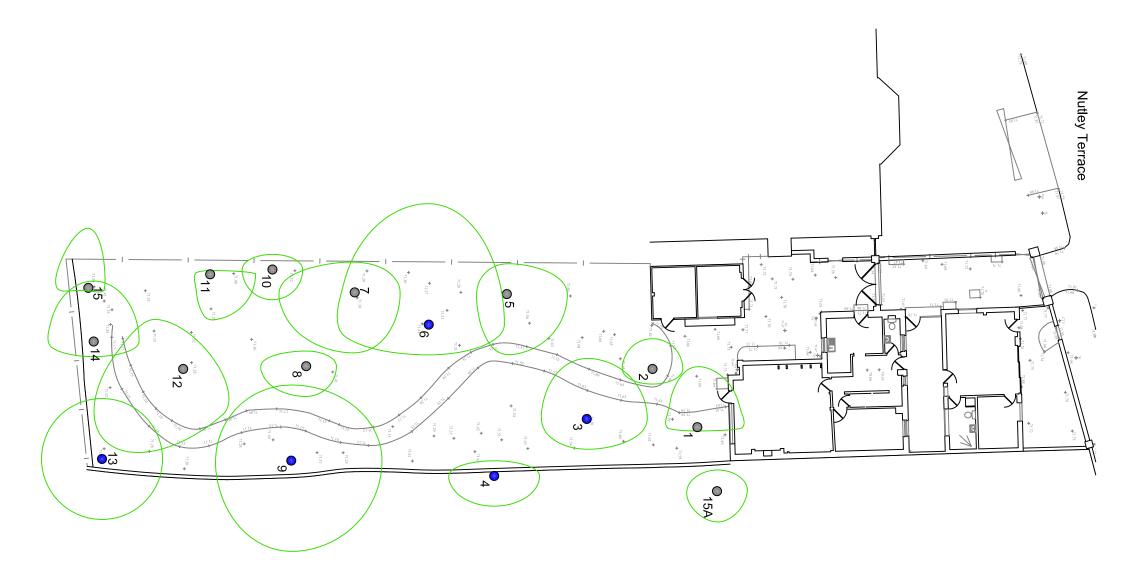
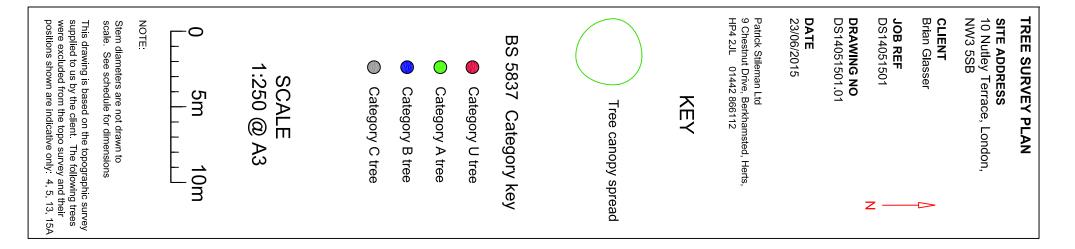
- 2.1 **Tree identification:** Individual trees have been allocated a number and groups of trees have been allocated a number prefixed by the letter G. Their locations are shown on the Tree Survey Plan drawing no: DS14051501.01 dated 23rd June 2015, included on Page 11 of this report. Data pertaining to each tree or group of trees is included in the Tree Survey Data on Pages 8-10 of this report.

This drawing is based on the topographic survey supplied to us by the client. The following trees were excluded from the topo survey and their positions shown are indicative only: 4, 5, 13, 15A

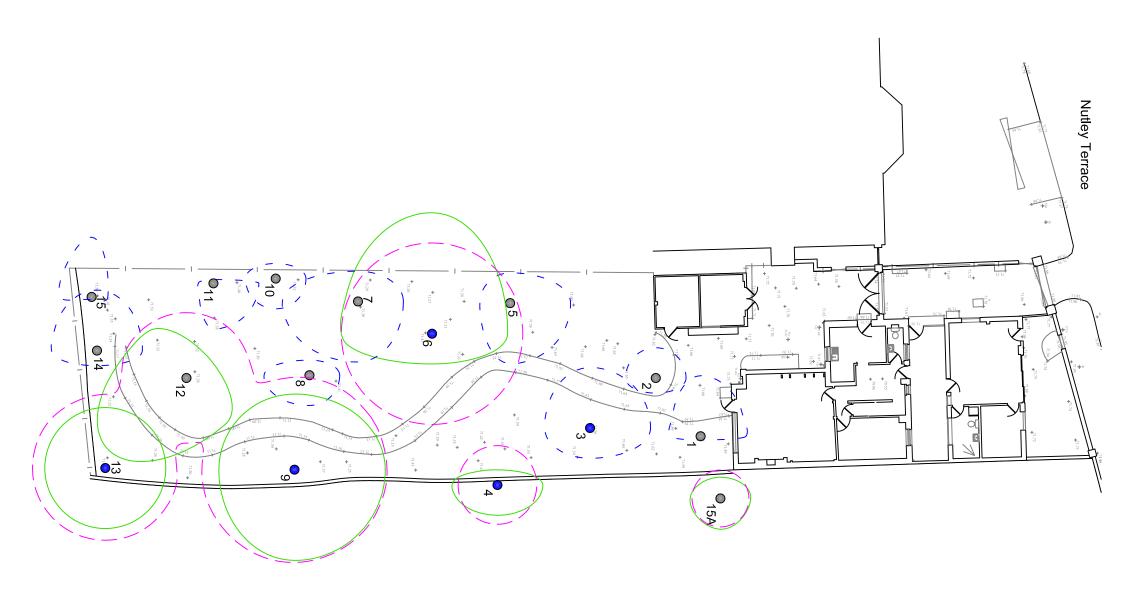
- 4.1 Based on the information obtained by the tree survey I have prepared a tree constraints plan (TCP), drawing no: DS14051501.02 dated 23rd June 2015, included on Page 12 of this report.

- 4.2 On the TCP, I have used different colours indicating tree crowns to distinguish between trees which should be removed for reasons of sound arboricultural management (red); trees which could defensibly be removed in order to facilitate development (blue); and trees with a higher retention priority which should, initially, be considered for retention (green). The TCP has been prepared as a working drawing and the suggested tree retention / removal balance is not definitive.

- 4.5 Category A trees are classified as trees of high quality and there should be a general presumption initially for retention of these.
- 4.6 The TCP shows the position of the Root Protection Area (RPA) for trees with a higher retention priority as broken pink lines. BS5837 (Section 3.7) defines the RPA as a 'layout design tool indicating the minimum area around a tree deemed to contain sufficient roots and rooting volume to maintain the tree's viability, and where the protection of the roots and soil structure is treated as a priority'. In other words, the RPA represents the **minimum** area around each tree in which the ground should remain largely undisturbed. The RPA is an area based on a circle with a radial distance of 12x the stem diameter at 1.5 metres in the case of singlestemmed trees, or 12x the combined stem diameter (calculated in accordance with a formula set out in BS5837) for trees with more than one stem. In situations where the site conditions clearly prevent consistent rooting around the tree (for example the presence of roads or buildings within the notional RPA circle) I modify the shape of the RPA to take this into account. At 10 Nutley Terrace I have not adjusted the RPA shape for any tree and these are all shown based on circles.

Stem diameters are not drawn to scale. See schedule for dimensions
