Refurbishment of Grade II* Listed Office Building

6 Bloomsbury Square
London
WC1A 2LP

Listed Building Consent Application ref. 2015/1269/L
Granted 2 September 2015

Release of Condition 5 - Cleaning Brickwork on Front Facade

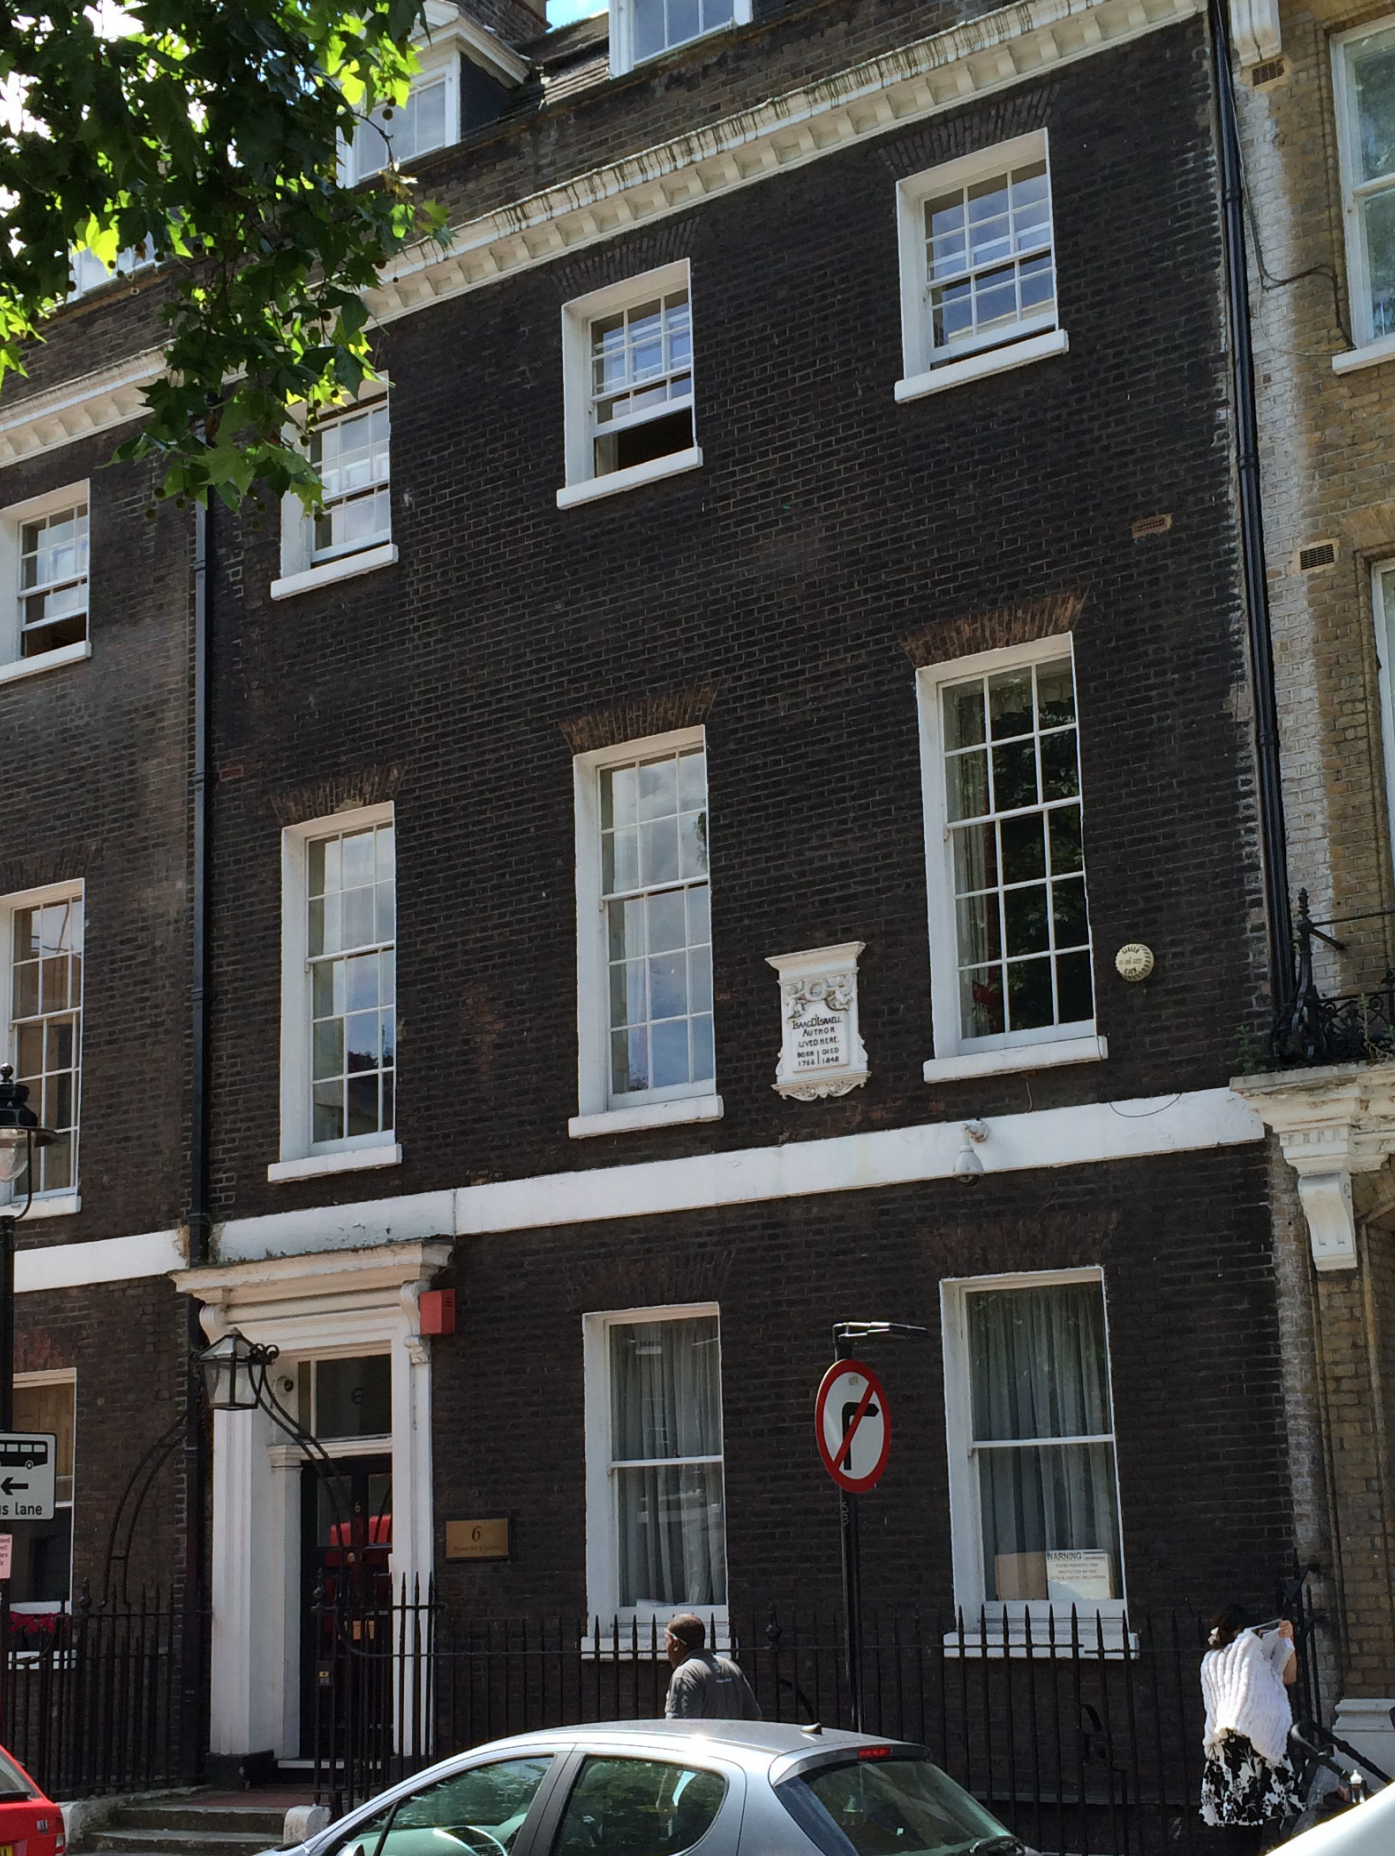
- 1 General view of front elevation showing existing condition
- 2 Proposed cleaning method with photograph of sample from Contractor, Stoneforce

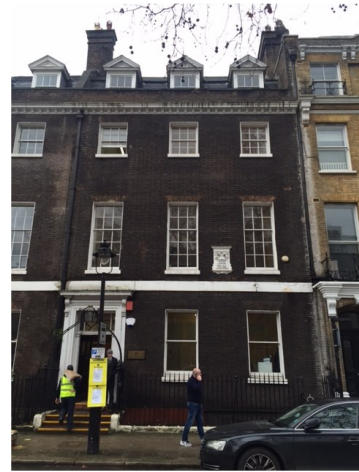
Scaffold will be erected in front facade for the entire height of the building. (See picture of building bellow) Scaffold will be covered in monoflex sheeting preventing any debris or water to go on to road or walk way.

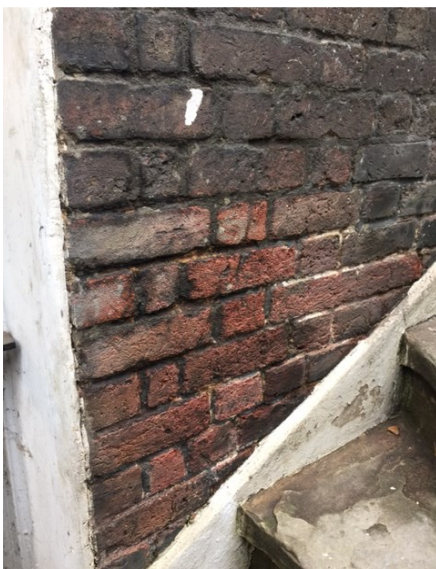
Once completed the building will look like sample that has been done as picture bellow:
