Basement Impact Assessment

Site | 13/15 John's Mews
London
WC1N 2PA

Our Ref | BIA/4507D Rev 5

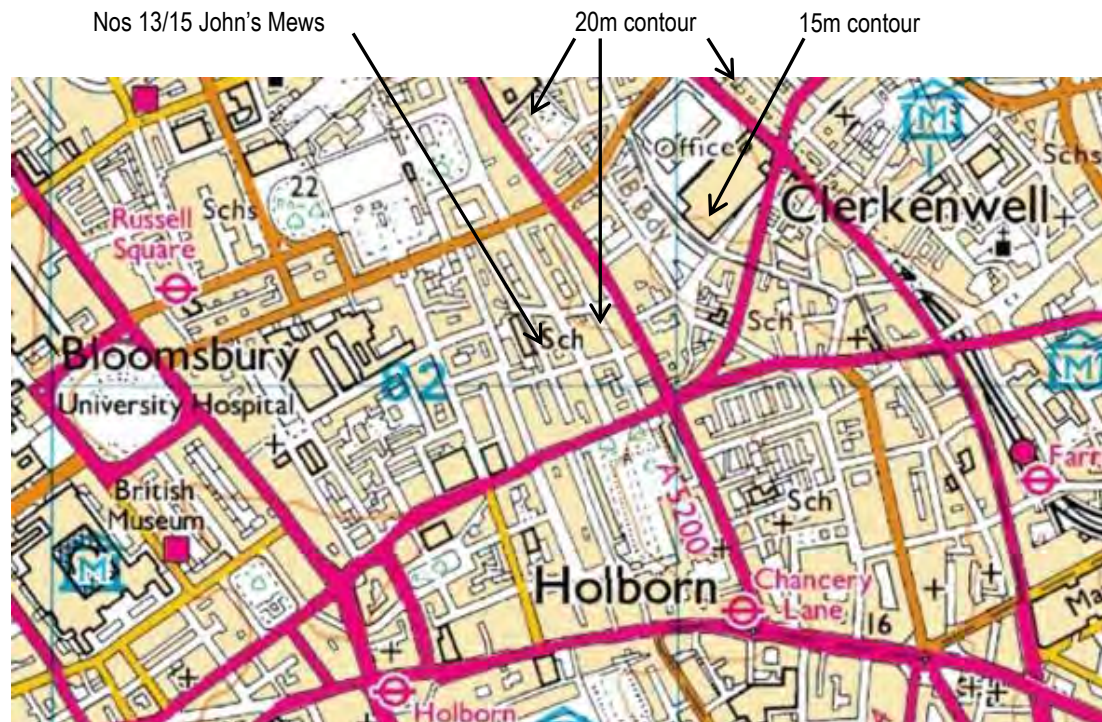
Figure 2: Enlarged extract from 1:25,000 Ordnance Survey map showing site location.

- 2.5 John's Mews is on a north-facing slope which leads down to Roger Street. The loop in the 20m contour (see Figure 2) shows that Roger Street is located in the base of a shallow valley which was formed by a former tributary to the river Fleet, one of the 'lost' rivers of London. That tributary was orientated broadly west-east and was located below or close to Roger Street. The likely locations of the Fleet tributaries are considered further in Section 5. The 15m and 20m contours on Figure 2 define the Fleet's main (north-south) valley.

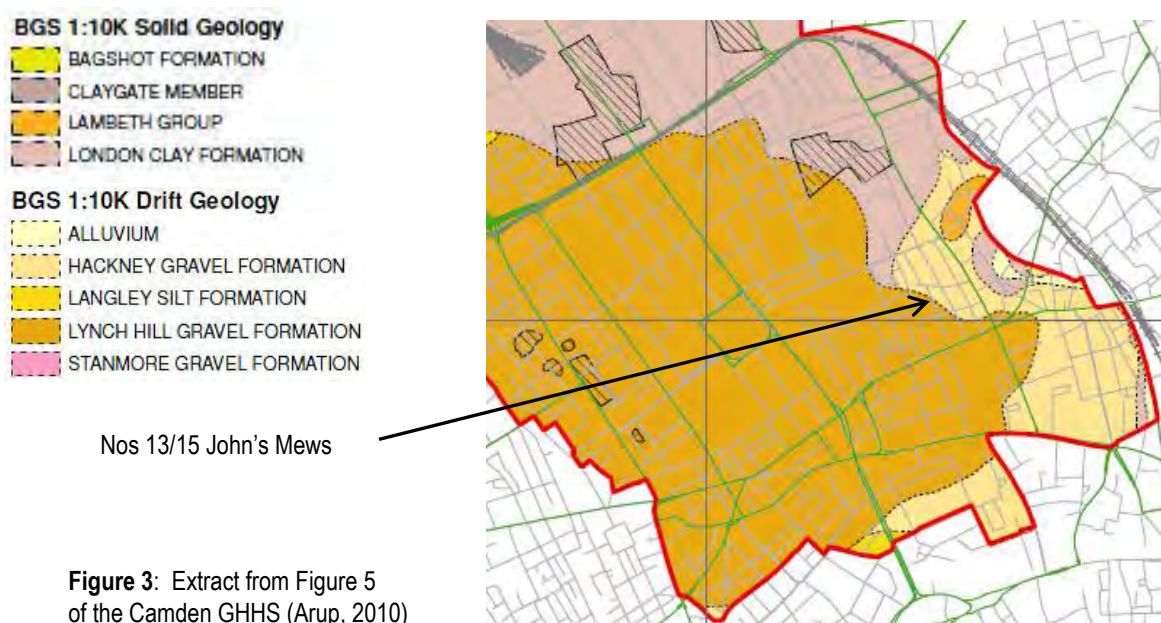
Figure 3: Extract from Figure 5 of the Camden GHHS (Arup, 2010)

4.1 Mapping by the British Geological Survey (BGS) indicates that the site is underlain by the Lynch Hill Gravel Member and possibly also the Hackney Gravel Member, which both overlie the London Clay Formation. Figure 3 shows an extract from Figure 5 of the Camden GHHS (Camden Geological, Hydrogeological and Hydrological Study by Arup, November 2010) which illustrates the site geology of the Holborn area. In urban parts of London, the natural geology is typically overlain by Made Ground.

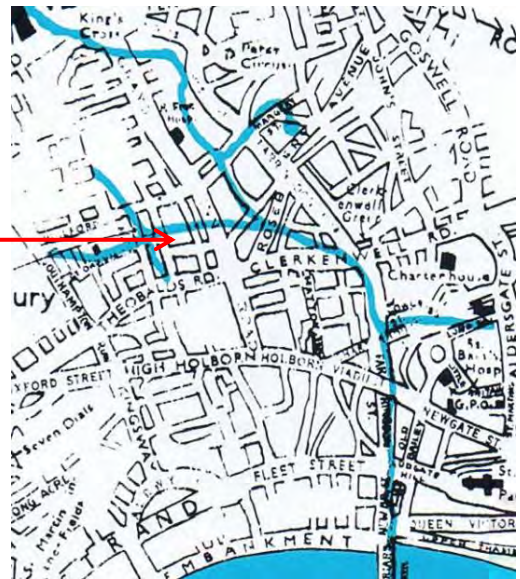
Figure 4: Extract from Figure 11 of the Camden GHHS (Arup, 2010) showing former watercourses, based on Barton (1992).

5.1 Two former tributaries to the Fleet, one of the 'lost' rivers of London, were present close to No's 13/15's site, as shown in Figure 4. As already noted, the west-east orientated former tributary to the Fleet is believed to be located below or close to Roger Street. It may run in a culvert or, more likely, now flows in the Victorian 1372x1016 sewer beneath Roger Street (see extract from Thames Water's sewer plan in Figure 5). The location of the small tributary which flowed northwards to the Roger Street tributary is less clear because Barton's map does not show all the roads. It is possible that it is/was in the abandoned sewer which formerly ran below Robert Street to the west of John's Mews, as shown in Figure 5.

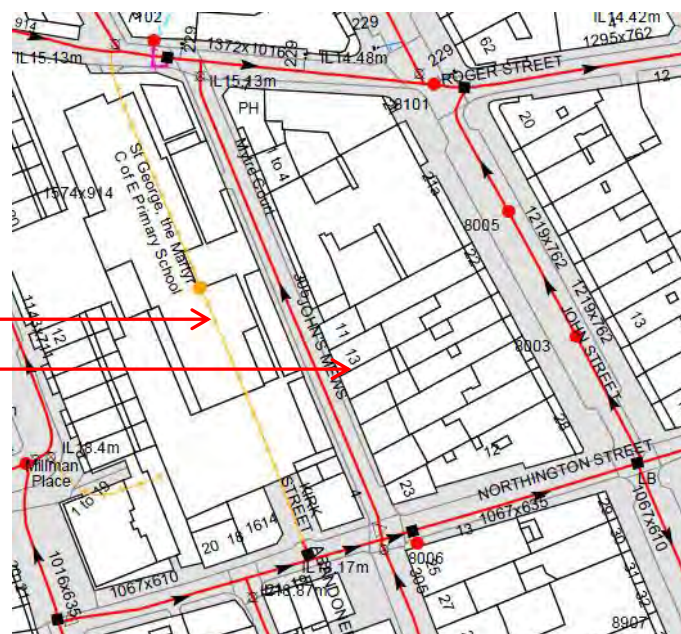
Figure 5: Extract from Thames Water's sewer plan.

Abandoned sewer
 Nos 13/15 John's Mews

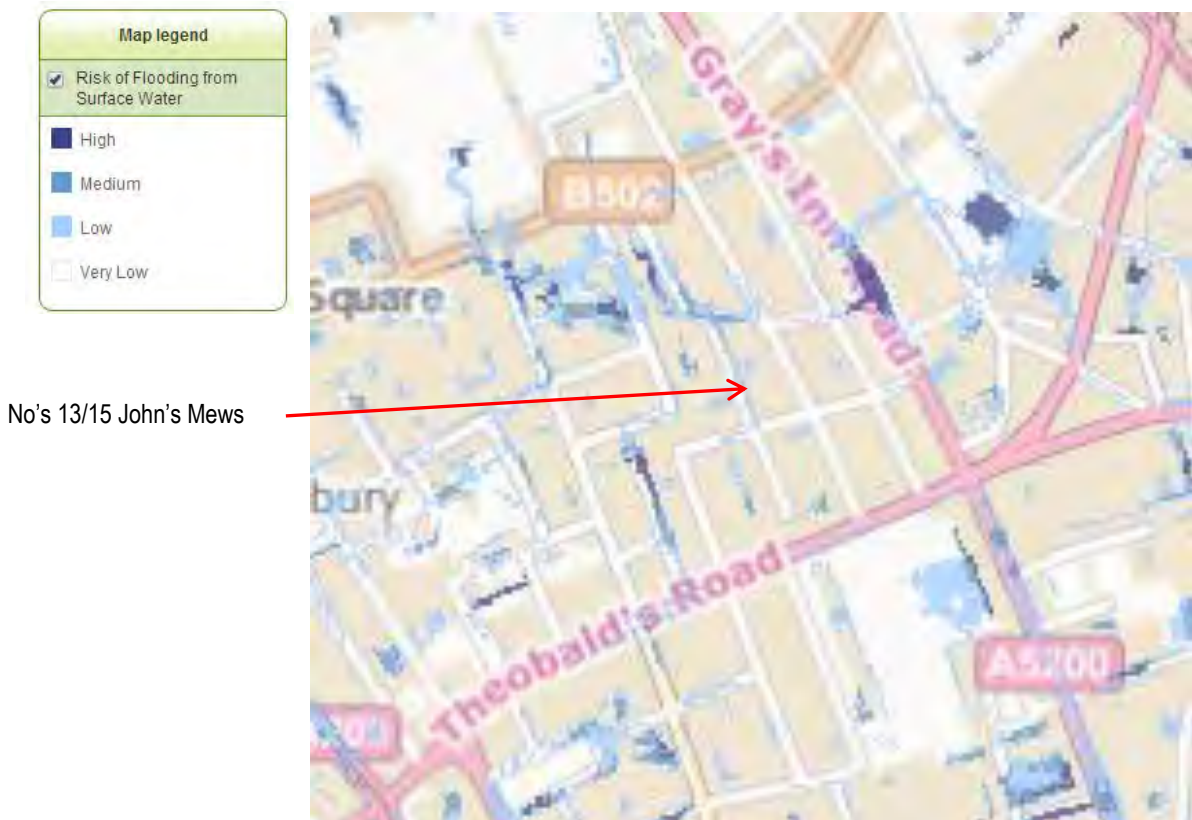
Figure 6: Extract from the Environment Agency's 'Risk of Flooding from Surface Water'.
 Ordnance Survey © Crown copyright 2014. All rights reserved. Licence No.100051531.

- 5.6 Modelling of surface water flooding has been undertaken by the Environment Agency and was published on its website in January 2014; an extract from their model is presented in Figure 6. While this map identifies four levels of risk (high, medium, low and very low) it is understood that it is based at least in part on depths of flooding. This modelling shows a 'Very Low' risk of flooding (the lowest category for the national background level of risk) for No's 13/15's site itself and a ribbon of 'Low' risk along the east side of the carriageway to John's Mews (and

5.7 More recently, surface water flood modeling has been undertaken by URS as part of a Strategic Flood Risk Assessment for the London Borough of Camden, and was published in July 2014; an extract from their model is presented in Figure 7. As per the Environment Agency modeling, this map identifies the same four levels of risk (high, medium, low and very low), and shows a 'Very Low' risk of flooding for No's 13/15 and most of the surrounding area. It also shows a similar ribbon of 'Low' risk of flooding from surface water on the east side of the John's Mews carriageway, as shown in Figure 6.

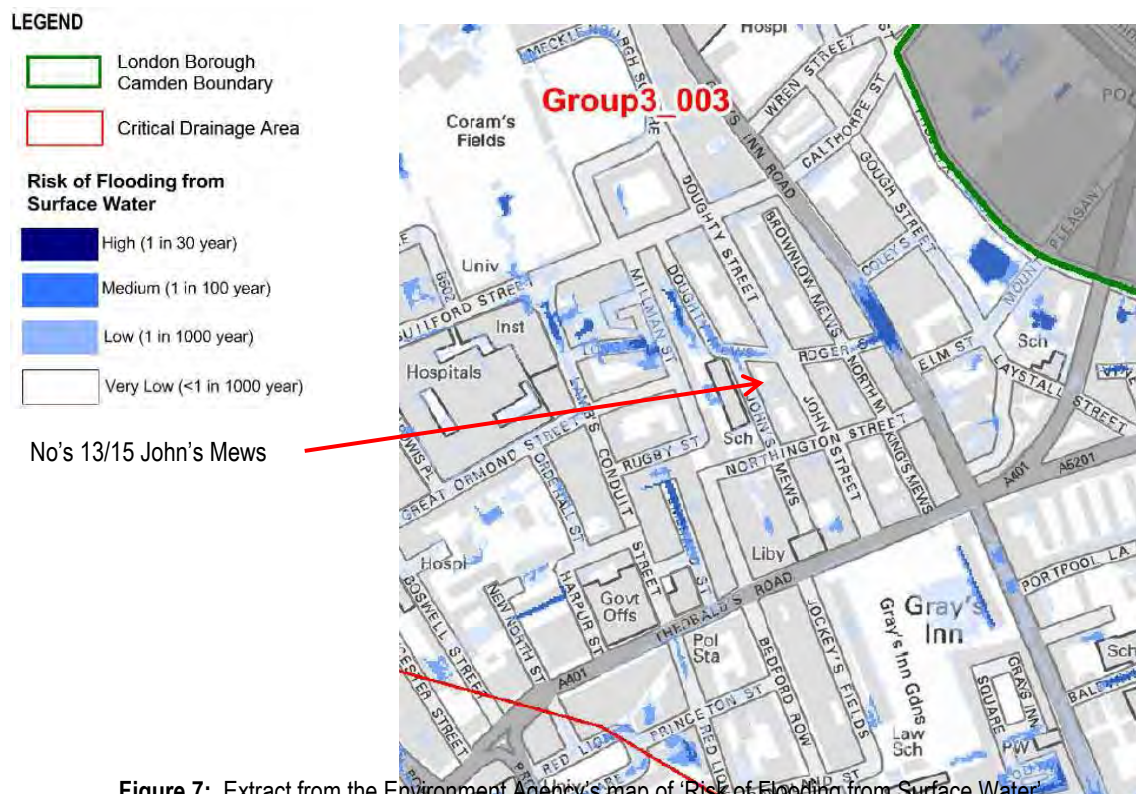
Figure 7: Extract from the Environment Agency's map of 'Risk of Flooding from Surface Water'. Ordnance Survey © Crown copyright 2014. All rights reserved. Licence No.100051531.

5.8 Figure 7 also shows that John's Mews falls within Critical Drainage Area Group3_003.

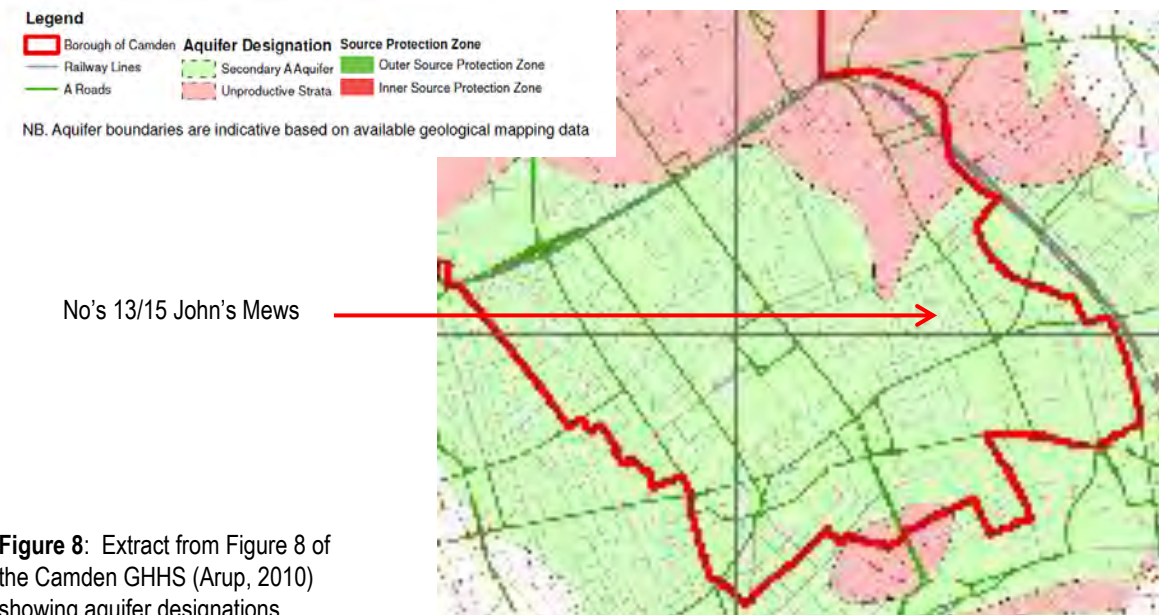
Figure 8: Extract from Figure 8 of the Camden GHHS (Arup, 2010) showing aquifer designations.

6.1 The River Terrace Deposits are classified by the Environment Agency as a superficial 'Secondary A Aquifer'; this groundwater is usually unconfined and commonly referred to as the 'Upper Aquifer'. The underlying London Clay is an 'Unproductive Stratum'. Figure 8 shows the extent of the Secondary A Aquifer in the vicinity of the site of current interest.

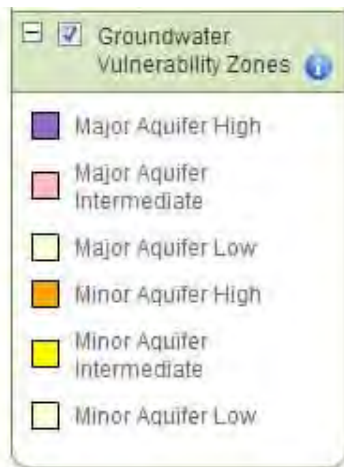
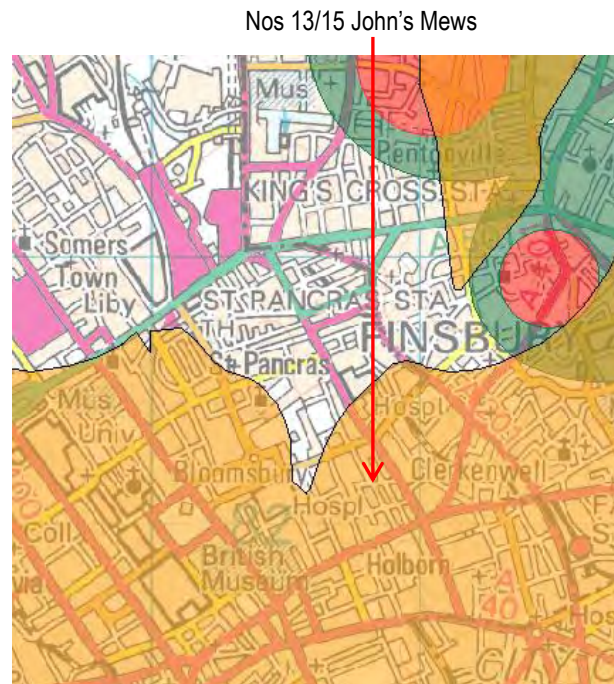
Figure 9: Extract from Environment Agency's map of Groundwater Vulnerability Zones and SPZs (Zone 1 = red, Zone 2 = dark green).
 Ordnance Survey © Crown copyright 2014.
 All rights reserved. Licence No.100051531.

- 6.3 Under the old groundwater vulnerability classification scheme, which now applies only to superficial soils, the site is in an area which is classed as 'Minor Aquifer High' groundwater vulnerability, as shown in Figure 9.

- 6.4 Other hydrogeological data obtained from the GroundSure EnviroInsight report (see Appendix E) include:
- There are no Source Protection Zones (SPZs) within 500m of the site (Figure 9 above and Appendix E, Section 5.6);

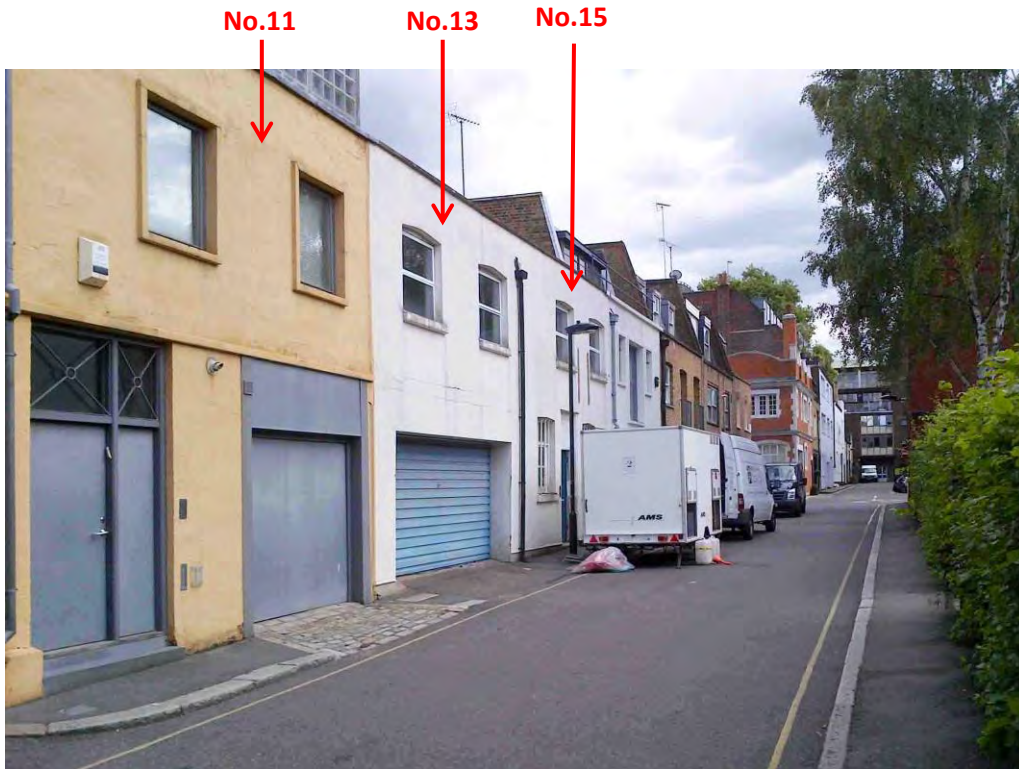
Photo 1: Front elevations of terrace looking south (uphill)

- 2.2 No's 13/15 share party walls with No.11 to the north and No.17 to the south, both of which have already had a third storey added (see cover photo and Photos 1 & 2 in Appendix A). Evidence of damp was visible in some of the walls, especially the 15/17 party wall. There was some broadly vertical cracking in the rear wall and a horizontal crack over No.13's garage door. Diagonal cracking in the front wall of No.11 suggested relative settlement of the 11/13 party wall.

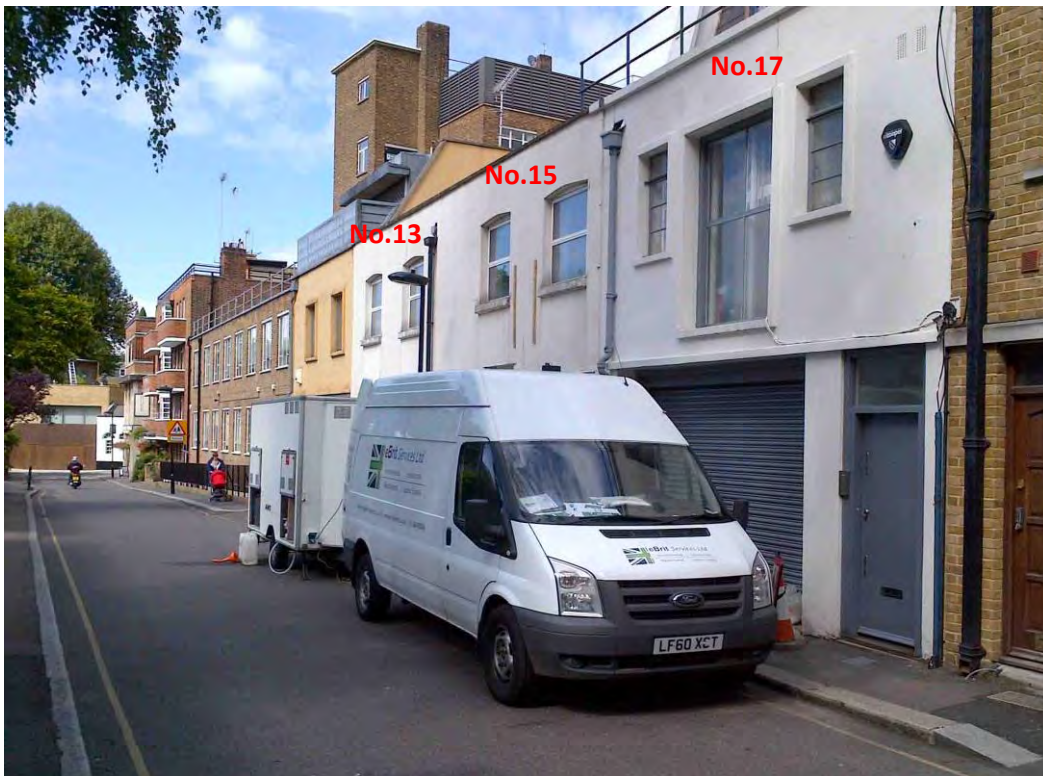
Photo 2: Front elevations of terrace looking north (downhill)

Baptist Chapel and annex, sometimes labelled "Sun. School"; an aerial photograph from 1947 shows the chapel still standing but the 1951/52 OS map shows the site vacant and the Sunday(?) School as a ruin. The site had been redeveloped with what appears to be the current building (see Photo 2) by 1962.

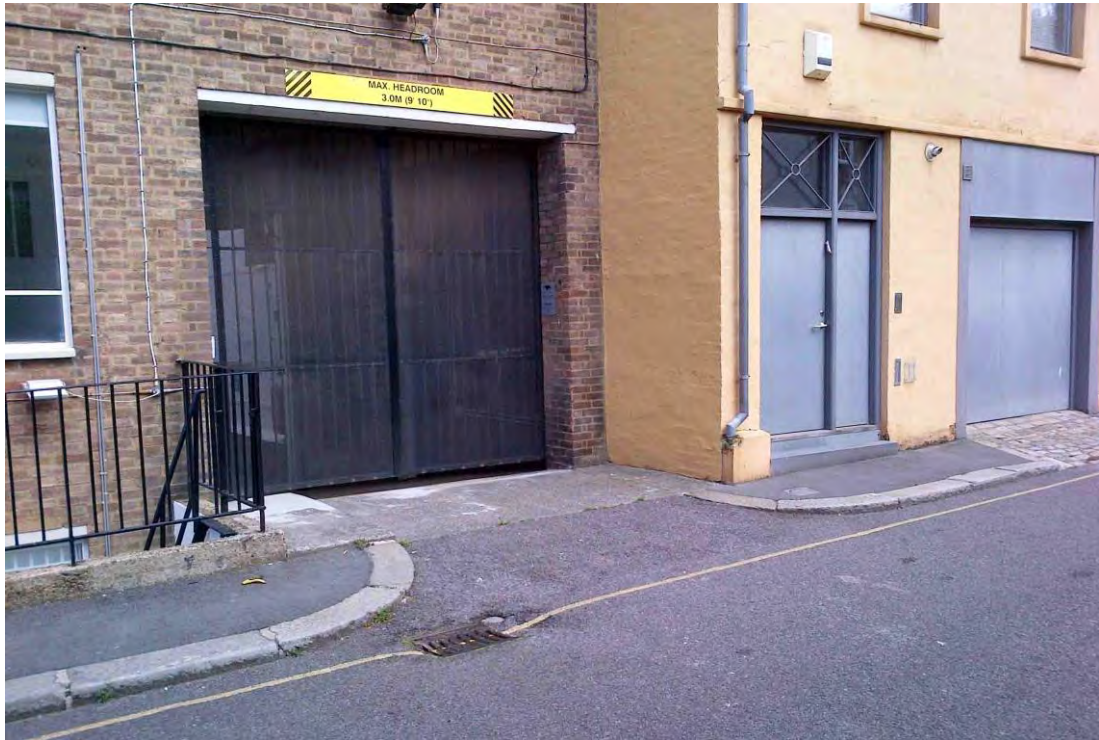
Photo 3: No.11 (on right) and adjoining commercial property.
Note lightwell to lower ground floor (behind railings) and steep ramp down from vehicle access.

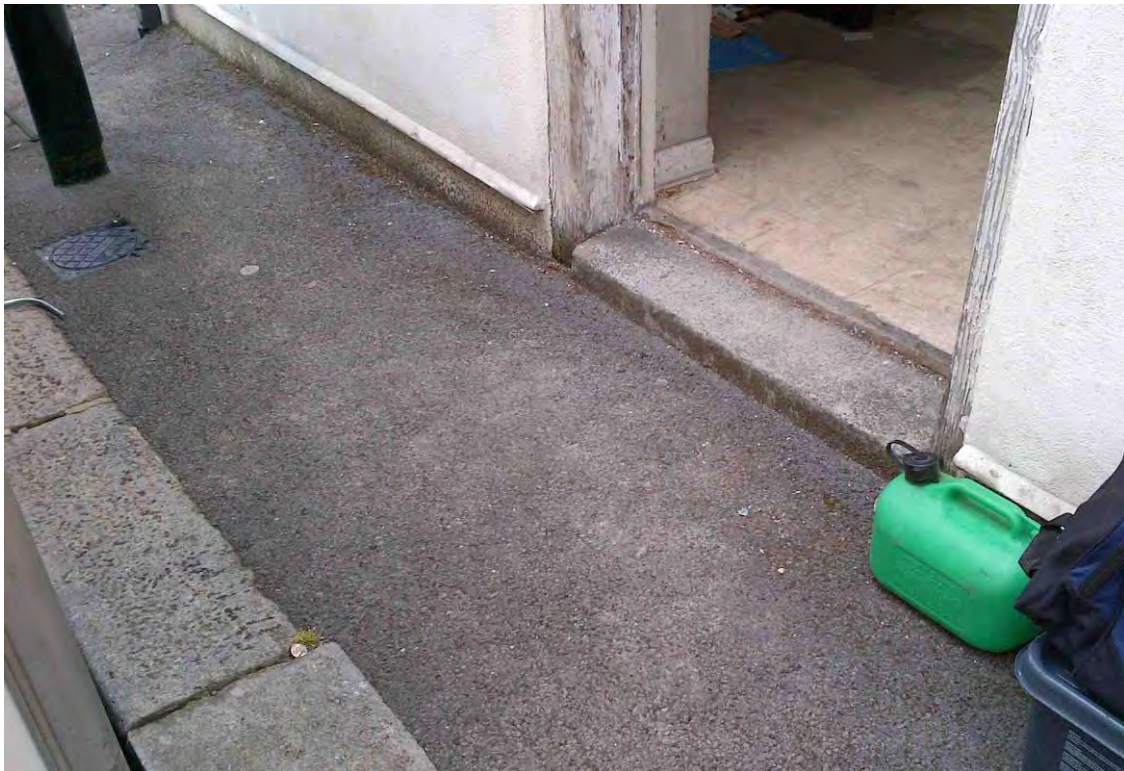
Photo 4: Threshold to No.15.

- 5.2 Photo 4 in Appendix A shows that the front entrance to No.15 is raised above the public footway, and the continued northwards slope of the road results in No.13's garage threshold (and adjacent No. 11 door – Photo 3) being well above road level.

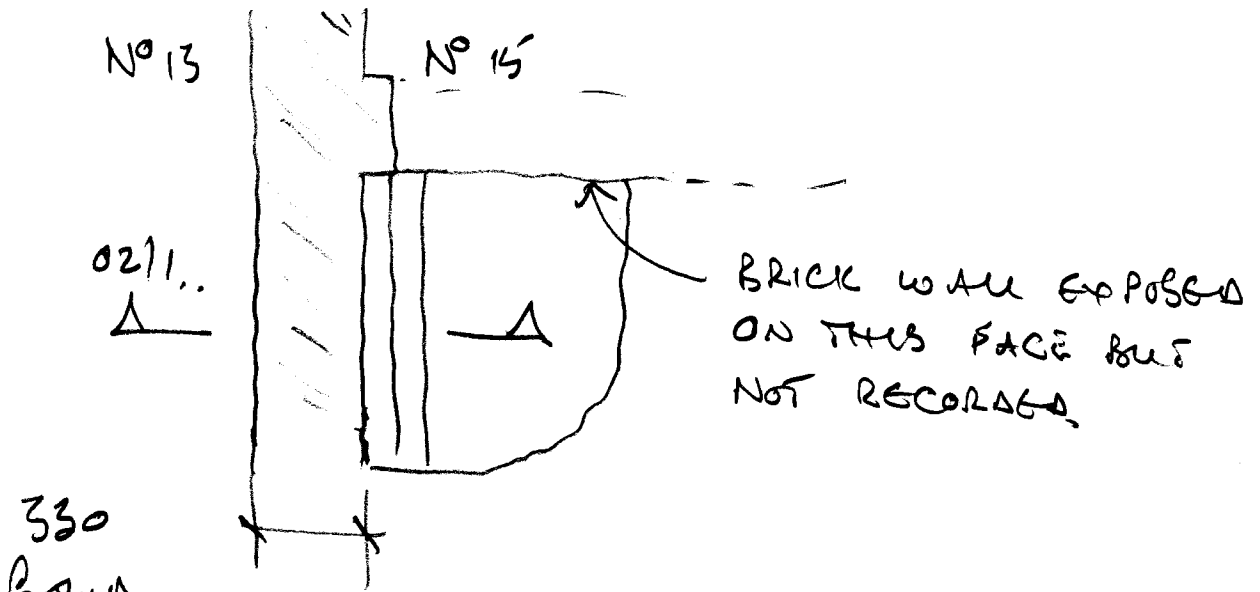
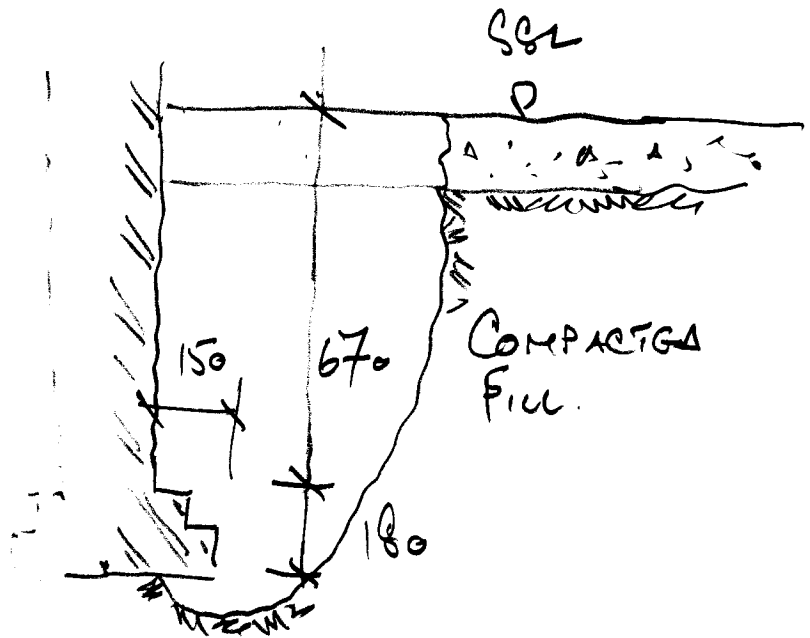
SECTION 02/1.

330
Solid
BRICK
WALL

- 13/15 party wall (TP2, Section B): Founded at 0.85m below ground level (bgl); 2 corbels which projected 150mm from face of wall.
- Rear wall No.15 (TP3, Section 2): Founded at 0.49m below internal GL; 1 corbel projecting 60mm.

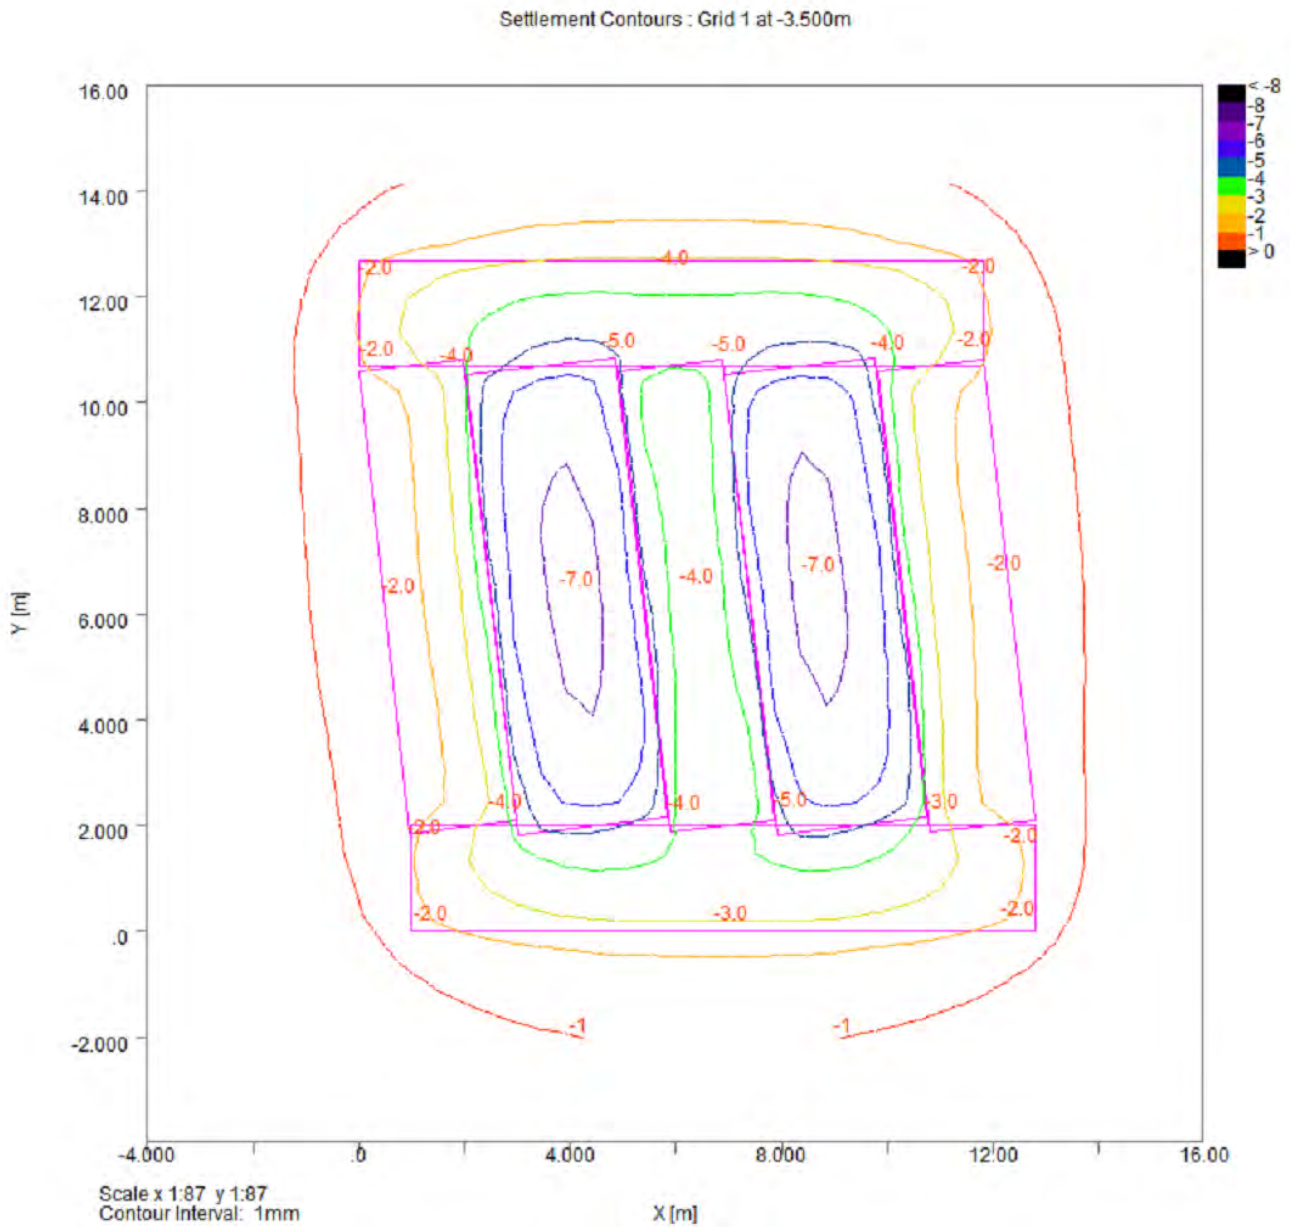
Figure C3. Short term (Stage 2) heave assessment contour

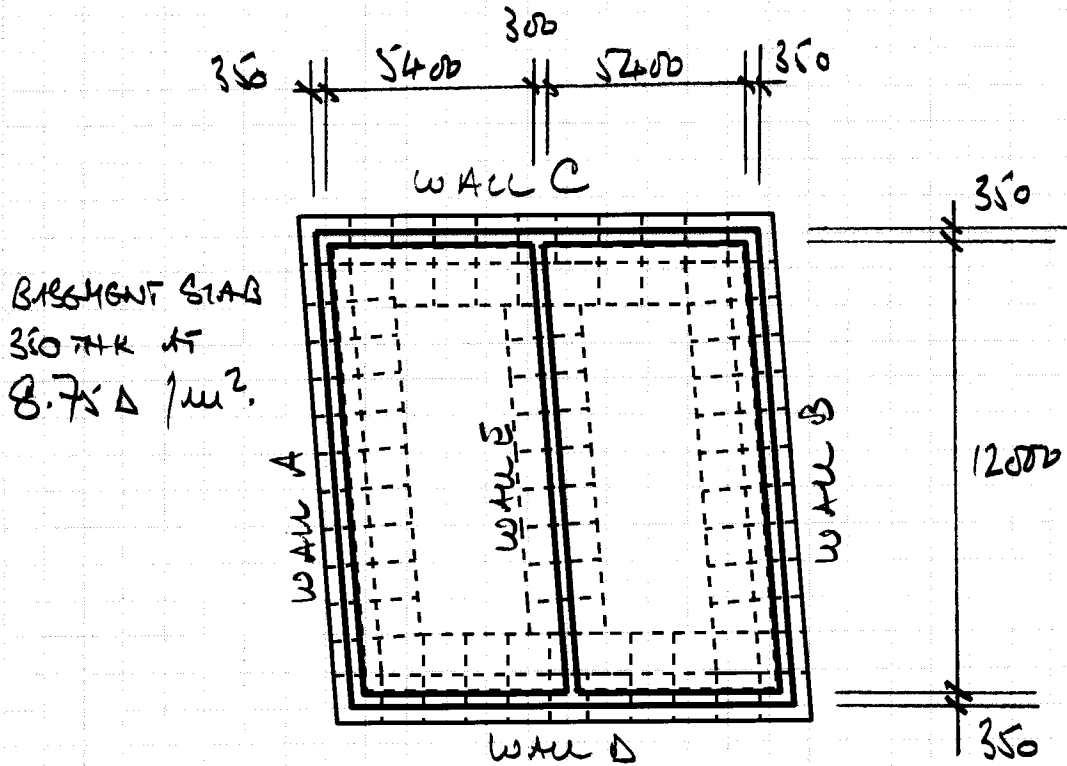
PLAN ON BASEMENT SHOWING LOADS ON WALLS

WALL REF	LOADING / METRE RUN.
A	101D + 15L (MIN.) 124D + 24L (MAX.) *
B	101D + 15L (MIN.) 124D + 24L (MAX.) *
C	50D + 5L
D	65D + 5L
E	140D + 30L
