Arboricultural Impact Appraisal and Method Statement
Front of 38 Regents Park Road, London

Date: 15 February 2013
Ref: 1209-AIA-Front-MW

This report contains the supporting tree information relating to the development proposal to refurbish the existing dwelling and extend the basement at the front of the property at 38 Regents Park Road, London.

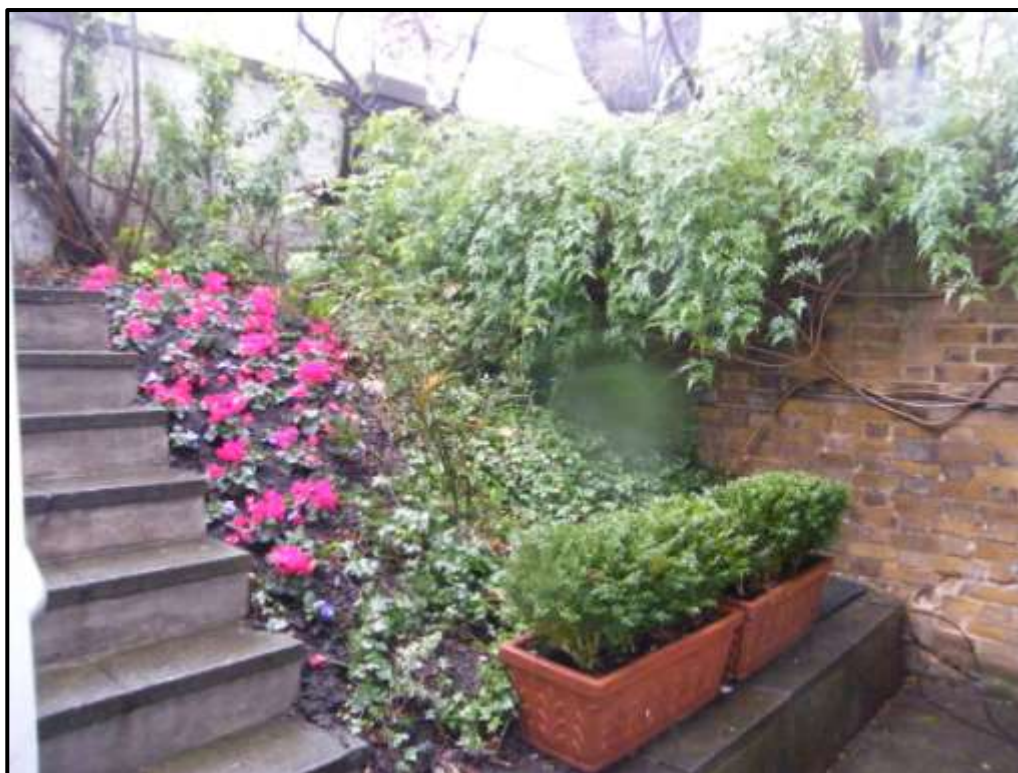
Image 1: The ground levels along the boundary wall have already been significantly reduced on the side of 38 Regents Park Road

Tree 1: From the provided layout, only one tree (T1) growing in the adjacent property is close enough to be affected by the proposed steps and the sunken courtyard area. Based on its estimated stem diameter it requires a RPA radius of 7.2m or an area of soil 162m². However, the tree grows about 3m from the boundary and the ground levels along the boundary wall have already been significantly reduced on the side of 38 Regents Park Road where the courtyard is proposed (Image 1). From my observations, I believe it is unlikely that roots from this tree have found their way beneath the wall foundations and are probably growing in the adjacent garden. If this is the case, the tree is unlikely to be affected by the works. However, if some roots have managed to find their way beneath the wall foundations, special precautions will be required to investigate whether any roots are present using hand digging techniques. If roots are encountered, then it may be possible for careful root pruning to be done but this will need specialist advice and should only be done under a supervision agreement to minimise any adverse effects on the tree's health or amenity value.

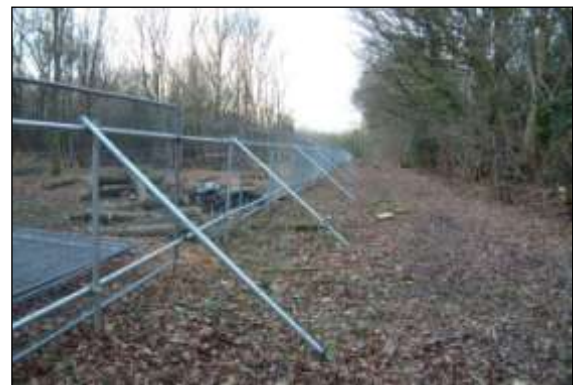
Photo 2: Heras fencing wired to scaffold braced posts is a robust and effective interpretation of the BS specification.

Various fencing options are illustrated in figure 1 and photos 2–4 below. The minimum specification for the fencing must be as described in figure 2 of BS 5837 (figure 1 below) or an equivalent design that effectively restricts access to the RPA it protects.

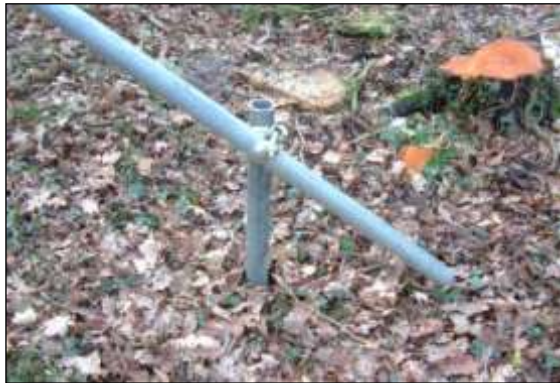
Photo 3: Close up of bracing detail, essential for increasing the stability of the vertical framework.

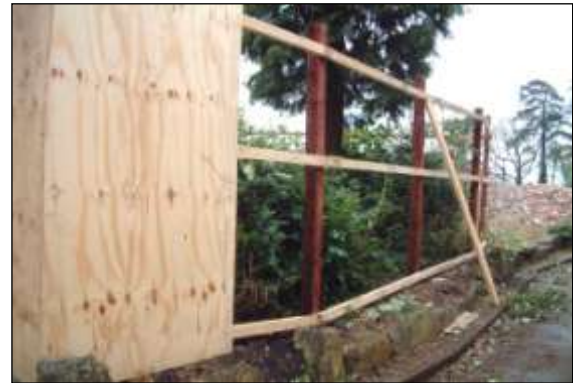
Photo 4: Board specification on secure wooden posts is a suitable alternative to the standard braced scaffold design.

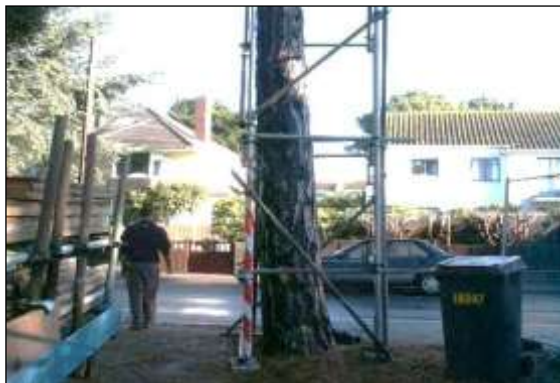
Photo 5: A scaffold braced framework surrounding the trunk reduces the risk of accidental impact.

Where individual trunks or branches are vulnerable to impact damage, a framework of scaffold or wood can be constructed to provide protection (photos 5 and 6).

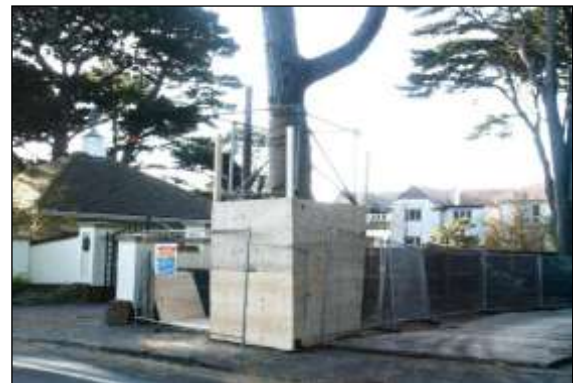
Photo 6: Board secured to scaffold framework adds another layer of protection for vulnerable trunks and branches.

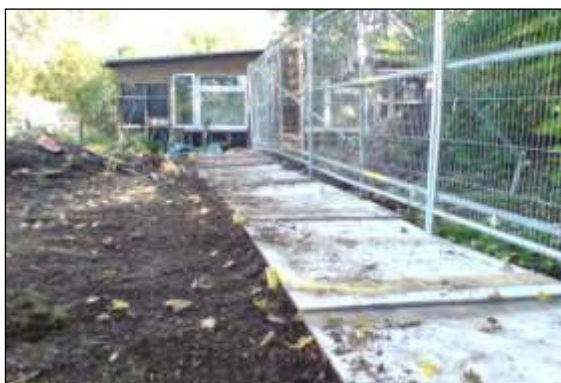
Photo 7: Heavy-duty plywood set onto a compressible woodchip layer and pinned into position is suitable to spread the loading from pedestrian access.

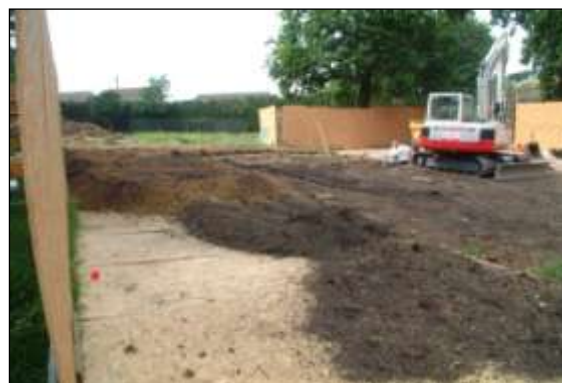
Photo 8: Spreading soil excavated from footings is an effective way of buffering the plywood surface from the wear of light vehicles.

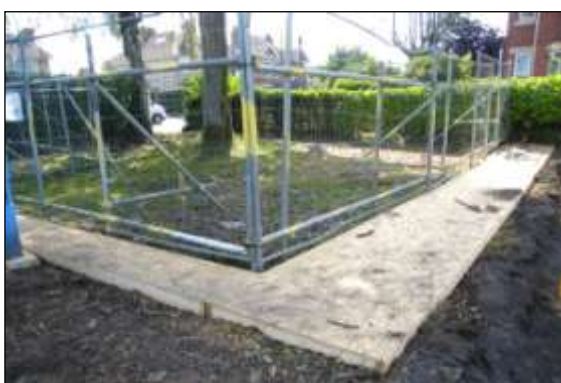
Photo 9: Plywood fixed to a wood frame is another effective method of protecting soil from pedestrian compaction.

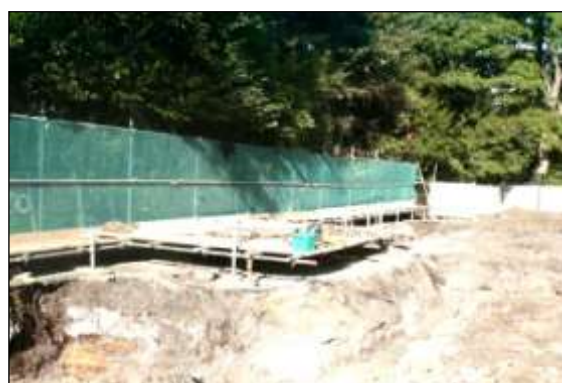
Photo 10: A scaffold framework attached to the main scaffold fencing can be used to support either scaffold planks or plywood to create an elevated platform with a gap beneath.

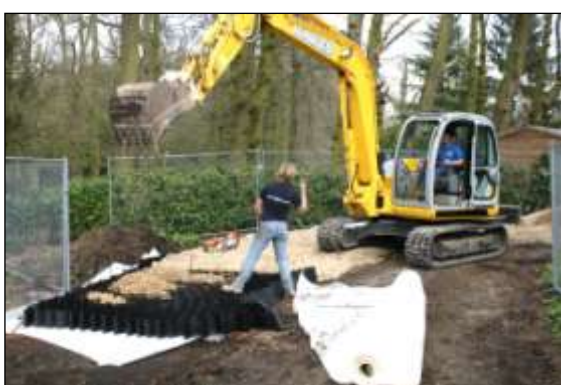
Photo 11: Cellular products are a very effective means of providing ground protection where heavy vehicle use is expected. Here, it is being used to temporarily widen an existing road, to be removed once the construction is finished.

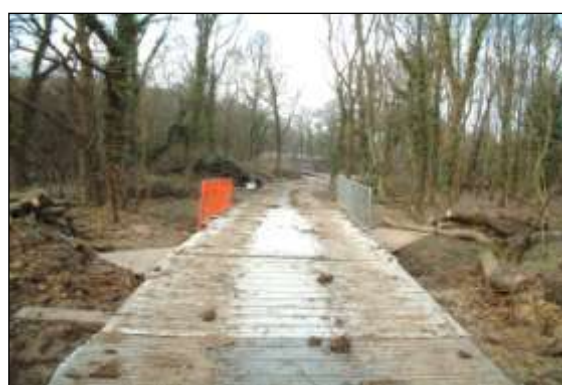
Photo 12: Custom designed sectional tracks can be joined to support very heavy traffic use through sensitive areas.

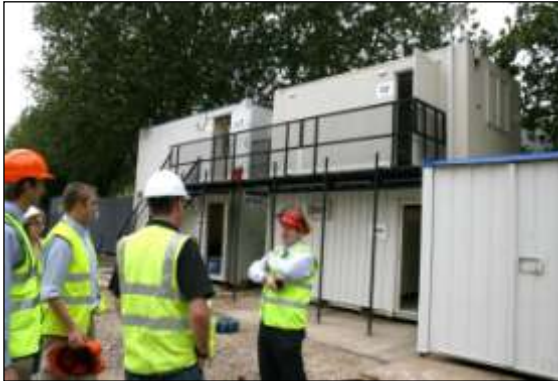
Photo 13: A combination of retaining existing surfacing and using temporary construction cabin accommodation can be a very effective means of preventing damage to sensitive areas.

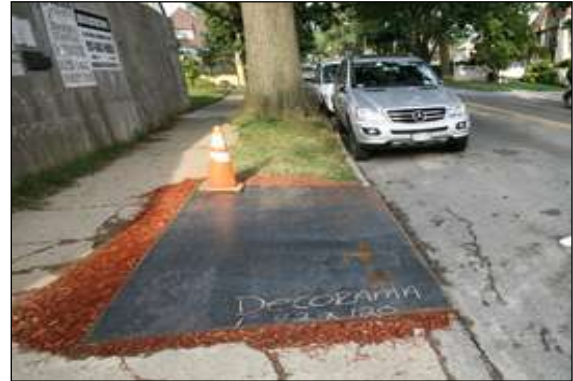
Photo 14: Steel plates can be an effective way of temporarily reinforcing weak surfacing over a construction access during the development activity.

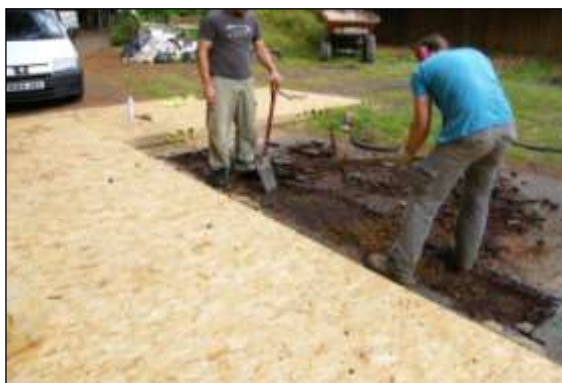
Photo 15: Careful hand-digging using conventional tools is acceptable for exposing roots in RPAs.

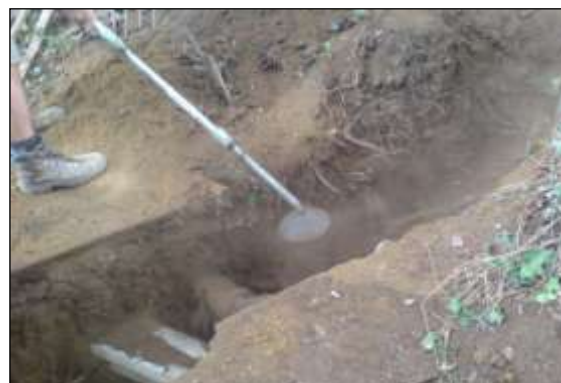
Photo 16: Air spades are very effective at exposing roots and services with minimal damage.

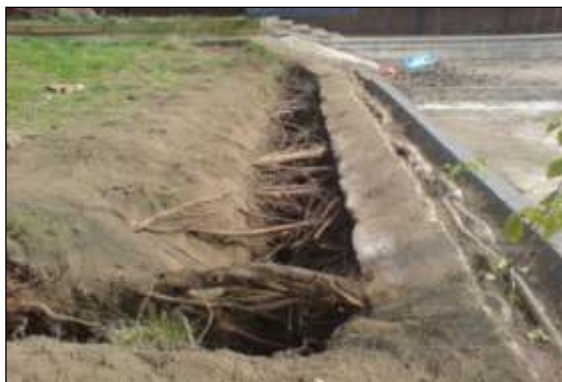
Photo 17: Air spades are particularly useful where roots are very dense.

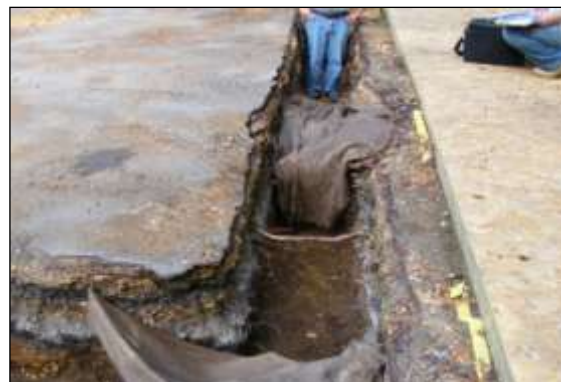
Photo 18: Exposed roots must be protected from light, drying out and extremes of temperature by covering with hessian sacking and boards until they can be covered back with soil.

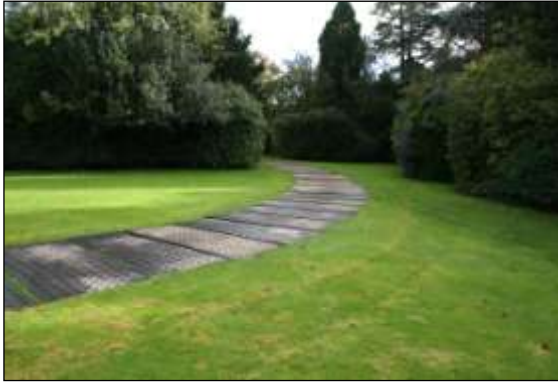
Photo 19: Ground protection must be used where repeated foot or vehicle traffic could cause compaction in sensitive RPAs. It can be as simple as plywood for pedestrians, but must be more robust for vehicles.

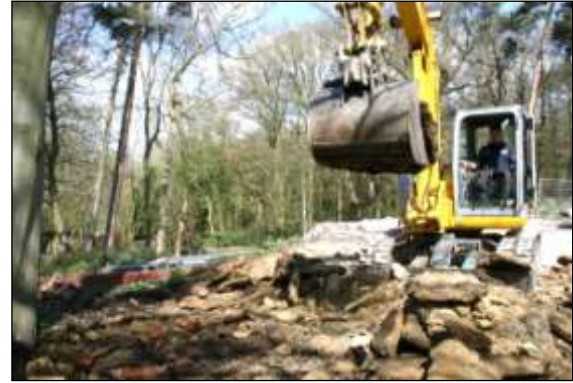
Photo 20: Machines with a long reach can be used to lift out heavy surfacing and structures as long as the machine sits outside the RPA and the exposed surface is protected before there is any further access.

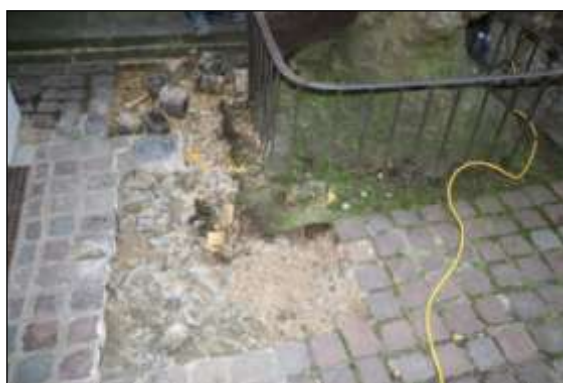
Photo 21: Careful lifting of cemented-in sets round this tree allowed them to be re-laid on a permeable sand base, improving the water input into the soil around the trunk.

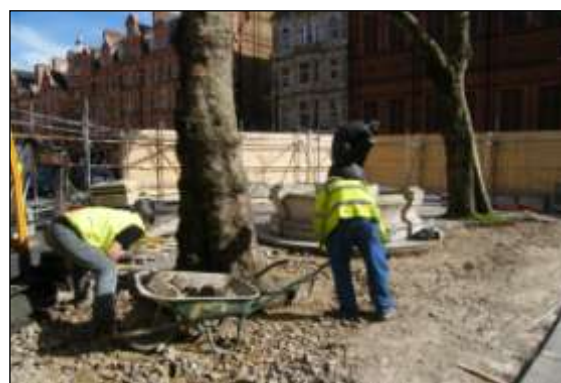
Photo 22: These trees had impermeable surfacing right up to their trunks, which had to be removed by hand before installing new structures.

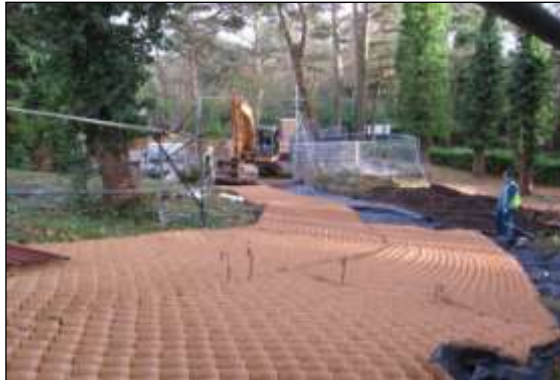
Photo 24: The three-dimensional cells are opened up, spread across the area to be surfaced and pinned in place ready for the stone filling.

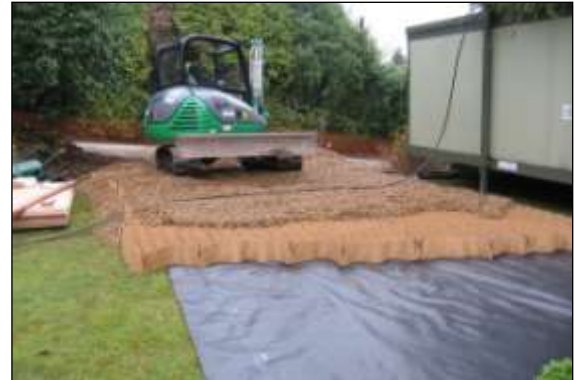
Photo 25: The stone-filled cells spread the load of traffic and the geotextile membrane on the ground prevents migration of the stone into the soil profile.

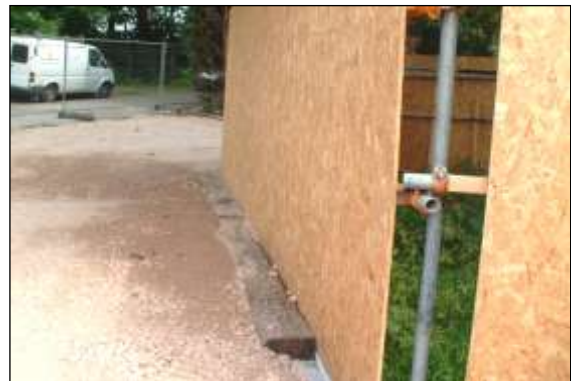
Photo 27: Although this is only a temporary surface, railway sleepers pinned into the ground can be used to retain the edges of new surfacing.

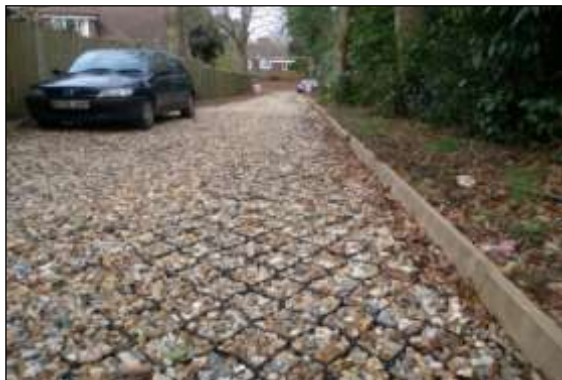
Photo 28: Wooden board pinned in place or held in position with backfilled topsoil can provide more informal and rustic surface edging.

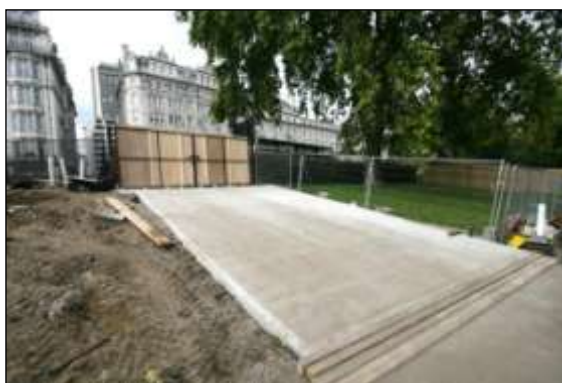
Photo 30: This temporary access for heavy construction traffic on the outer edge of a RPA is a concrete slab cast above ground level and will be removed when the project is completed.

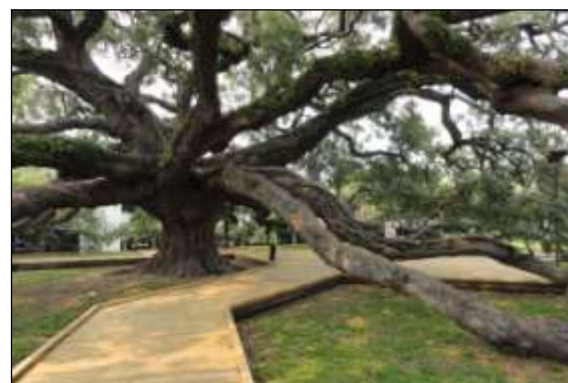
Photo 31: Board walks supported on posts or a light frame are another way of providing pedestrian access across sensitive RPAs.

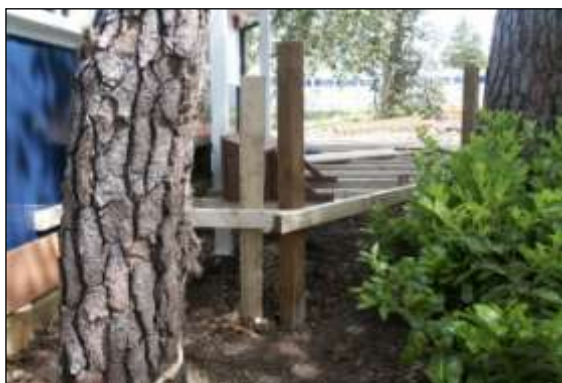
Photo 32: New surfacing can be supported above the ground on posts leaving the soil surface beneath undisturbed.

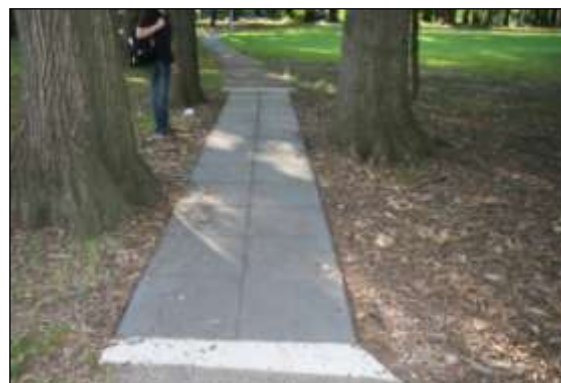
Photo 33: Where surfacing is needed close to rapidly growing buttress roots, a light metal frame with rubberised surfacing will allow the path to distort without cracking as the roots grow.

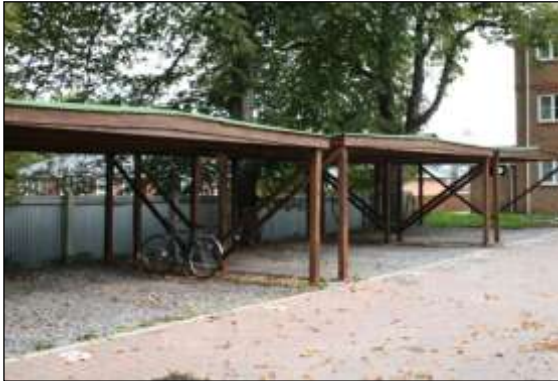
Photo 34: These carports are formed by wooden posts above a three dimensional cellular no-dig and load-spreading surface of permeable crushed stone.

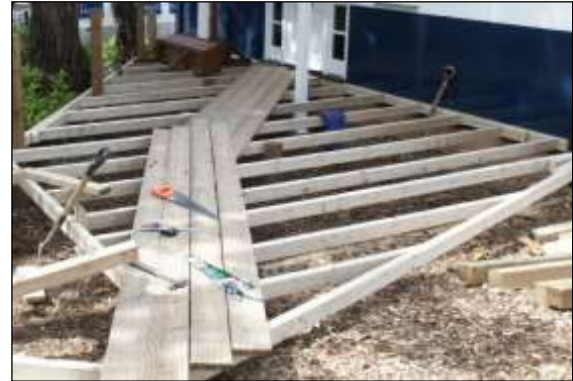
Photo 35: This deck supported above the ground on small posts provides a low-impact alternative to conventional stone patio surfacing in RPAs.

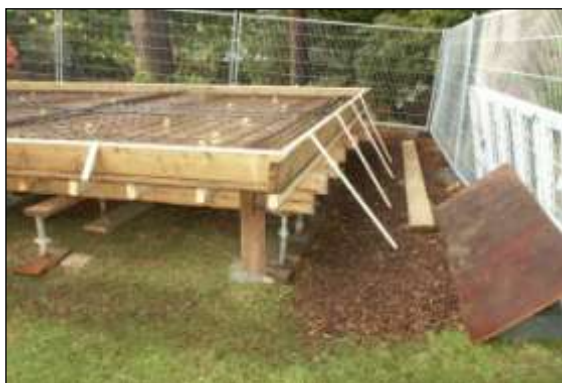
Photo 36: Small diameter piles (less than 150mm) are an effective means of supporting structures in RPAs with minimal disturbance.

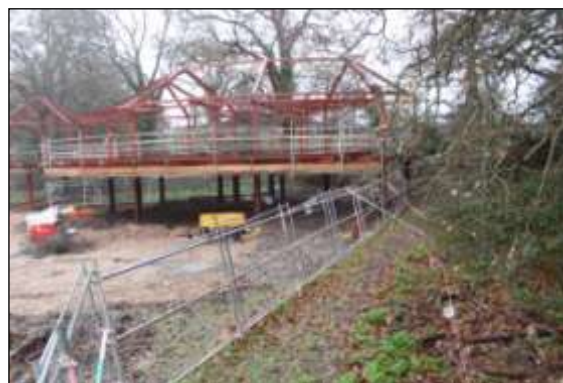
Photo 37: It is possible to support very large structures on piles within sensitive RPAs without any significant adverse impact on tree roots.

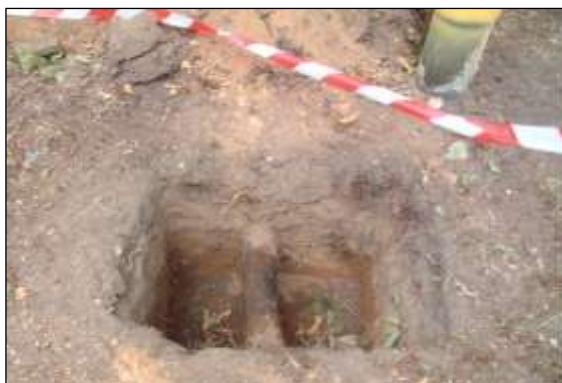
Photo 38: Where piles are proposed close to trunks, it is essential to excavate 50–75cm deep to see if there are any significant roots in the way, with provision to move the pile location if roots are found (note the pile was finally installed to avoid this root).

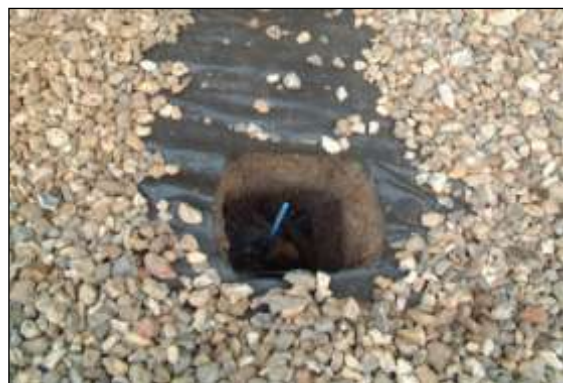
Photo 39: Ground protection must be used to spread the load of the piling rig once excavation has confirmed that no substantial roots are in the preferred pile location.

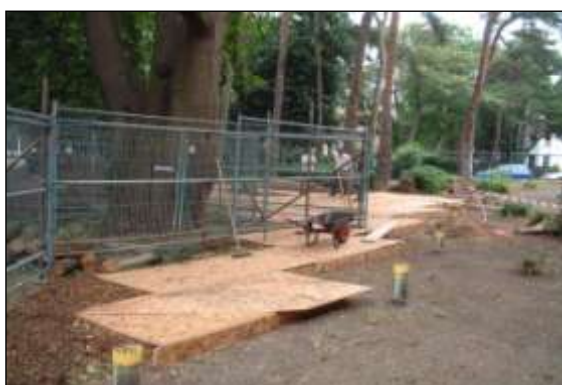
Photo 40: Once the piles have been installed (yellow tops), the ground protection to support the piling rig is removed ready to fix the void-former onto the bare soil, in advance of pouring the building slab.

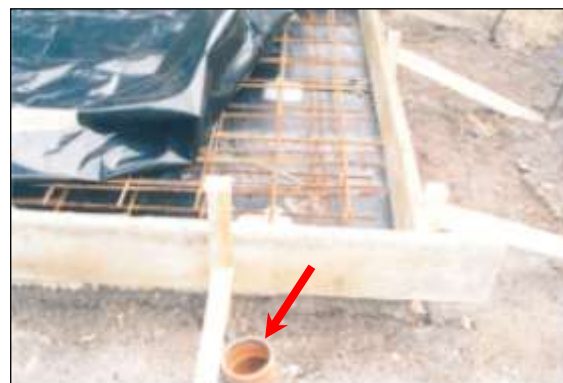
Photo 43: This reinforced base slab for a double garage has drainage provision (red arrow) beneath the structure to redirect roof runoff to supply roots with water.

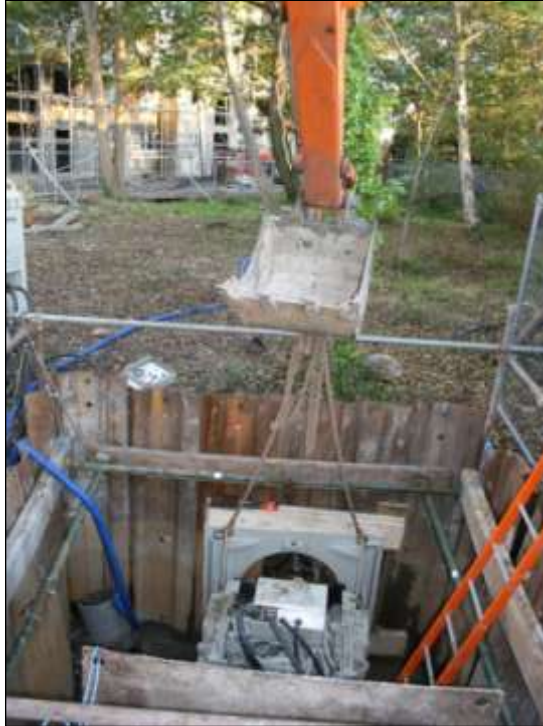
Photo 44: If possible, thrust boring is the preferred option for installing service routes through the RPAs of important trees, but there has to be space at the start and finish to dig substantial working pits.

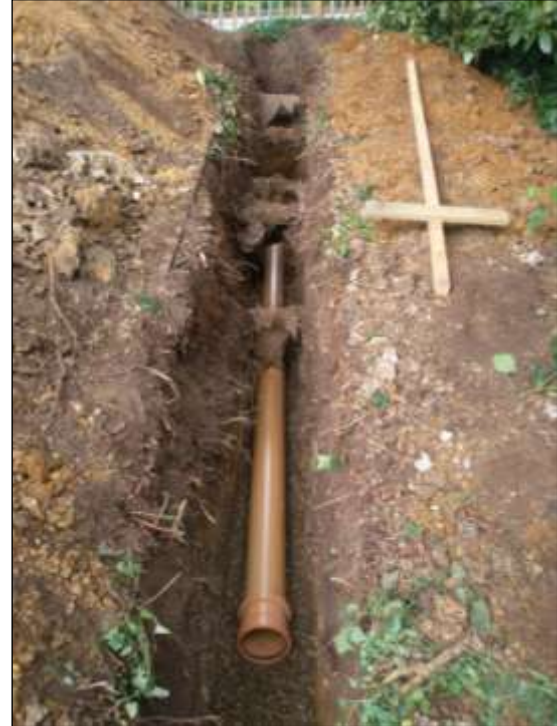
Photo 45: Continuous trenches dug by hand so that important roots can be retained (with the service ducting threaded beneath) is an effective means of minimising damage (note the ground protection boards with soil piled on top on the left).

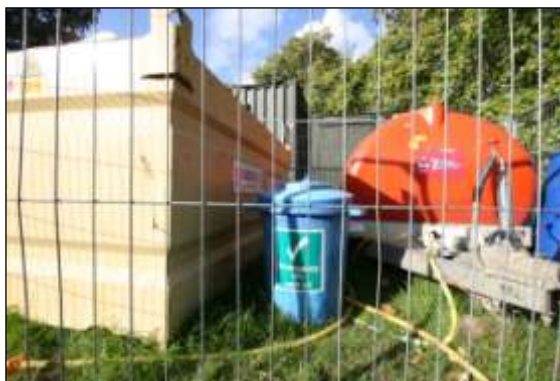
Photo 46: Where fuel or other chemical are stored on site, it is now standard practice to have emergency spillage kits available to restrict the environmental impact of accidents.

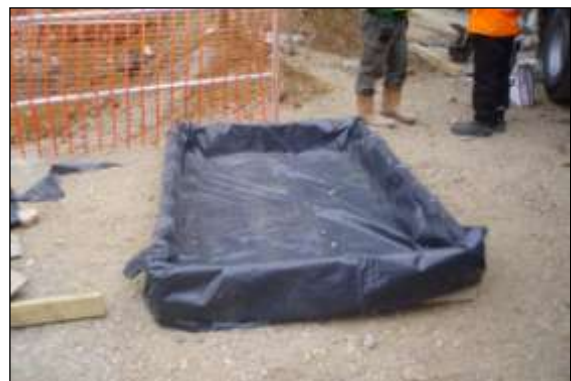
Photo 47: Soil bunding or a supporting framework covered in heavy-duty plastic sheeting is essential where there is a risk of spillages contaminating RPAs. This specifically applies to cement mixing areas and vehicle washing facilities.

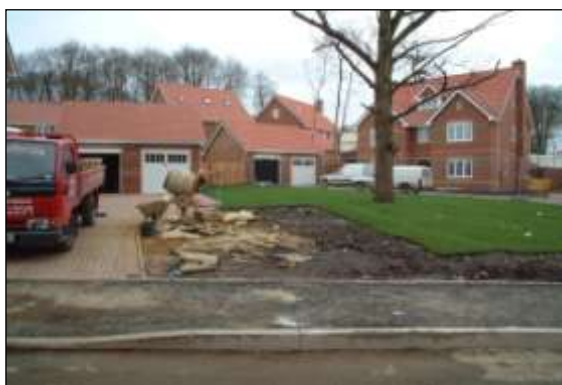
Photo 48: The RPA of this tree was not effectively protected during construction and excessive compaction of the soil meant it died soon after this turf covered up the damage.

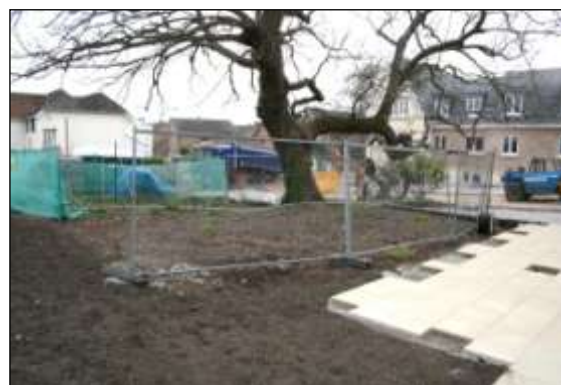
Photo 49: This tree had tarmac parking within its RPA that was removed and replaced with an organic mulch near the trunk and limited no-dig surfacing on the outer edges of its RPA.

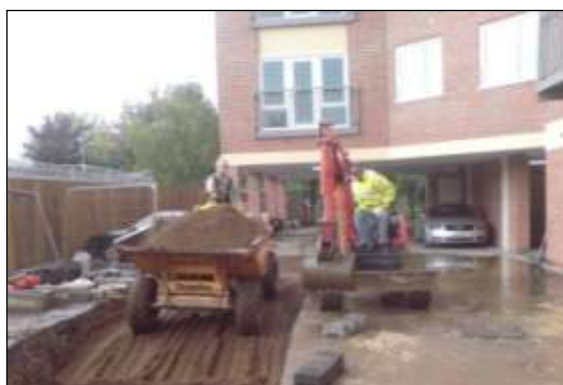
Photo 53: Structural tree soil retains sufficient structure for tree roots to grow, even when compacted.

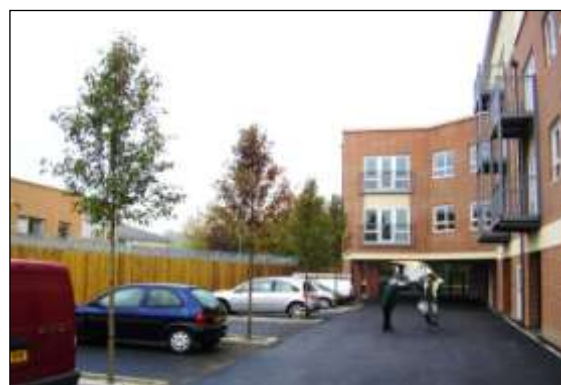
Photo 54: It allows trees to be successfully established in areas of extensive hard surfacing, with very little, if any, loss of parking space

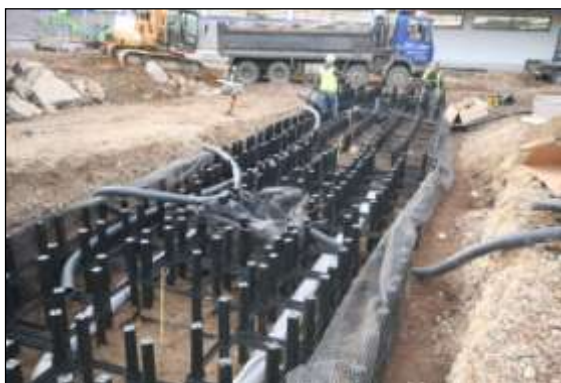
Photo 55: The individual Silva Cells can be assembled in layers and service ducting threaded through before filling with soil and fitting the reinforced tops.

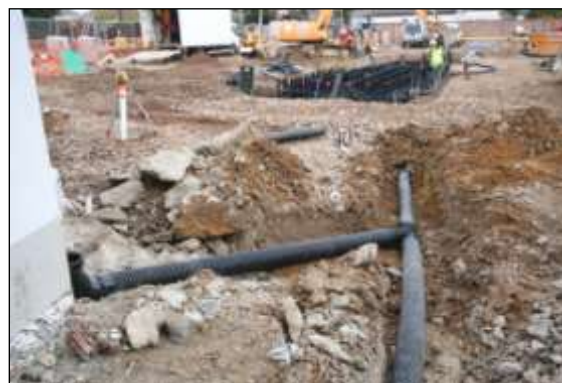
Photo 56: Drainage from adjacent buildings can be directed into Silva Cells, significantly buffering rainwater runoff from urbanised areas.

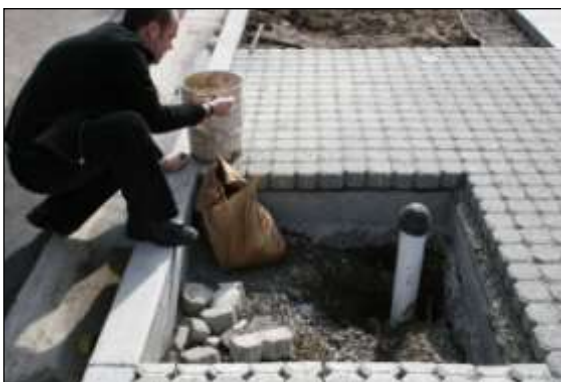
Photo 57: The finished surfacing is profiled to leave the tree pit open, ready to be filled with good quality topsoil and the new tree.

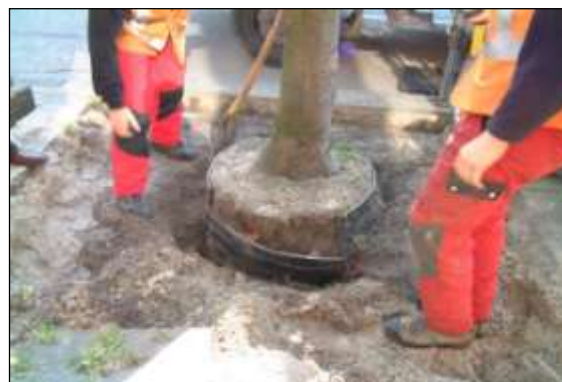
Photo 58: This excavated tree shows the root deflectors that were installed when it was planted seven years previously. The product has deflected roots downwards and prevented damage to the adjacent surfacing. Note that this is a permeable sandy soil and the roots were able to grow beneath the bottom of the deflectors.
