PROJECT NO: 1004 CLIENT/PROJECT: LAS IGUANAS, BRUNSWICK CTR

TITLE: PROPOSED EXTERNAL SEATING AREA & SHOPFRONT

DWG. NO: 1004_220 REV: A

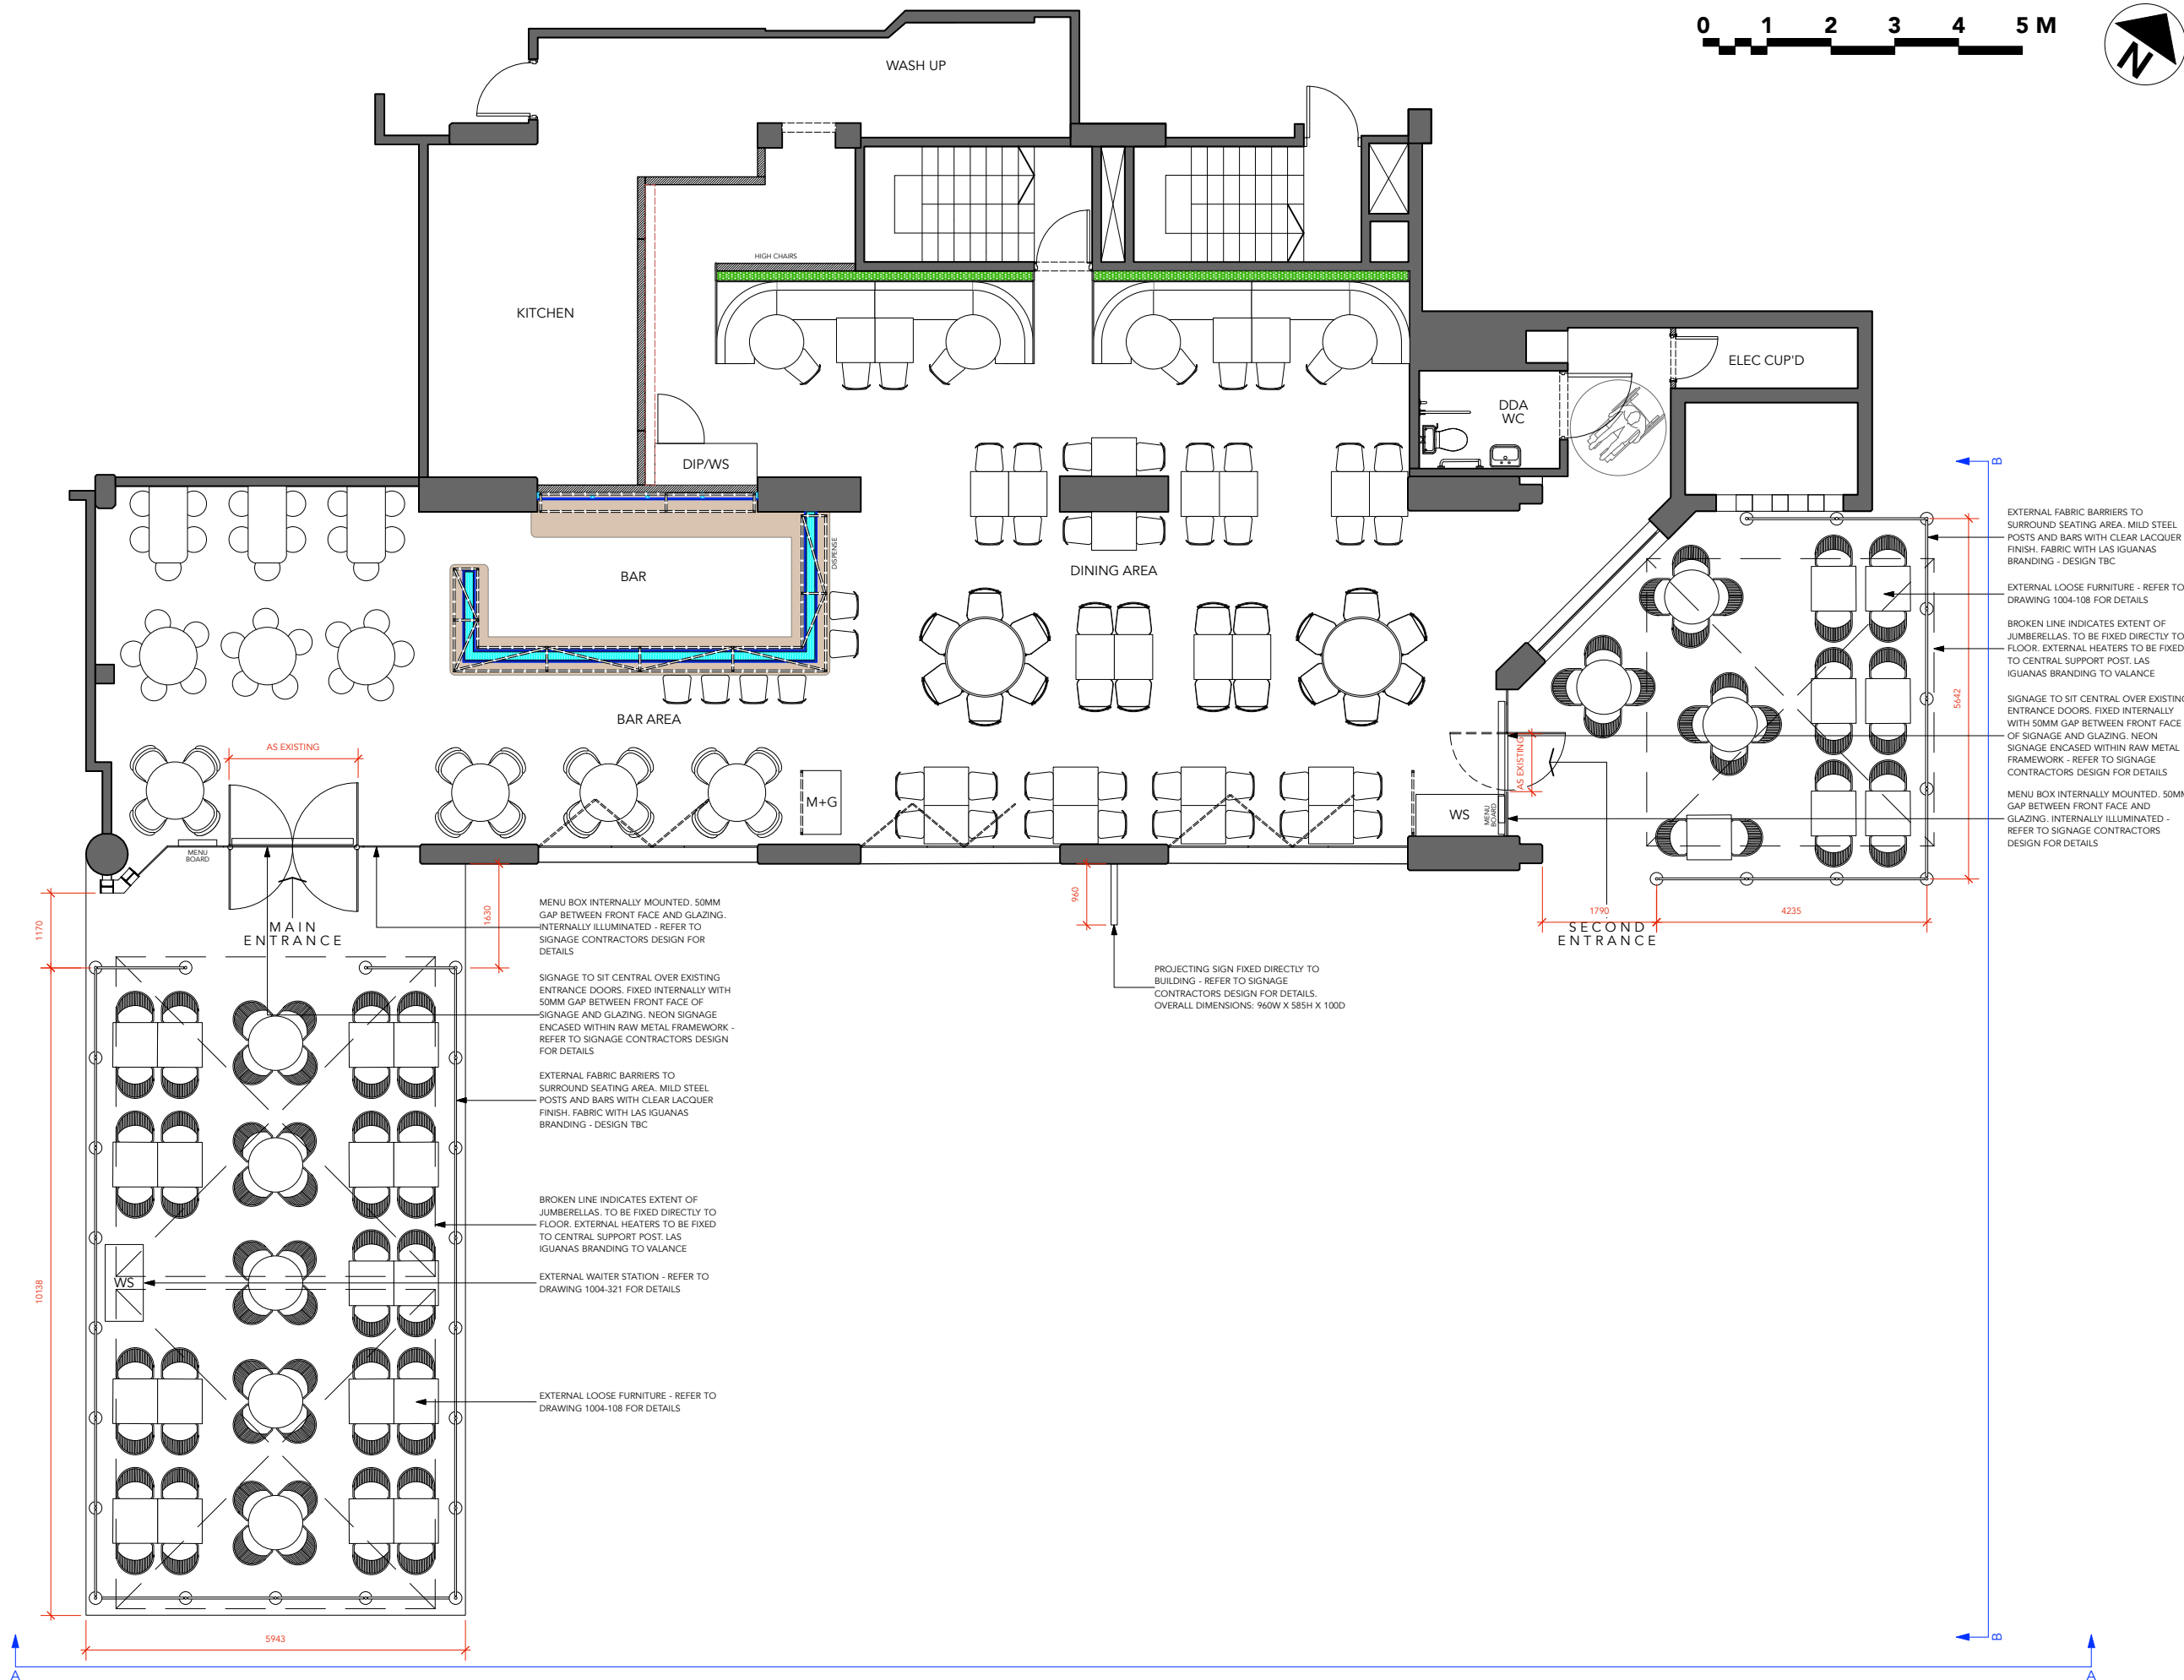
- EXISTING GLAZING TO BE RETAINED, MADE GOOD AND RECEIVE DEEP CLEAN. BI-FOLDING DOOR MECHANISM TO BE REPAIRED IF NEEDED.
- ALL SIGNAGE, EXTERNAL FURNITURE, BARRIERS, PLANTERS AND JUMBERELLAS TO BE INSTALLED TO BRUNSWICK CENTRE GUIDELINES
- PLEASE REFER TO SIGNAGE CONTRACTORS DESIGN FOR ADDITIONAL DETAILS

REVISIONS:		
CODE	DATE	DESCRIPTION
A	14.01.16	EXTERNAL PLANTERS REMOVED AND REPLACED WITH FABRIC BARRIERS
