CLIENT	University College London
PROJECT	Campbell House
TITLE	Typical Detail: Tree Protection

Drawing & Revision Number:
 BD 0112 DD 300 Roo

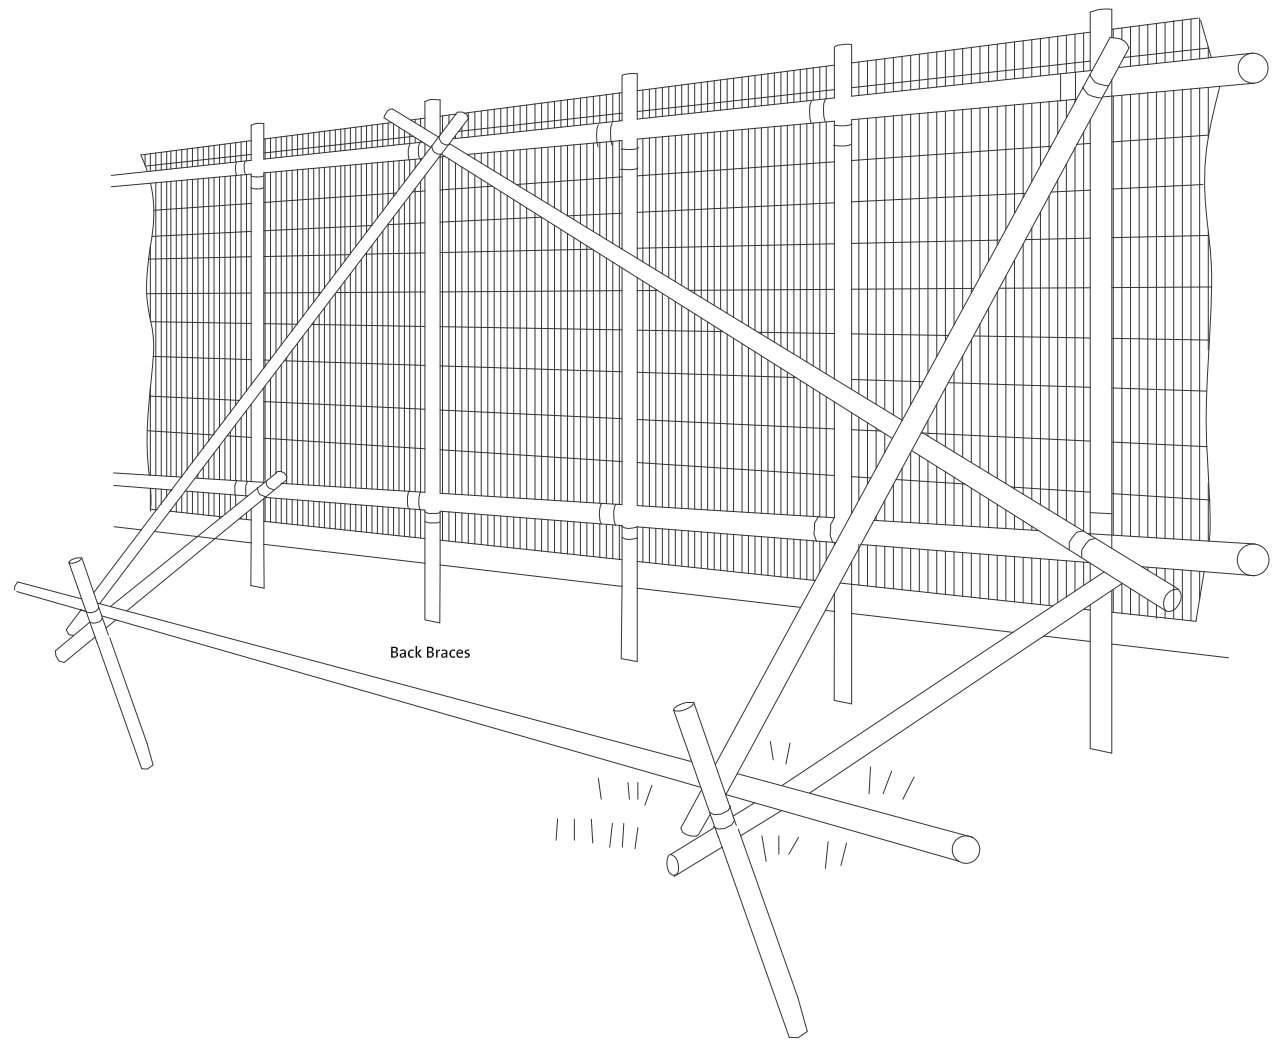
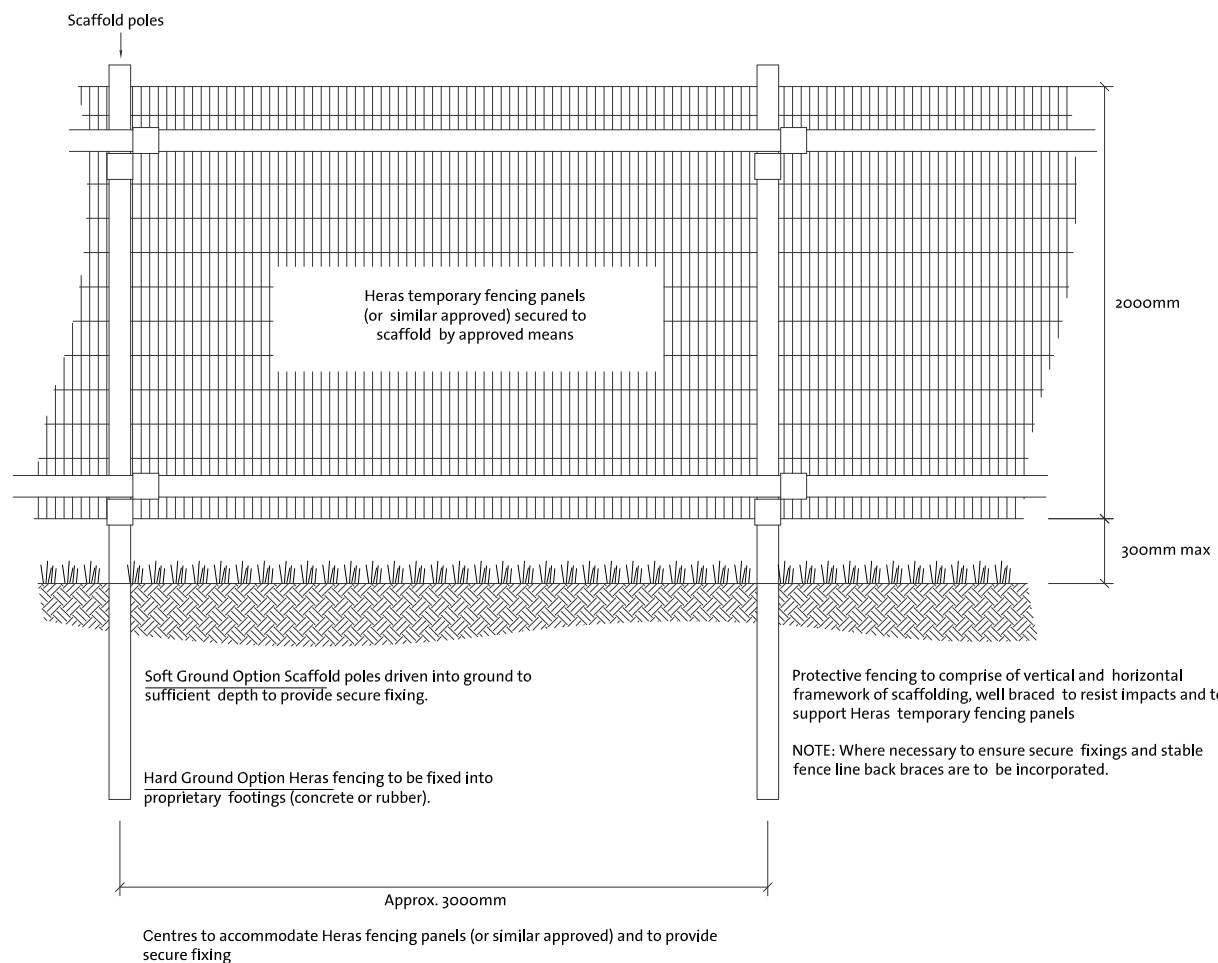
Refer to Tree Retention & Removals Plan BD 0112 DD 005 for location
