rev date amendmen project 73 Maygrove Road

drawing Site context

drawing no. PL-503

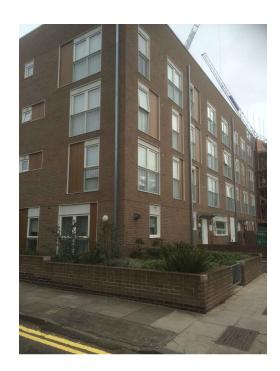
61 Maygrove

note:
plastic trims to window reveals redundant
galvanized metal balustrades
silver foil to block out lower part of window
for privacy

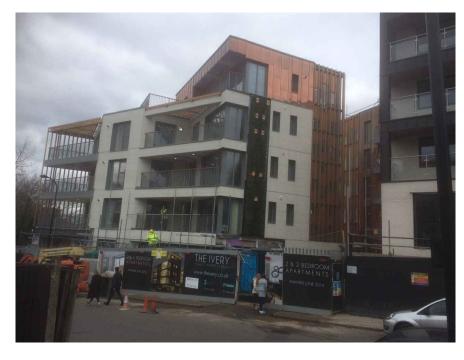
The Ivery Development. Iverson Road

Use of numerous materials: large porcelain tiles, copper cladding, galvanized metal balustrades, timber pergola, green wall

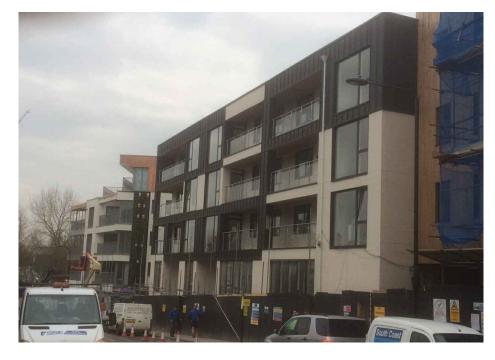
New development on Iverson Road

Use of numerous materials: white imitation brick tiles, black zinc, grey zinc, timber cladding, white drain water pipes, glass balustrades, complicated junctions resulting in poor detailing
