CLIENT Kay Georgiou Solicitors

PROJECT 40 Great James Street

DRAWING TITLE Proposed Typical New Partition Details

DRAWING NO. C(22)01

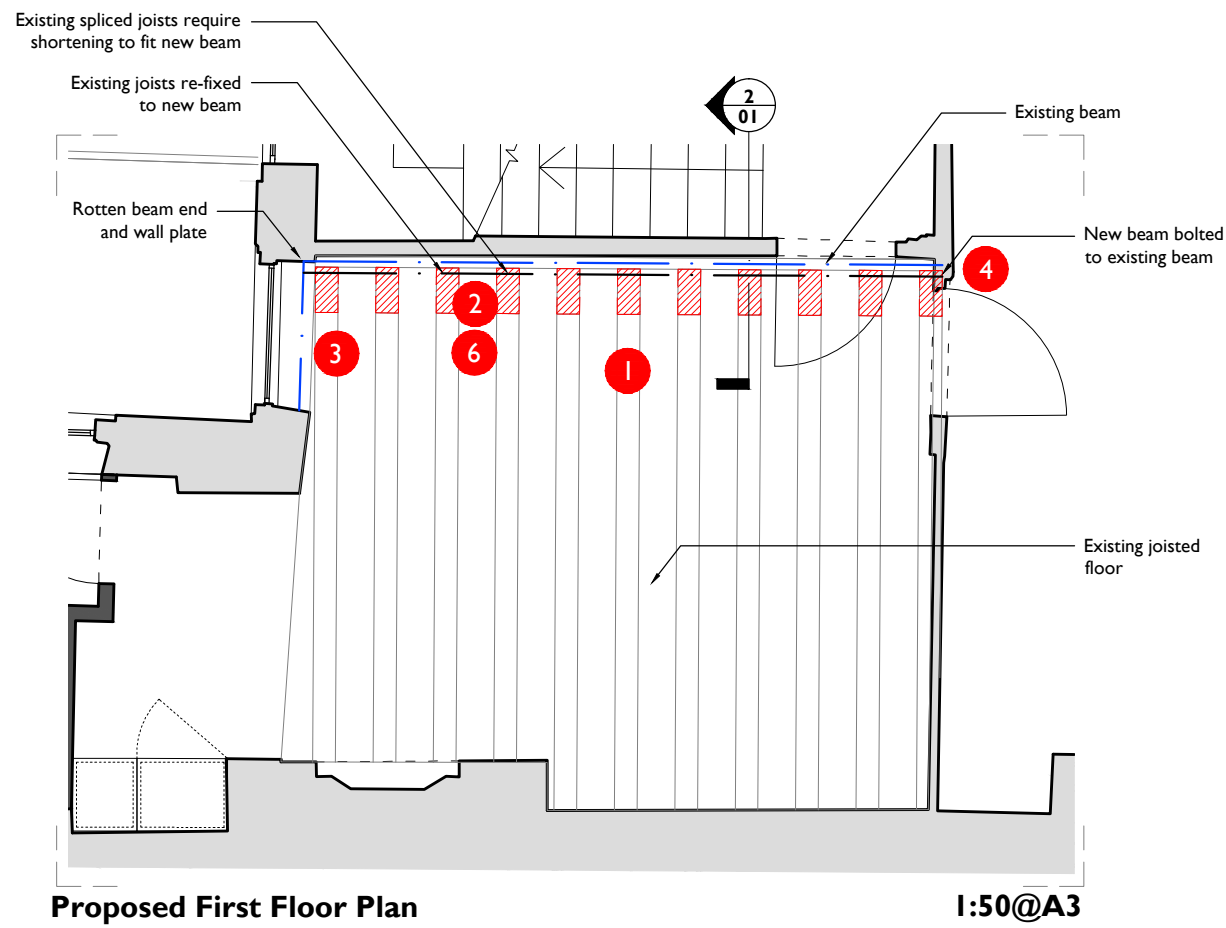
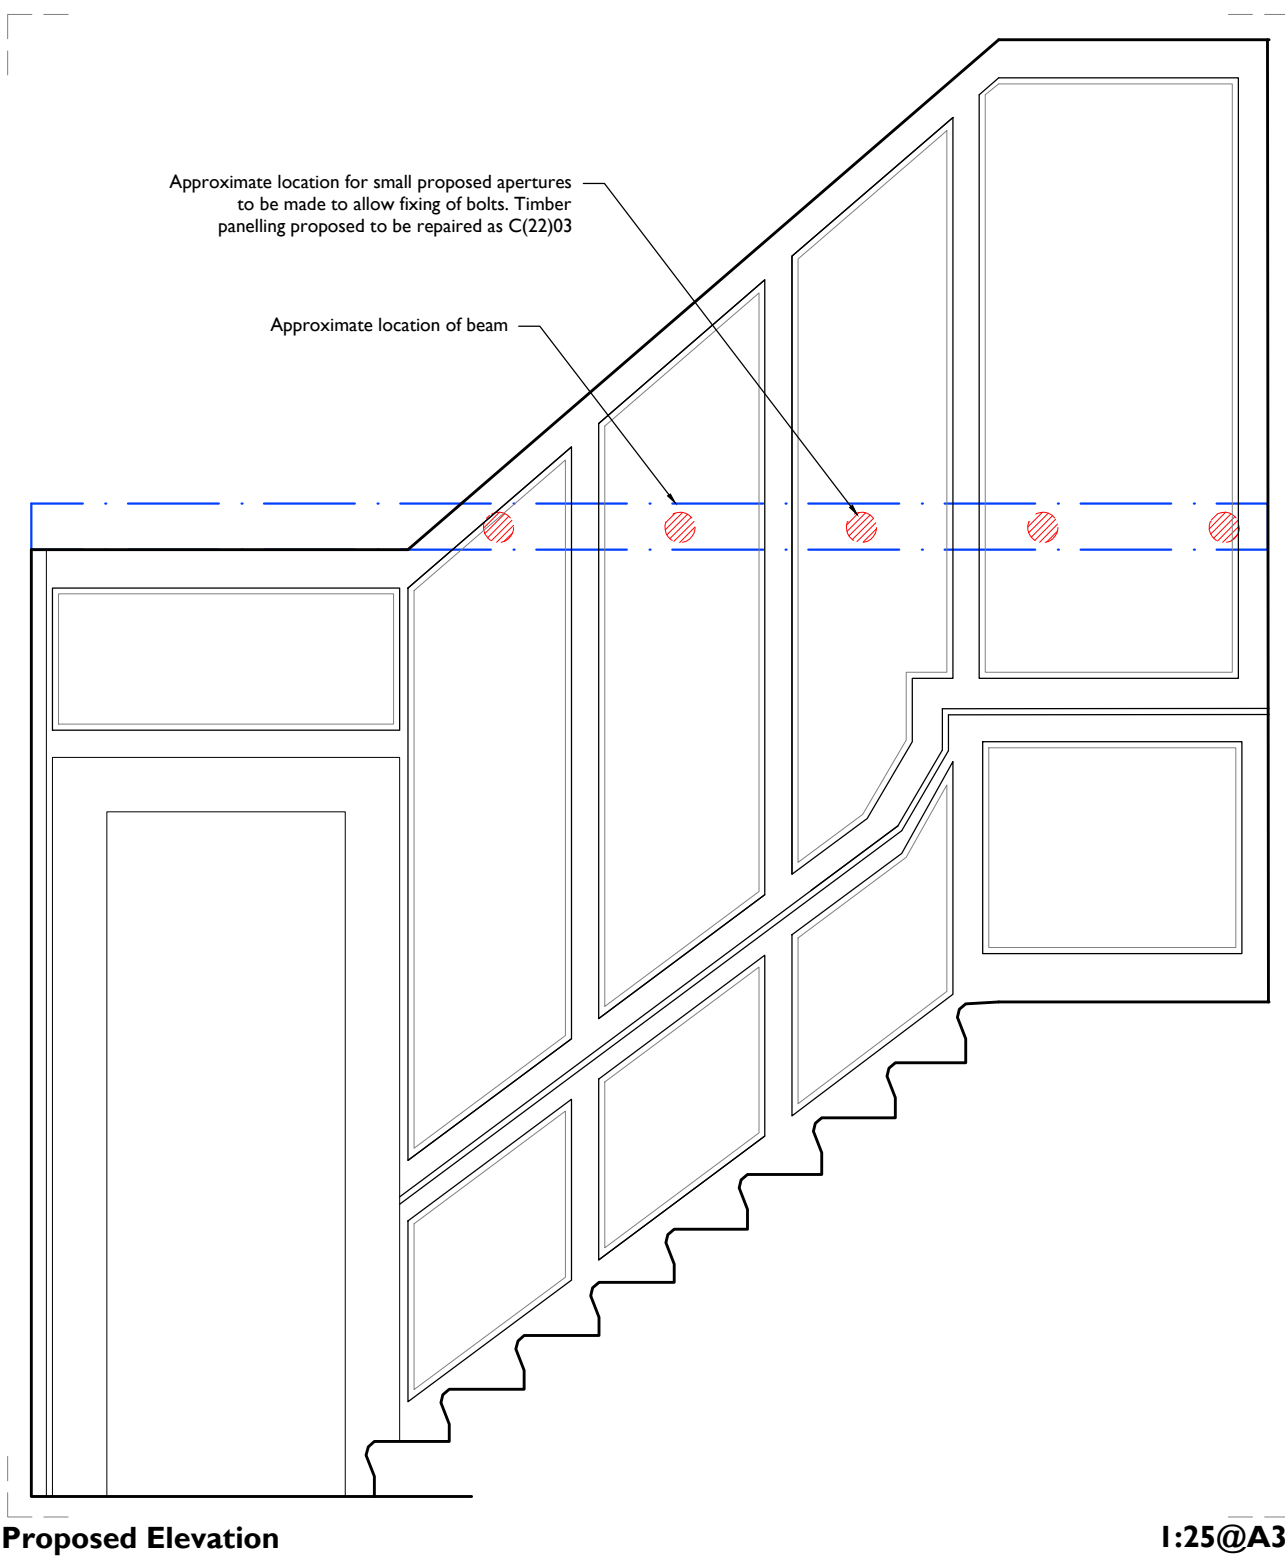
METHOD STATEMENT

- 1 Remove floorboards adjacent to panelling
- 2 Cut back joists to allow fitting of new timber beam alongside existing
- 3 Renew wall plate
- 4 New beam bolted to existing beam. Existing joists re-fixed to new beam via joist hangers or similar
- 5 Re-fix joists
- 6 Re-fit floorboards
