4 The Grove – Record of samples undertaken 29 4 16

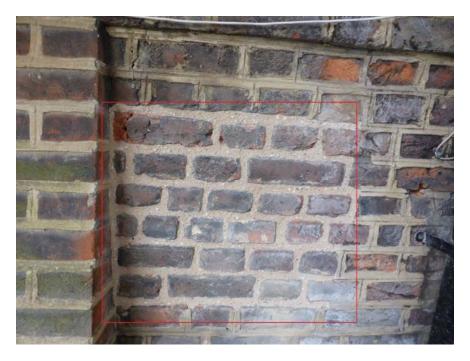
Mix 1; As installed on return wall 15 3 16

- 2 parts washed Sharp sand <8mm
- 1 part Naturally Hydraulic Lime 2
- 1/2 fine builders sand
- 1/2 part chalk crumb <5mm

This was applied recessed with a brushed finish to raise the aggregate

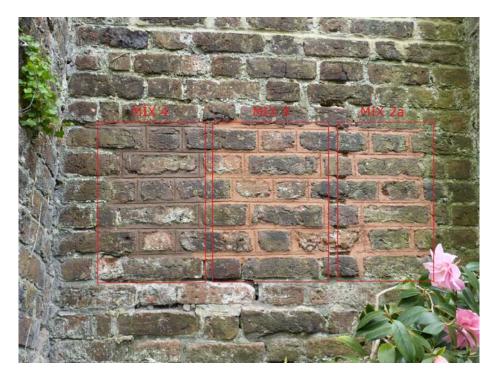
Mix 3; Middle of sample panel (shown below)

1.5 parts washed Sharp sand <3mm
1.5 parts Naturally Hydraulic Lime
³/₄ part fine builders sand
¹/₂ part chalk crumb <3mm
¹/₄ part Chard sand
³/₄ crushed RED brick dust <1mm

This was brushed and penny struck

Mix 4; LHS of sample panel (shown below)

1.5 parts washed Sharp sand <3mm
1.5 parts Naturally Hydraulic Lime
34 part fine builders sand
1/2 part chalk crumb <3mm
34 crushed RED brick dust <1mm
2 tsps by weight of Vegetable Black Natural Earth pigment to 500ml water (if 3 litres water to 25kg bag then 12tsps per bag)

Mix 2a; RHS of sample panel (shown overleaf)

- 1.5 parts washed Sharp sand <5mm
- 1.5 parts Naturally Hydraulic Lime
- 3/4 part fine builders sand
- 1/2 part chalk crumb <5mm
- 3/4 crushed RED brick dust <1mm

This was brushed and penny struck
