Highgate High St Elevation Section B-B

Highgate High St Elevation Section A-A

1st Level Plan View

Ground Level Plan View

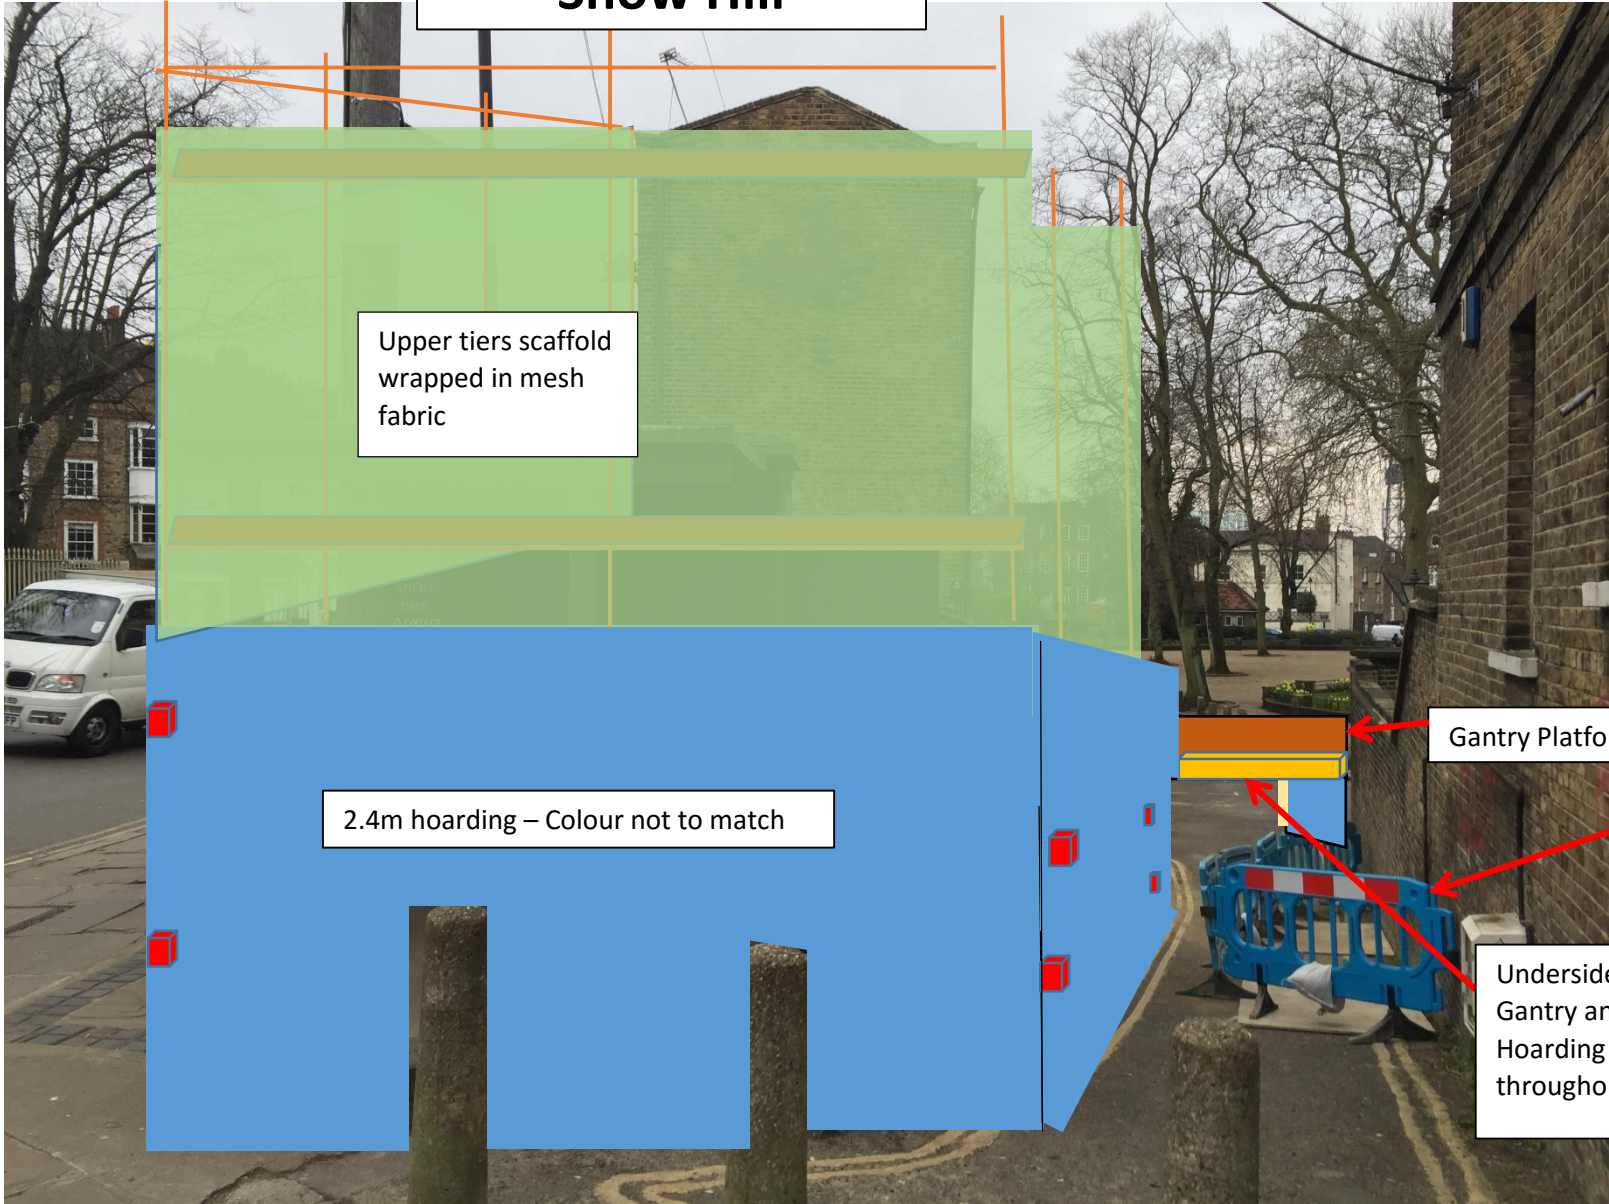
Upper tiers scaffold wrapped in mesh fabric

2.4m hoarding – Colour not to match

Gantry Platform

Barriers now removed with full access through this area.

Underside of Gantry and Hoarding well-lit throughout

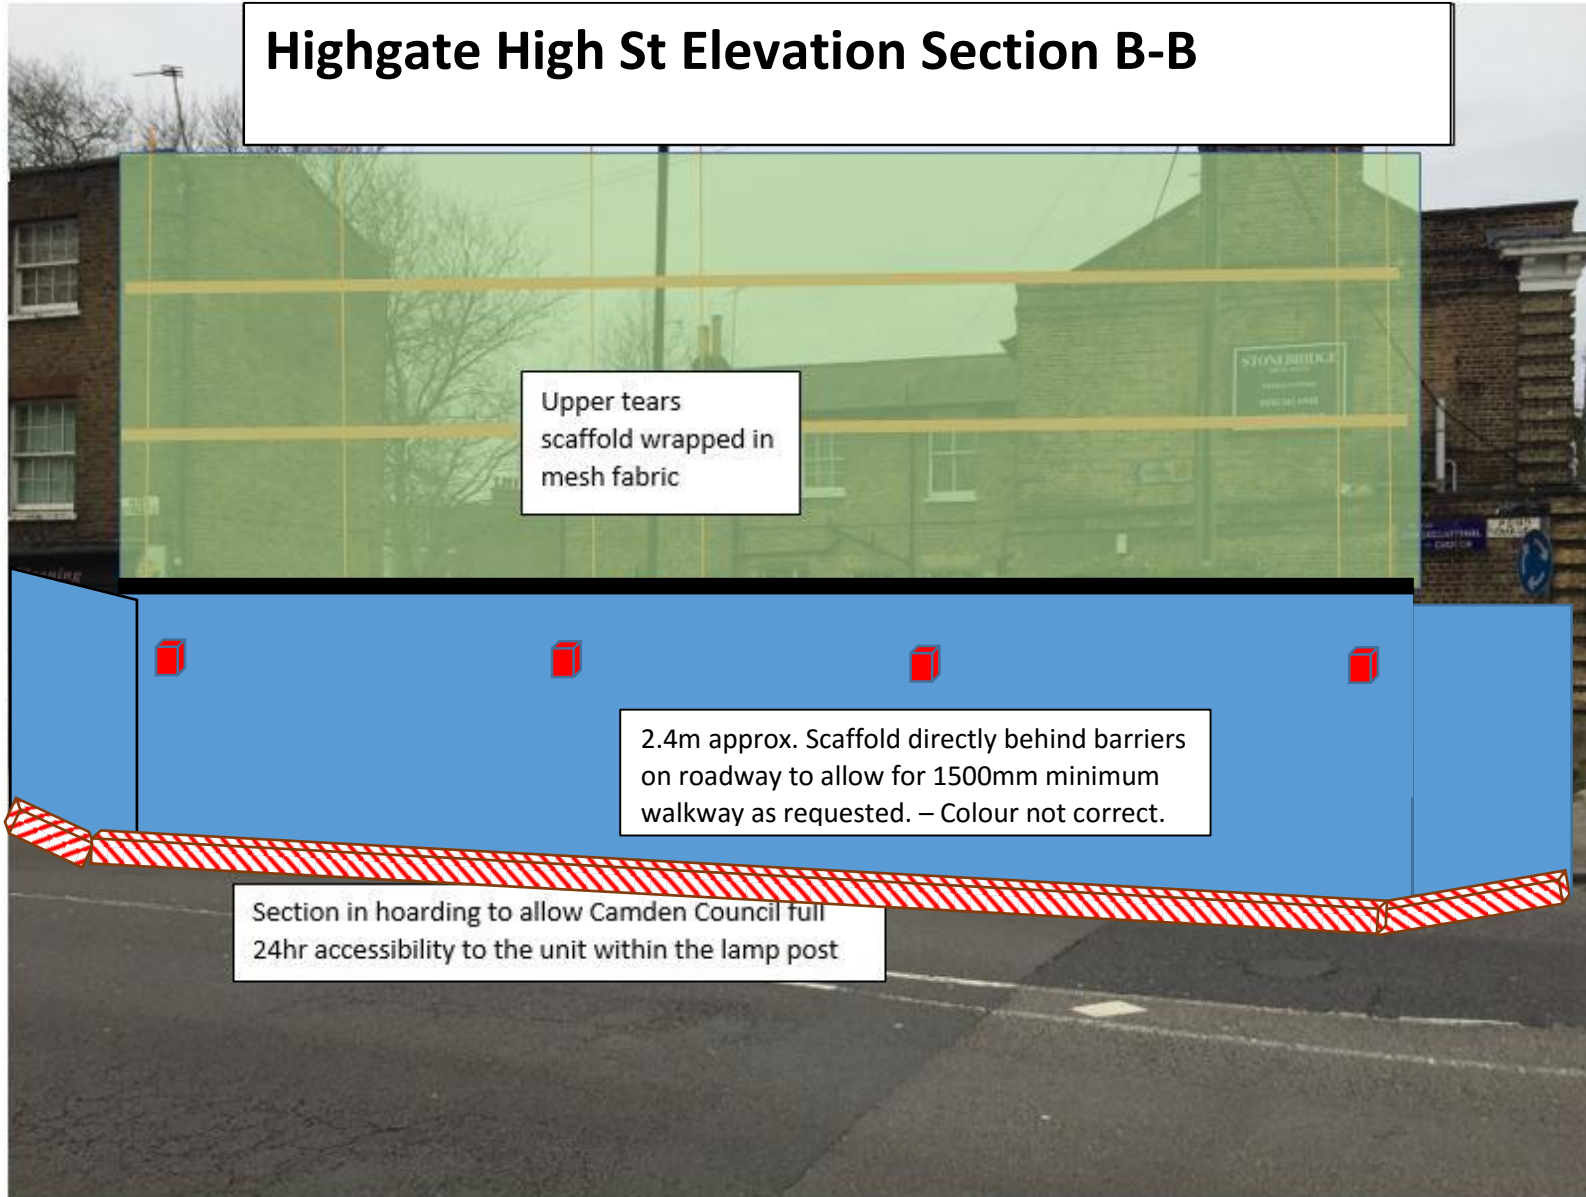
Upper tiers
scaffold wrapped in
mesh fabric

2.4m approx. Scaffold directly behind barriers
on roadway to allow for 1500mm minimum
walkway as requested. – Colour not correct.

Section in hoarding to allow Camden Council full
24hr accessibility to the unit within the lamp post

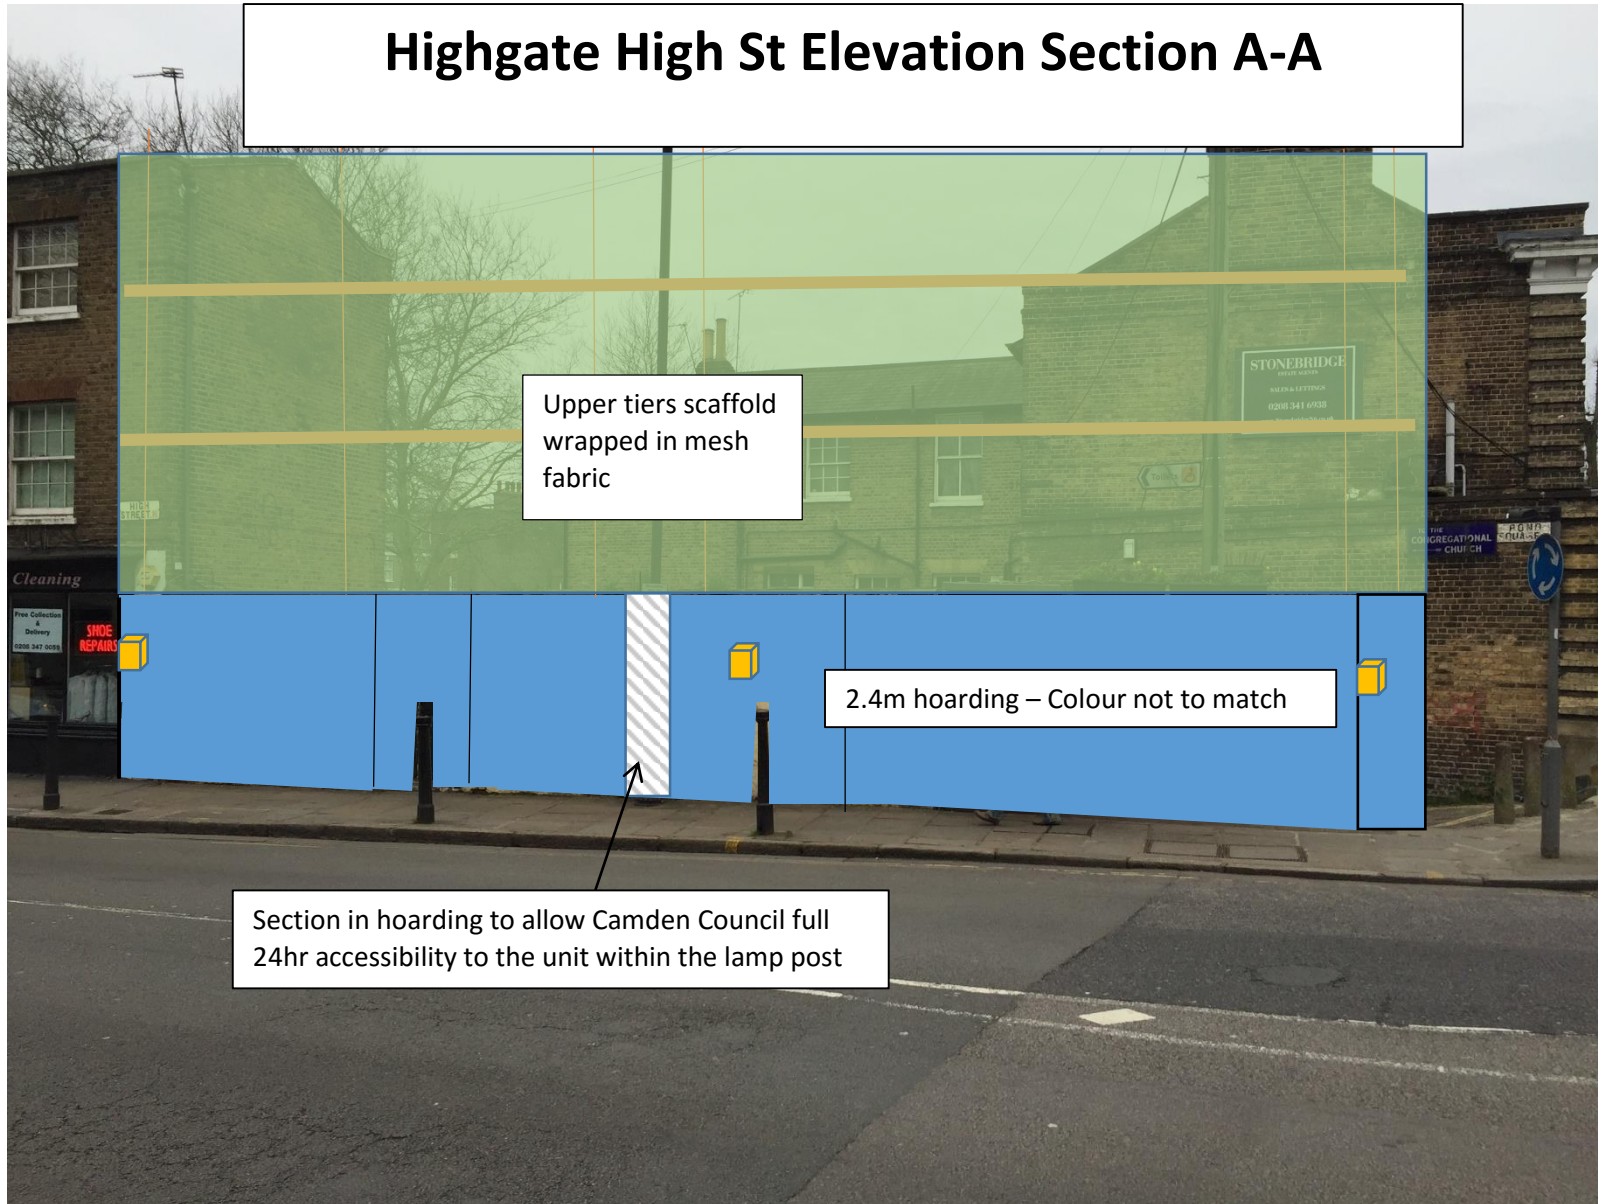
Upper tiers scaffold wrapped in mesh fabric

2.4m hoarding – Colour not to match

Section in hoarding to allow Camden Council full 24hr accessibility to the unit within the lamp post

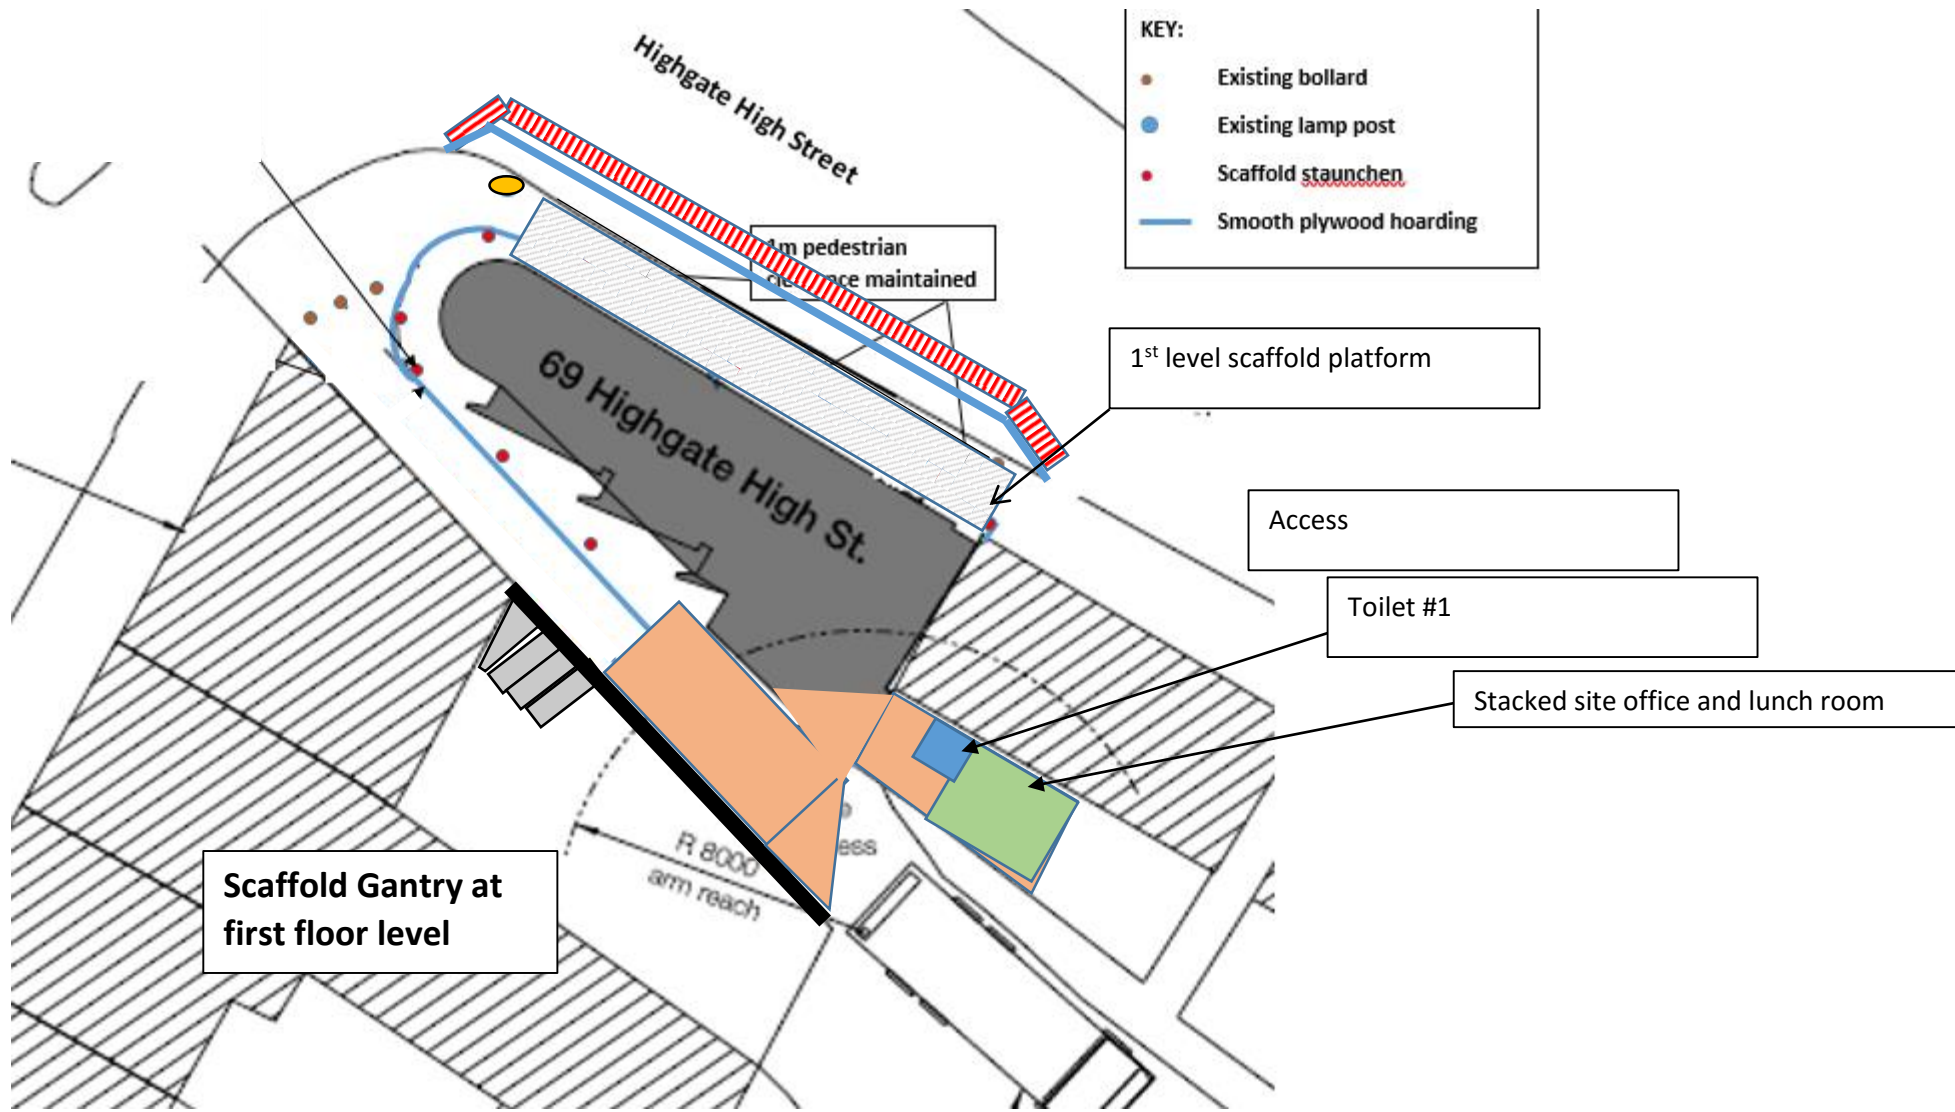
3m pedestrian clearance maintained

1st level scaffold platform

Access

Toilet #1

Stacked site office and lunch room

Scaffold Gantry at first floor level

R 8000 arm reach

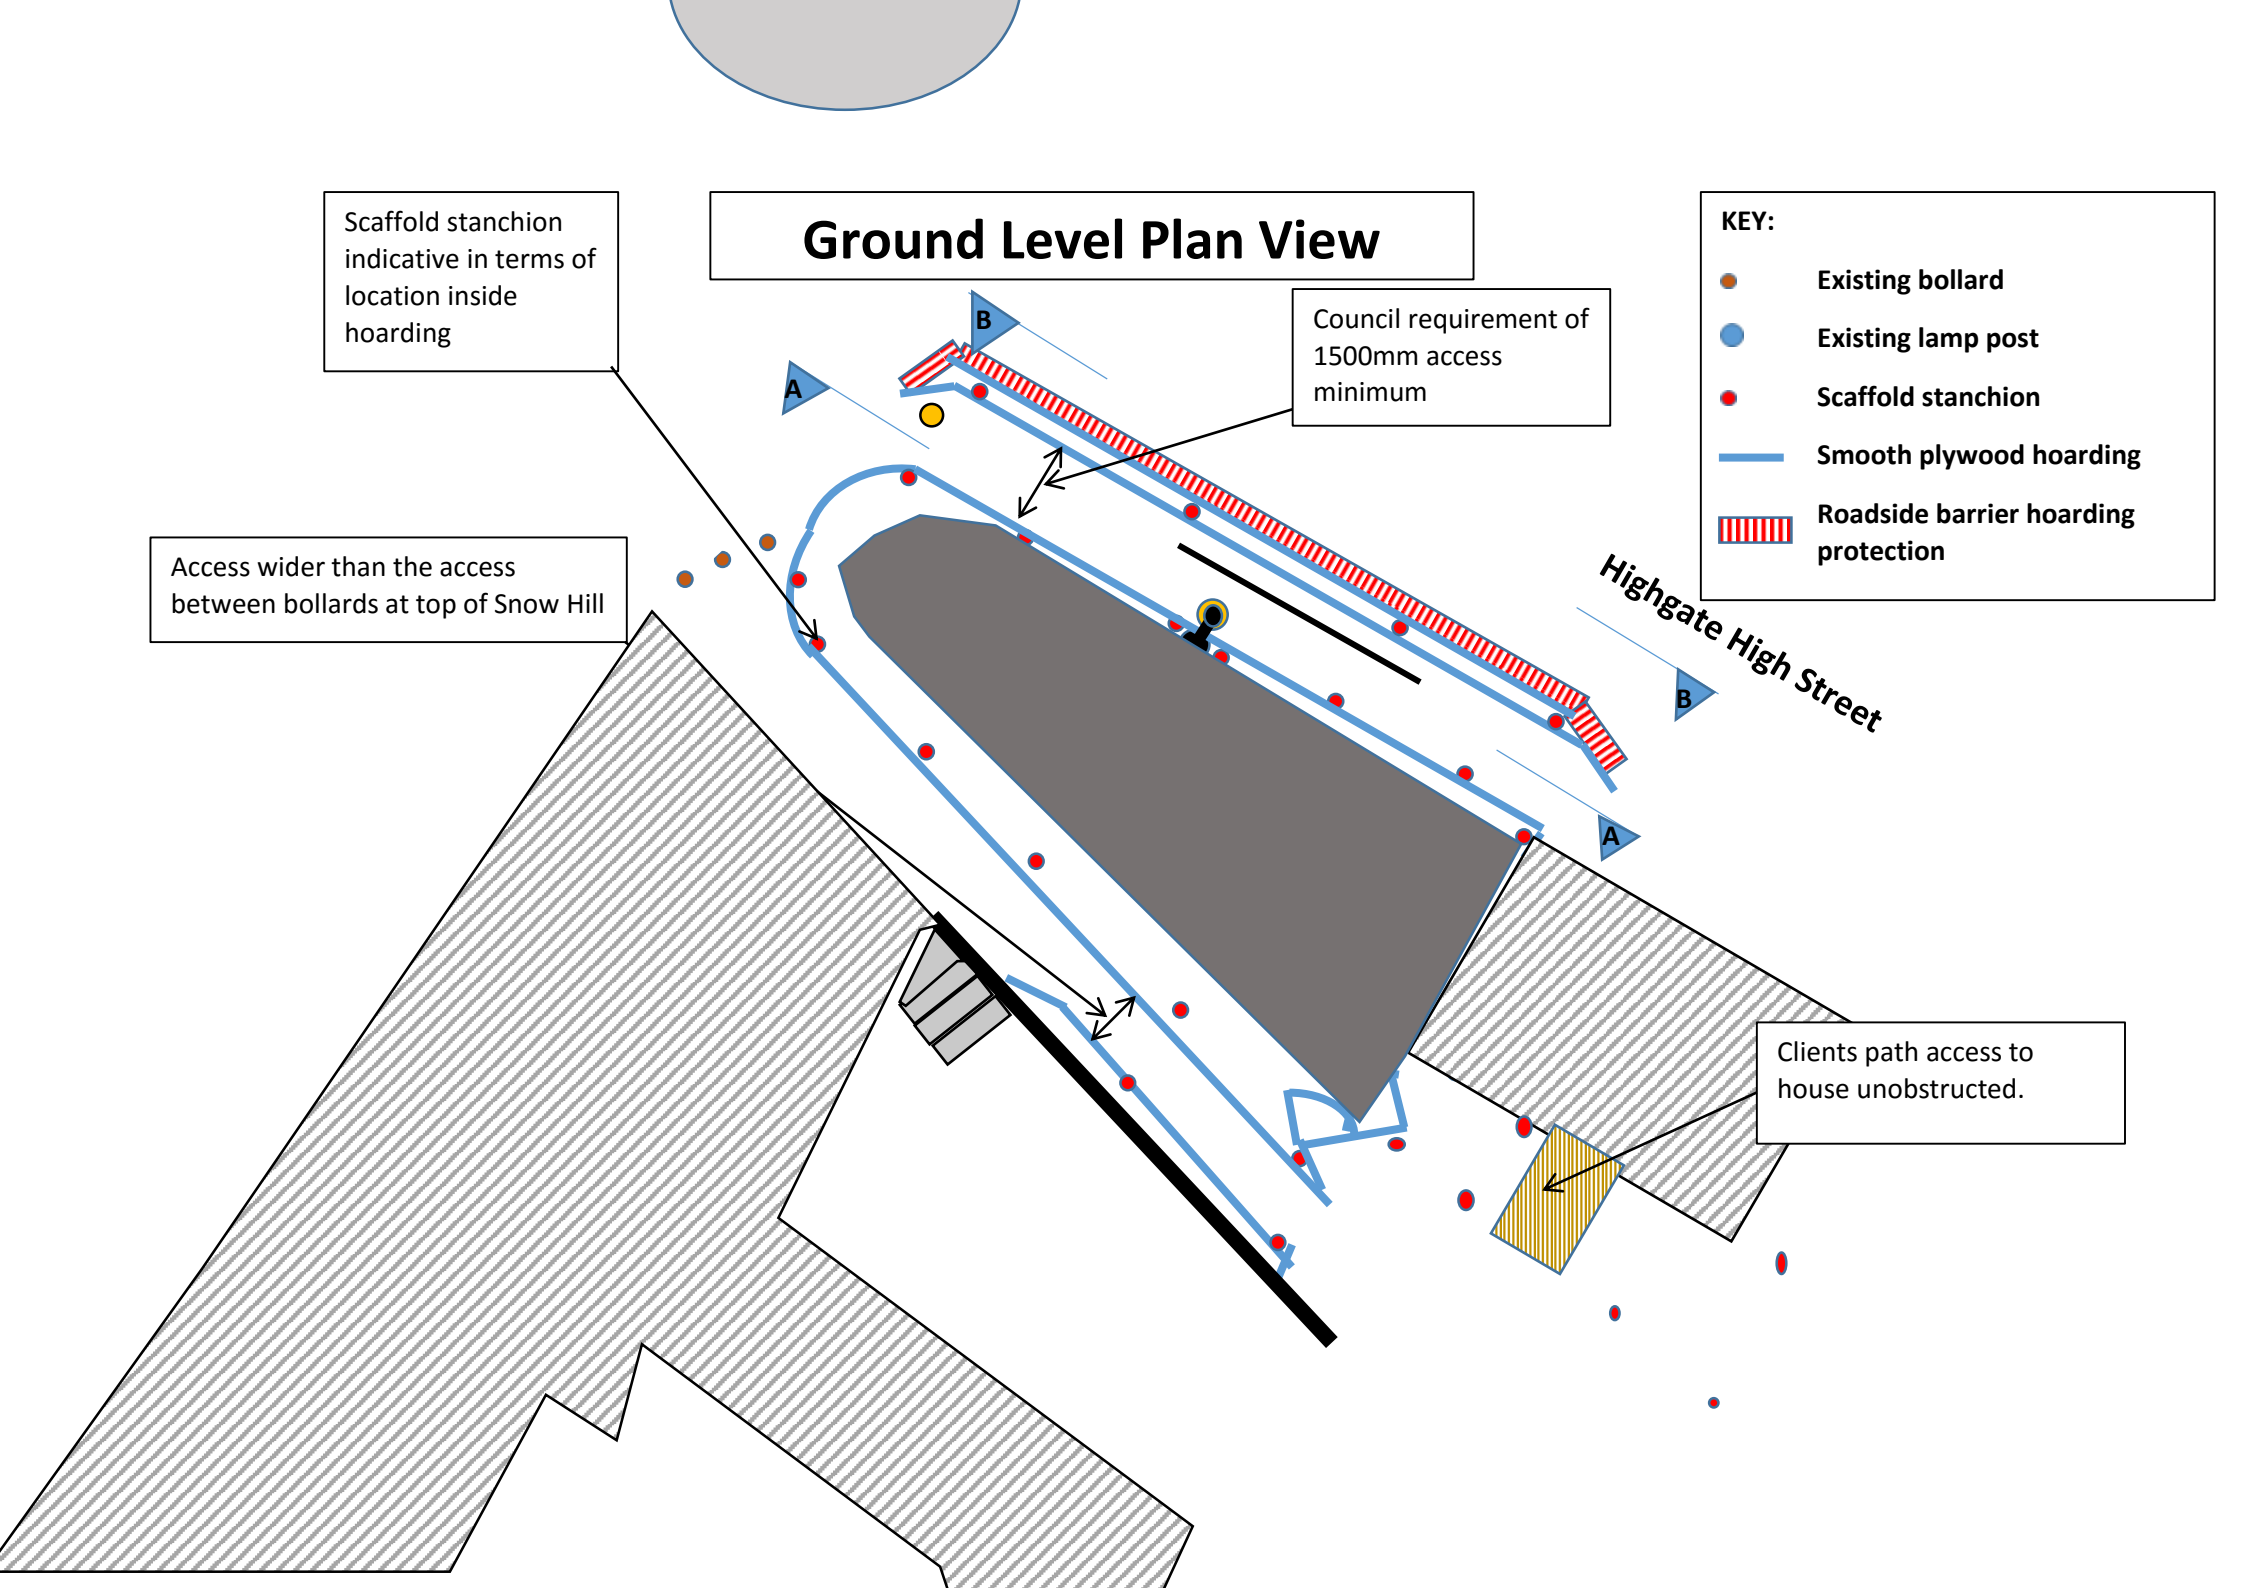
Scaffold stanchion indicative in terms of location inside hoarding

Council requirement of 1500mm access minimum

Access wider than the access between bollards at top of Snow Hill

Clients path access to house unobstructed.

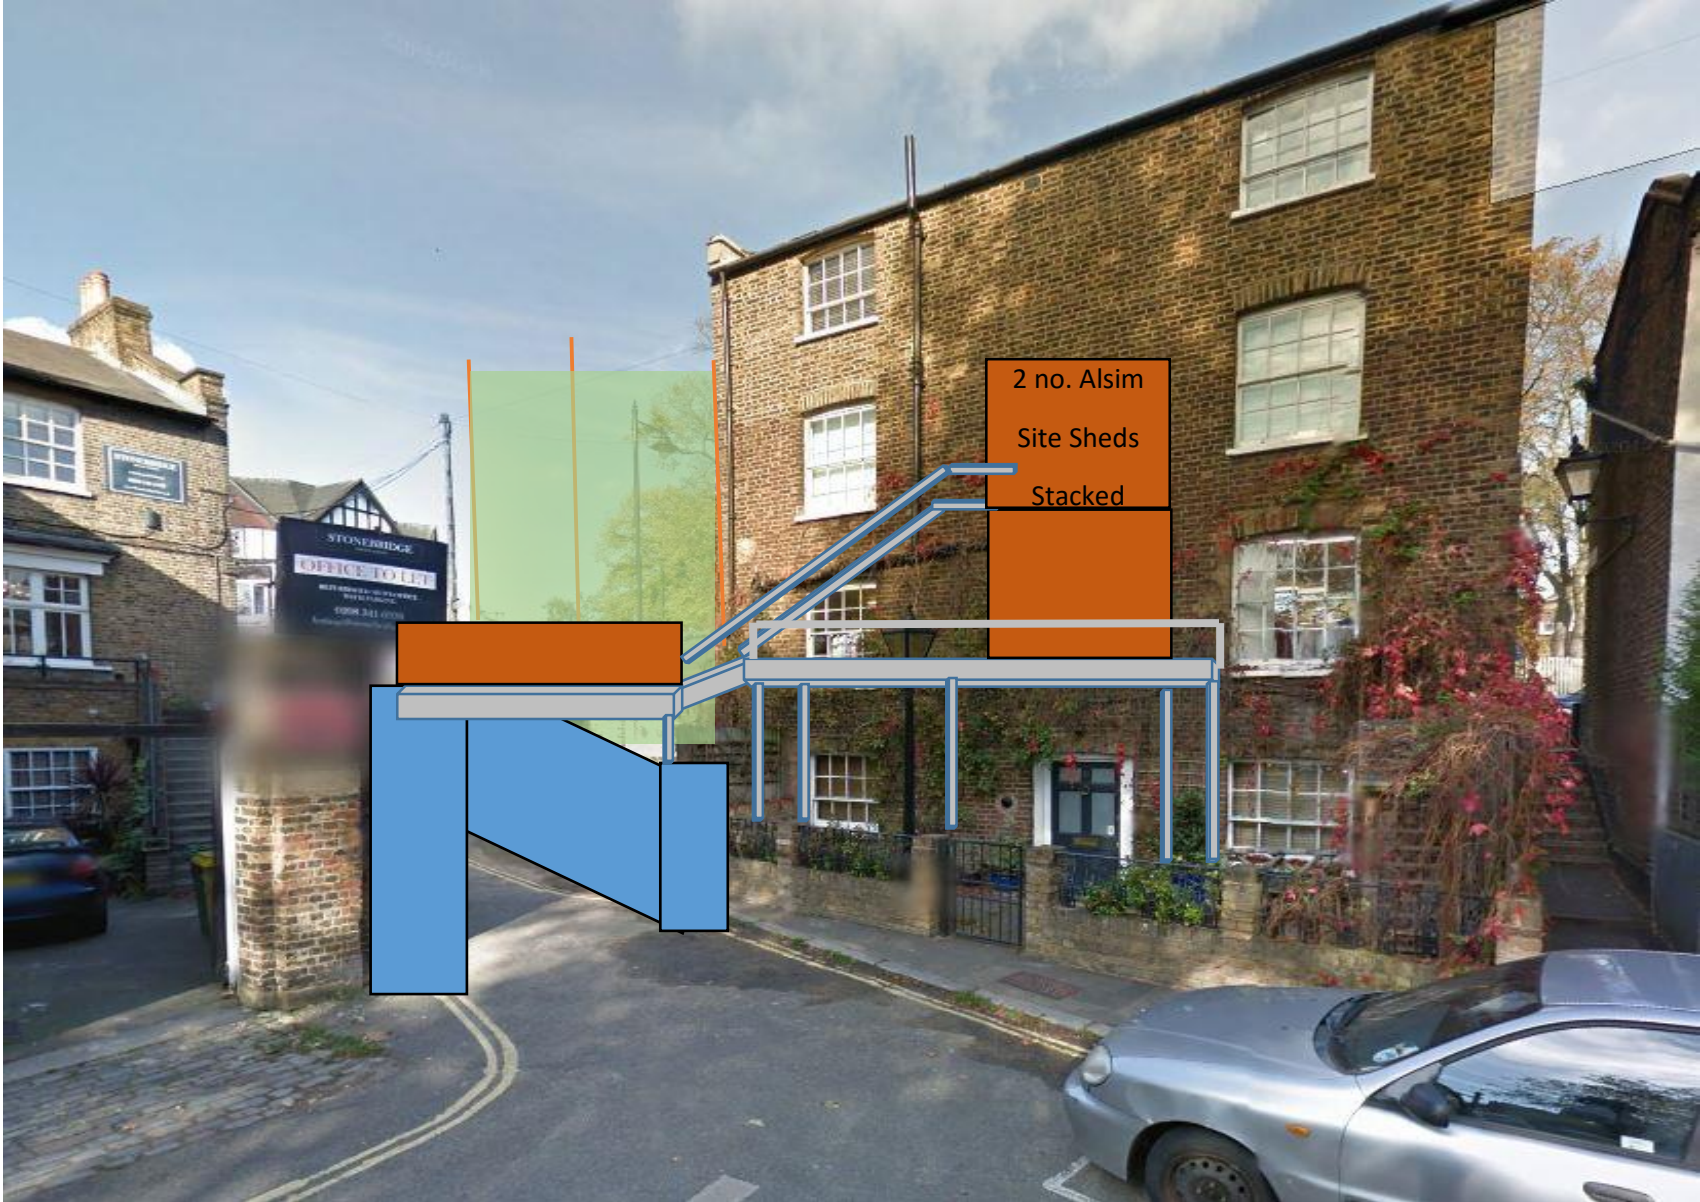
2 no. Alsim
Site Sheds
Stacked
