ARBORICULTURAL IMPACT ASSESSMENT REPORT FOR:

Nos 4-8 and 1-3 Ferdinand Place
Camden
London
NW1 8EE

Ref: CSA/FPL/AIA/01

Date: 29th February 2016

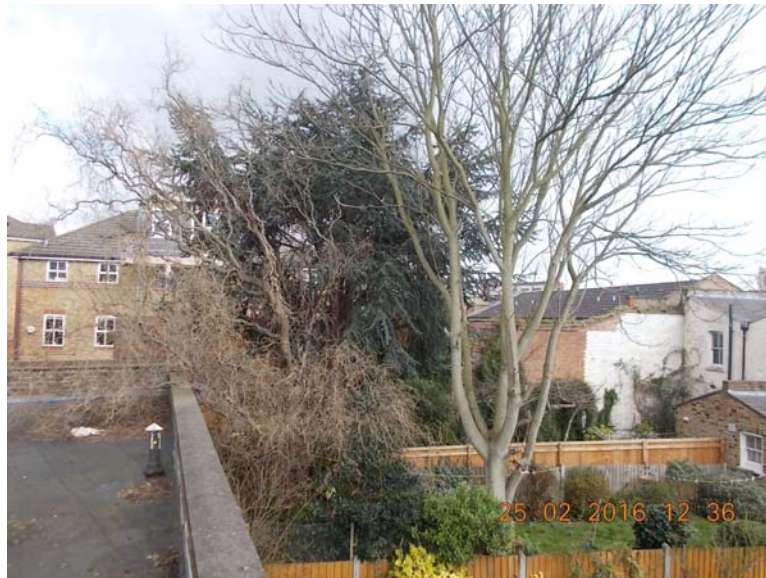
Photograph 1: T2 – T4 abutting the eastern site boundary wall of Site A

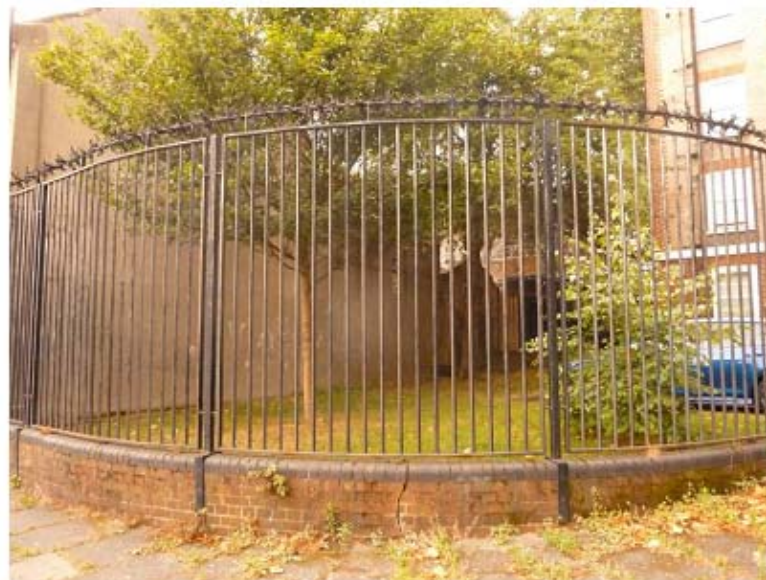
Photograph 2: T5 & T6 lying adjacent to north elevation wall of Site B

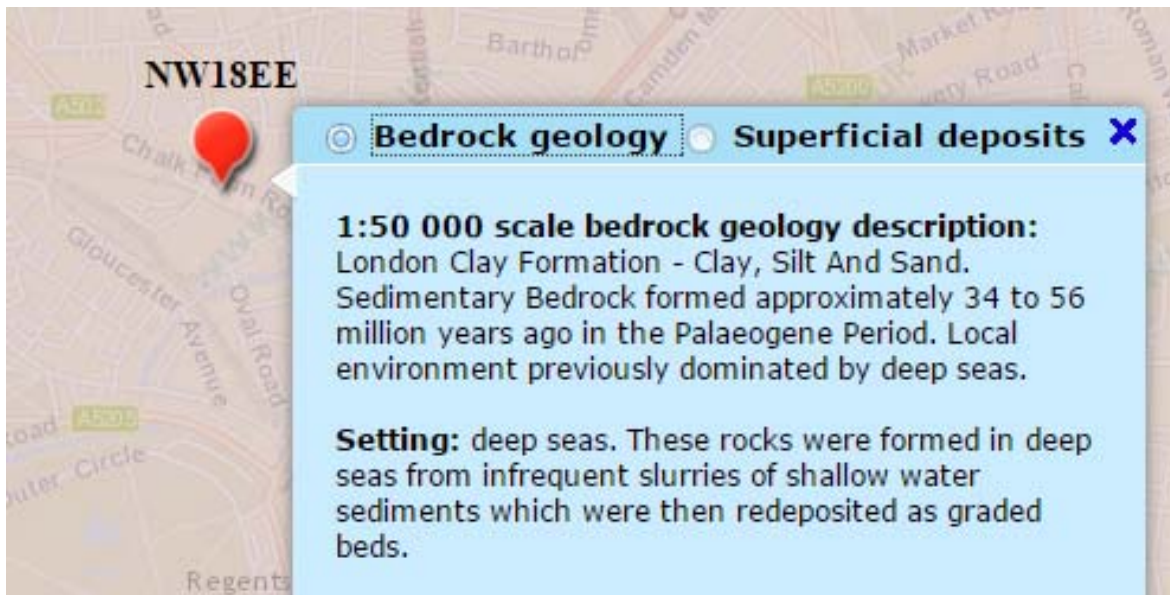
- 3.1.3 In terms of the British Geological Survey, the site overlies the London Clay Formation (see indicated location on Fig.1 plan extract below). The associated soils are generally, highly shrinkable clay; e.g. slowly permeable seasonally waterlogged fine loam over clay. Such highly plastic soils are prone to movement: subsidence and heave. The actual distribution of the soil series are not as clearly defined on the ground as on plan and there may be anomalies in the actual composition of clay, silt and sand content.

Figure 1: Extract from the BGS Geology of Britain Viewer

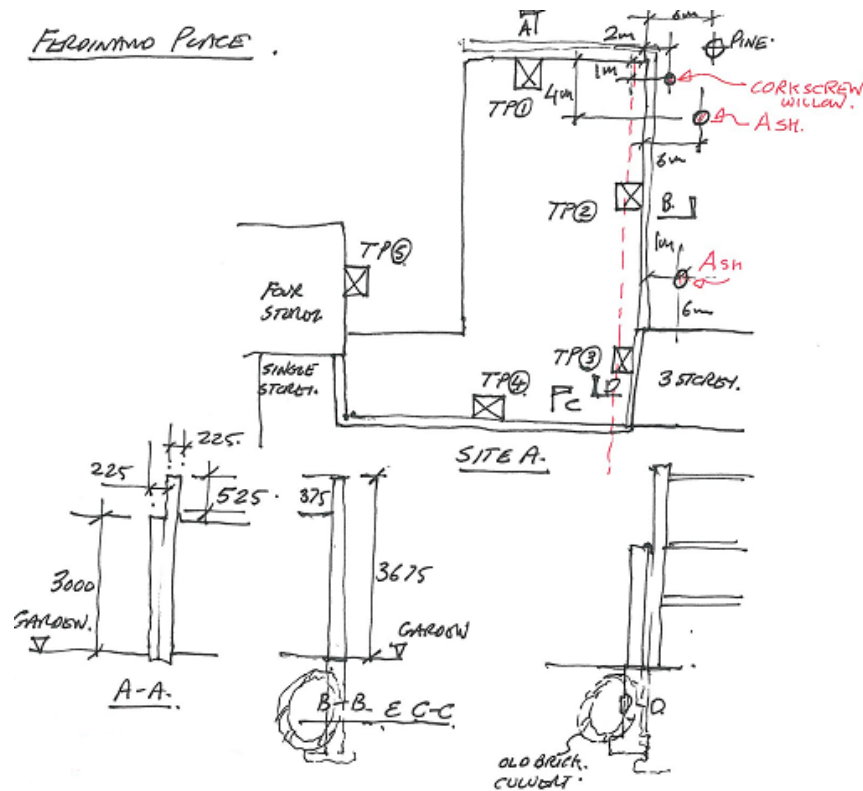
- 3.1.2 Both sites are level throughout and bordered with substantial walls. It is also noted that an historic culvert runs along the length of the eastern boundary of Site A (see sketch extract below).

Sketch extract 1: Location of historic culvert

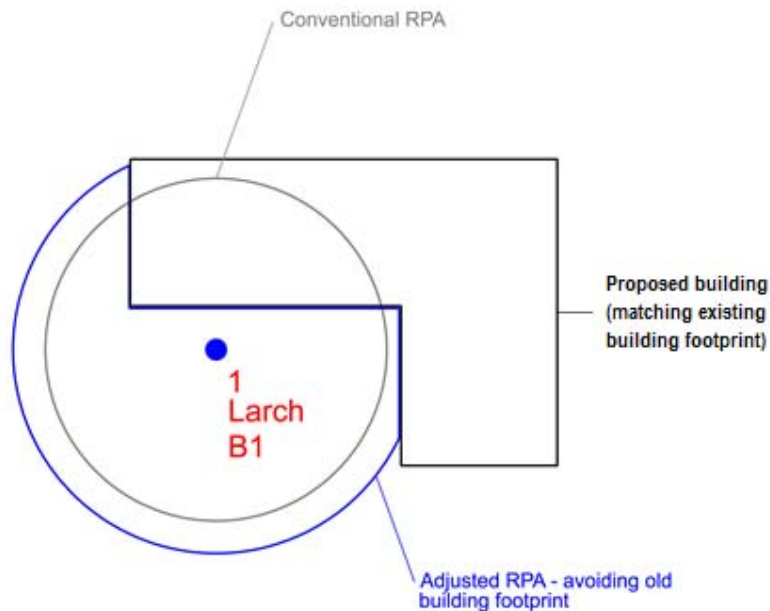
- 4.1.1 BS5837: 2012 gives Recommended Protection Areas (RPA's) for any given tree size. The individual RPA's are calculated in the Tree Schedule in Appendix 1 to this report, or rather the notional radius of that RPA, based on a circular protection zone. The prescribed radius is 12-x stem diameter at 1.5m above ground level, except where composite formulae are used in the case of multi-stemmed trees.
- 4.1.2 Circular RPA's are appropriate for individual specimen trees grown freely, but where there is ground disturbance, the morphology of the RPA can be modified to an alternative polygon, as shown in the diagram below (Figure 2). Alternatively, one need principally remember that RPA's are area-based and not linear – notional rather than fixed entities.

Figure 2 – Generic BS 5837 RPA Adjustments

- 4.1.3 In BS5837, paragraph 4.6.2 states that RPA's should reflect the morphology and disposition of the roots; where pre-existing site conditions or other factors indicate that rooting has occurred asymmetrically, a polygon of equivalent area should be produced. Modifications to the shape of the RPA should reflect a soundly based arboricultural assessment of likely root distribution.
- 4.1.4 No *a priori* modifications have been made in this instance, though further investigations are recommended, where the proposals encroach / come near RPA and their modification could have a bearing on the impact assessment.

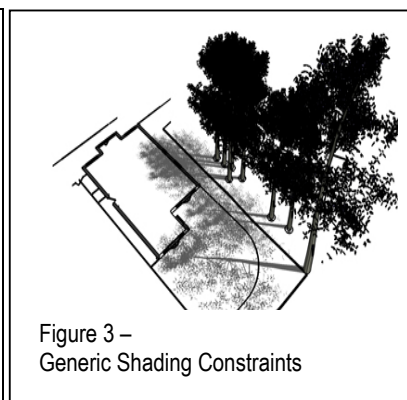
4.2.1 The second type of constraint produced by trees that are to be retained is that the proximity of the proposed development to the trees should not threaten their future with ever increasing demands for tree surgery or felling to remove nuisance shading (Figure 3), honeydew deposition or perceived risk of harm.

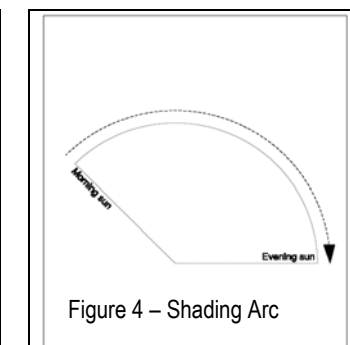
4.2.2 The shading constraints are crudely determined from BS5837 by drawing an arc from northwest to east of the stem base at a distance equal to the height of the tree, as shown in the diagram opposite. Shade is less of a constraint on non-residential developments, particularly where rooms are only ever temporarily occupied.

4.2.3 This arc (see Figure 4) represents the effects that a tree will have on layout through shade, based on shadow patterns of 1x tree height for a period May to Sept inclusive 10.00-18.00 hrs daily.

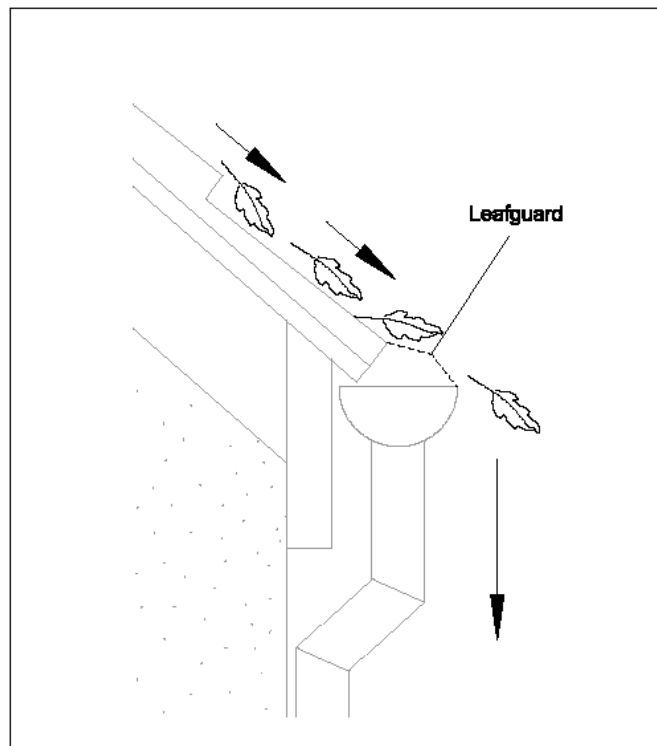
Figure 5: Filtration traps, as shown above, could be fitted on the gutters which can easily be maintained at 2-3m above ground.

6.3.5 Nuisance deposition can be further mitigated with routine maintenance, light pruning / deadwooding and the fitting of filtration traps on guttering (see Figure 5 below).

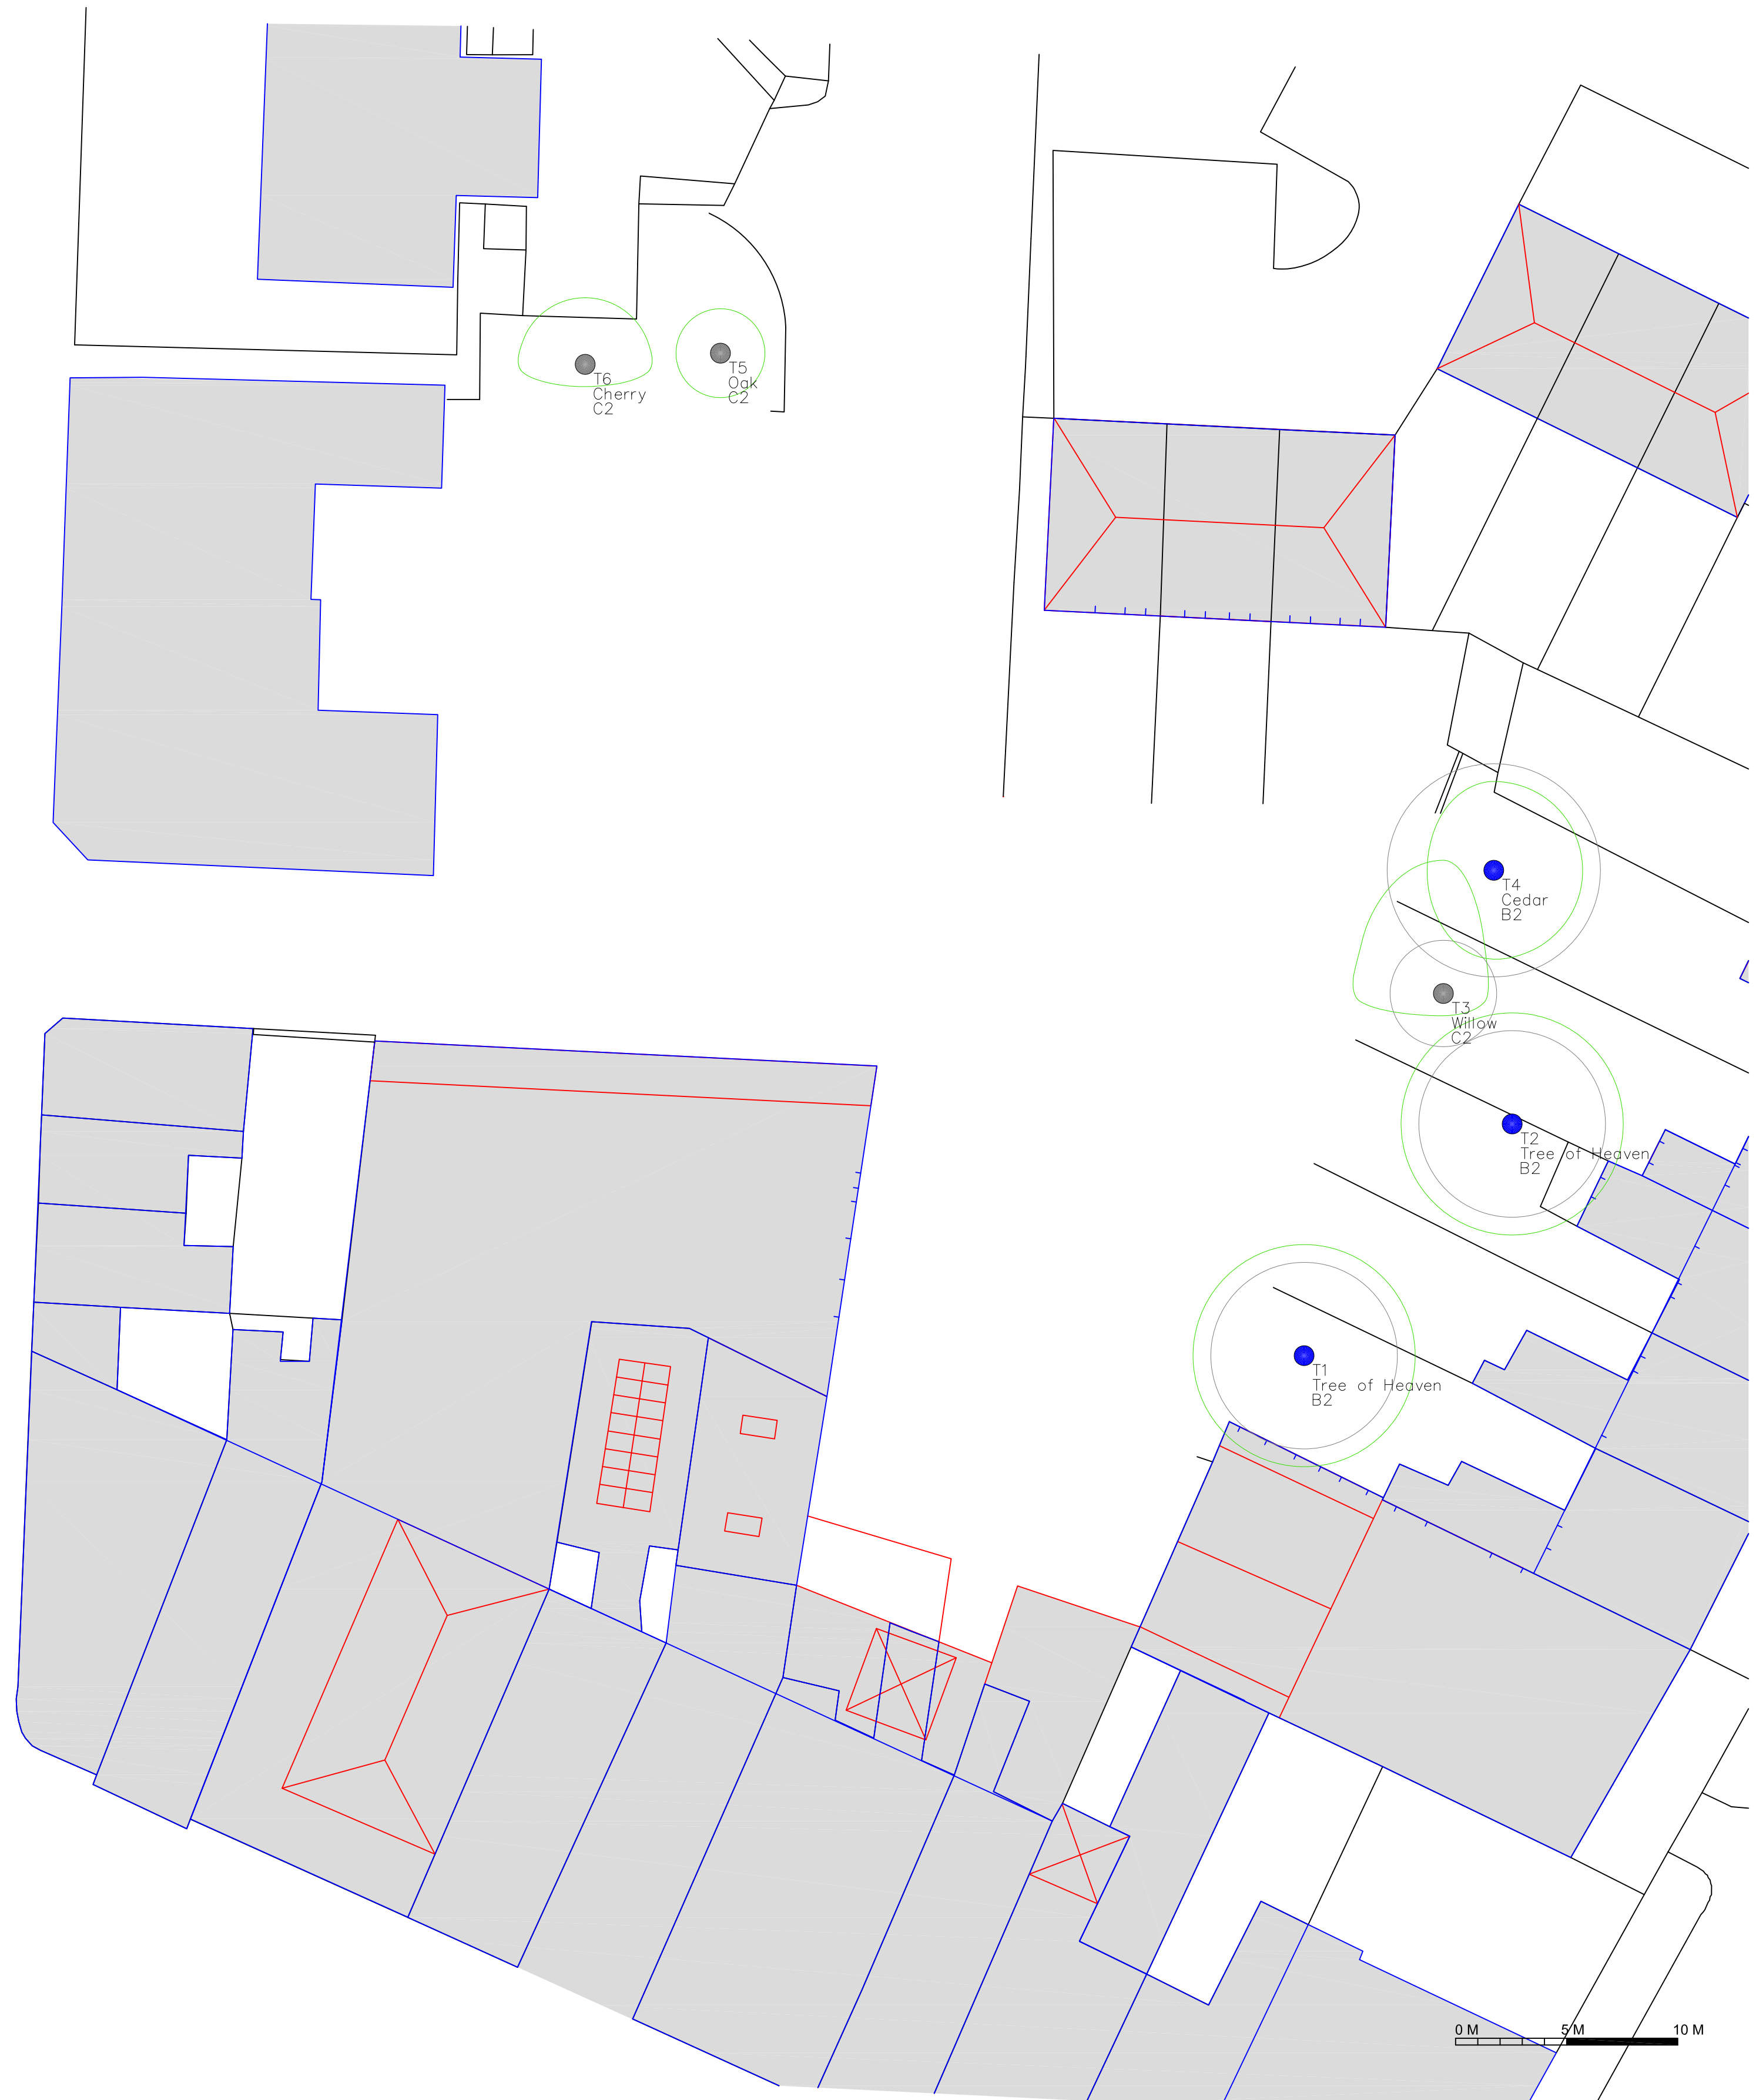
TREE CONSTRAINTS PLAN

- 2.4.3 This plan also serves as the Tree Constraints Plan with the theoretical Recommended Protection Areas (RPA's), tree canopies and shade constraints, (from BS5837: 2012) overlain onto it. These constraints are then overlain in turn onto the Instructing Party's proposals to create a second Arboricultural Impact Assessment Plan in Part 3. General observations and discussion follow, below.

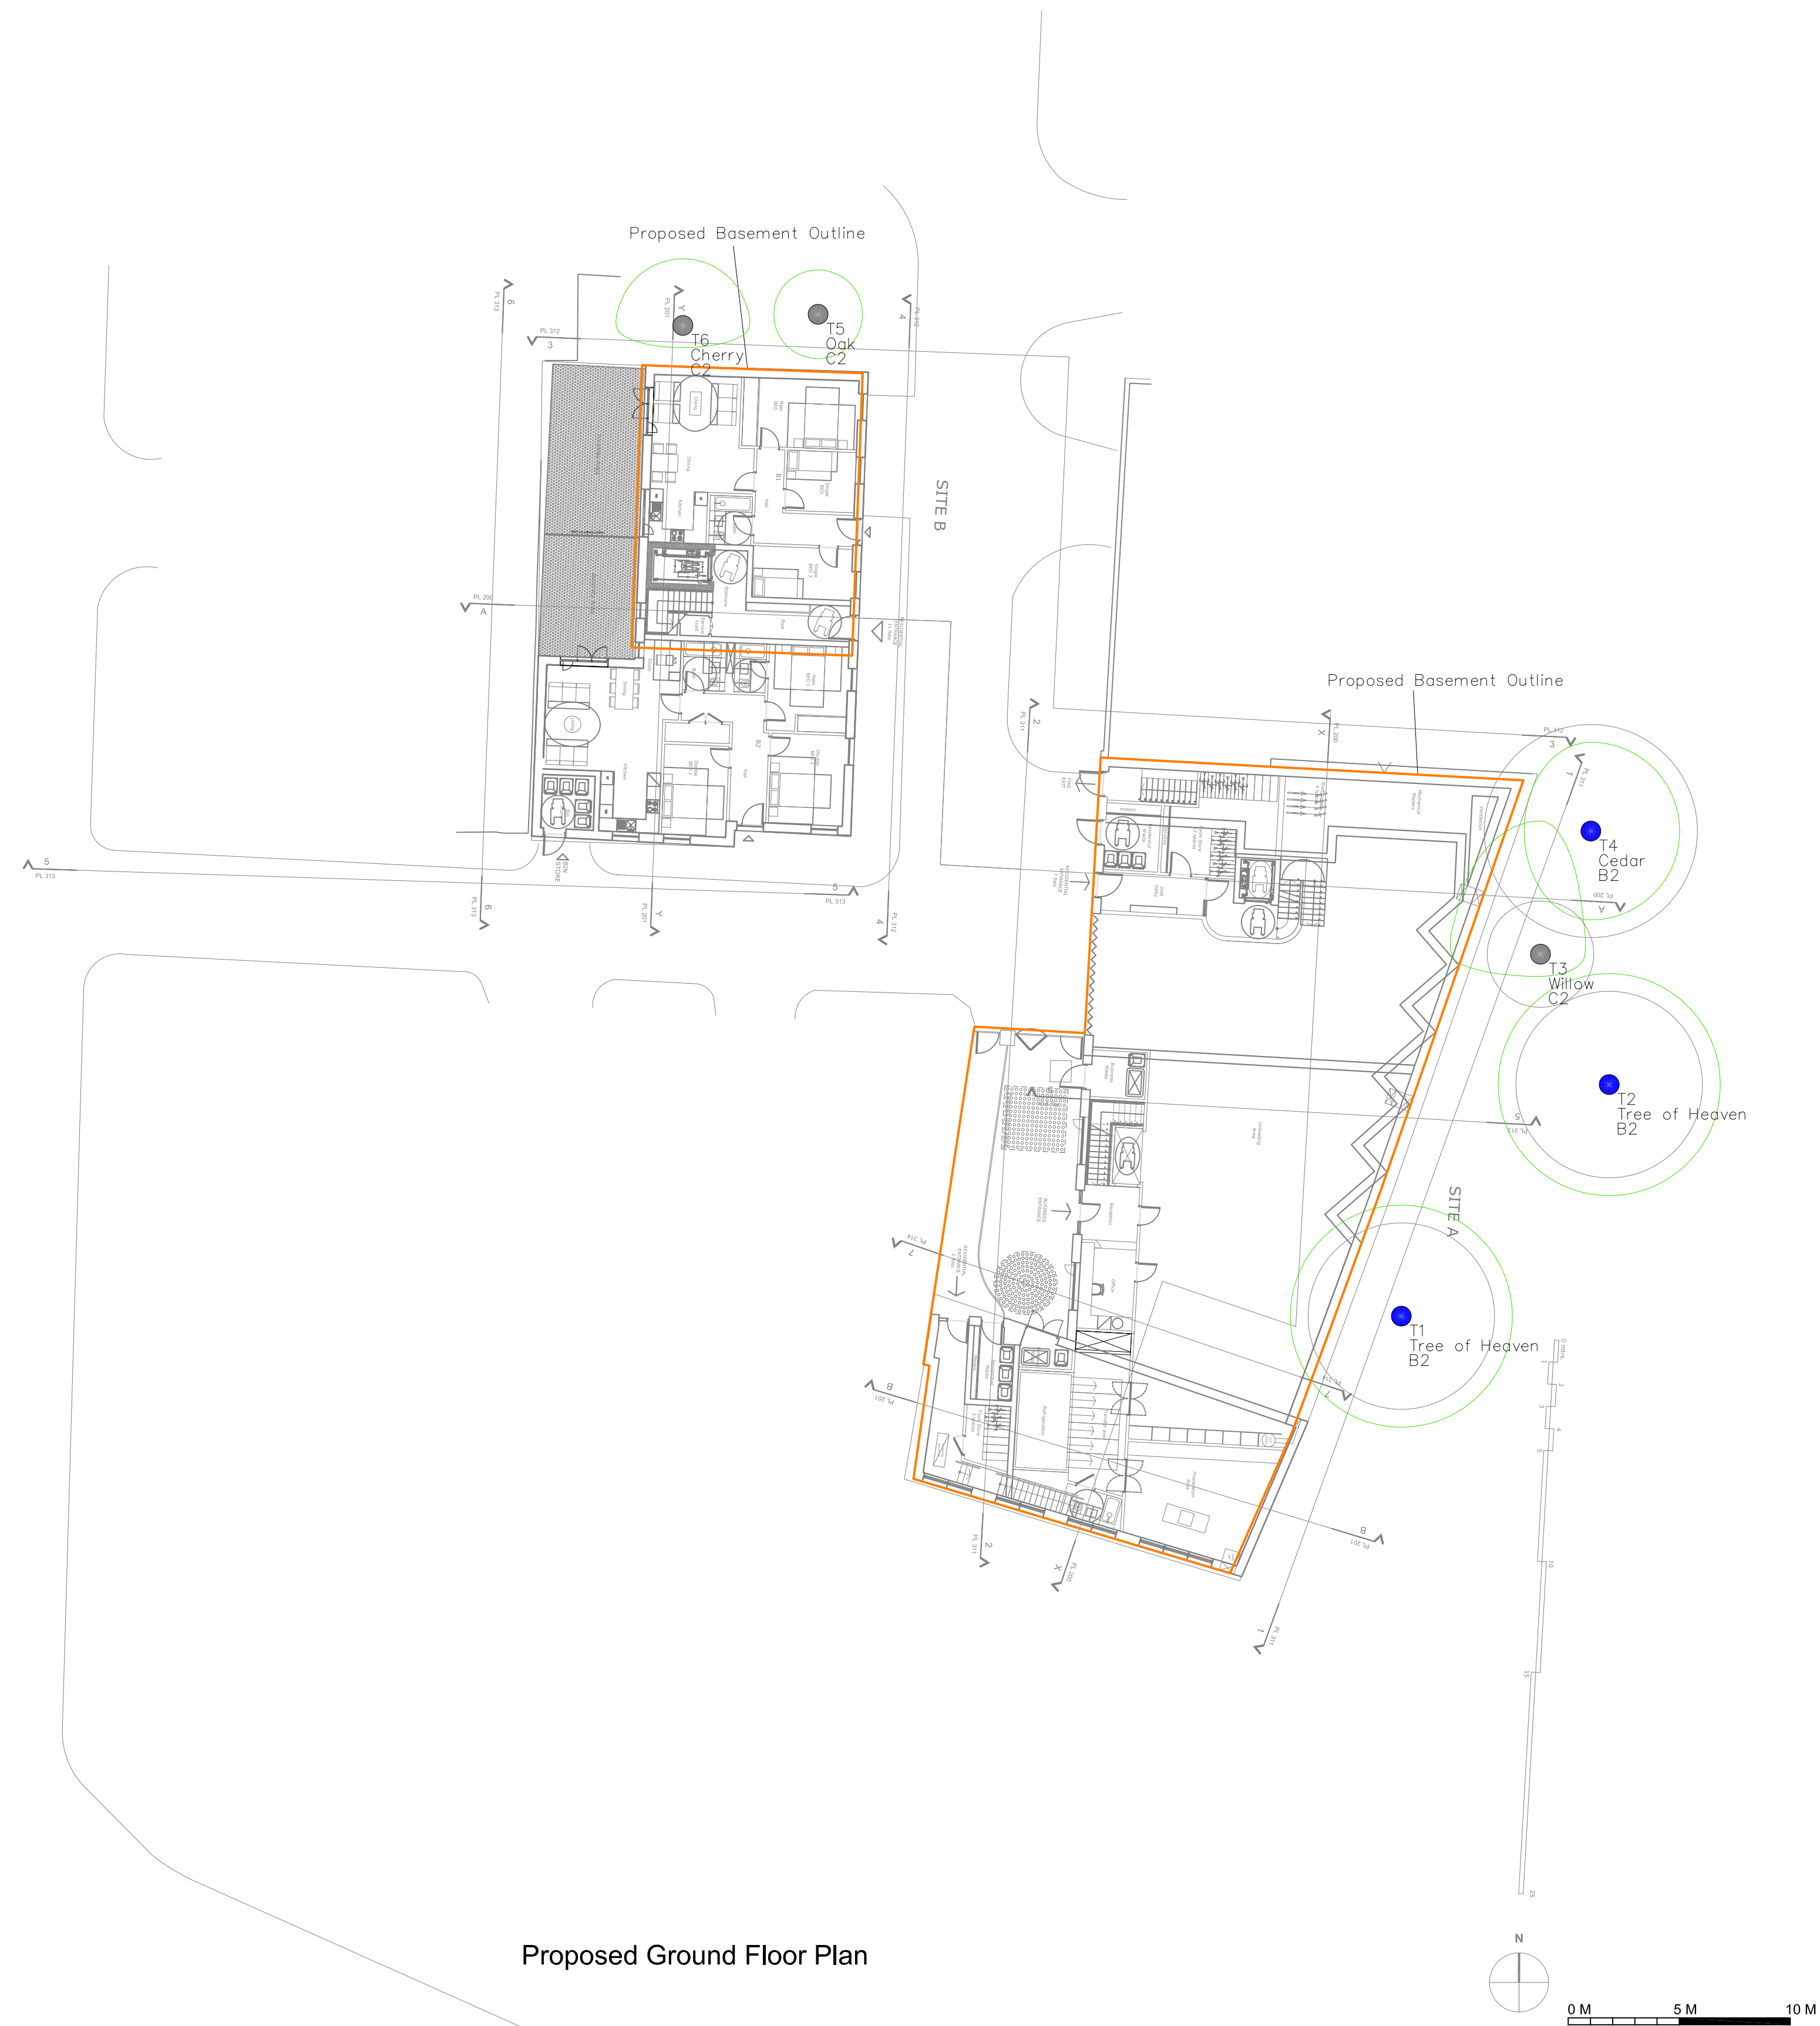
ARBORICULTURAL IMPACT ASSESSMENT PLAN (S)

Proposed Ground Floor Plan
