STABLES MARKET
HORSE HOSPITAL

**DESIGN AND ACCESS
STATEMENT AND
HERITAGE STATEMENT**

For proposed works to Units 87-91

Stables Market: Horse Hospital – Units 87-91 – Design and Access and Heritage Statement

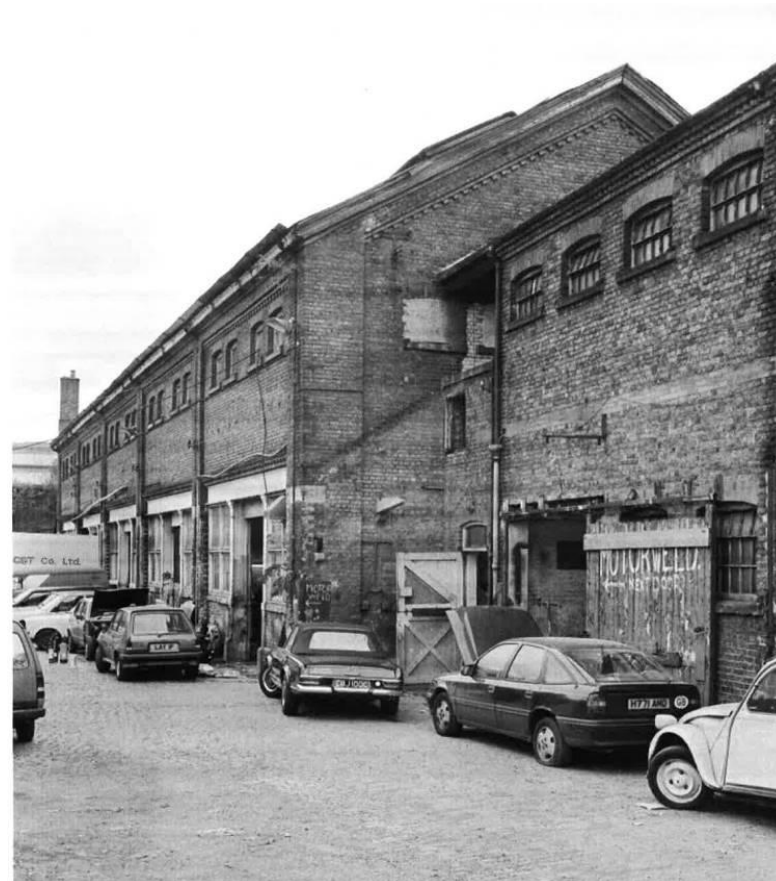
Figure 4: 1992 photograph of the south elevation looking towards Unit 92. Photograph from the National Monuments Record in the Historic England Archive in Swindon, taken by Derek Kendall of the former Royal Commission on the Historic Monuments of England (RCHME), on 08/10/1992 (Crown Copyright).

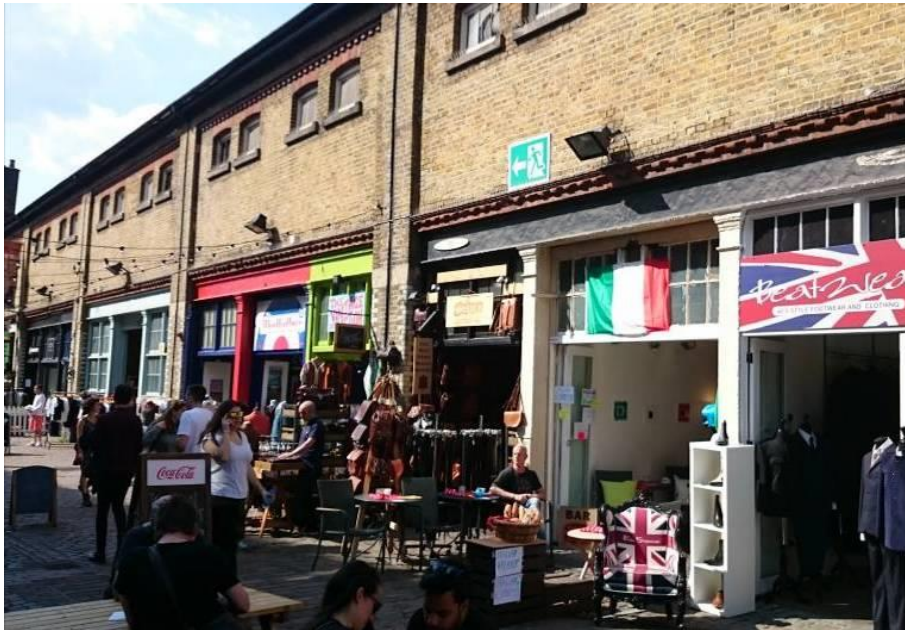
Figure 5: Units 87-91 - south elevation as existing.

The ground-floor elevational arrangement consist of 5 bays, each with pair of cast-iron pilasters with classical detailing either side of wide central opening and supporting cast-iron girders.

The central openings were originally flanked by large multi-pane wooden windows (Fig. 5). However this arrangement survives intact only in the central bay (Unit 89). Others are assumed to have been altered in the late 20th C to incorporate varying modern shop fronts, some retaining the original upper windows (Fig. 6). All but central unit (89) are divided into two or three shops (Fig. 7).

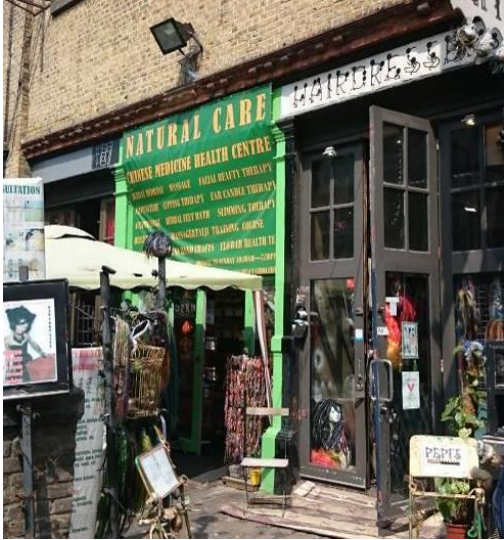
<p>Figure 8: Unit 87</p>	<p>Modern full height glazed folding doors;</p>	<p>Cast-iron pilasters and cast-iron girders to be retained and repaired as necessary;</p> <p>Internal cast-iron columns and historic fixtures to be retained in situ.</p> <p>New central opening, with timber sliding doors, and side brick parapet walls, with multi pane timber windows, to match central unit 89.</p>	<p>Beneficial / Moderate</p>

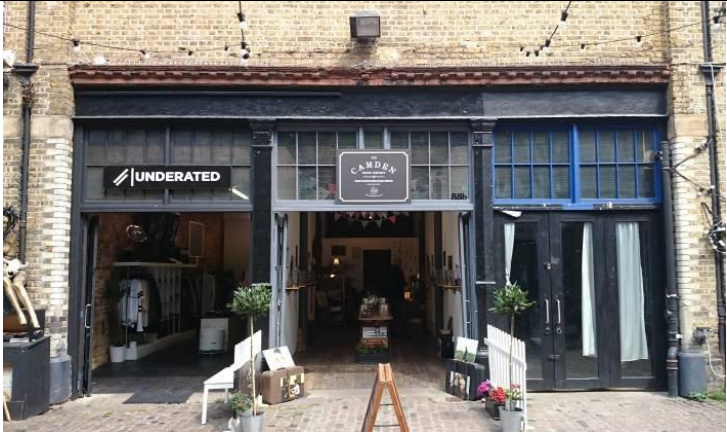
<p>Figure 9: Unit 88</p>	<p>Modern glazed folding doors with fixed clerestory timber multi pane windows.</p>	<p>Cast-iron pilasters and cast-iron girders to be retained and repaired as necessary; Internal cast-iron columns and historic fixtures to be retained in situ. New central opening, with timber sliding doors, and side brick parapet walls, with multi pane timber windows, to match central unit 89.</p>	<p>Beneficial / Moderate</p>

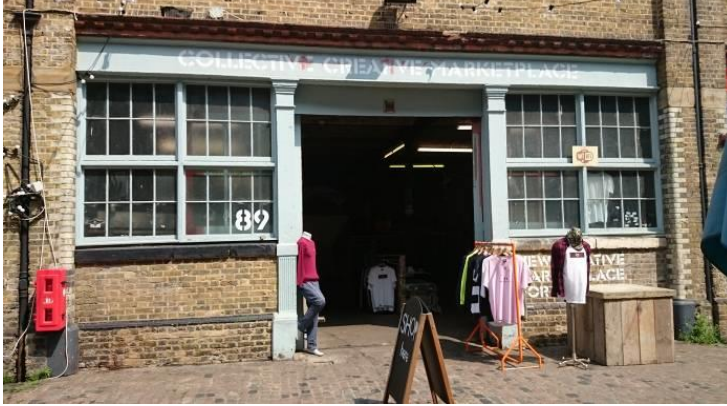
<p>Figure 10: Unit 89</p>	<p>Historic arrangement of the frontage - wide central opening with timber sliding doors (with upper panes glazed). Side brick parapet walls with fixed timber multi pane windows above.</p>	<p>Cast-iron pilasters and cast-iron girders to be retained and repaired as necessary; Timber windows and doors – general overhaul and repair; Brick parapet walls and stone cills – repair as necessary, repointing; Internal cast-iron columns and historic fixtures to be retained in situ.</p>	<p>Beneficial / Negligible</p>

The proposed replacement of the existing modern frontages with an appropriate and suitable new frontage will reinstate the historic central wide opening with sliding timber doors flanked by the large multi-pane timber windows and brick parapet walls.

The new top hung timber sliding doors and multi-pane windows will match the historic details preserved at the central bay, which will be repaired and overhauled as needed. Likewise, the
