26 GORDON STREET LONDON SE26 4AU

UNDERGROUND SERVICES SURVEY

SURV	EYED FOR	J COFFEY CONSTRUCTION 93-95 GREENFORD ROAD HARROW LONDON HA1 3QF	LTD	SURVEYOR DATE		JLLOCK 2016	
NO	DATE	REVISION					
		DRAWING NO	T	G 8410/	1	REV	0
DRAWING TITLE				UNDERGROUND			
SCALE				1 : 200(A2)			
SEE ALSO DWG NOS							
SHEET REF NO				1 of	1		
				G 8410

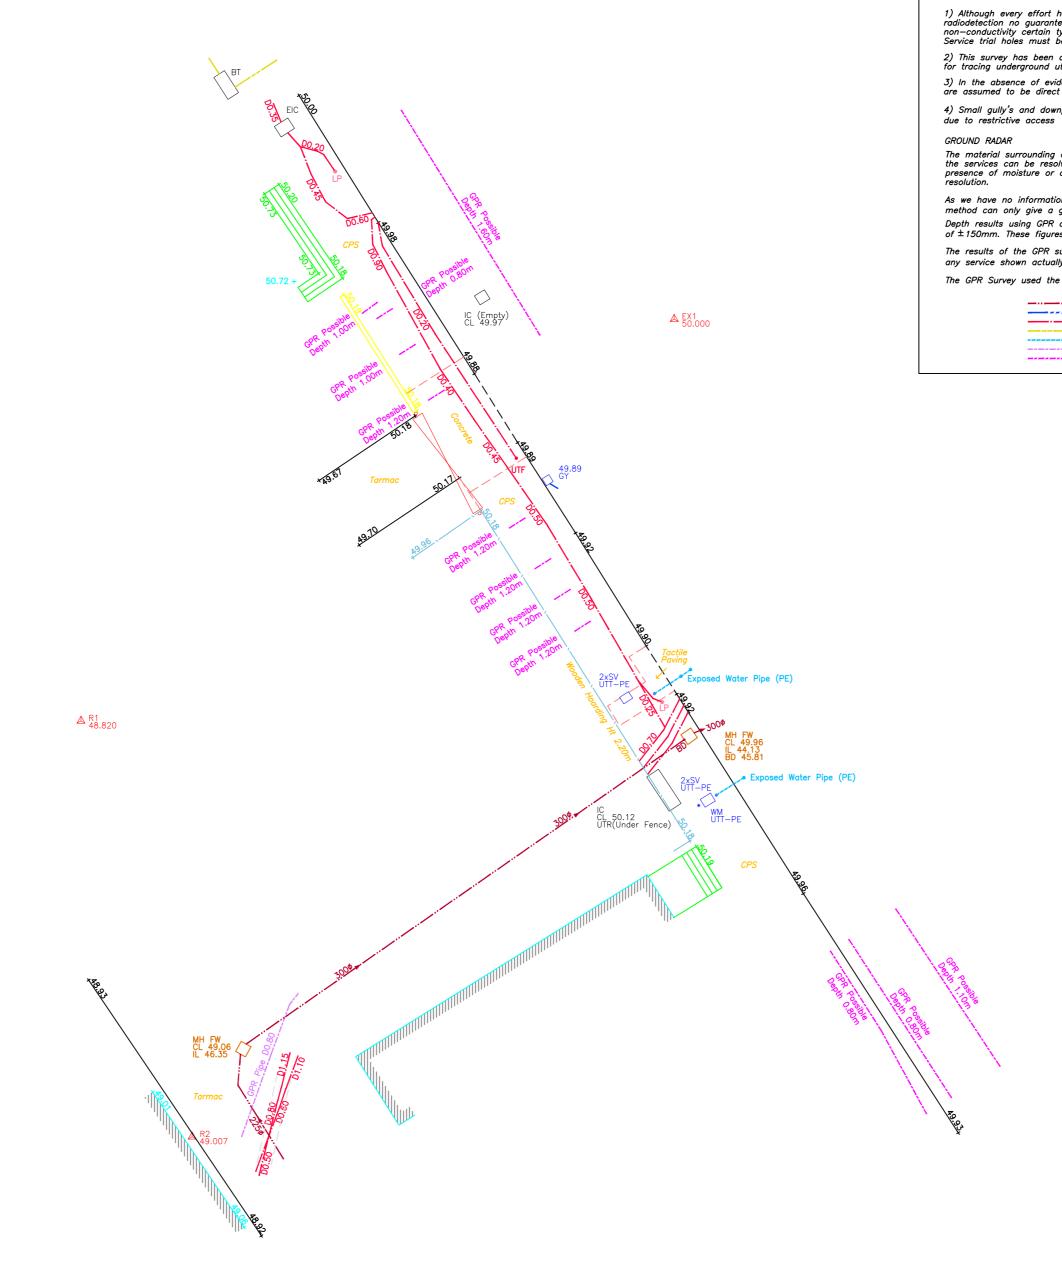
1) Although every effort has been made to trace underground services using radiodetection no guarantee can be given that all have been found. Due to their non-conductivity certain types of gas and water pipes have not been possible to trace. Service trial holes must be dug prior to excavation.

In the absence of evidence to the contrary the routes of confirmed manhole connections are assumed to be direct and straight.

4) Small gully's and downpipes that go straight into the ground could not be traced due to restrictive access

As we have no information with respect to the material overlaying any services the GPR method can only give a guaranteed accuracy of 50%.

Depth results using GPR are typically accurate to within 10% with a horizontal accuracy of \pm 150mm. These figures will vary as the velocity of the ground is assumed at 80m/s.

The results of the GPR survey should be treated with caution as there is no guarantee that any service shown actually exists, only a possibilty that something can seen on the records.

The GPR Survey used the 500Mhz Antenna on this job and was seeing services down to 1.8m

* Whilst every effort has been made to achieve accuracy on this plan, CRUCIAL clearance dimensions, levels and invert levels should be checked prior to design and construction.
