GEOTECHNICAL

for Subsidence Management Services

96 Haverstock Hill, Lower Belsize Park, London, NW3 2BD

Client: Subsidence Management Services
 Client Contact: Raymond Borrow
 Client Ref: IFS-AVI-SUB-14-0052426
 Policy Holder: Haverstock Hill Limited
 Report Date: 03 November 2014
 Our Ref: C18151G7214

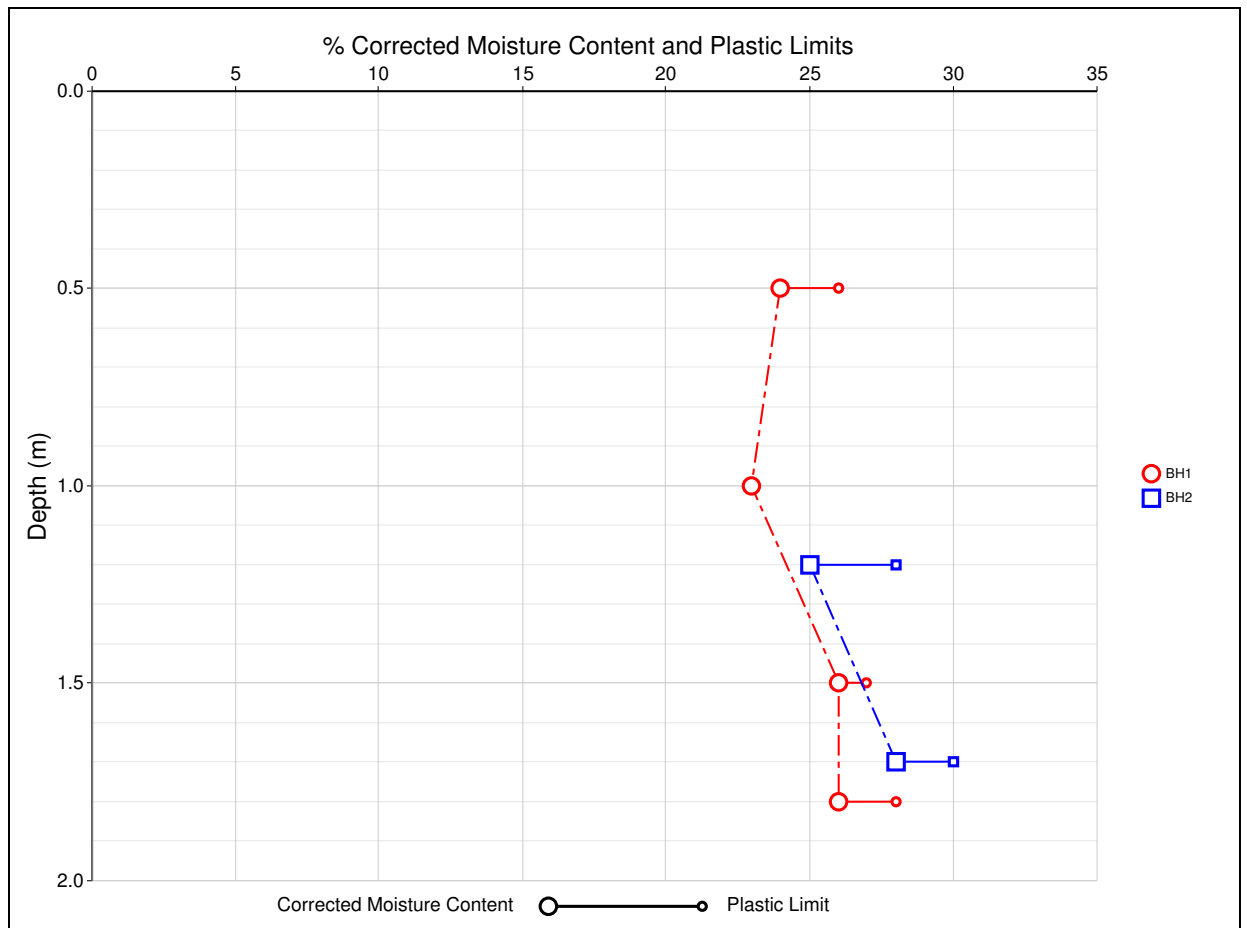
Corrected Moisture Content and Plastic Limits Graph

Where appropriate moisture contents have been corrected to demonstrate the equivalent moisture content following the sample being passed through a .425 mm sieve for comparison with the Liquid & Plastic Limit. Where this is not available, uncorrected moisture contents have been used in the graph on the following page.

Lab Ref	Depth (m)	MC (%)	Corr MC (%)	LL (%)	PL (%)	PI (%)	% Passing .425mm
Samples from BH1							
001	0.50	24	24	62	26	36	100
002	1.00	23					
003	1.50	26	26	65	27	38	100
004	1.80	26	26	68	28	40	100
Samples from BH2							
005	1.20	25	25	69	28	41	100
006	1.70	28	28	71	30	41	100

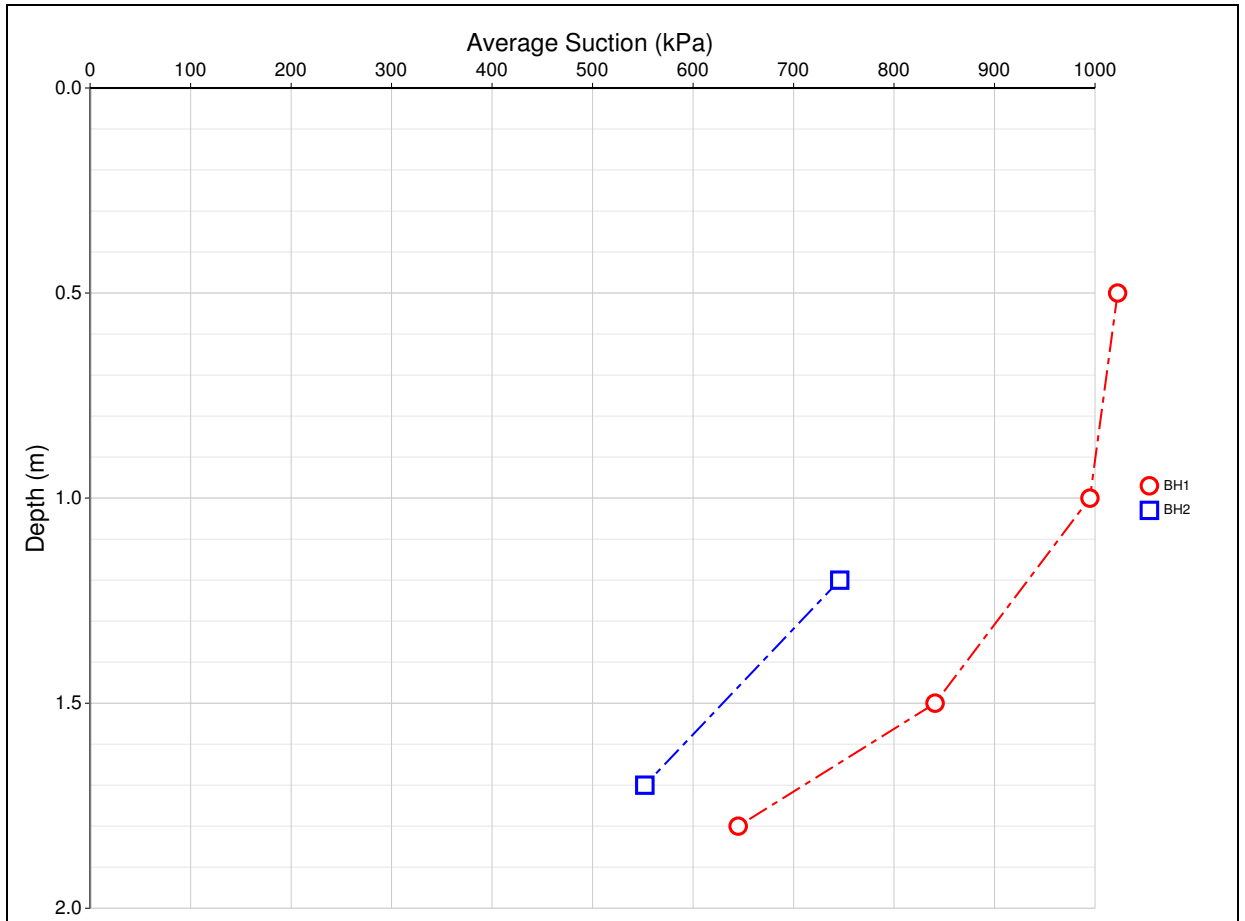
Average Suction

Lab Ref	Depth (m)	Filter Paper	Bag Weight (g)	Bag + Wet Filter (g)	Bag + Dry Filter (g)	Oven Dry Filter (g)	Water Content (%)	Suction (kPa)	Average (kPa)
Samples from BH1									
001	0.50	Top	1.308	1.789	1.679	0.372	29.610	996.041	1022.905
		Middle	1.298	1.777	1.669	0.371	29.118	1068.656	
		Bottom	1.302	1.784	1.674	0.372	29.554	1004.017	
002	1.00	Top	1.298	1.777	1.666	0.369	30.122	925.559	995.576
		Middle	1.295	1.770	1.664	0.370	28.687	1136.692	
		Bottom	1.301	1.780	1.669	0.368	30.130	924.476	
003	1.50	Top	1.293	1.780	1.666	0.373	30.579	866.885	841.326
		Middle	1.292	1.778	1.663	0.371	30.997	816.522	
		Bottom	1.294	1.770	1.658	0.364	30.795	840.573	
004	1.80	Top	1.303	1.802	1.679	0.376	32.739	636.270	645.715
		Middle	1.305	1.788	1.669	0.364	32.710	638.882	
		Bottom	1.299	1.780	1.662	0.364	32.462	661.992	
Samples from BH2									
005	1.20	Top	1.295	1.774	1.658	0.363	31.938	713.569	746.576
		Middle	1.299	1.785	1.669	0.370	31.360	775.209

Bottom	1.308	1.791	1.675	0.367	31.582	750.950	
006	1.70	Top	1.303	1.800	1.675	0.373	33.557	565.916	552.081
		Middle	1.296	1.801	1.672	0.376	34.318	507.508	
		Bottom	1.301	1.789	1.667	0.366	33.352	582.818
