# GEOTECHNICAL

**96 Haverstock Hill, Lower Belsize Park, London, NW3 2BD**

Client: Subsidence Management Services  
 Client Contact: Raymond Borrow  
 Client Ref: IFS-AVI-SUB-14-0052426  
 Policy Holder: Haverstock Hill Limited  
 Report Date: 27 March 2015  
 Our Ref: C18151G9987

# SOIL ANALYSIS

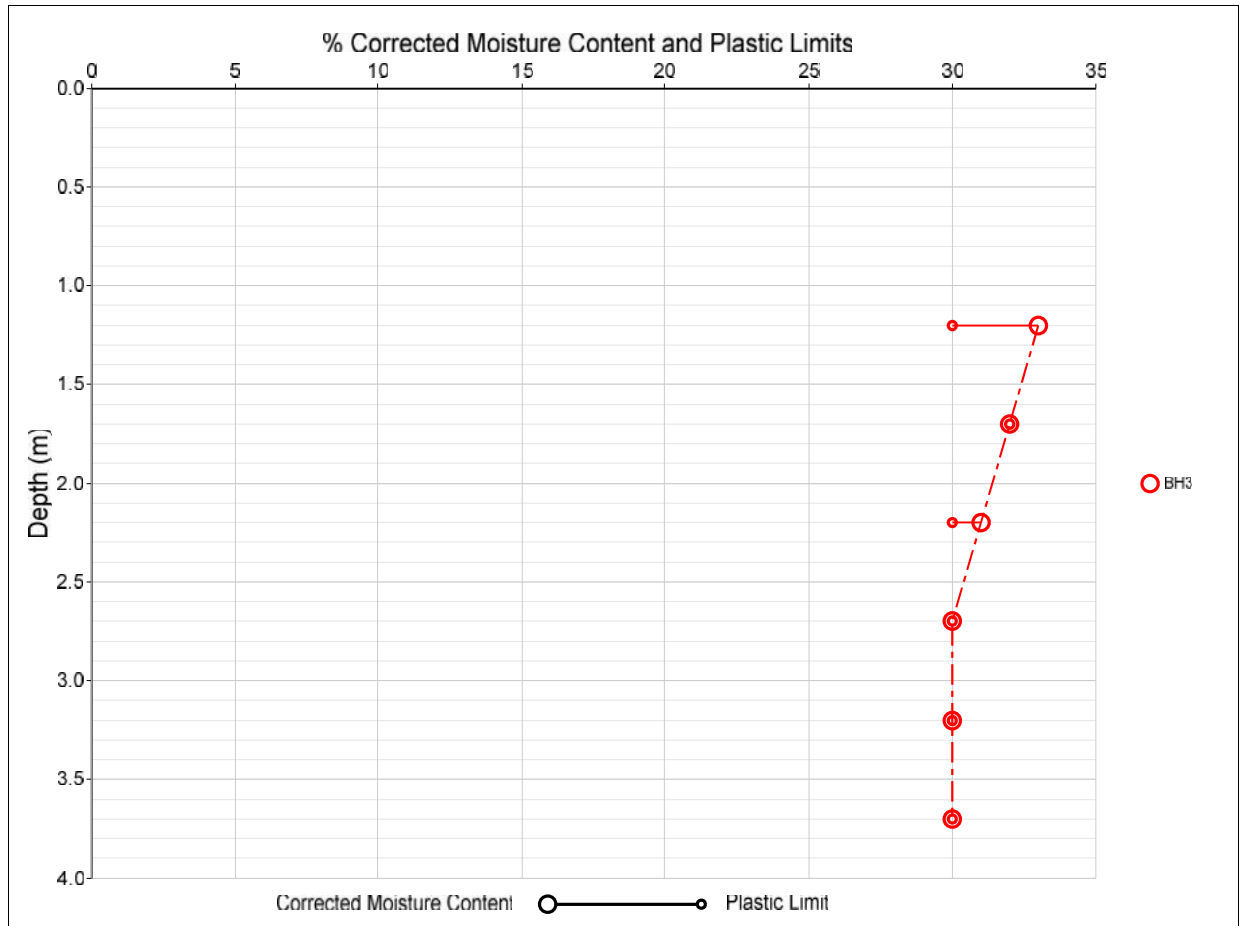
**Corrected Moisture Content and Plastic Limits Graph**

Where appropriate moisture contents have been corrected to demonstrate the equivalent moisture content following the sample being passed through a .425 mm sieve for comparison with the Liquid & Plastic Limit. Where this is not available, uncorrected moisture contents have been used in the graph on the following page.

Lab Ref	Depth (m)	MC (%)	Corr MC (%)	LL (%)	PL (%)	PI (%)	% Passing .425mm
Samples from BH3							
001	1.20	33	33	71	30	41	100
002	1.70	32					
003	2.20	31	31	68	30	38	100
004	2.70	30					
005	3.20	30	30	68	30	38	100
006	3.70	30

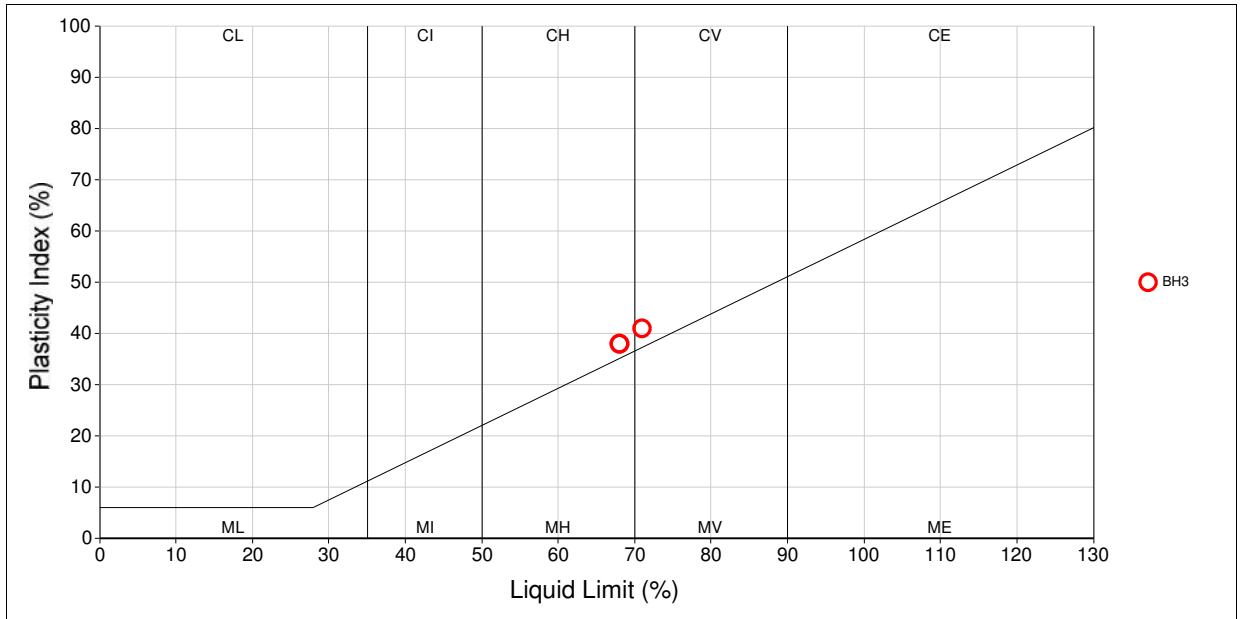
### Plasticity Chart for Casagrande Classification

Lab Ref	Depth (m)	Description	BS:5930	NHBC Chapter 4.2
Samples from BH3				
001	1.20	Brown CLAY.	CV	High
002	1.70	Brown CLAY.		
003	2.20	Brown CLAY.	CH	Medium
004	2.70	Brown CLAY.		
005	3.20	Brown CLAY.	CH	Medium
006	3.70	Brown CLAY.

The following provides a brief interpretation of the test results by comparison of the results to published classifications. The Atterberg Limit test may be used to classify the plasticity of soils; the plasticity classes defined in BS5930:1999 "Code of Practice for Site Investigations" are as follows.

CL (ML)	CLAY and CLAY/SILT of Low plasticity
CI (MI)	CLAY and CLAY/SILT of Intermediate plasticity
CH (MH)	CLAY and CLAY/SILT of High plasticity
CV (MV)	CLAY and CLAY/SILT of Very High plasticity
CE (ME)	CLAY and CLAY/SILT of Extremely High plasticity
O	The letter O is added to prefixes to symbolise a significant proportion of organic matter.
NP	Non-plastic

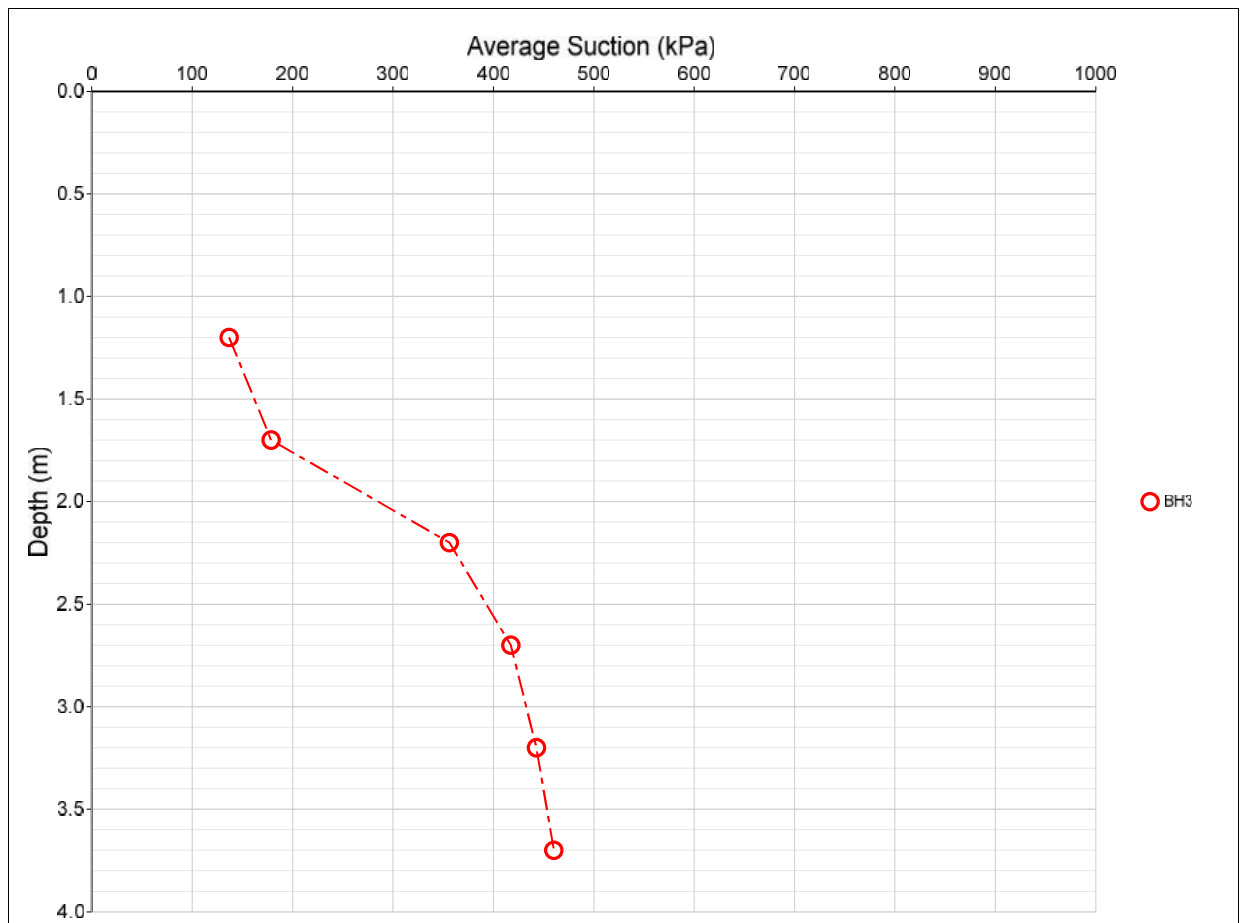
### Average Suction

Lab Ref	Depth (m)	Filter Paper	Bag Weight (g)	Bag + Wet Filter (g)	Bag + Dry Filter (g)	Oven Dry Filter (g)	Water Content (%)	Suction (kPa)	Average (kPa)
<b>Samples from BH3</b>									
001	1.20	Top	1.298	1.832	1.671	0.373	43.129	143.676	137.337
		Middle	1.294	1.838	1.673	0.380	43.478	136.663	
		Bottom	1.299	1.828	1.667	0.368	43.738	131.671	
002	1.70	Top	1.296	1.807	1.659	0.363	40.726	202.681	179.585
		Middle	1.294	1.791	1.645	0.351	41.548	180.181	
		Bottom	1.297	1.809	1.656	0.360	42.559	155.892	
003	2.20	Top	1.293	1.787	1.655	0.362	36.424	375.351	356.709
		Middle	1.294	1.796	1.661	0.367	36.775	356.954	
		Bottom	1.297	1.795	1.660	0.363	37.159	337.821	
004	2.70	Top	1.298	1.799	1.667	0.369	35.792	410.916	418.126
		Middle	1.294	1.786	1.657	0.363	35.518	427.370	
		Bottom	1.296	1.782	1.654	0.359	35.704	416.094	
005	3.20	Top	1.295	1.775	1.651	0.356	34.812	472.824	443.111
		Middle	1.296	1.794	1.664	0.368	35.336	438.652

Bottom	1.297	1.788	1.659	0.362	35.675	417.858	
006	3.70	Top	1.293	1.777	1.653	0.360	34.444	498.374	460.235
		Middle	1.297	1.791	1.663	0.366	34.982	461.429	
		Bottom	1.297	1.780	1.653	0.357	35.624	420.901
