Door schedule

Window schedule

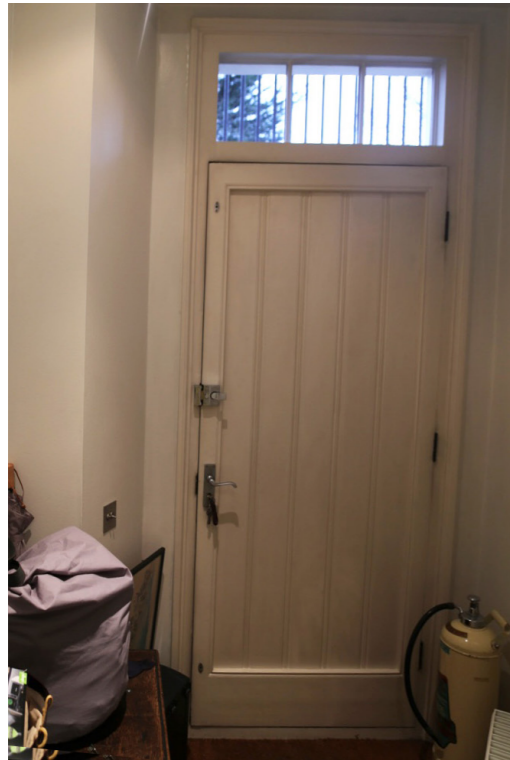
ED B1 01

Single panel with 5 vertical bars solid timber door

Basement entry

Structural opening - W/H - existing door opening to be altered to window opening

Door - to be removed, rubbed back, repaired as necessary, repainted and repositioned. New ironmongery to be installed.

Architrave - to be repositioned

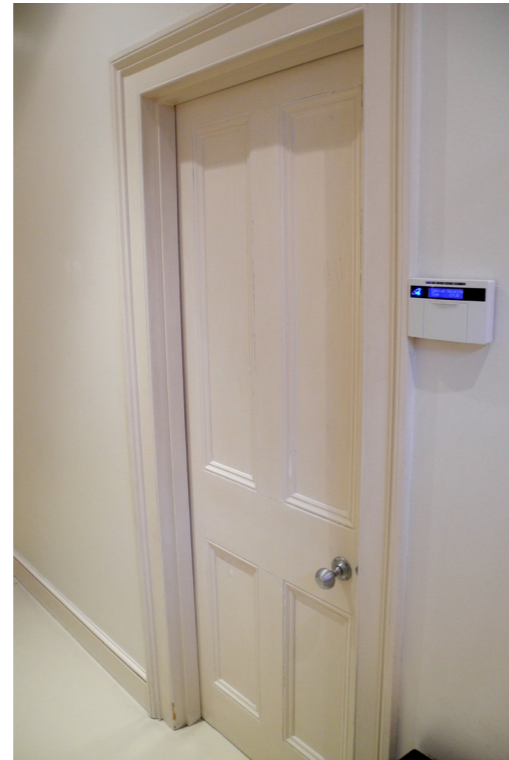
PD B1 01

Four panel solid timber door

Utility room West

Structural opening - W/H - to be removed

Door - to be removed

Architrave - to be removed

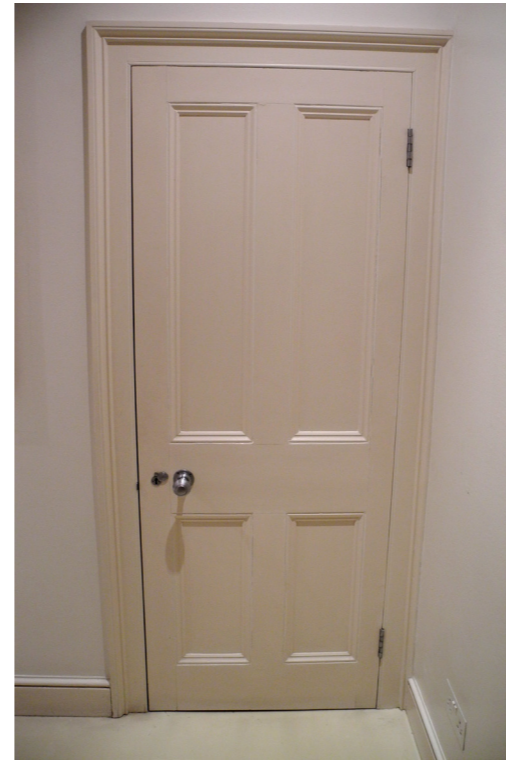
PD B1 02

Four panel solid timber door

Storage

Structural opening - W/H - to be removed

Door - to be removed

Architrave - to be removed

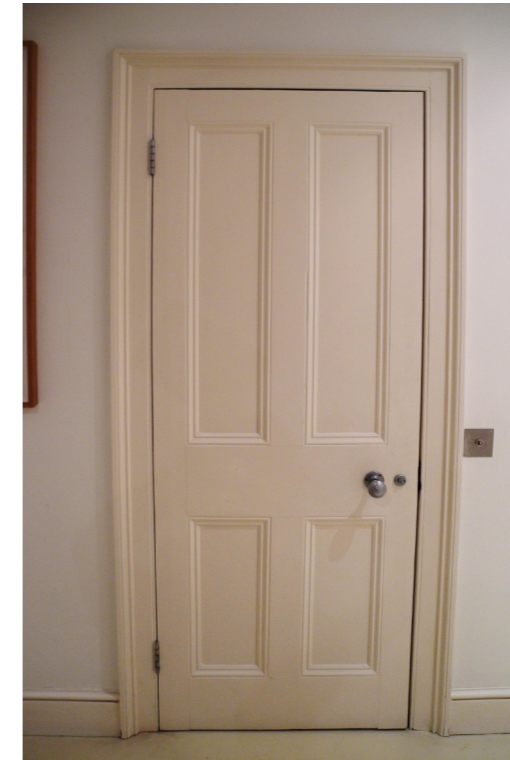
PD B1 03

Four panel solid timber door

Guest Bathroom

Structural opening - W/H - to be removed

Door - to be removed

Architrave - to be removed

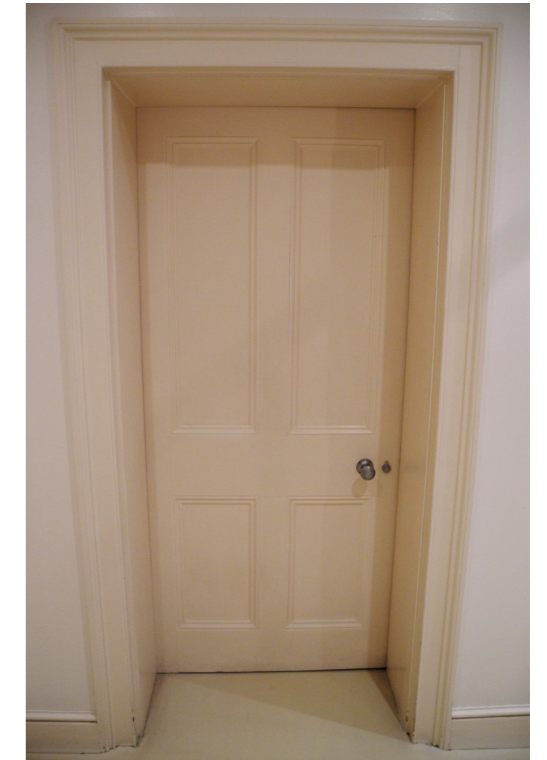
PD B1 04

Four panel solid timber door

Gym

Structural opening - W/H - to be removed

Door - to be removed

Architrave - to be removed

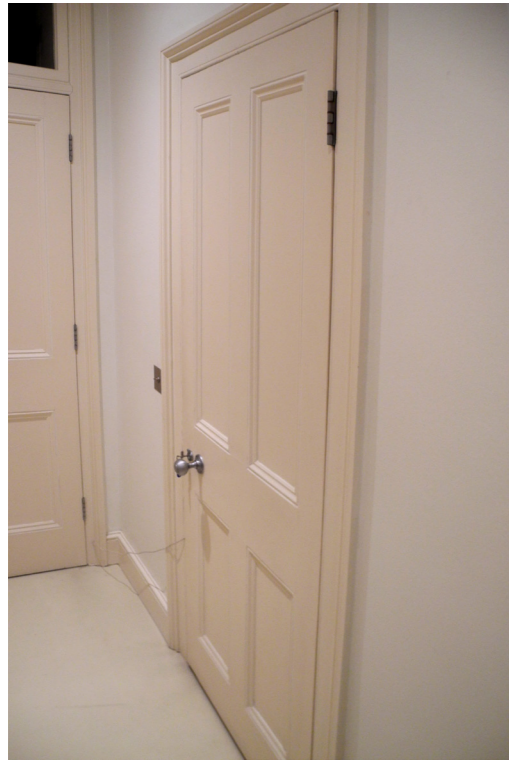
PD B1 05

Four panel solid timber door

Storage

Structural opening - W/H - to be removed

Door - to be removed

Architrave - to be removed

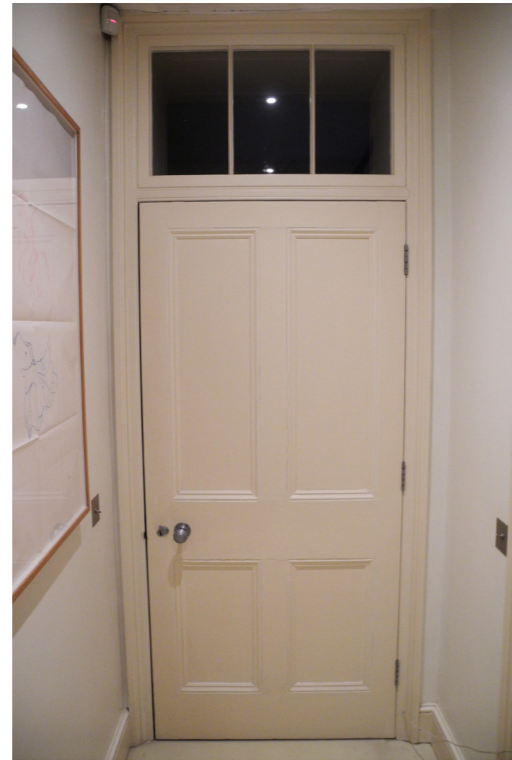
PD B1 06

Four panel solid timber door

Link

Structural opening - W/H - to be removed

Door - to be removed

Architrave - to be removed

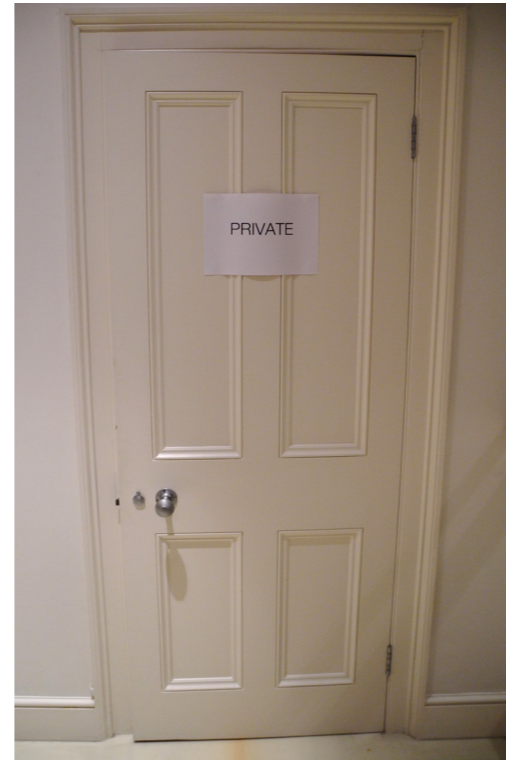
PD B1 06

Four panel solid timber door

Changing room

Structural opening - W/H - to be removed

Door - to be removed

Architrave - to be removed

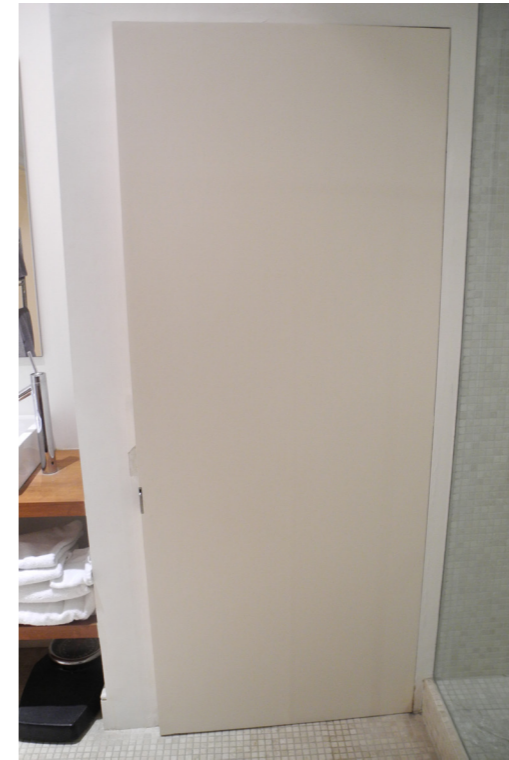
PD B1 07

Solid timber door

Changing room WC

Structural opening - W/H - to be removed

Door - to be removed

Architrave - to be removed

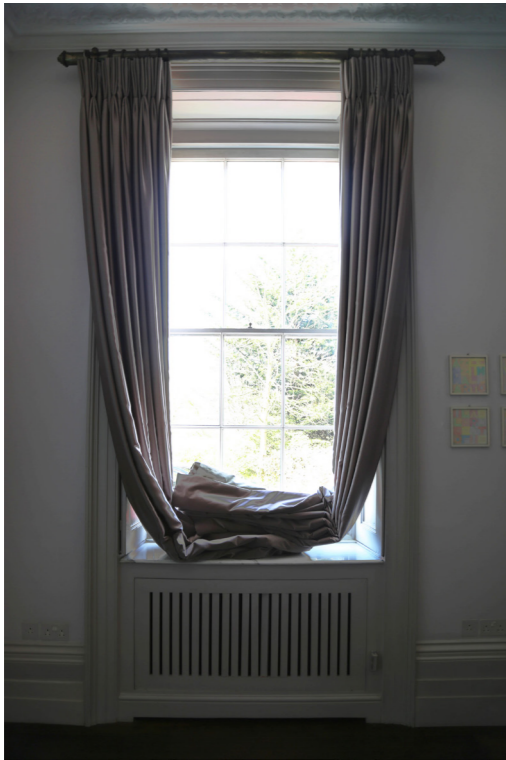
EW 00 01

Timber framed box sash window

Dining room x 2

Structural opening - W/H - as existing

Window - to be retained, carefully repaired and weather - stripped by an approved specialist. New ironmongery to be installed

Architrave - N/A shutters to be stripped back carefully repaired and repainted

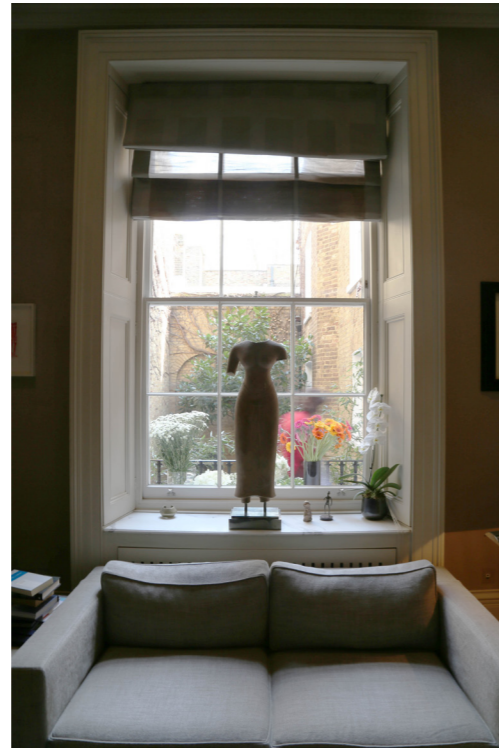
EW 00 02

Timber framed box sash window

Library x 1

Structural opening - W/H - as existing

Window - to be retained, carefully repaired and weather - stripped by an approved specialist. New ironmongery to be installed

Architrave - N/A shutters to be stripped back carefully repaired and repainted

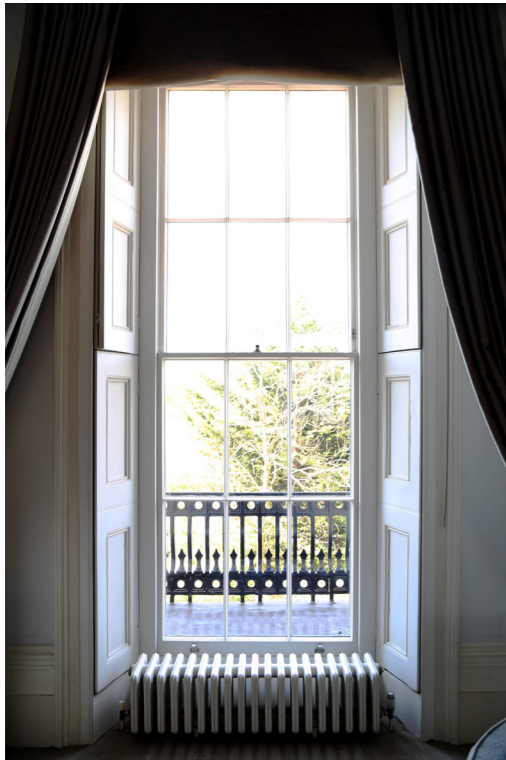
EW 01 01

Timber framed box sash window

Drawing room West x 3

Structural opening size - W/H- as existing

Window - to be retained, carefully repaired and weather - stripped by an approved specialist. New ironmongery to be installed

Architrave - N/A shutters to be stripped back carefully repaired and repainted

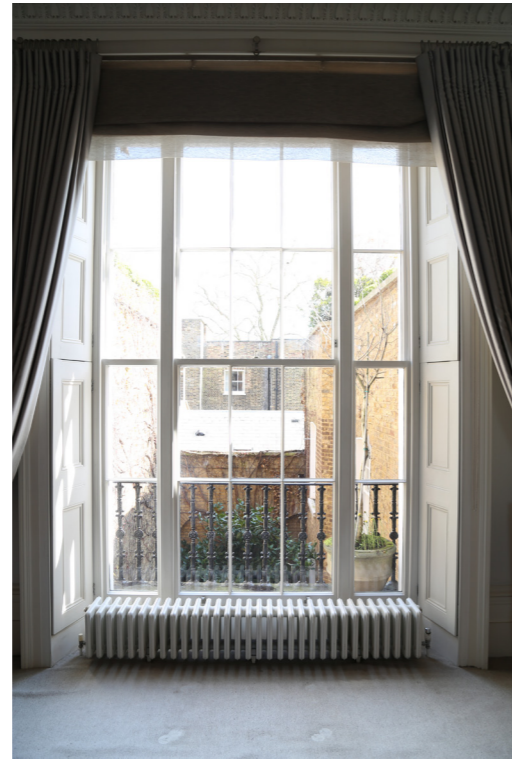
EW 01 02

Venetian sash window

Drawing room East x 1

Structural opening size - W/H- as existing

Window - to be retained, carefully repaired and weather - stripped by an approved specialist. New ironmongery to be installed

Architrave - N/A shutters to be stripped back carefully repaired and repainted

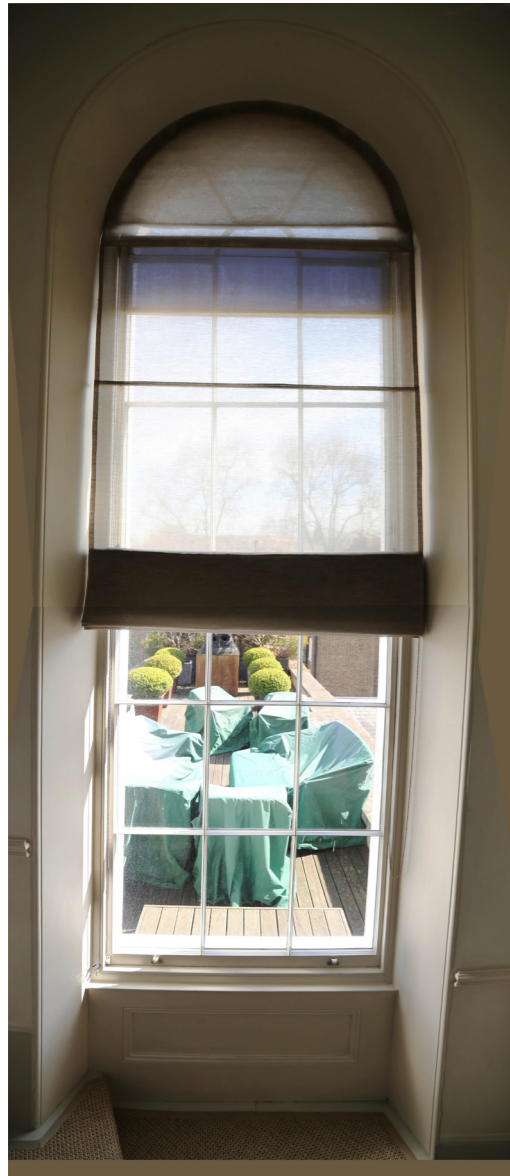
EW 02 01

Top arched sash window

Second floor landing

Structural opening size - W/H - as existing

Window - full length like for like sash window replacement

Architrave - N/A

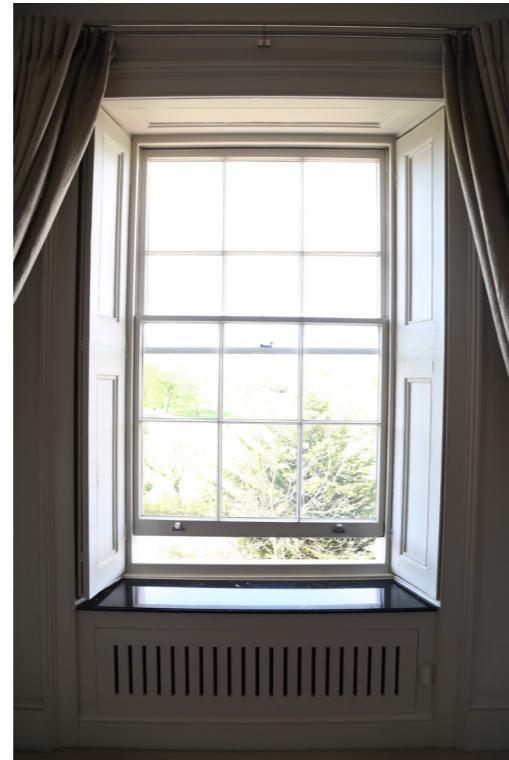
EW 02 02

Timber framed box sash window

Master bedroom x 2 and walk in closet x 1

Structural opening size - W/H - as existing

Window - to be retained, carefully repaired and weather - stripped by an approved specialist. New ironmongery to be installed

Architrave - N/A

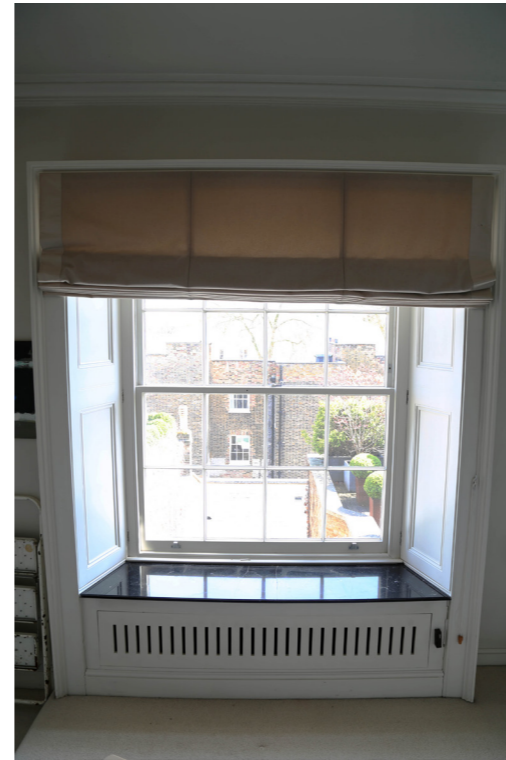
EW 02 03

Timber framed box sash window

Master bathroom

Structural opening size - W/H - as existing

Window - to be retained, carefully repaired and weather - stripped by an approved specialist. New ironmongery to be installed

Architrave - N/A

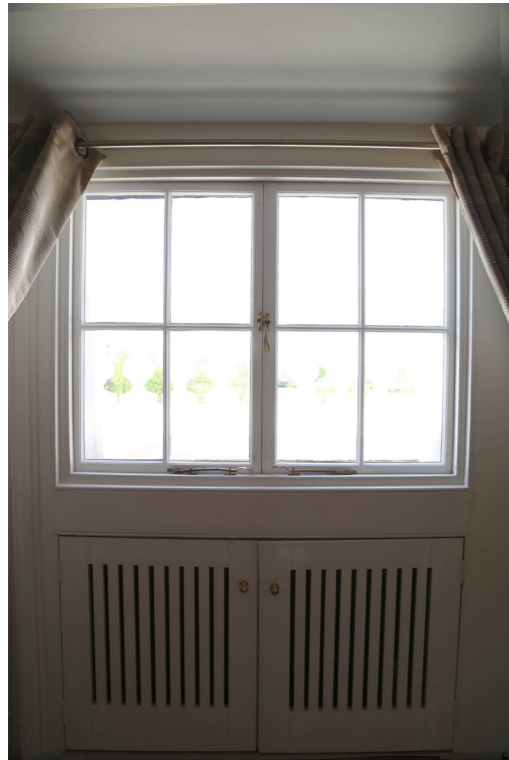
EW 03 01

Timber framed box casement window

Bedroom A x 2

Structural opening size - W/H - as existing

Window - to be retained, carefully repaired and weather - stripped by an approved specialist. New ironmongery to be installed

Architrave - N/A

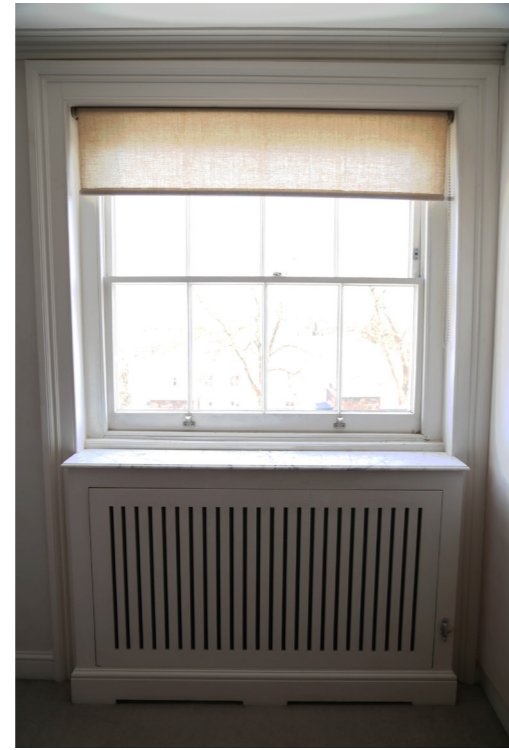
EW 03 02

Timber framed box sash window

Bedroom B x 1

Structural opening size - W/H - as existing

Window - to be retained, carefully repaired and weather - stripped by an approved specialist. New ironmongery to be installed

Architrave - N/A

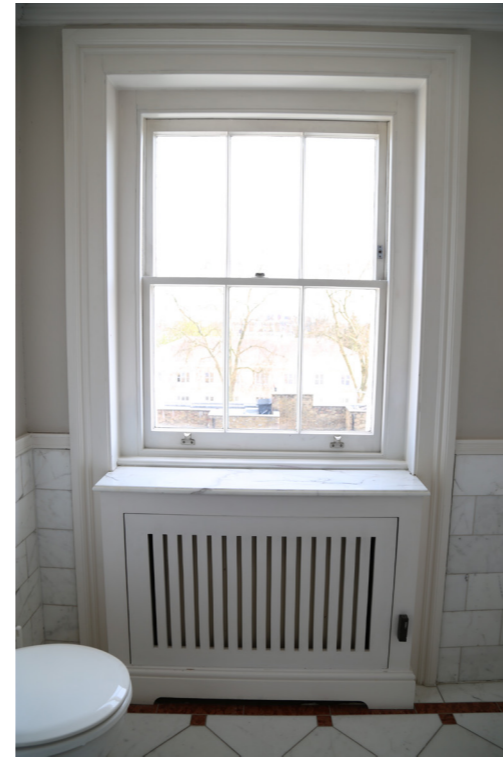
EW 03 03

Timber framed box sash window

Bathroom B x 1

Structural opening size - W/H - as existing

Window - to be retained, carefully repaired and weather - stripped by an approved specialist. New ironmongery to be installed

Architrave - N/A

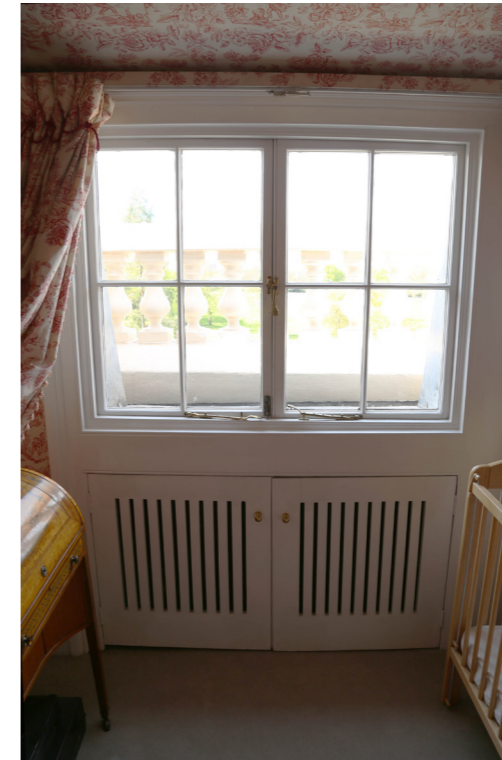
EW 03 04

Timber framed box casement window

Bedroom C x 1

Structural opening size - W/H - as existing

Window - to be retained, carefully repaired and weather - stripped by an approved specialist. New ironmongery to be installed

Architrave - N/A

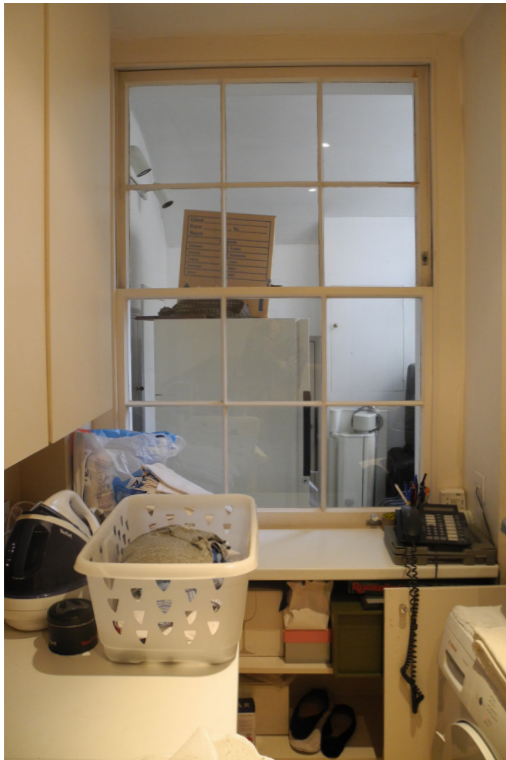
EW B1 01

Timber framed box sash window

Utility room West

Structural opening size - W/H - existing window opening to be extended to be door opening

Window - to be removed, carefully repaired, weather - stripped by an approved specialist, and repositioned. New ironmongery to be installed.

Architrave - N/A

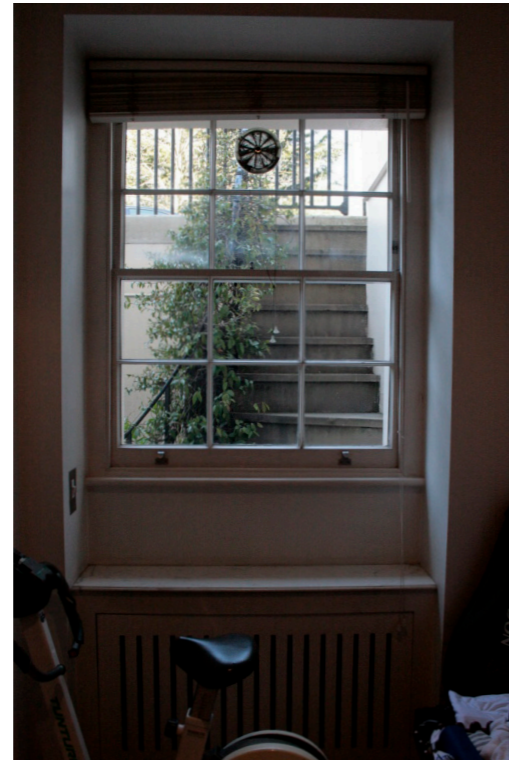
EW B1 02

Timber framed box sash window

Changing room

Structural opening size - W/H - as existing

Window - to be retained, carefully repaired and weather - stripped by an approved specialist. New ironmongery to be installed

Architrave - N/A

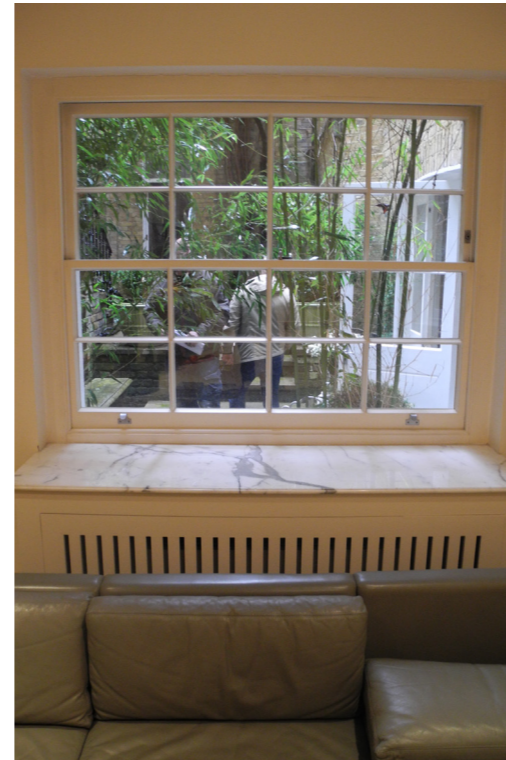
EW B1 03

Timber framed box sash window

Gym

Structural opening size - W/H - to be removed

Window - to be removed and replaced in new wall position with a type EW 02 03 window

Architrave - N/A
