ARBORICULTURAL IMPACT ASSESSMENT REPORT

& METHOD STATEMENT FOR:

8 Prince Albert Road
Camden
London
NW1 7SR

Ref: NLP/8PAR/AIM/01b

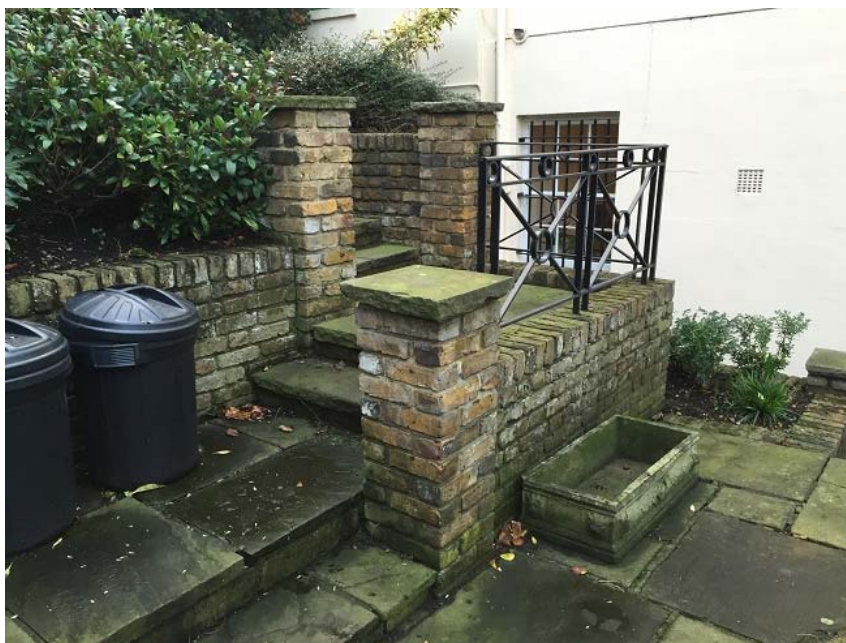
Photograph 2: Level changes and hard landscaping between T5&6 and likely footprint

- 6.1.2 Whilst it is feasible that some roots have undermined the boundary wall and retaining walls present and will be affected by the proposal, this likelihood is remote. Notwithstanding this, mitigation of the hand excavation of the top 750mm of the line of the foundations where they pass through the RPAs and pre-emptive pruning of any roots discovered is proposed.

6.3.2 The path of foundations through RPAs will be manually excavated to 750mm depth under arboricultural supervision; any roots encountered within the trenches / pits will be cleanly pruned back to an appropriate junction with a sharp pruning saw or secateurs back to a junction. Roots larger than 25mm diameter may only be cut in consultation with an arboriculturalist.

6.3.3 The replacement paving/hard landscaping will require a no-dig construction technique, either using a cellular confinement system with no fines aggregate for the sub-base or simply building upon the existing sub-base without disturbing the ground below. Choice of construction method will initially depend upon root penetration within the existing sub-grade. The key principle is not to excavate in the presence of roots and to provide a porous surface to promote healthy soil water relations for future root growth. A further consideration in the use of a more expensive cellular confinement system or similar, may be the claimed reduction in risk of possible future slab / surface displacement by roots of trees growing in paved areas.
