19 Fitzroy Square London W1T 6EQ

Heritage Assessment

18th July 2016

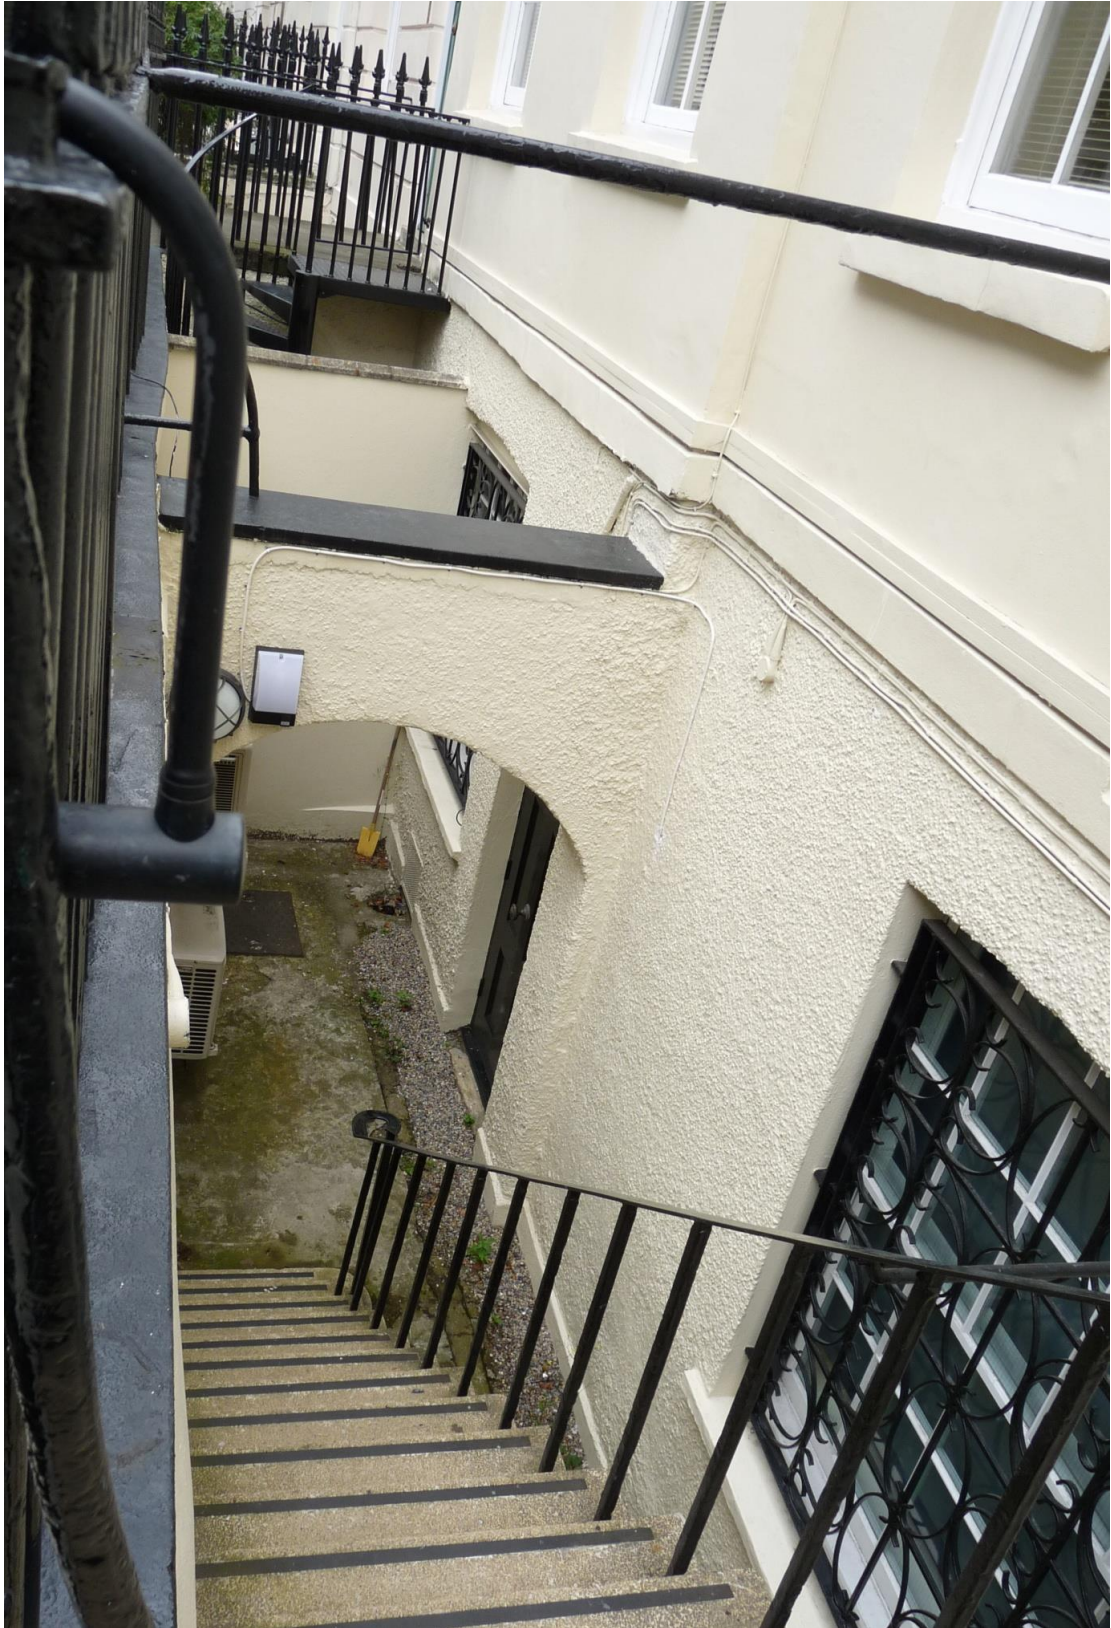
APPENDIX F

Back Wing showing intrusive services and inappropriate wall finishes at basement level.

- 3.2.1.3 The northwest corner of the main building has been rebuilt, possibly at the same time as the back wing along Conway Street was built/rebuilt. The pebble dash finish to the lower ground floor level detracts from the significance of the building.

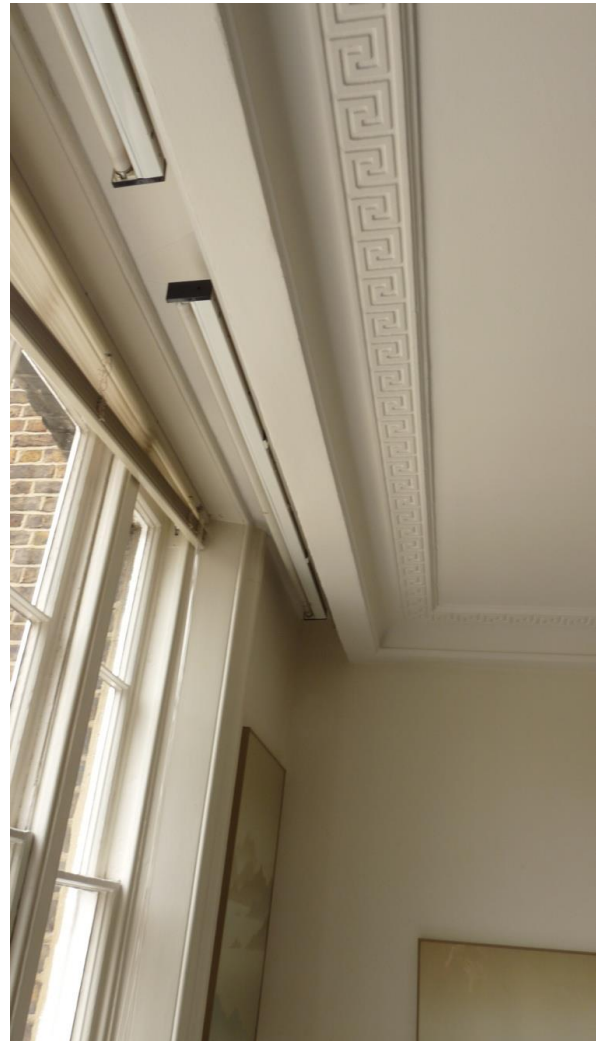
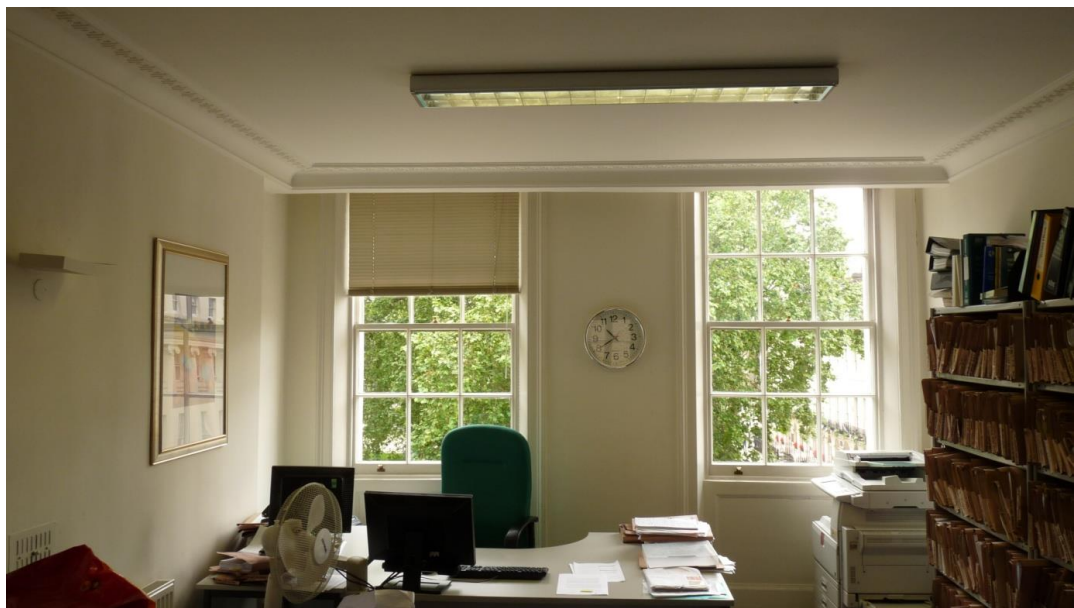
APPENDIX G

- 3.2.2 Building: Interior
 - 3.2.2.1 The main form of the building has been retained but, from both visual inspection and examination of the drawings related to the 2004 planning and listed building consent, there have been a lot of alterations to the internal partitions and finishes.
 - 3.2.2.2 Many of the finishes for both the ceilings and some of the walls and also the related joinery and plaster friezes have been replaced, generally using appropriate joinery sections and decorative plaster mouldings. Many of the ceilings have been dropped below the original levels and the window heads it is believed to conceal steelwork installed as part of the 1958 works – see 3.1.6 above . This has been confirmed by limited investigation on site.

Dropped ceilings due to the insertion of steel work above.

- 5.10 It is proposed to remove the structural steelwork which was introduced in the second half of the last century from the principle rooms at the front to the basement, ground and first floors. This will allow the original ceilings including decorative friezes to be revealed and restored. Together with other alterations to restore original partitions it is considered that these will offer substantial heritage benefits.

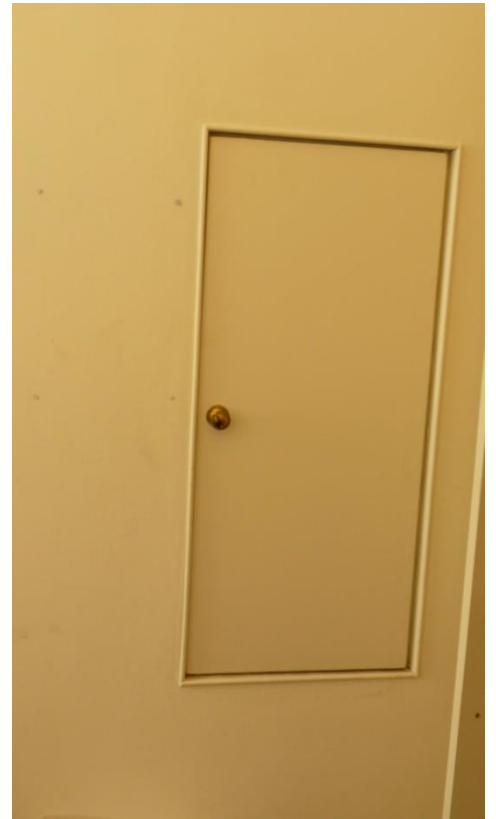
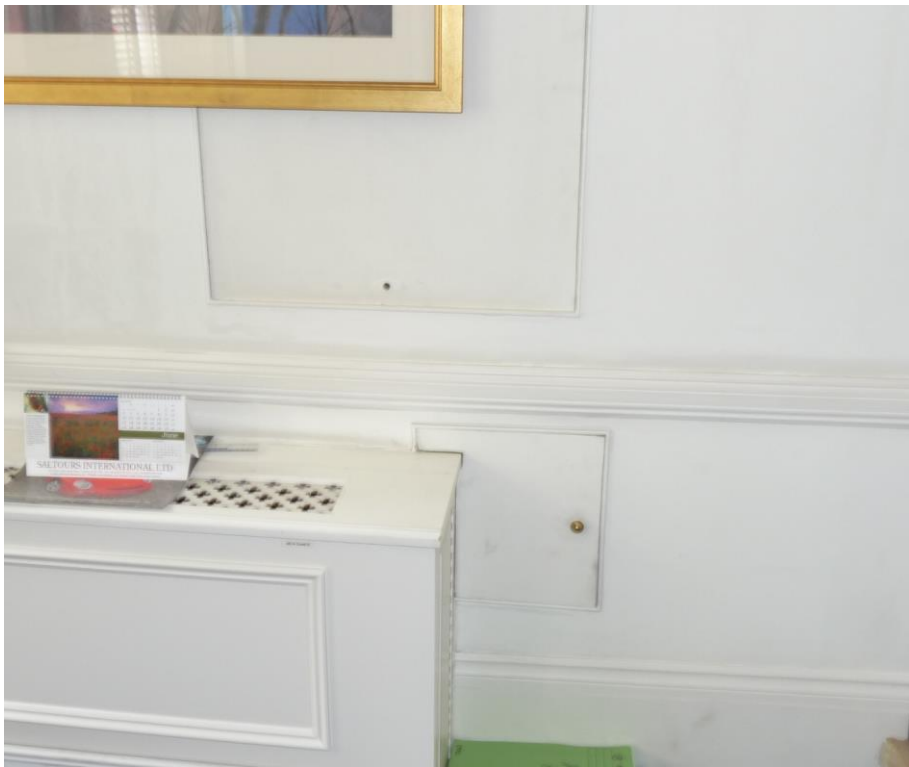
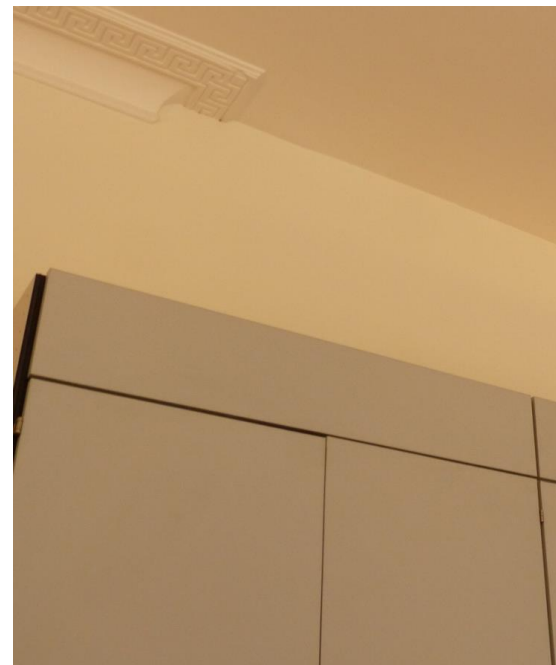
3.2.2.4 There are a number of visually intrusive access panels to what are presumed to be vertical services.

APPENDIX H
Access panels etc.
