Technical Note 001 Revision A
Pruning required to allow for the construction of the
proposed replacement building

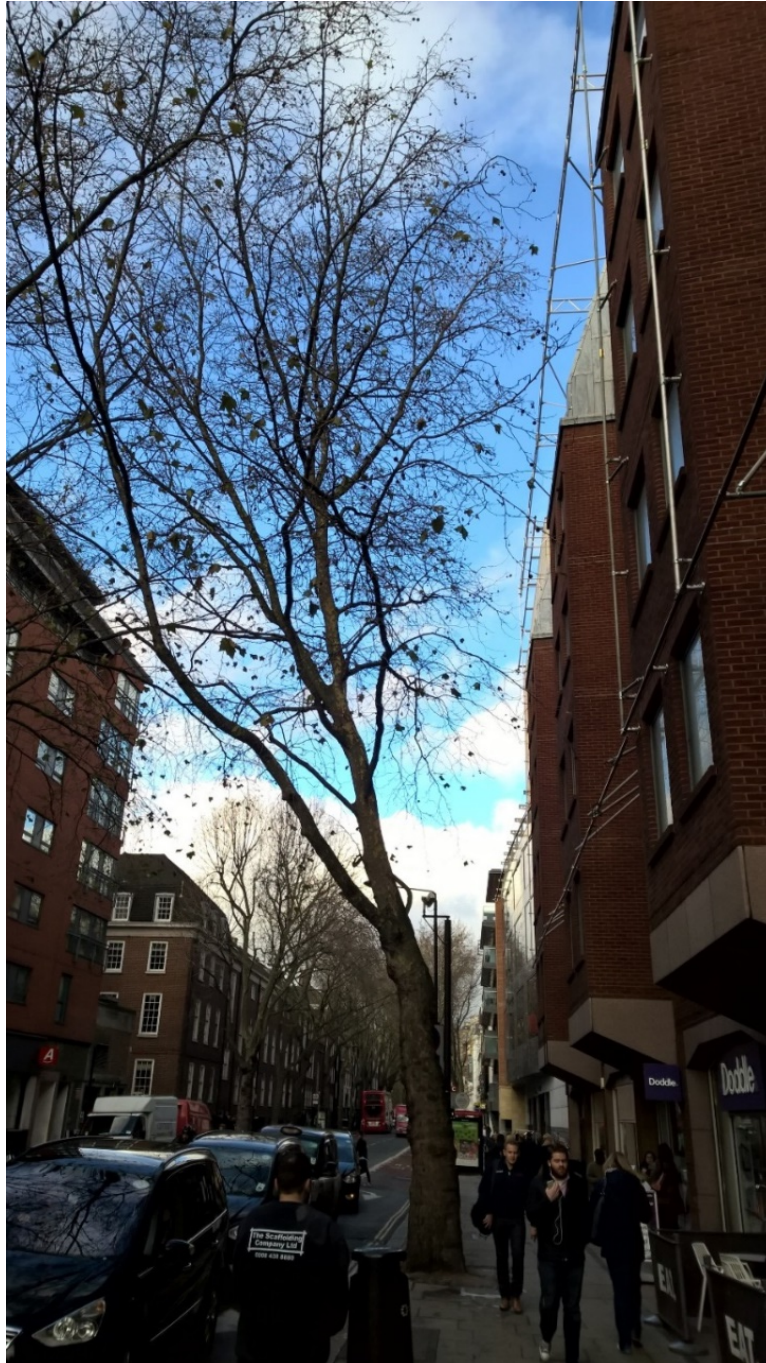
If we look in more detail at the requirement we should consider the actual appearance of the trees and their relationship to the current and proposed building. Figure 1 below shows tree 1 and its relationship to the current building. It was taken at the time of the tree survey in November 2015. One can see that the tree stem leans away from the building, that also projects over the pavement, and over the road. There is already a significant separation between the existing building and the branches of the tree.

On this façade the proposed 2nd floor building projection is from circa 7m above footpath level and so is above the point at which the stem bends out across the road. Despite the already good separation between building and tree there is a need to prune further branches. One can determine from the photo that these branches are relatively minor in relation to the tree and that their loss does not materially alter the appearance of the tree – the tree is already one-sided as is expected when such large species of tree is grown next to a building.

Figure 1: Tree 1 showing relationship to existing building

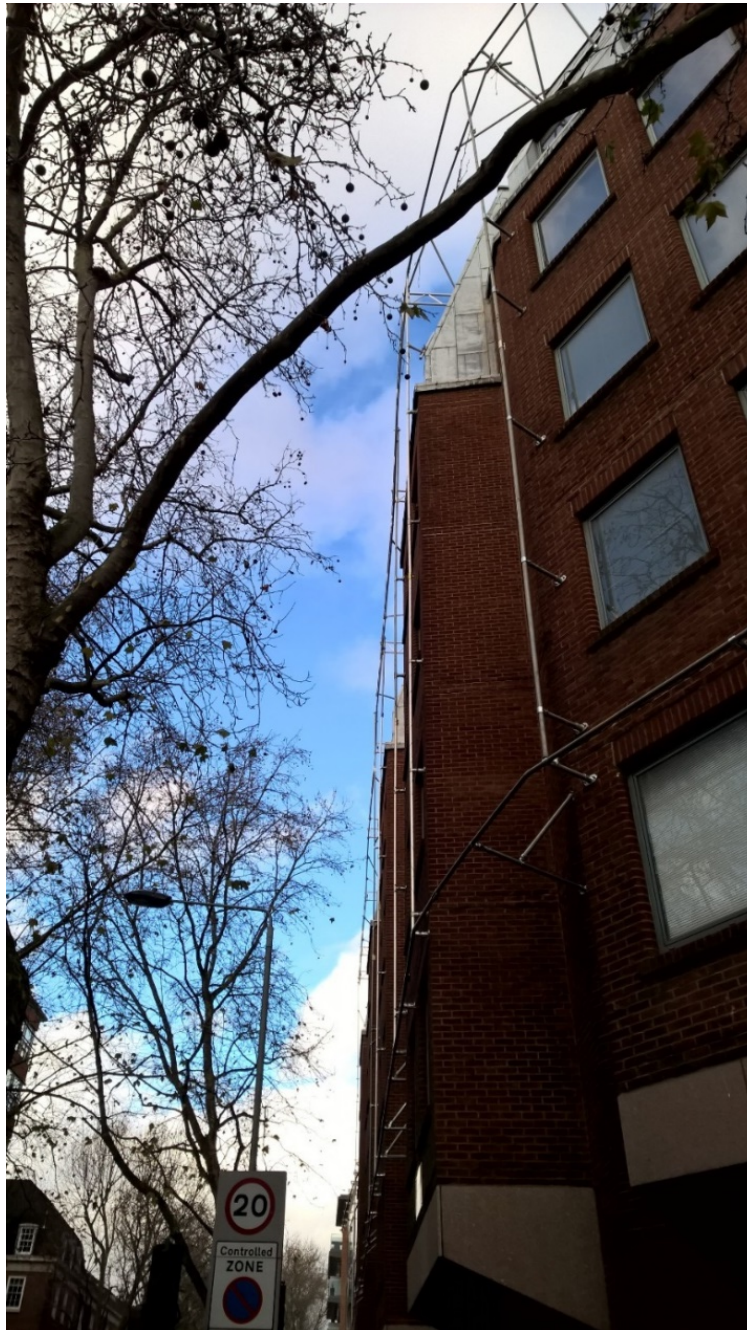
Figure 2 below, also taken at the time of the tree survey, shows tree 2 and its relationship to the existing building. One can also determine that there is good separation from the existing building. If one looks closely one can see the truncated branch ends associated with current pruning that results in the generous separation. A stray limb extends to the upper right of the picture to cross the southern elevation of the building. It cannot be seen in this photograph but it too is remote from the façade. These ‘outlying’ type branches are vulnerable to breakage as they are subject to abnormal wind loads. At some future point, the tree owner may be obliged to undertake pruning to reduce the branch length and therefore its propensity to breakage.

One can determine from the photograph that the pruning required to accommodate the proposed building will require further shortening of already truncated branches and pruning of other minor pruning. Akin with tree 1 the visual results of the pruning are little different to that experienced with the current regime. Pruning to accommodate this large species of tree so close to a building will merely continue the one-sided appearance

Figure 2: Tree 2 and its relationship to the building. Tree 1 is in the background where the degree of separation from the building can be seen
