No 10 Downside Crescent

**Camden Geological, Hydrogeological  
and Hydrological Study**  
Areas of landslide potential

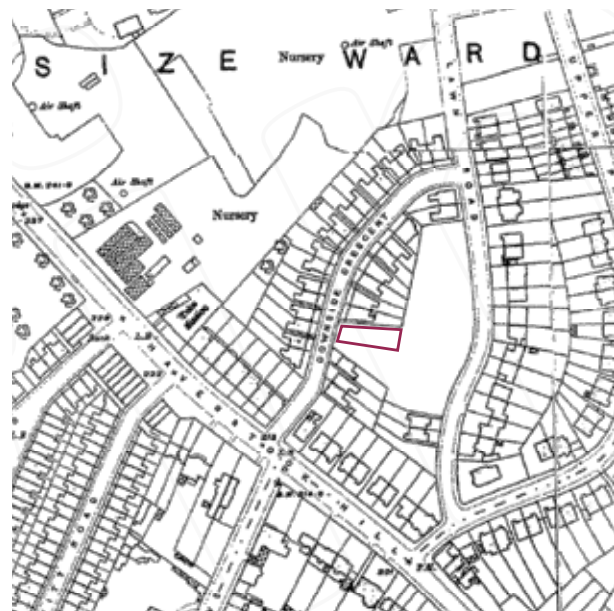
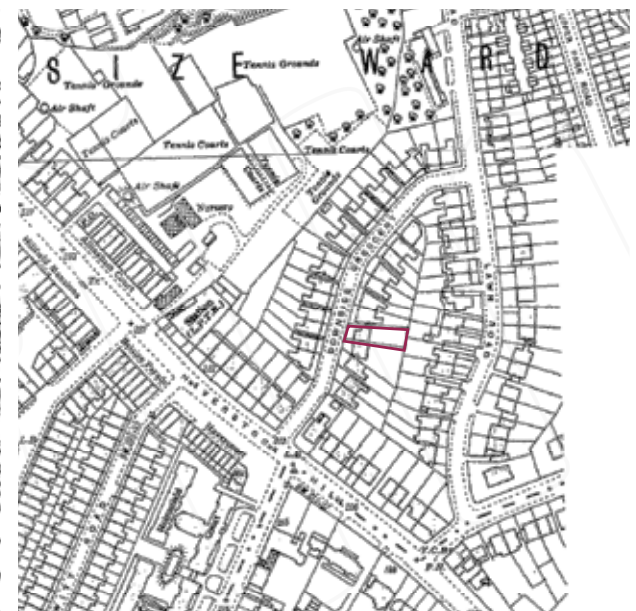
FIGURE 19

1890

1910

1930

Maps showing the development of the land at no 10 over time.
